**CALSPAN ON-SITE ADVANCED OCCUPANT PROTECTION SYSTEM
CRASH INVESTIGATION**

SCI CASE NO: CA04-014

**VEHICLE: 2004 SATURN ION
LOCATION: PENNSYLVANIA
CRASH DATE: FEBRUARY, 2004**

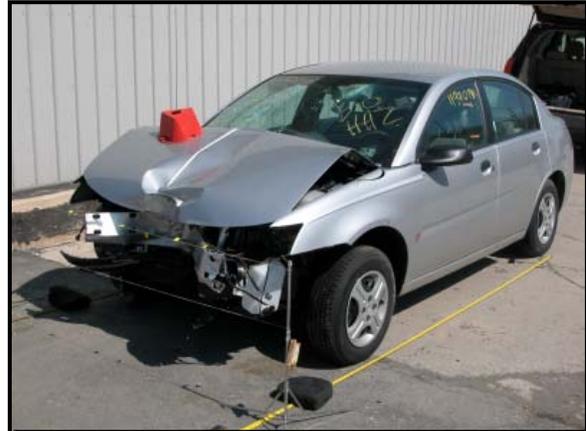
This on-site investigative effort focused on the performance of the Advanced Occupant Protection System (AOPS) in a 2004 Saturn Ion, **Figure 1**. The Saturn was involved in a fixed object frontal impact with a tree. The Saturn was equipped with an AOPS that consisted of dual-stage frontal air bags and retractor pretensioners for the front safety belts. The AOPS was not commanded to deploy in the moderate severity frontal crash. Additionally, the vehicle was equipped with an Event Data Recorder (EDR) that had the capabilities to record both pre-crash vehicle systems and crash related data. That data was downloaded during the inspection as a supplement to the investigation. The 23 year old

Figure 1: 2004 Saturn Ion.

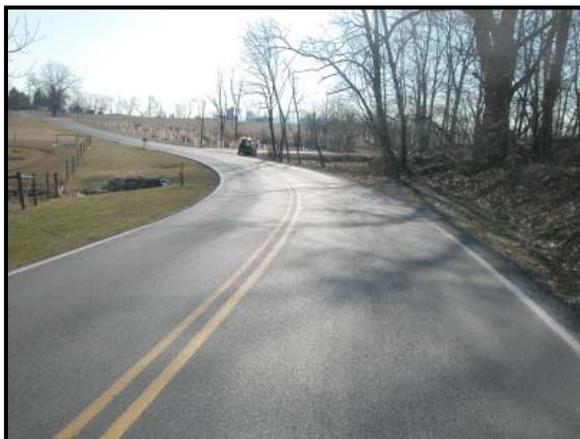
Figure 3: Eastbound trajectory view 55 m (180 ft) from impact.

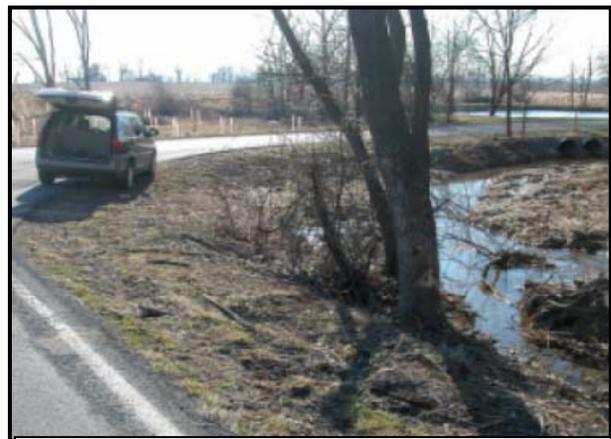
Figure 2: View of the point of impact.

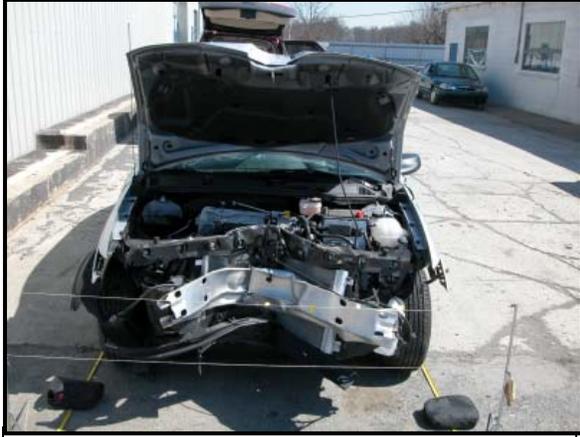
Figures 3 and 4 are the front and overhead views of the Saturn. The frontal plane of the vehicle sustained 28 cm (11.0 in) of direct contact damage as a result of the tree impact. The direct damage started 14 cm (5.5 in) left of center and ended 14 cm (5.5 in) right of center. The combined width of the direct and induced frontal damage extended across the entire 145 cm (57 in) frontal width of the vehicle. The components damaged in the impact included the front bumper fascia and reinforcement bar, center grille, hood, radiator, air conditioner condenser, upper radiator support and headlamp assemblies. The right forward uni-body frame end deformed 15 cm (6 in) inboard during the impact phase, as the bumper reinforcement bar crushed into a U-pattern. The residual crush profile measured along the reinforcement bar was as follows: C1 = 1 cm (2.5 in), C2 = 21 cm (8.3 in), C3 = 49 cm (19.3 in), C4 = 58 cm (22.8 in), C5 = 50 cm (19.7 in), C6 = 1 cm (2.5 in). The right wheelbase reduction measured 6 cm (2.5 in). The left wheelbase was unchanged. All four doors remained closed during the impact and were operational at the time of the SCI inspection. The Collision Deformation Classification (CDC) was 12-FCEN-3. The delta V of the crash calculated by the Barrier Algorithm of the WINSMASH model was 35 km/h (21.7 mph). The longitudinal and lateral components were -35 km/h (-21.7 mph) and 0, respectively.

Figure 4: Front view of the Saturn.

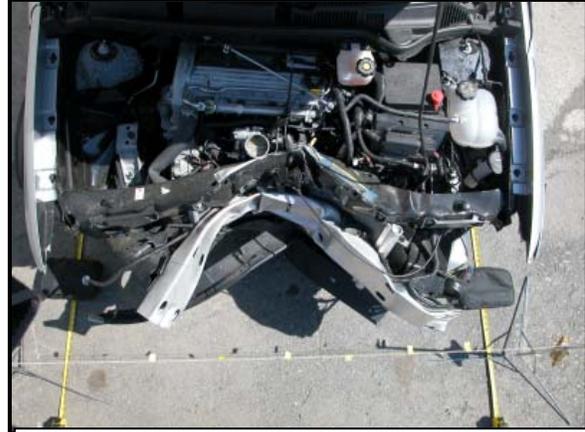
Figure 5: Overhead view of the frontal damage.

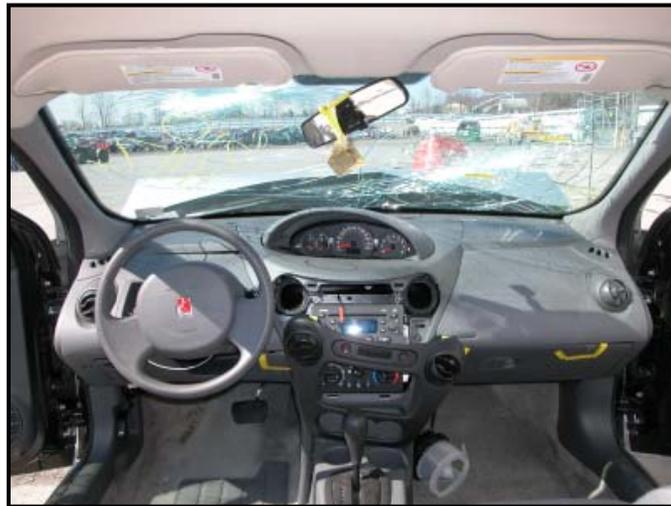
Figure 6 is an interior view of the Saturn. The vehicle's interior damage consisted of the identified (unrestrained) occupant interior contacts. There was no intrusion or damage related to the exterior force of the impact. There was no deployment of the vehicle's frontal air bags.

Figure 6: Interior view.

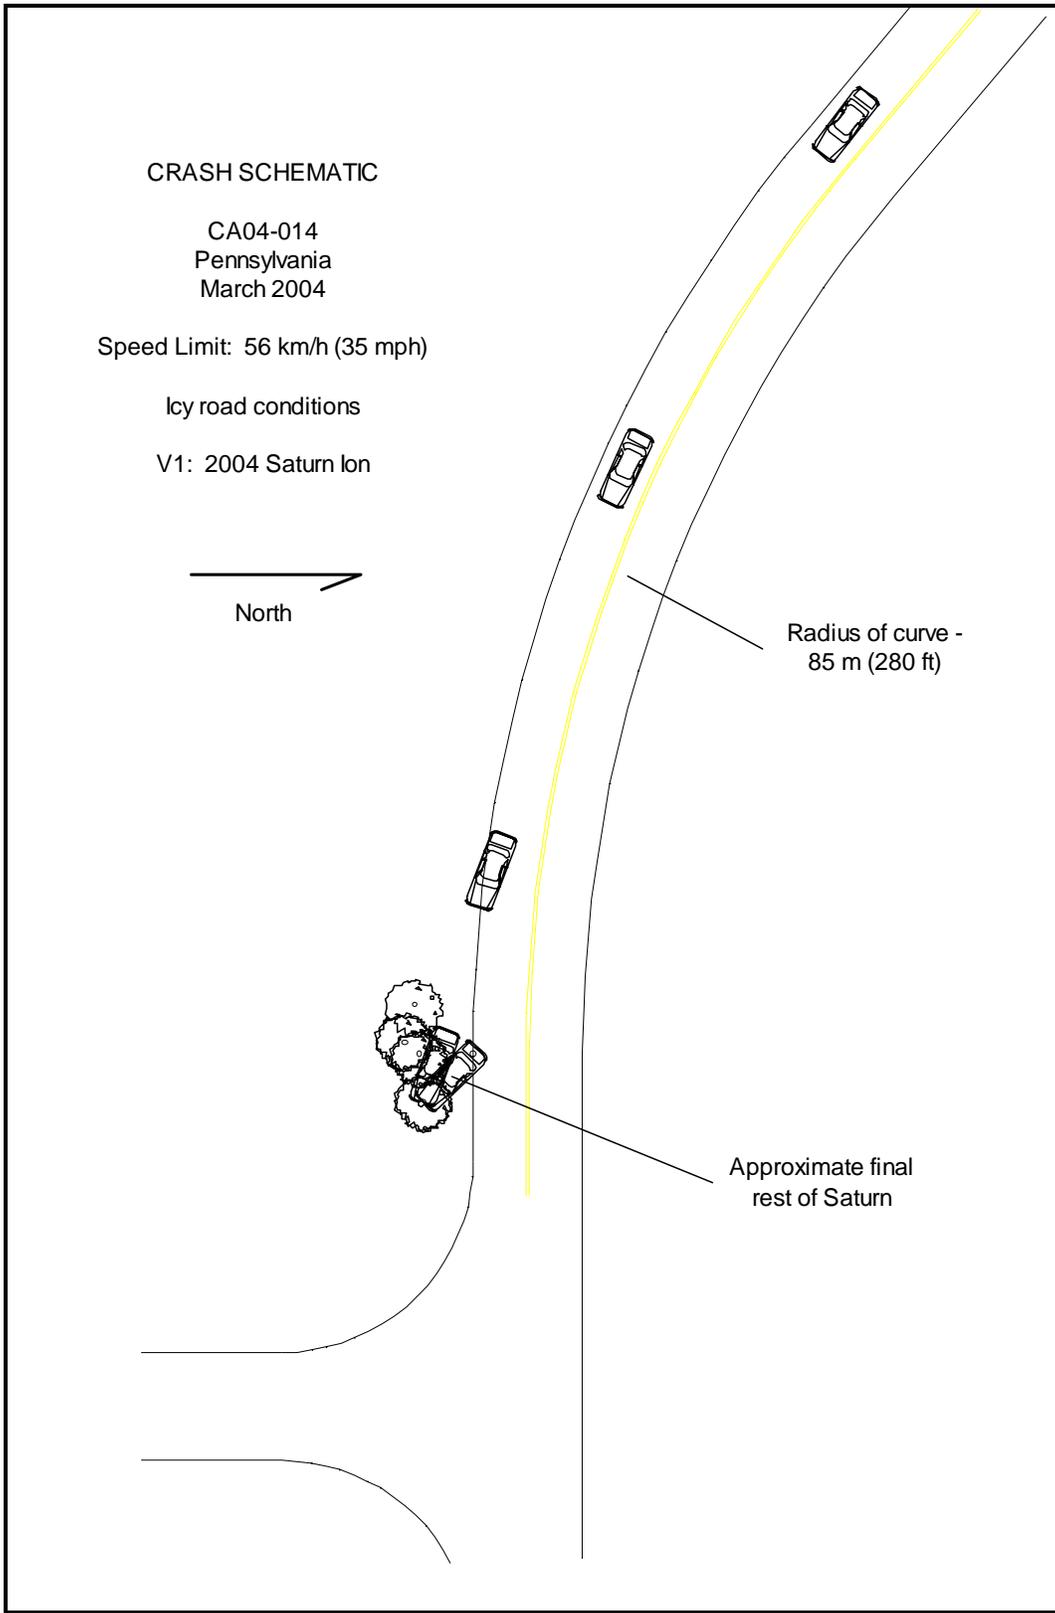
Figure 7: Crash Schematic.

The 23-year-old male driver was operating the Saturn eastbound attempting to negotiate the left curve. The road conditions were reported as icy; the weather was snow and sleet. A 25 year old male was seated in the vehicle's front right position. Neither occupant of the Saturn was restrained by the vehicle's manual safety belt system. As the Saturn approached the exit of the curve, the driver lost directional control and the vehicle departed the right side of the road. A probable tire mark located 16 m (52 ft) west of the point of impact defined the location of the vehicle's roadside departure. A schematic of the crash is attached to the end of this report as **Figure 7**.

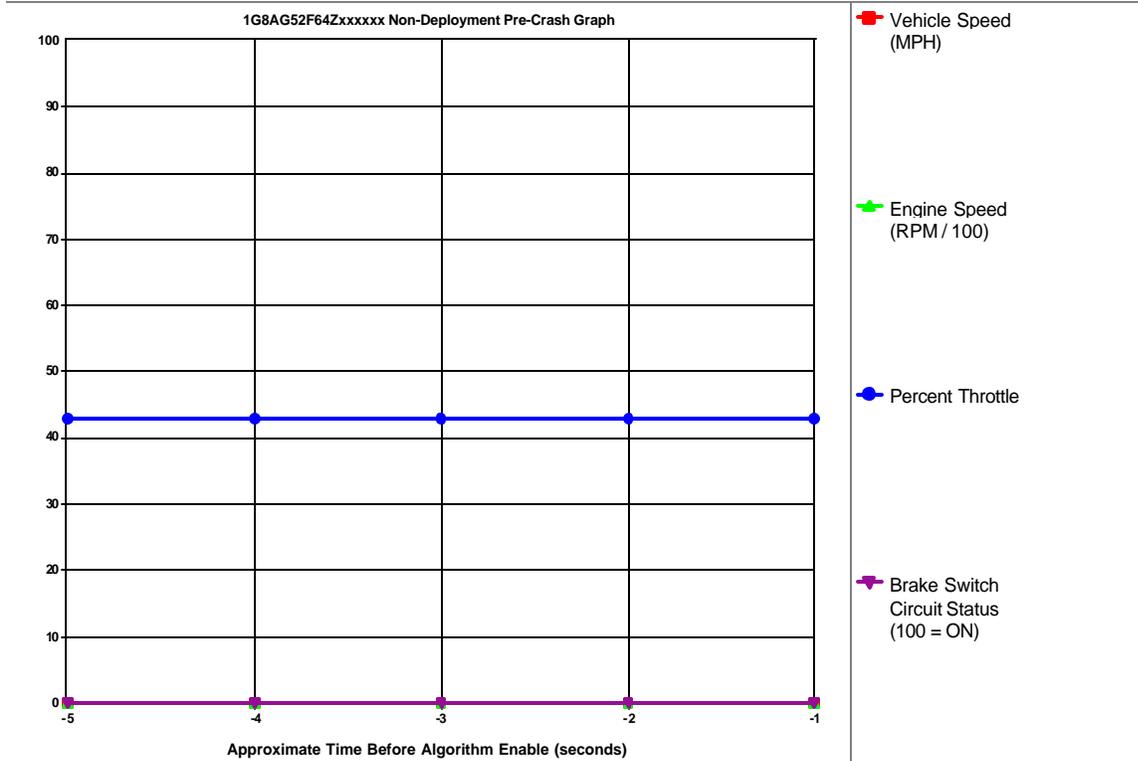
Seconds Before AE	Vehicle Speed (MPH)	Engine Speed (RPM)	Percent Throttle	Brake Switch Circuit Status
-5	0	0	43	OFF
-4	0	0	43	OFF
-3	0	0	43	OFF
-2	0	0	43	OFF
-1	0	0	43	OFF

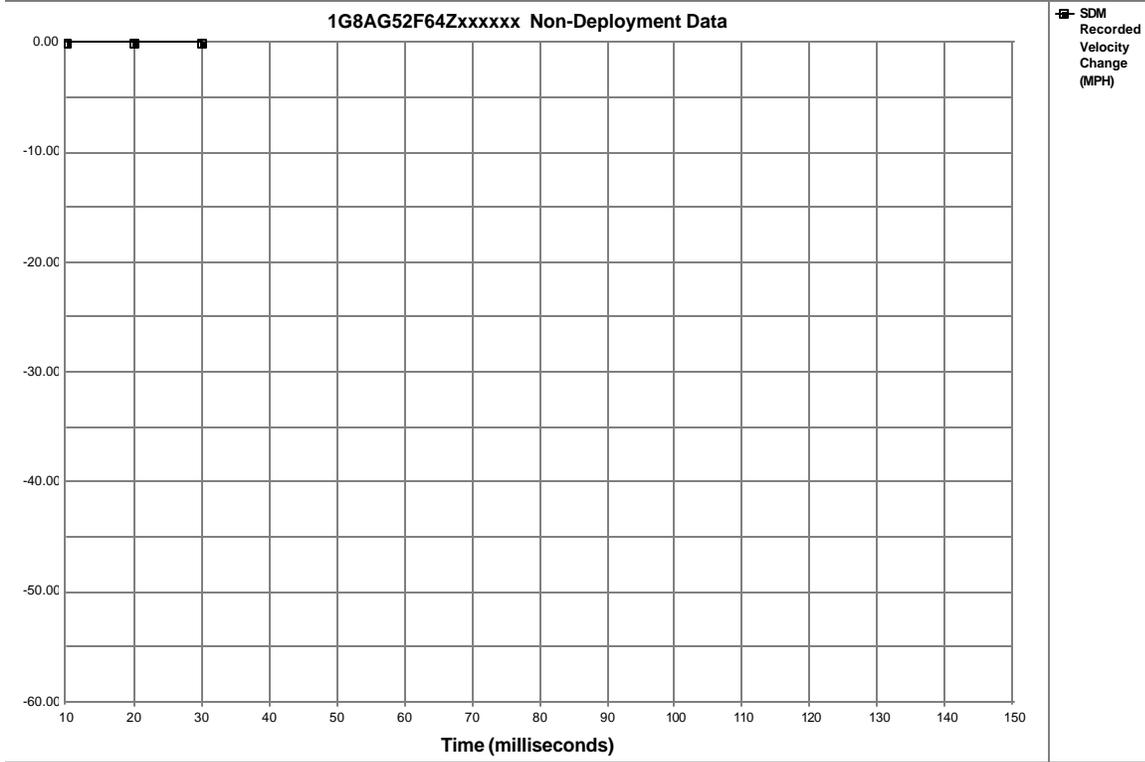
The Vetronix CDR hardware was connected to the J1962 port located under the left aspect of the instrument panel and the EDR was downloaded on ignition cycle 323. The data indicated a non-deployment event was stored on ignition cycle 321. Given that the key cycle of the event and the download were only separated by two cycles, it was possible that the stored data was related to the subject crash. However upon review of the EDR data, the stored data was deemed unreliable. The Pre-Crash vehicle speed and Engine RPM were recorded as Zero and the crash pulse data (Delta V) was also Zero. The maximum recorded SDM velocity change was -0.6 km (-0.40 mph) for this moderate severity crash.

Time (milliseconds)	10	20	30	40	50	60	70	80	90	100	110	120	130	140	150
SDM Recorded Velocity Change	0.00	0.00	0.00	N/A
