# INDIANA UNIVERSITY

## ON-SITE CERTIFIED ADVANCED 208- COMPLIANT VEHICLE INVESTIGATION

CASE NUMBER - IN-04-016  
LOCATION - TEXAS  
VEHICLE - 2004 DODGE DURANGO LIMITED  
CRASH DATE - April 2004

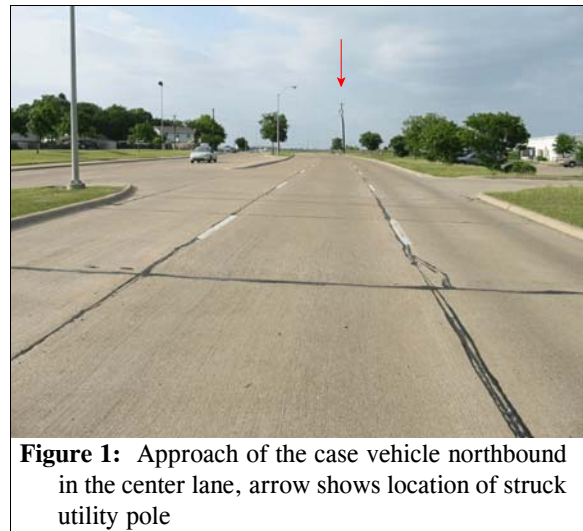
**Figure 1:** Approach of the case vehicle northbound in the center lane, arrow shows location of struck utility pole

**Pre-Crash:** The case vehicle was traveling north in the center lane approaching the curve, and the driver was intending to continue northwest bound (Figure 1 above). The case vehicle did not negotiate the curve, but continued straight ahead and departed the east side of the roadway. There was no indication in the police report or during this contractor's scene inspection that the case vehicle's driver took any actions to avoid the crash. The pre-crash motion of the case vehicle relative to its travel lane and area where it departed the roadway (Figure 2) shows the case vehicle essentially traveled straight ahead in the curve indicating the driver may have fallen asleep; however, it is unknown why the case vehicle departed the roadway. The case vehicle's driver stated to police, and to this contractor's investigator, that he steered right to avoid a vehicle that cut into his lane from the outside lane, which caused him to depart the roadway. The police crash report listed two witnesses that stated there were no other vehicles near the case vehicle prior to the crash. The crash occurred on the east side of the roadway.

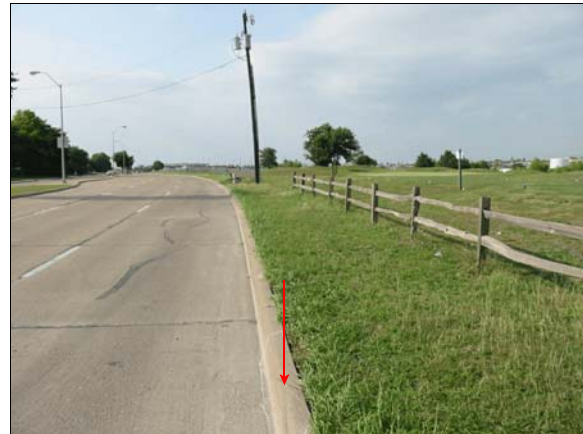
**Crash:** The impacts to the case vehicle involved a decorative, split-rail, wooden fence and a utility pole (Figure 2) followed by a passenger side leading rollover. The utility pole was wooden and bolted onto the east side of the pole was a large, metal conduit pipe housing electrical cable that connected to three transformers mounted on top of the pole. This contractor's investigation and information in the police crash report indicated that the wooden fence extended up to the utility pole, and a section of it was broken out by the case vehicle during the impact sequence. However, there was little evidence on the case vehicle of the apparent contacts with the wooden fence. This is most likely due to the materials and construction of the wooden fence. Fences of this type are made of soft wood and the support posts are not buried deep in the ground and offer little resistance to an impact by a motor vehicle. The front right portion of the case vehicle appears to have first impacted the wooden fence (Figure 3), and then the front (Figure 4) immediately

**Figure 2:** Approach of case vehicle to utility pole impact, arrow shows case vehicle tire mark on curb

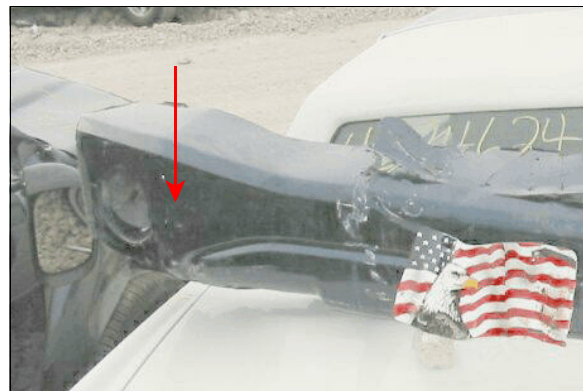
**Figure 3:** Arrow shows direct damage from wooden fence impact to right corner of front bumper cover

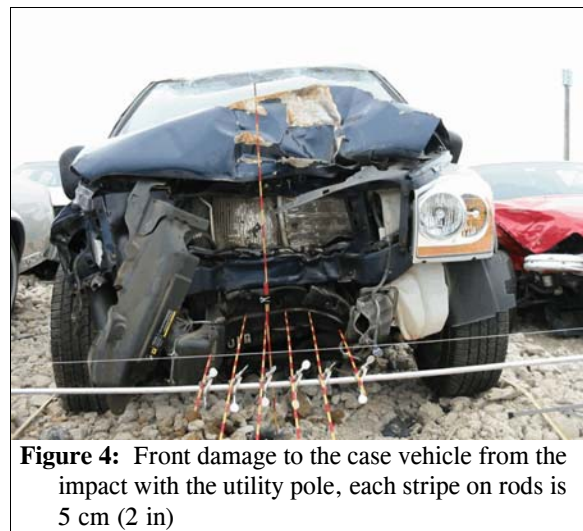
**Figure 4:** Front damage to the case vehicle from the impact with the utility pole, each stripe on rods is 5 cm (2 in)

**Damage Classification:** Based on the vehicle inspection the CDCs for the damage to the case vehicle were determined to be: **12-FRLE-1 (0 degrees)** for the front impact to the wooden fence, **12-FYEW-3 (0 degrees)** for the front impact to the utility pole, **03-RPEW-1 (90 degrees)** for the right side impact to the wooden fence and, **00-TZDO-2** for the rollover.

The WinSMASH reconstruction program could not be used on the case vehicle's impact with the utility pole because the pole fractured. However, the WinSMASH program was used to determine a barrier equivalent speed of 48.1 km.p.h (29.9 m.p. h.) based on the damage to the front of the case vehicle.

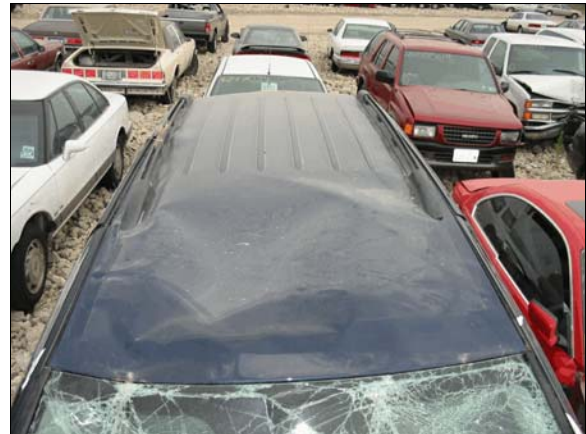
**Figure 5:** Rollover damage to the top

(Figure 5 above and Figures 9 and 10). In addition, the left side had a few dents and some scratches, the left side view mirror was broken off its mount and the driver’s door window was cracked. This damage appeared to be related to rolling the vehicle back onto its wheels in order to tow the vehicle from the crash scene. The table below shows the case vehicle’s front crush profile

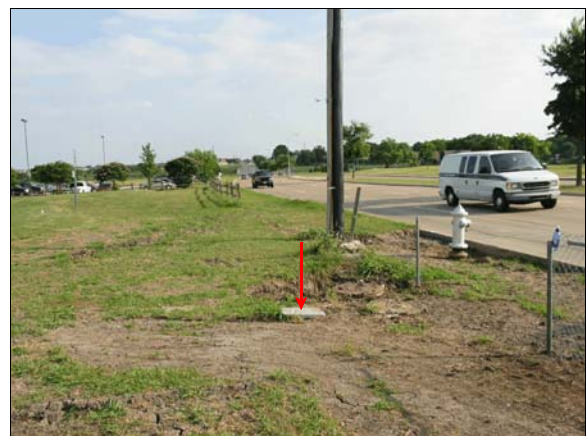
**Post-Crash:** The case vehicle came to rest on its top facing west about five meters (16.4 feet) from the roadway (**Figure 6**). Following the utility pole impact, the broken section of the utility pole impacted and damaged a section of woven wire fence north of the base of the utility pole (**Figure 6**). In addition, the police crash report indicates a "water main" located a short distance north of the utility pole was also damaged. There was no indication on the police crash report or during this contractor's scene inspection that a fire hydrant located a short distance northwest of the utility pole was also impacted. Also, there was no damage apparent on the case vehicle indicating an impact with the woven wire fence, a water main (or water main cover) or the fire hydrant. This contractor therefore concludes that the damage to these objects resulted from contact by the broken section of the utility pole.

**Figure 6:** View to southwest showing damage to woven wire fence, missing section of wooden fence, water main cover (arrow), fire hydrant and area of rest of case vehicle (near bottom of photo)

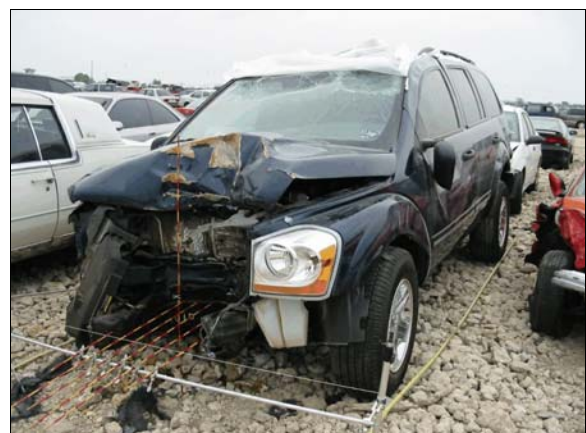
**Figure 7:** Overview of front and left side of case vehicle and damage to front of vehicle from impact with the utility pole

**Exterior Damage:** The case vehicle's impact with the utility pole involved the front bumper, grille and hood (**Figure 7** above). The center of the direct damage was offset to the left of the centerline of the case vehicle 8 centimeters (3.2 inches). The direct damage began 16 centimeters (6.3 inches) left of the front right bumper corner and extended 43 centimeters (17.9 inches) along the bumper. The crush pocket approximated the shape of the utility pole. Crush measurements were taken at the front bumper bar because the front bumper cover was off the vehicle. The maximum crush to the front bumper bar occurred at C<sub>2</sub> (**Figure 8**) and was measured as 58 centimeters (22.8 inches). There was a small area of direct damage scratches on the front bumper cover (**Figure 3** above) about 20 centimeters in length beginning at the right corner of the bumper cover. This appeared to be the result of the impact with the wooden fence. In addition, there were several small areas of direct damage to the right side of the case vehicle that also appeared to be due to impact with the wooden fence. Direct and induced damage from the rollover involved the right side, top and windshield of the case vehicle

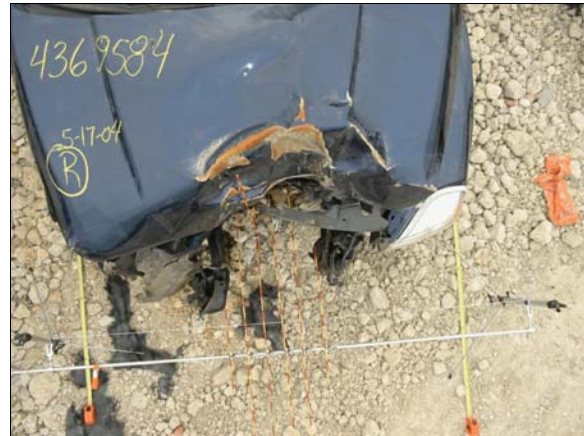
**Figure 8:** Top view of front crush

Units	Event	Direct Damage		Field L	C <sub>1</sub>	C <sub>2</sub>	C <sub>3</sub>	C <sub>4</sub>	C <sub>5</sub>	C <sub>6</sub>	Direct	Field L
		Width CDC	Max Crush								±D	±D
cm	1	43	58	43	13	58	57	54	51	0	-8	0
in		16.9	22.8	16.9	5.1	22.8	22.4	21.3	20.1	0.0	-3.2	0.0

The case vehicle’s wheelbase was unchanged on the left side and extended 1 centimeter (0.4 inch) on the right side. Induced damage involved the hood, both front fenders, the roof and right side.

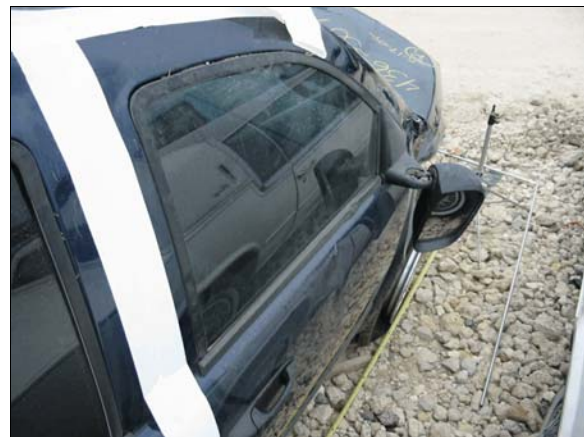
**Figure 9:** Rollover damage to right front door

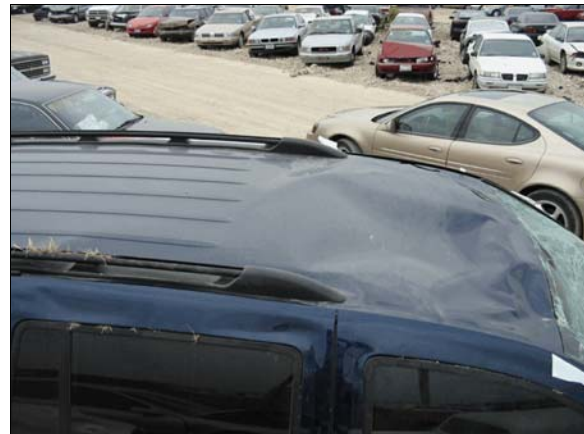
**Figure 10:** Rollover damage to right roof side rail and roof

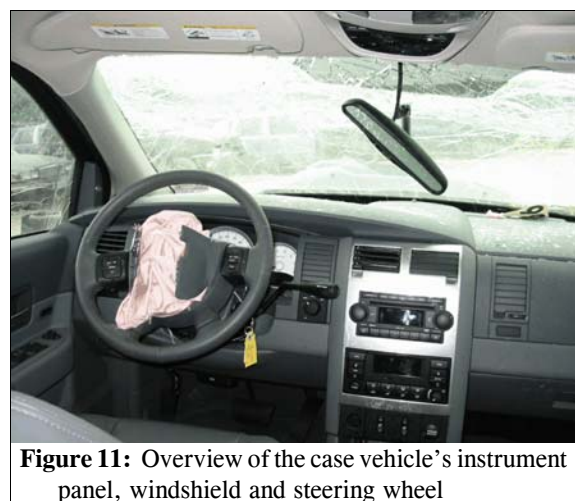
**Vehicle Interior:** Inspection of the case vehicle’s interior (Figure 11) revealed no evidence of occupant contact to any interior surfaces or components. The case vehicle sustained eight occupant compartment intrusions, all occurring in the front seat row. The most severe intrusions were 14 centimeters (5.5 inches) of vertical roof intrusion into the front right seat area, 12 centimeters (4.7 inches) of vertical windshield intrusion into the front right seat area, and 10 centimeters (3.9 inches) of vertical windshield intrusion into the driver’s seat area. There was no

Figure 11: Overview of the case vehicle’s instrument panel, windshield and steering wheel

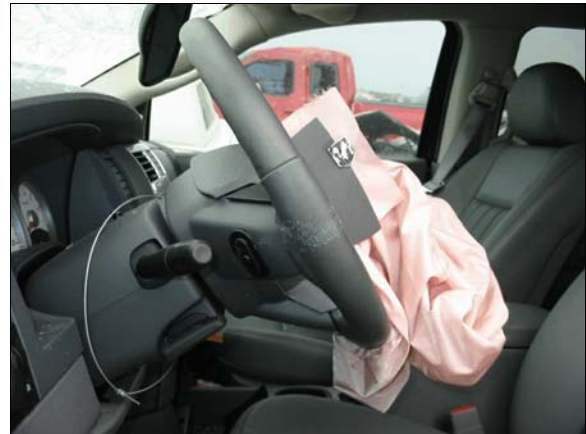
apparent compression of the energy absorbing steering column, and no deformation of the steering wheel rim was observed (**Figure 12**)

**Figure 12:** Overview of case vehicle's steering wheel and steering column; Note, spots on steering wheel rim are from adhesive tape

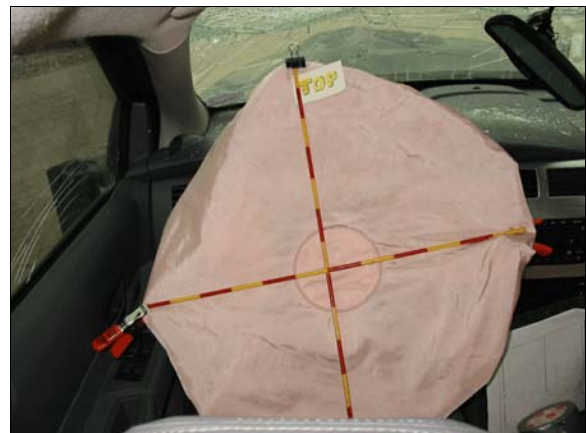
The case vehicle's driver air bag was located in the steering wheel hub. An inspection of the air bag module cover flaps and the air bag fabric revealed that the cover flaps opened at the designated tear points. There was no evidence of damage during the deployment to the module cover flaps, but the air bag had a few scuffs on it that appeared related to the deployment. The deployed driver's air bag (**Figure 13**) was round with a diameter of approximately 63 centimeters (24.8 inches). The air bag was designed with two

**Figure 13:** Case vehicle's driver air bag

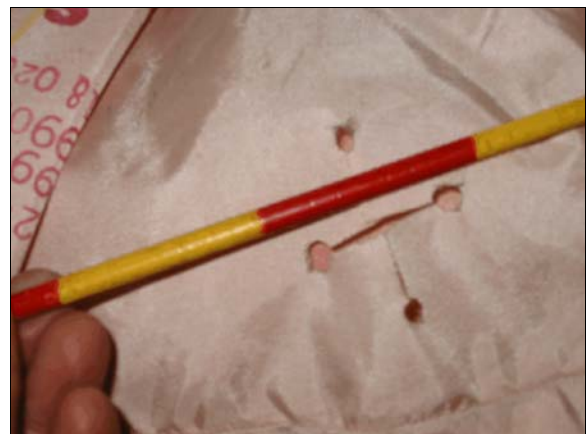
**Figure 14:** One of case vehicle's two driver air bag vent ports

tethers, each approximately 4.5 centimeters (1.8 inches) in width, and had two X-shaped vent ports located at the 11 and 1 o'clock positions. The vent ports were 4.5 centimeters (1.8 inches) in width with a 0.5 centimeter (0.2 inch) hole at each corner (**Figure 14** above). The two air bag module flaps (**Figure 15**) were constructed of pliable vinyl with a cloth backing. The top of each flap was straight while the bottom was rounded. The tear seams ran across the top, down the middle and along the bottom of the flaps. There was a Dodge emblem on the left flap and a cut-out on the right flap that mated with the emblem. Each flap was 13.5 centimeters (5.3 inches) in height along the vertical tear seam and 7.5 centimeters (3 inches) in width at its widest point. The distance between the mid center of the driver's seat back, as positioned at the time of the inspection, and the front surface of the air bag at full excursion was 29 centimeters (11.4 inches).

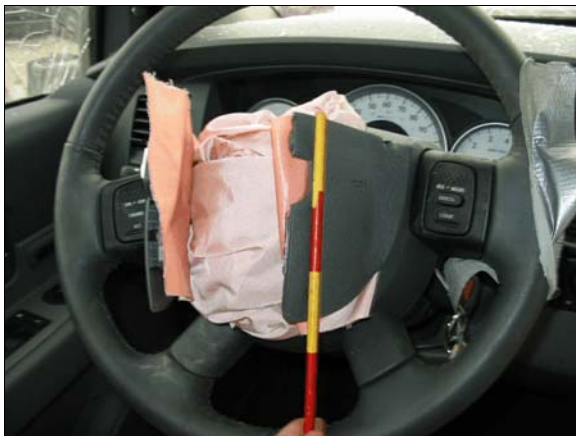
**Figure 15:** Case vehicle's driver air bag module flaps

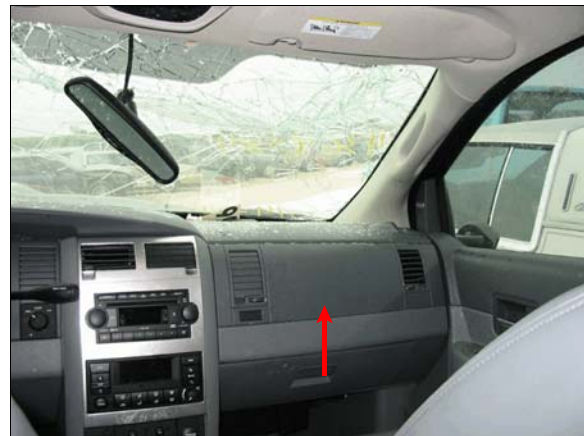
**Figure 16:** Overview of case vehicle's right instrument panel and location of front right air bag (arrow)

The front right passenger's air bag was located in the middle of the instrument panel (**Figure 16**). The deployment of the front right air bag was properly suppressed by the case vehicle's advanced occupant protection system because there was no front right passenger in the case vehicle at the time of the crash.

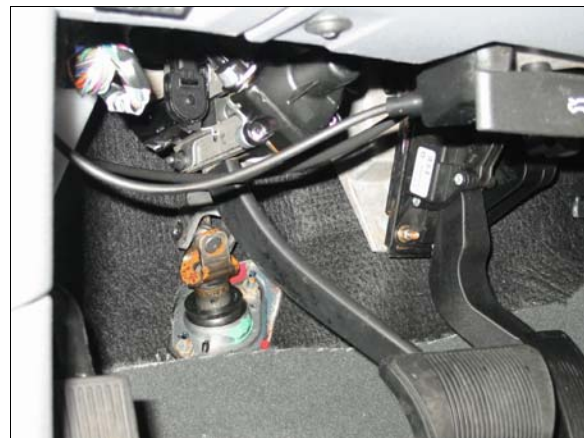
**Figure 17:** Case vehicle's adjustable brake and accelerator foot pedals

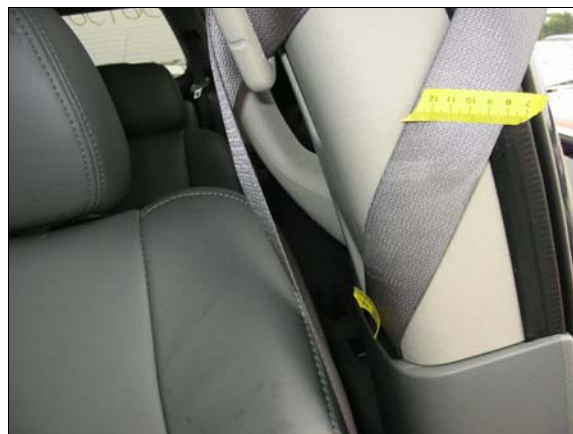
The case vehicle's driver was restrained by his manual, three-point, lap-and-shoulder, safety belt system. The safety belt system was equipped with a belt pretensioner and load limiting retractor. These components were housed within the B-pillar. Inspection of the seat belt assembly revealed load marks on the shoulder belt webbing (**Figure 18**). The driver also stated in his interview that he was wearing the lap and shoulder belt.

**Figure 18:** Load marks on driver's shoulder belt, between the yellow tapes
