**CALSPAN ON-SITE CERTIFIED ADVANCED 208-COMPLIANT
VEHICLE CRASH INVESTIGATION**

CASE NO.: CA04-019

VEHICLE: 2004 HONDA ACCORD

CRASH DATE: MARCH 2004

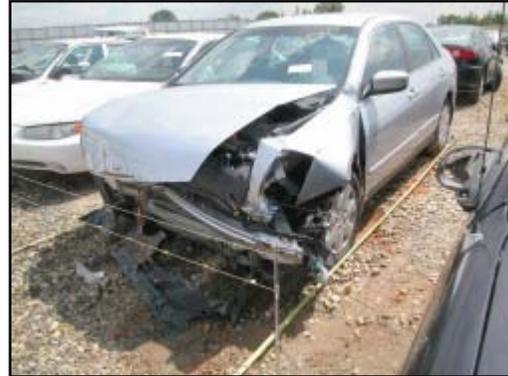
This on-site investigative effort focused on the performance of the Certified Advanced 208-Compliant (CAC) safety system that was present in a 2004 Honda Accord sedan (**Figure 1**). The 2004 Honda Accord was equipped with dual stage frontal air bags for the driver and front right passenger positions, seat track positioning sensors, a front right weight sensor, safety belt buckle switches, retractor-mounted safety belt pretensioners, and an Event Data Recorder (EDR). The Accord was occupied by a 21-year-old restrained female driver. The driver was operating the Accord on the outboard southbound lane of an eight-lane divided highway during daylight hours. The police reported that the driver initiated a lane change maneuver and lost control of the vehicle.

Figure 1. Damaged 2004 Honda Accord

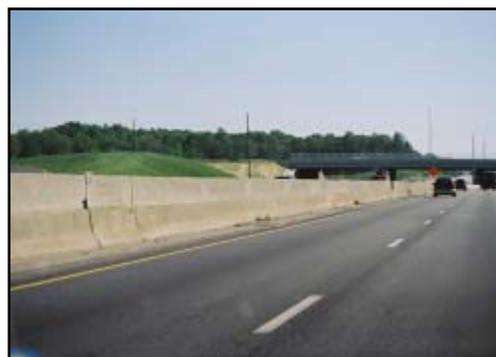
This single-vehicle crash occurred during the daylight hours of March 2004 in the state of Georgia. At the time of the crash, the weather was clear and the asphalt roadway surface was dry. The crash occurred on the southbound lanes of an eight-lane divided highway (**Figure 2**). The north/south travel lanes were separated by an extended-height Jersey median barrier that was approximately 178 cm (70") in height. Each of the four southbound travel lanes measured 3.7 m (12.0') in width and were bordered by asphalt shoulders and Continuous Shoulder Rumble Strips (CSRS). The roadway was straight and level at the crash site and the posted speed limit was 105 km/h (65 mph). Due to traffic flow, a scale scene schematic was not constructed. An approximated scene schematic is included as **Figure 10** of this narrative report.

Figure 2. View of crash site

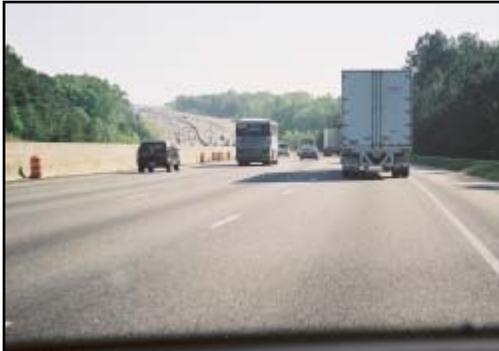
The 21-year-old female driver was operating the vehicle in a southbound direction on the outboard southbound travel lane (**Figure 3**). The pre-crash travel speed was unknown. Police indicated that the driver may have initiated a lane change maneuver and lost control of the vehicle. The Accord traveled to the left across the four southbound travel lanes in a slight counterclockwise (CCW) yaw toward the extended-height Jersey median barrier (**Figure 4**). According to the Police Accident Report (PAR), police documented 11.9 m (39.0') of pre-impact tire marks from the Accord.

Figure 3. Approach from outboard travel lane

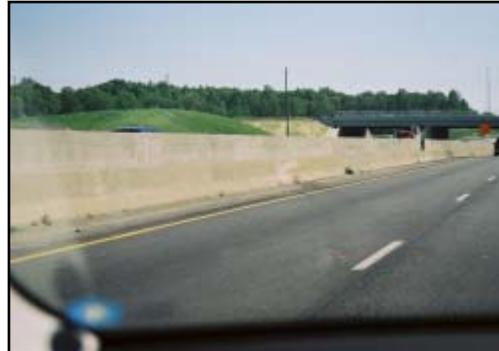
Figure 4. Approach across the travel lanes and point of impact

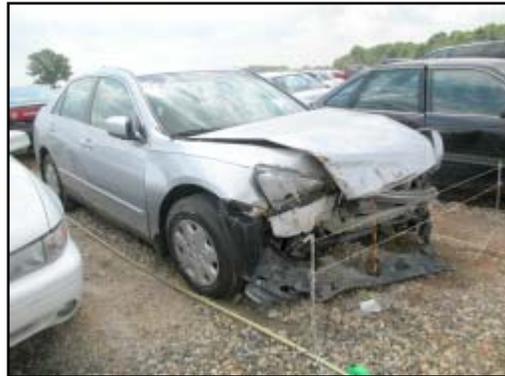
The 2004 Honda Accord sustained moderate frontal damage as a result of the impact with the concrete median barrier (**Figure 5**). The direct contact damage on the leading edge of the hood began 22.9 cm (9.0") left of center and extended 111.8 cm (44.0") to the front right corner. Although the bumper fascia was separated, the left corner of the bumper beam sustained deformation consistent with direct contact across the entire frontal width. The leading edge of the hood sustained longitudinal buckling, abrasions, and displacement to the left. Lateral abrasions were present on the right headlamp. Due to the lateral component of the direction of force, and CCW rotation as the Accord engaged the concrete barrier, the frontal structure was shifted to the left. **Figure 6** illustrates the lateral displacement of the bumper beam to the left, which measured 36.8 cm (14.5"). The leading edge of the right front fender was crushed and displaced to the left from direct contact. The combined direct and induced damage to the front of the Accord involved the entire frontal width of the vehicle and measured 114.3 cm (45.0") along the bumper beam. The left front fender was bowed outward. The frontal crush displaced the left front wheel rearward, which resulted in the reduction of the left wheelbase by 11.0 cm (4.3"). Six crush measurements were documented along the front bumper beam and were as follows: C1 = 22.9 cm (9.0"), C2 = 24.1 cm (9.5"), C3 = 26.7 cm (10.5"), C4 = 27.9 cm (11.0"), C5 = 22.2 cm (8.8"), C6 = 13.3 cm (5.3"). The Collision Deformation Classification (CDC) for the impact with the median barrier was 02-FDEW-2.

Figure 5. Right front view of the damaged 2004 Honda Accord

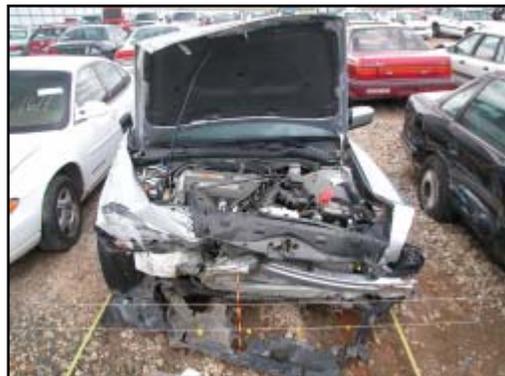
Figure 6. View of frontal damage showing end shift

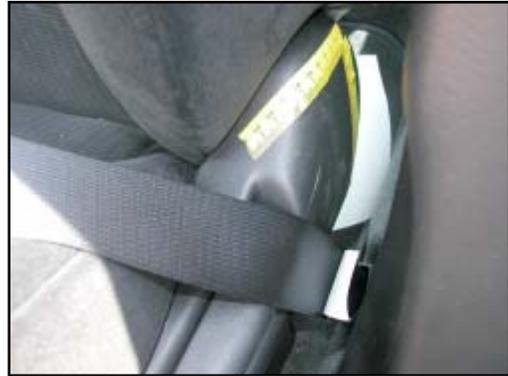
An abrasion from the driver's safety belt webbing (**Figure 7**) was present on the outboard aspect of the plastic trim on the driver's seat cushion. The abrasion measured 9.5 cm (3.8") in width and 11.4 cm (4.5") in height. The abrasion began 3.8 cm (1.5") forward of the rear edge of the seat cushion and was located 2.5 cm (1.0") above the bottom aspect of the trim.

Figure 7. View of abrasion from driver's safety belt webbing

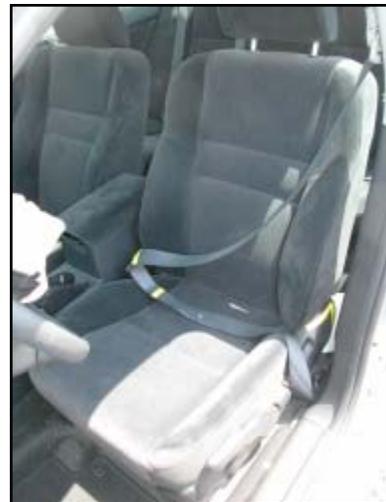
The 2004 Honda Accord was configured with manual 3-point lap and shoulder belts for each seating position. The driver's safety belt (**Figure 8**) was configured with a sliding latch plate and an Emergency Locking Retractor (ELR). The adjustable D-ring was located in the full-down position. The safety belt was found restricted in the used position at the time of the vehicle inspection. A total length of 156.2 cm (61.5") of the webbing was extended between the D-ring and the anchor. The plastic-coated latch plate exhibited minor abrasions consistent with loading, and the webbing exhibited minor rippling that began 73.7 cm (29.0") above the anchor and extended 16.5 cm (6.5") up the webbing. A plastic transfer from the plastic-coated D-ring was present on the rear inboard aspect of the webbing that measured 5.7 cm (2.3") in height and 1.3 cm (0.5") in width. The transfer was located immediately below the D-ring.

Figure 8. Driver's safety belt

The restricted nature of the driver's safety belt suggested that the driver's retractor-mounted pretensioner fired during the crash, which was confirmed by the EDR summary.

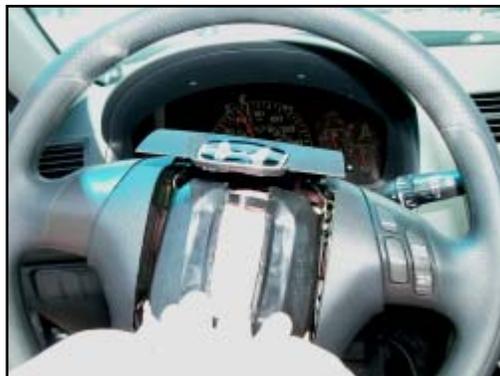
The driver's air bag deployed from the steering wheel hub as a result of the impact with the extended-height Jersey barrier. The driver's air bag module was configured with H-configuration cover flaps. The top flap measured 12.1 cm (4.8") in height, the bottom flap measured 6.4 cm (in height), and the tear seam measured 12.1 cm (4.8") in width. Two pliable, symmetrical, I-configuration vinyl flaps were present behind the exterior module cover flaps (**Figure 9**). Each secondary flap measured 10.5 cm (4.1") in height, 5.1 cm (2.0") in width, and extended to a vertical fold at the outboard aspects of the module. The flaps wrapped around and continued an additional 5.1 cm (2.0") in a forward direction along the side aspects of the module. Each flap exhibited two 1.9 cm (0.8") wide tabs on the leading edges. The driver's air bag measured 61.0 cm (24.0") in diameter in its deflated state. A small makeup transfer that measured 7.0 cm (2.8") in width and 5.7 cm (2.3") in height was located on the face of the air bag 12.7 cm (5.0") left of the vertical centerline and extended upward from the horizontal centerline. Two faint red linear transfers, possibly makeup, were present on the upper right quadrant of the air bag face, 3.2 cm (1.5") and 1.3 cm (0.5") right of the vertical centerline. The transfers were located 19.1 cm (7.5") and 11.4 cm (4.5") above the horizontal centerline, and measured 2.5 cm (1.0") and 0.6 cm (0.3") in height, respectively. A series of linear blue fabric transfers were located 3.5 cm (1.4") left of the vertical centerline and 12.7 cm (5.0") below the horizontal centerline. The transfers measured 5.7 cm (2.3") in height and 3.8 cm (1.5") in width. A faint, curved, linear blue fabric transfer was present on the bottom rear aspect of the air bag. The transfer began 4.4 cm (1.8") left of the vertical centerline and measured 7.0 cm (2.8") in width. The air bag was vented by two circular ports that measured 4.4 cm (1.8") in diameter and were located at the 11 and 1 o'clock positions on the rear of the air bag. The vent ports were laterally spaced 12.7 cm (5.0") apart and located 14.0 cm (5.5") from the peripheral seam. The air bag was tethered by two internal straps located at the 12 and 6 o'clock positions, which measured 7.0 cm (2.8") in width.

Figure 9. Close-up of secondary vinyl module flaps

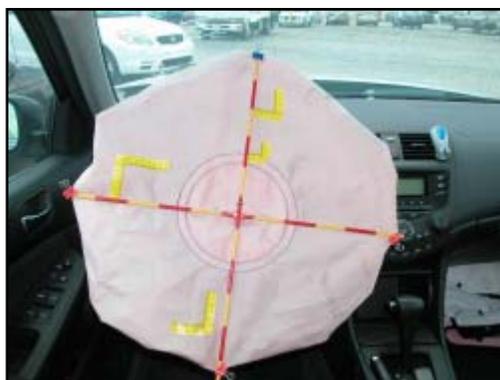
Figure 10. Deployed driver's air bag
