ON-SITE ADVANCED OCCUPANT PROTECTION SYSTEM INVESTIGATION

CASE NUMBER - IN-04-020

VEHICLE - 2004 GMC ENVOY

CRASH DATE - May 2004

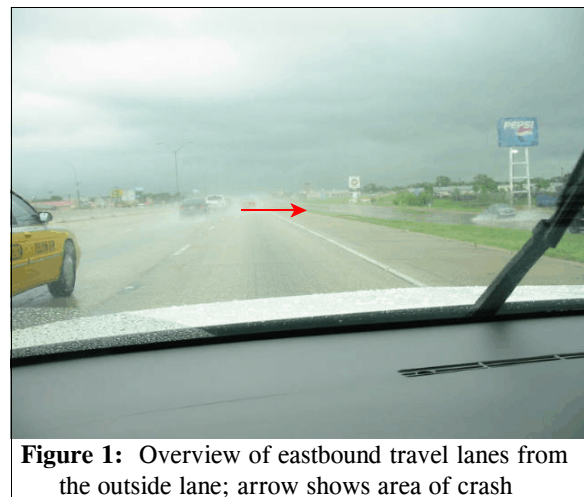
Pre-Crash: The case vehicle was traveling east in the center lane approaching an entrance ramp from a service roadway that ran parallel to the case vehicle's roadway (**Figure 1**). The case vehicle was traveling at an EDR recorded speed of 97 km.p.h. (60 m.p.h.) 5 seconds prior to algorithm enable, and the driver was intending to continue eastbound. According to the driver of the case vehicle, a car was also traveling east and was behind the case vehicle. The car changed lanes to the left inside lane and began to pass the case vehicle and then moved to the right into the case vehicle's lane. The impact between the car and

Figure 1: Overview of eastbound travel lanes from the outside lane; arrow shows area of crash

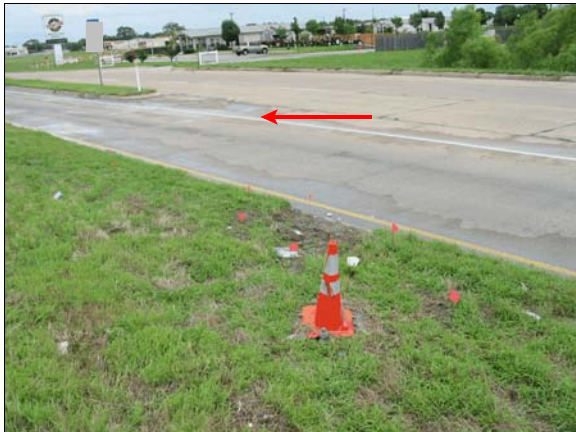
case vehicle occurred in the case vehicle's travel lane. The case vehicle's subsequent impact with the luminaire pole occurred off the south side of the roadway in the gore (**Figure 2** below) followed by a driver side leading rollover across the adjacent entrance ramp and service roadway (**Figure 3** below). The driver indicated she took no actions to avoid the impact with the car and was unsure what, if any, actions she may have taken following that impact.

Figure 2: Orange cone shows base of luminaire pole impacted by case vehicle, photo view to southeast, arrow shows area of rollover

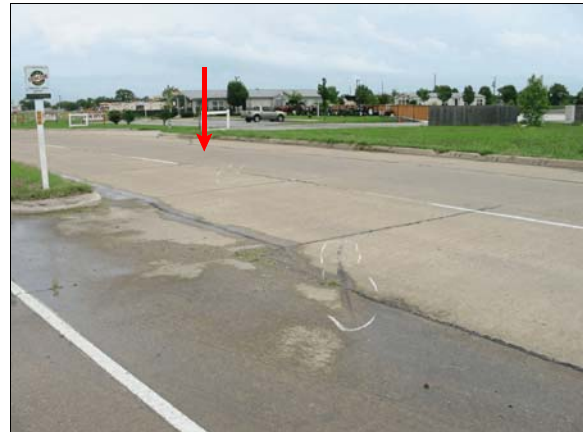
Figure 3: Overview of area of rollover across service roadway, plastic and/or rubber transfer from case vehicle's luggage rack and/or right door gasket highlighted in white in foreground, arrow shows area of final rest

Post-Crash: The car that initially impacted the case vehicle did not stop and left the scene of the crash. Following the rollover, the case vehicle came to rest on its top across both lanes of the service roadway facing south (**Figure 3**).

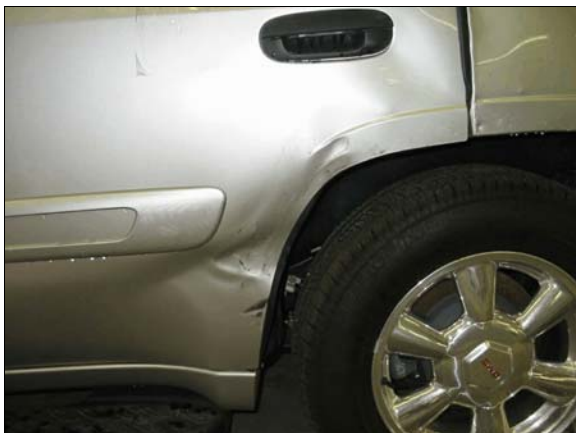
Crash: The right front corner of the car impacted the left rear door of the case vehicle just in front of the left rear wheel (**Figure 4**). The case vehicle driver probably steered right and the vehicle began to rotate clockwise and traveled across the outside, eastbound lane and shoulder, departed the south edge of the roadway and entered the gore of the entrance ramp. The case vehicle's left fender and left front wheel (**Figure 5**) then impacted and broke off a luminaire pole. The case vehicle then began a driver side leading rollover as it departed the gore and entered the entrance ramp. The case vehicle rolled over one-and-one-half times (six quarter turns) across the entrance ramp and service roadway (**Figure 3** and **Figures 6** and **7** below). Neither the driver or front right air bags deployed during the crash. The EDR data indicated that the case vehicle's longitudinal deceleration due to the luminaire pole impact was not sufficient to require air bag deployment.

Figure 4: Damage to case vehicle's left rear door from impact by hit-and-run car

Exterior Damage: The case vehicle's impact with the hit-and-run car produced a small area of direct and induced damage to the left rear door adjacent to left rear wheel house (**Figure 4** above). The direct damage began at the front of the left rear wheel housing and extended about 33 centimeters (13 inches) along the left rear door, and maximum crush was approximately 3 centimeters occurring just forward of the left rear wheel house. The impact with the luminaire pole produced direct damage to the left fender and hood, and displaced the left front wheel rearward 8 centimeters (3.2 inches). The direct damage began 281 centimeters (110.6 inches)

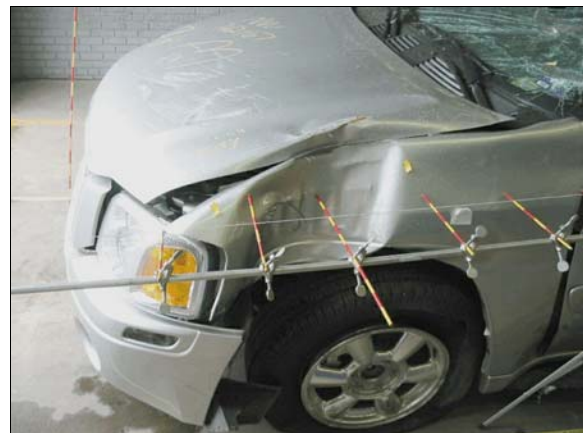
Figure 5: Damage to case vehicle's left fender and left front wheel from impact with luminaire pole

forward of the left rear axle and extended 46 centimeters (18.1 inches) along the left fender. Crush measurements were taken at the left fender and the maximum crush was measured as 14 centimeters (5.5 inches) occurring at C₄. The rollover produced extensive direct damage and crush to the case vehicle's roof (**Figure 6** and **7**). There was extensive pavement grinding marks on the A-pillars and roof rails as well as pavement scratches on the hood (**Figure 7**). The table below shows the case vehicle's crush profile for the left fender impact with the luminaire pole.

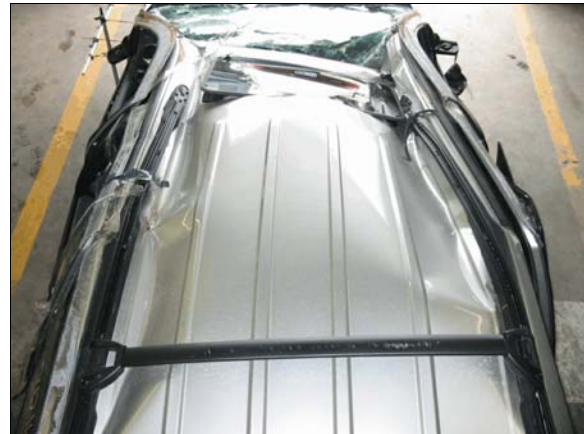
Figure 6: Crush to the case vehicle's roof from rollover; view from back of vehicle

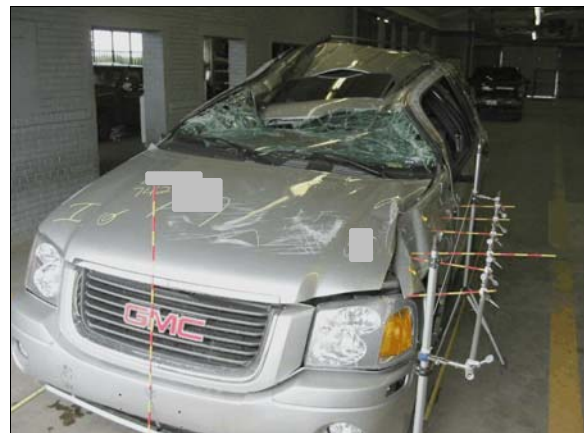
Figure 7: Roof crush, hood scratches and pavement grinding to A-pillars and roof rails from rollover

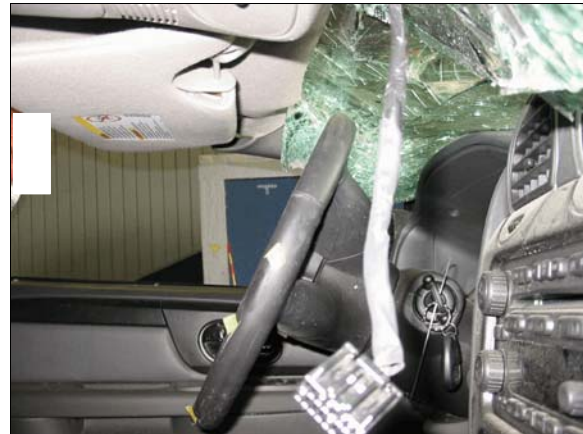
Vehicle Interior: Inspection of the case vehicle's interior revealed evidence of possible occupant contact to the steering wheel rim. However, there was no evidence of compression of the energy absorbing steering column, and no deformation of the steering wheel rim was observed (**Figure 8** below). In addition, there was evidence of occupant contact to the roof, above the driver's seat position at the forward edge of the sunroof. There appeared to be scuffs in the roof nap in this area. No other occupant contact marks were observed. There were numerous occupant compartment intrusions due to the rollover damage to the roof. Some of the most severe intrusions occurred to the driver's occupant space (**Figure 9** below). They were as follows: 34 centimeters (13.4 inches) of vertical roof and windshield header intrusion, 25 centimeters (9.8 inches) of vertical and 16 centimeters (6.3 inches) of lateral left A-pillar intrusion and, 25 centimeters (9.8 inches) of vertical and 16 centimeters of lateral left roof side rail intrusion.

Figure 8: Right side view of steering wheel and steering column showing no deformation

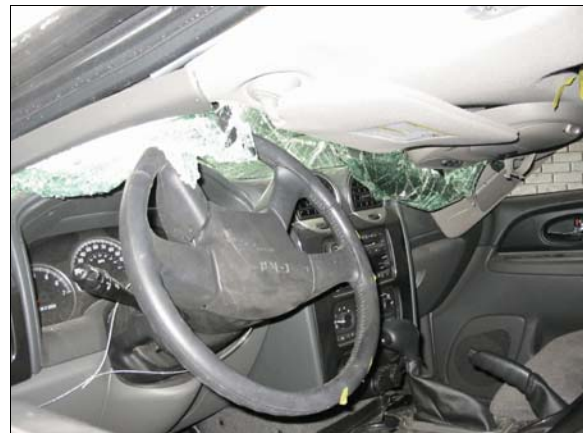
The case vehicle was equipped with dual stage driver and front right passenger air bags as well as front seat back-mounted side impact air bags. The case vehicle’s driver air bag was located in the steering wheel hub (**Figure 9**) and the front right passenger air bag was located in the middle of the right instrument panel (**Figure 10**). Neither air bag deployed in this crash. In addition, neither side impact air bag deployed. The EDR data indicated that the front air bag deployment criteria was not achieved during the crash sequence.

Figure 9: Intrusion into driver’s occupant space and overview of steering wheel (rotated 180 degrees) and instrument panel

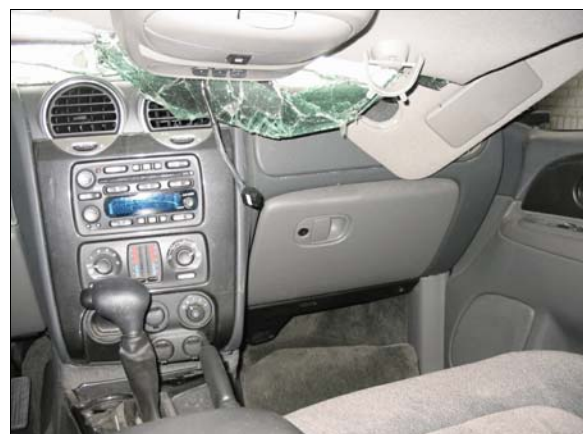
Figure 10: Center and right instrument panel; front right air bag module cover just above glove box door

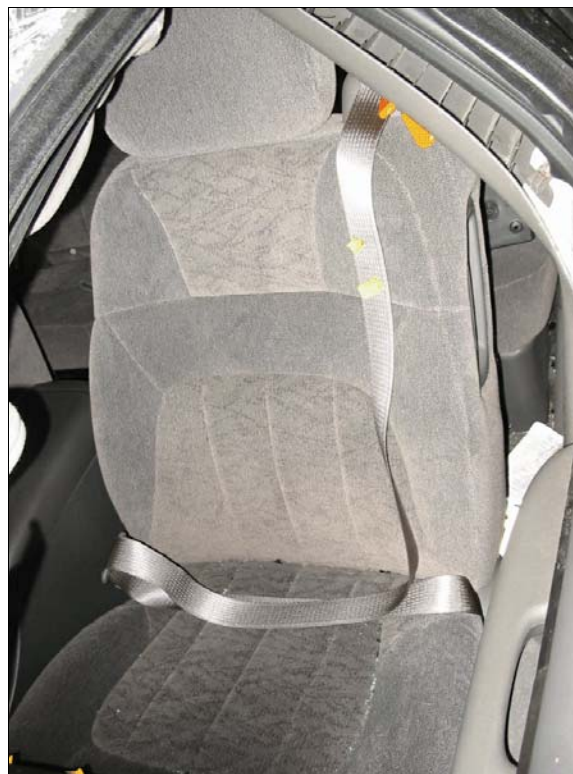
Based on the evidence observed during the vehicle inspection and supported by the EDR data, the case vehicle's driver was restrained by her integral, three-point, lap-and-shoulder safety belt system. Inspection of the seat belt assembly revealed some rippling of the shoulder belt webbing in an area of the belt consistent with usage in the crash (**Figure 11**). In addition, the driver stated she was restrained by her lap-and-shoulder belt during the crash.

Figure 11: Overview of case vehicle driver's safety belt, yellow tape shows area of slight rippling in shoulder belt

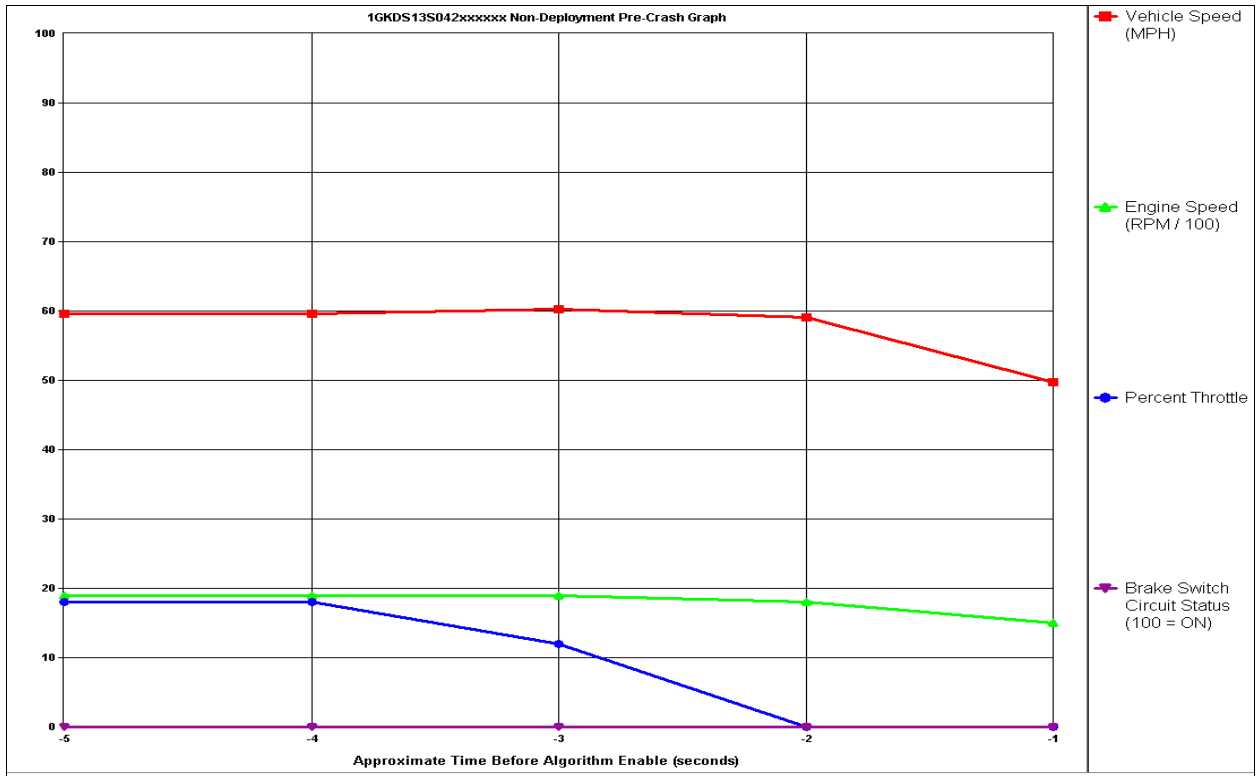
The pre-crash data graph show that the case vehicle was traveling 96.5 km.p.h. (60 mph) five seconds prior to AE. The case vehicle's speed then decreased to 80.5 km.p.h. (50 m.p.h.) from three seconds to one second prior to AE, and the percent throttle fell to 0% indicating the driver had removed her foot from the accelerator, probably in response to the impact by the hit-and-run vehicle.

Figure 15: The case vehicle's Non-Deployment Pre-Crash Graph

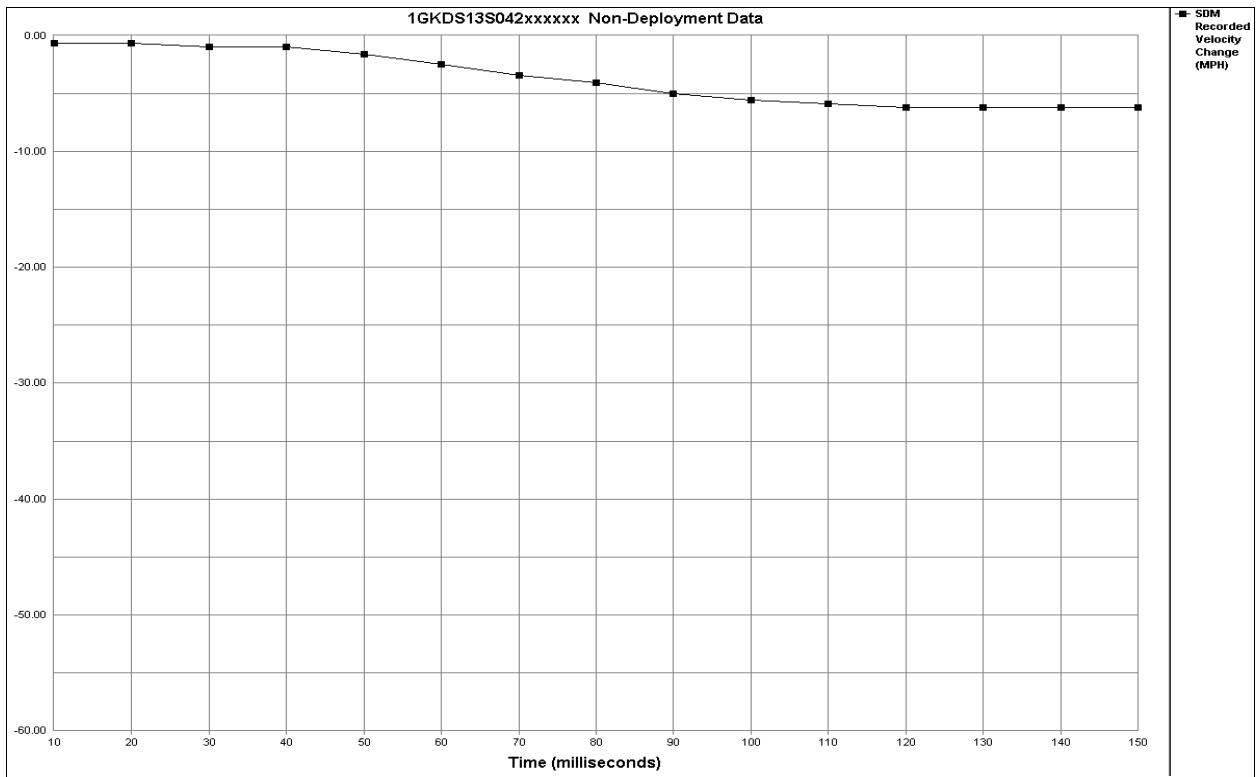
The system status report for the non-deployment event show that the SIR warning lamp was recorded as off and the driver's seat belt switch circuit was recorded as buckled. The system status report also shows the maximum SDM recorded velocity change (i.e., Delta-V) was -10.30 km.p.h. (-6.40 m.p.h.) occurring 122.5 milliseconds after algorithm enable (AE), and the event recording was complete.

Figure 16: The case vehicle's SDM Recorded Velocity Change graph
