Side Air Bag Investigation / Vehicle to Vehicle  
Dynamic Science, Inc. / Case Number: DS04020  
2004 Honda Accord  
Washington  
August, 2004

1. Report No. DS04020	2. Government Accession No.		3. Recipient Catalog No.	
4. Title and Subtitle Side Air Bag Investigation			5. Report Date February 8, 2006

**Dynamic Science, Inc.**  
**Crash Investigation**  
**Case Number: DS04020**

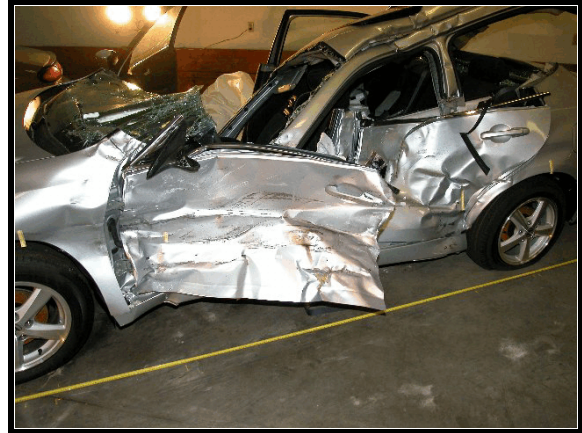
**Figure 1.** Left side, Honda Accord

The driver's seat back mounted side air bag deployed at this time. The driver sustained a left leg laceration, a laceration to the left side of her head, and a possible concussion. She was transported to a local hospital where she was hospitalized for four days. The front right occupant sustained three left rib fractures, a left lung laceration, and a contusion to the left side of her head. She was transported to a local hospital where she was admitted and hospitalized for six days. The second row right seat occupant sustained seat belt bruises. She was transported by ambulance to a local hospital where she was treated and released.

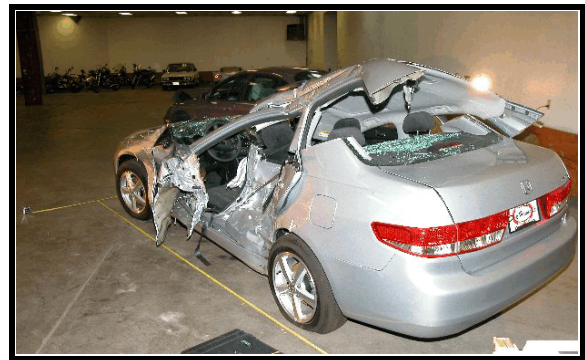
The driver of the Honda failed to stop at the intersection. The front of the Jeep struck the left side of the Honda (10LPAW3). The total velocity change as calculated by the missing vehicle algorithm of WinSmash collision model was 23.5 km/h (14.6 mph). The longitudinal and lateral delta V components were -8.0 km/h (-5.0 mph) and 22.1 km/h (13.7 mph), respectively. The driver's seat back mounted side air bag deployed at this time.

**Figure 4.** Rear left, Honda Accord

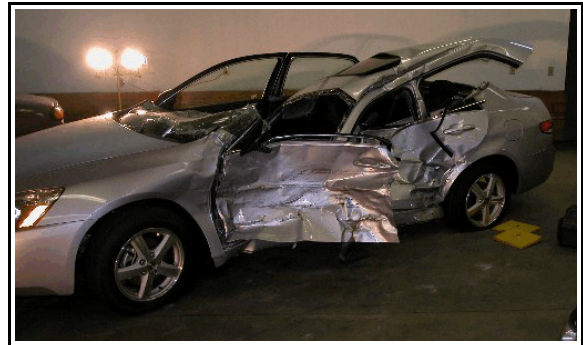
Damage Description:	Moderate lateral crush to left side doors Roof cut off by rescue personnel.	
CDC:	10LPAW3	
Delta V:	Total	23.5 km/h (14.6 mph)
	Longitudinal	-8.0 km/h (-5.0 mph)
	Latitudinal	22.1 km/h (13.7 mph)
	Energy	66,870 joules (49,320 ft lbs)

The case vehicle sustained 220.0 cm ( 86.6 in) of direct contact damage along the left side beginning 39.0 cm(15.3 in) forward of the front axle and extending to the rear. The residual crush measured above the sill was as follows: C1=0 cm (0 in), C2=17.5 cm (6.9 in), C3=39.0 cm (15.3 in), C4=13.0 cm (5.1 in), C5=15.0 cm (5.9 in), C6=11.0 cm (4.3 in). The C4 measurement was at the sill level. The maximum crush was located between C4 and C5 at the B pillar and measured 43.0 cm (16.9 in). The principle direction of force was within the 10 o'clock sector and was an estimated 290 degrees.

**Figure 5.** Left side, Honda Accord

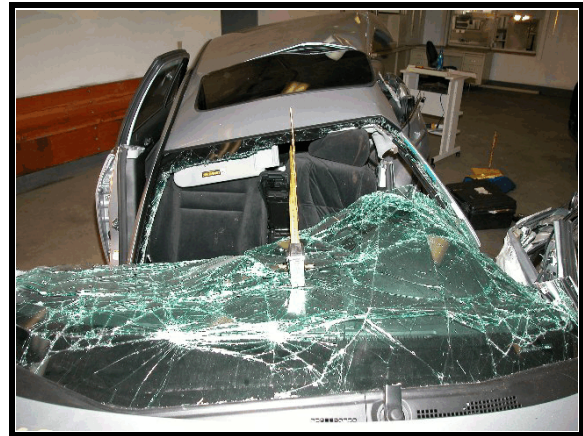
Interior damage to the Accord was significant. Both left side doors were jammed shut and it appears likely that all the glazing on the left side disintegrated during the crash. The left side doors, A and B pillar, and sill sustained lateral intrusion. The left front seat was compressed from the intrusion. The center console was shifted by occupant contact. There were scuffs to the left door and door handle. The left lower instrument panel was cracked from contact with the driver's knee.

**Figure 6.** Overview of vehicle intrusion

Position	Intruded Component	Magnitude of Intrusion	Direction
LF	Left front door	15.0 cm (5.9 in)	Lateral
LF	Sill	12.0 cm (4.7 in)	Lateral
LF	Left B pillar	29.0 cm (11.4 in)	Lateral
LF	Left A pillar	4.0 cm (1.6 in)	Lateral
LR	Left rear door	44.0 cm (17.3 in)	Lateral
LF	Left roof side rail	Unknown	Lateral
LF	Left window frame	Unknown	Lateral
LF	Kicker panel	$\geq 3.0$ cm (1.2 in) to $< 8.0$ cm (3.1 in)	Lateral
LF	Seat back	$\geq 8.0$ cm (3.1 in) to $< 15.0$ cm (5.9 in)	Lateral
LF	Seat cushion	Unknown	Lateral
LF	Roof	Unknown	Vertical
LR	Left window frame	Unknown	Lateral
LR	Left roof side rail	Unknown	Lateral
LR	Sill	Unknown	Lateral

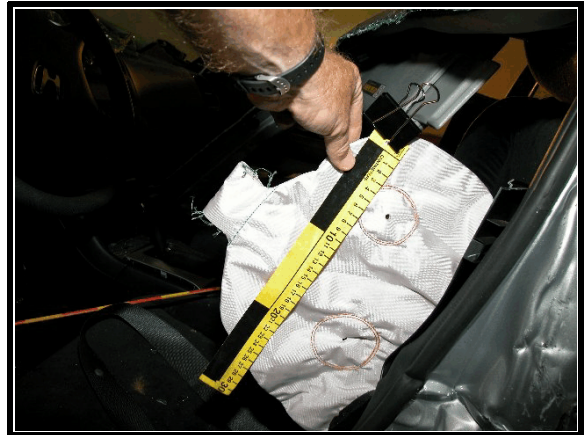
The Honda Accord was equipped with seat back mounted side air bags for the front seat positions. The driver's side air bag deployed. The air bag is semi-circular in shape with a height of 32.0 cm (12.6 in) and an excursion of 27.0 cm (10.6 in). There are two vents, located at the 11 and 5 o'clock position as viewed from the left side of the vehicle. There was no damage to the air bag. There were blood drops found on the inward facing portion of the air bag. The front right passenger side air bag is controlled by what Honda calls its Occupant Position Detection System (OPDS). The OPDS determines the size and position of the passenger, and prevents deployment whenever it could cause head or neck injuries. It also alerts the driver when the passenger's position is unsuitable for side air bag deployment. The passenger's seat back incorporates position sensors running from top to bottom. These determine the height of the occupant. A further sensor is incorporated into the seat back bolster, this determines the lateral position of the occupant. Signals from these sensors allow the OPDS to determine the passenger's seated position. In a side collision, OPDS can calculate if it is safe to deploy the side air bag or not.

**Figure 7.** Outboard facing portion of side air bag

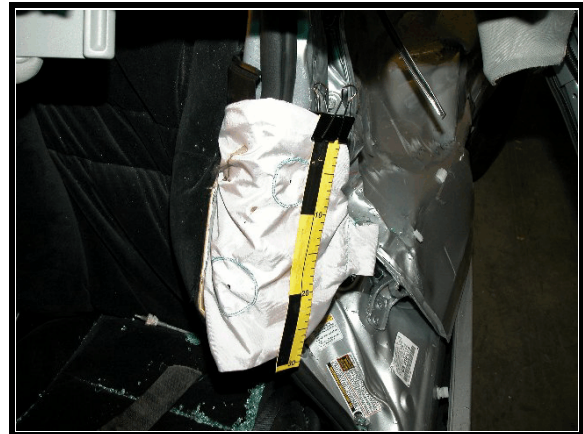
**Figure 8.** Inboard facing view of driver's side air bag

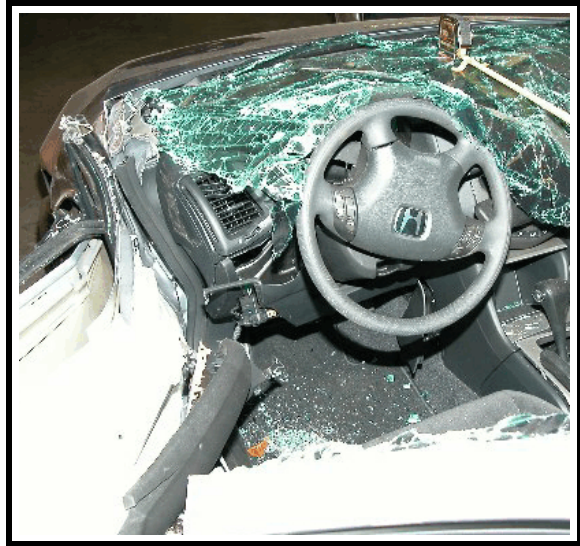
The 36-year-old female driver of the Honda Accord was seated in a forward facing, upright fashion. She was wearing the available 3-point manual lap and shoulder belt. The shoulder belt anchorage adjustment was in the full up position. The fabric covered bucket seat was in the middle track position according to the interviewee. The seat back angle was 77 degrees from horizontal. The seat bottom angle was 13 degrees from horizontal. Both of her hands were on the steering wheel (unknown clock position). Her left foot was on the floorboard; her right was on the accelerator. She was looking straight ahead. At impact with the Jeep, the driver's seat back mounted side air bag deployed. The driver initiated a lateral and slightly forward trajectory to the left. Her left hip/thigh contacted the door and door handle causing a laceration. Her head likely contacted some portion of the window frame, causing a laceration behind her left ear. She removed from the vehicle by EMTs. She was transported and hospitalized for four days.

**Figure 9.** Driver's seated position

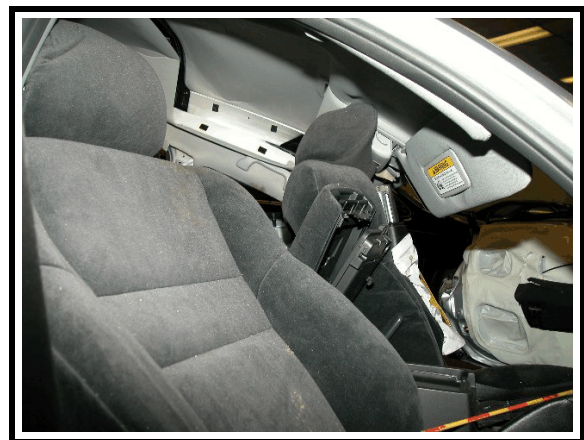
The 60-year-old female front right occupant was seated in a forward facing, upright fashion. She was wearing the available 3-point manual lap and shoulder belt. The shoulder belt anchorage adjustment was in the full down position. The fabric covered bucket seat was adjusted to between the rearmost and middle track position according to the vehicle inspection. The seat back angle was 51 degrees from horizontal at the time of the vehicle inspection. The seat bottom angle was 13 degrees from horizontal. Both of her feet were on the floor. At impact, this occupant initiated a lateral and slightly forward trajectory to the left. She pivoted laterally and struck the console with her left torso—causing the rib fractures and lung laceration. She was removed from the vehicle by EMTs. She was transported and hospitalized for six days.

**Figure 10.** Front right passenger's seated position
