INDIANA UNIVERSITY

ON-SITE CERTIFIED ADVANCED 208- COMPLIANT VEHICLE INVESTIGATION

CASE NUMBER - IN-04-021
LOCATION - TEXAS
VEHICLE - 2003 CHEVROLET C1500 TAHOE
CRASH DATE - May 2004

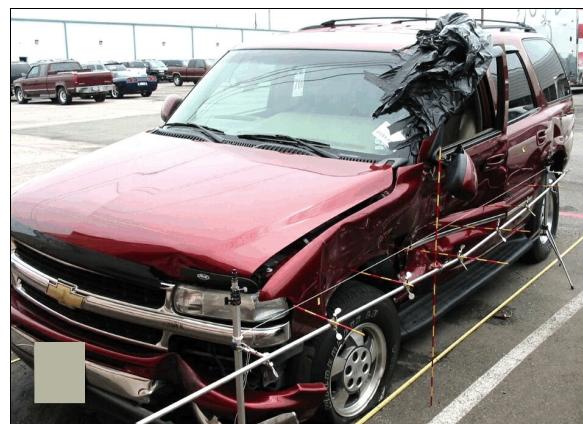
Figure 6: Case vehicle's initial (1st event) left side damage from impact by front of Chrysler (case photo #27)

Exterior Damage: The case vehicle's initial contact with the Chrysler (i.e., 1st event) involved the front half of the left side (**Figures 6 and 7** above). Direct damage began 87 centimeters (34.3 inches) forward of the left rear axle and extended 243 centimeters (95.7 inches) forward along the left side of the vehicle. The Field L measured 260 centimeters (102.4 inches). Residual maximum crush was measured as 22 centimeters (8.7 inches) at C₃ (**Figure 7** above). The case vehicle's left fender, left front wheel assembly, left front door, left outside rearview mirror, and a small area of the left rear door were

directly damage and crushed inward. As a result of the initial impact, there was induced damage to the left side of the windshield (cracked but in place), and the left front window's glazing was disintegrated.

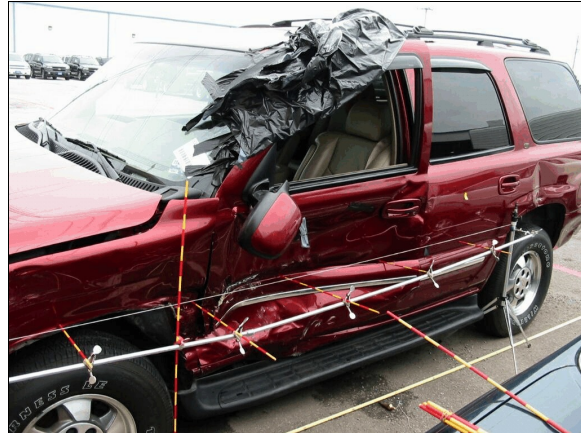
Figure 7: Case vehicle's initial (1st event) left side damage showing C₁ through C₃ crush positions with contour gauge positioned above sill level (case photo #29)

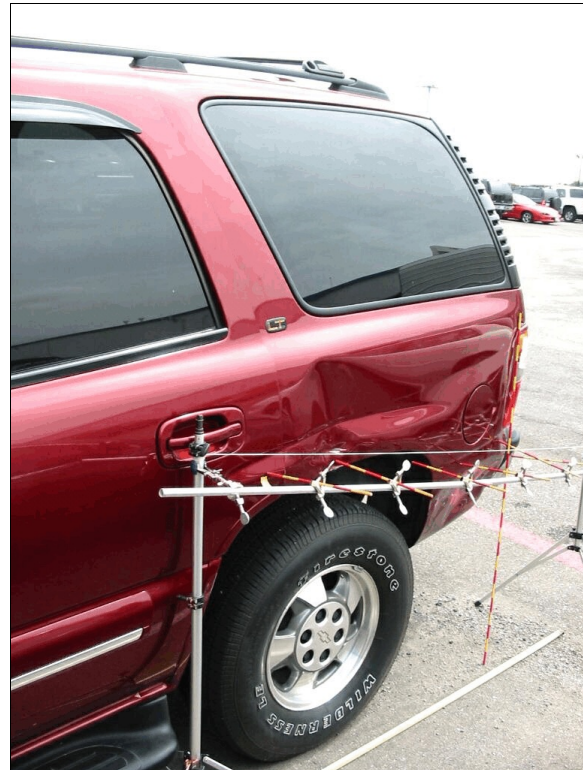
Figure 10: Case vehicle’s left side slap damage (2nd event) from impact with Chrysler’s right side (case photo #33)

The case vehicle's left side slap with the Chrysler (i.e., 2nd event) involved the rear half of the left side (**Figure 10** above). Direct damage began 31 centimeters (12.2 inches) forward of the left rear axle and extended 139 centimeters (54.7 inches) rearward. Residual maximum crush was measured as 4 centimeters (1.6 inches) at C₁ (**Figure 18**). The case vehicle's left quarter panel, left rear bumper, and left rear tail/stop light and turn signal assemblies were directly damaged and crushed inward. There was induced damage to the left rear door.

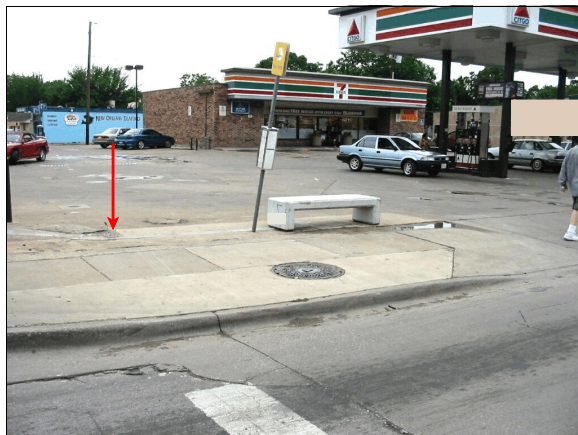
vehicle, the most likely scenario is that after the case vehicle departed the northwest corner of the intersection, the front left impacted a metal protective corner post (Figure 12–4th event–Note: metal post was not present during scene inspection) while at about the same time the front right bumper collided with the southeast corner of a concrete bus bench (Figure 11 and Figure 13 below–5th event). Once again, neither of the case vehicle’s frontal air bags deployed. The case vehicle moved the bench clockwise as it continued along its west-northwest travel path. Furthermore, the bus stop sign post (Figure 14 below–Note: bus stop sign post has most likely been replaced since crash because current post shows no damage) impacted the right rear portion (Figures 15 and 16 below–6th event) of the case vehicle as the case vehicle continued forward. The case vehicle came to rest in the convenience store parking lot, heading northwest (Figure 17 below).

Figure 11: Case vehicle’s follow-up impacts with post (arrow), bench, and bus stop sign post, and final rest position; Note: this contractor believes the southeast corner of the bench was on the south side of the bus stop sign post at time of crash (case photo #06)

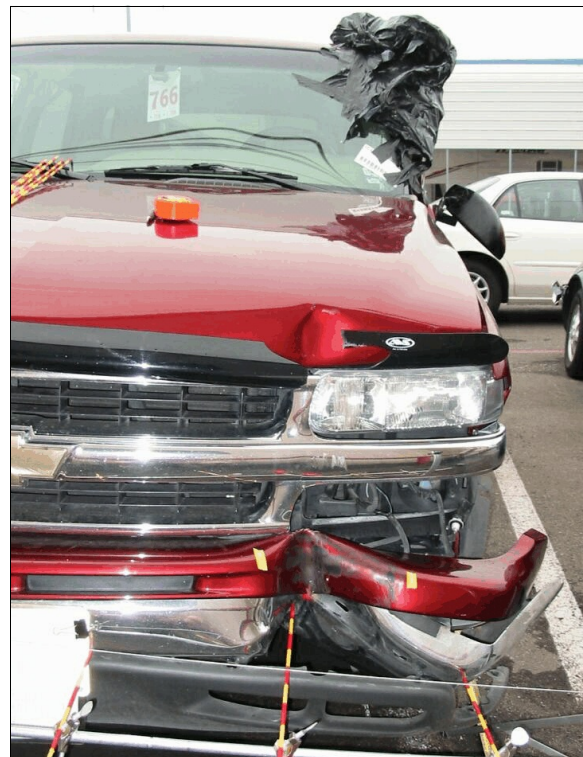
Figure 12: Case vehicle’s impact (4th event) with protective corner post (case photo #22)

The case vehicle had two frontal impacts—4th and 5th events, and the damage (i.e., direct and induced) was distributed across the entire front (**Figures 12** and **13** above). The first frontal impact (i.e., 4th event) was with a metal sign post and involved the left portion of the bumper. Direct damage began 18 centimeters (7.1 inches) inward from the front left bumper corner and extended 25 centimeters (9.8 inches) rightward along the front bumper. Residual maximum crush was measured as 21 centimeters (8.3 inches) at C₂ (**Figure 19**). The case vehicle's front upper and lower bumper fascia, grille, hood, and left front headlight and turn signal assemblies were directly damaged and crushed rearward. There was induced damage to the entire front bumper. No remote buckling was noted. The second frontal impact (i.e., 5th event) was with the concrete bus bench and involved the right portion of the front bumper. Direct damage began 29 centimeters (11.4 inches) inward of the front right bumper corner and extended 6 centimeters (2.4 inches) leftward along the front bumper. Residual maximum crush was measured as 9 centimeters (3.5 inches) at C₅. The case vehicle's front right bumper fascia was directly damaged and crushed rearward. Once again, the entire front bumper sustained induced damage.

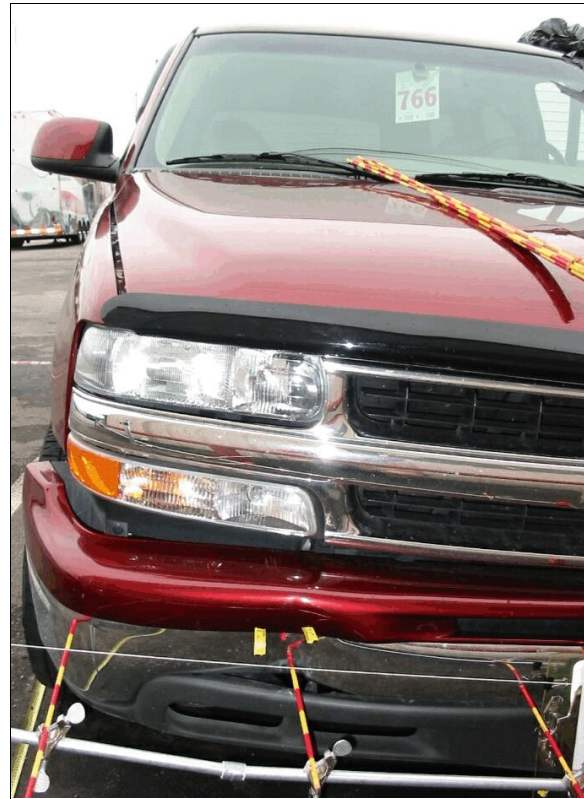
Figure 13: Case vehicle's impact (5th event) with corner of concrete bus bench (case photo #20)

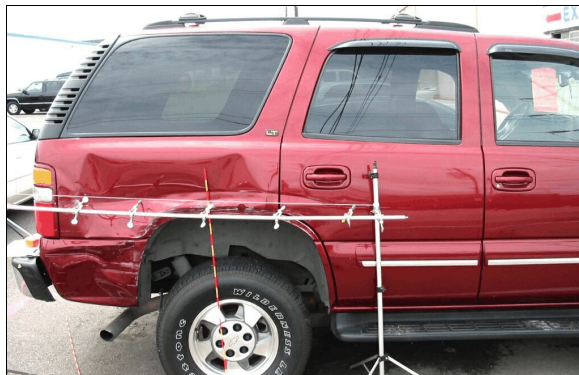
Figure 15: Case vehicle's right quarter panel damage (6th event) most likely from impact with bus stop sign post with contour gauge positioned above sill (case photo #40)

The case vehicle's right sideswipe impact-6th event, with the bus stop sign post involved approximately the rear one-third of the right side (**Figure 15** above). Direct damage began 56 centimeters (22.0 inches) forward of the right rear axle and extended 156 centimeters (61.4 inches) rearward. Residual maximum crush was measured as 4 centimeters (1.6 inches) at C₂ and C₃ (**Figure 20** above). The case vehicle's right rear door, right quarter panel, and rear bumper were directly damaged and crushed inward. There was damage to the right front door, but it could not be determined if this damage was related to this crash or prior damage. There was no obvious induced damage or remote buckling noted as a result of this impact.

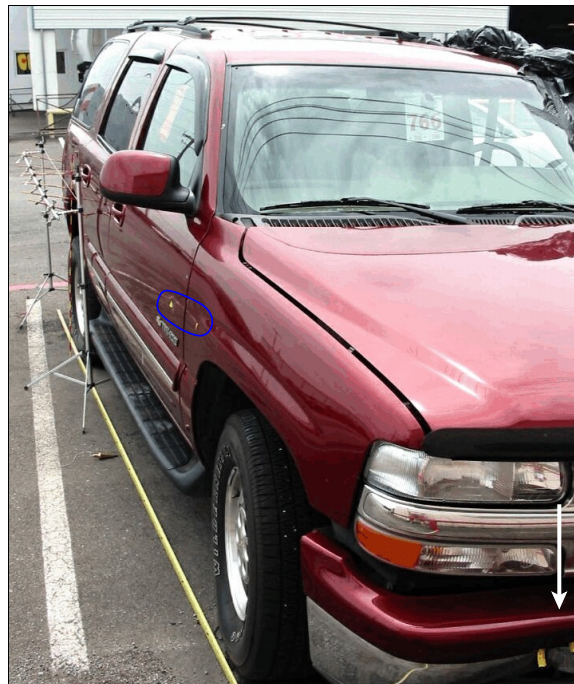
Figure 16: Case vehicle's impact with corner of concrete bus bench (arrow), unknown damage—current versus prior, near right "A"-pillar, and damage to right quarter panel from bus stop sign post (case photo #44)

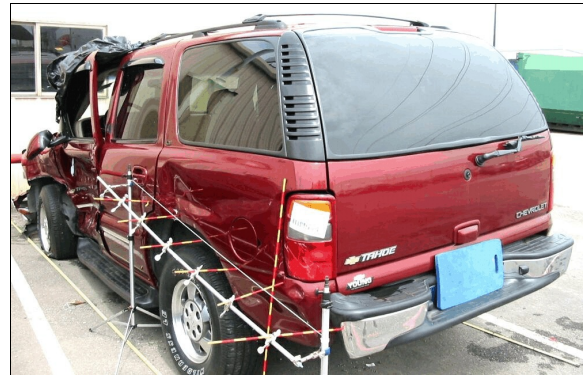
Figure 18: Case vehicle's left side slap damage (2nd event) viewed from left of back (case photo #36)

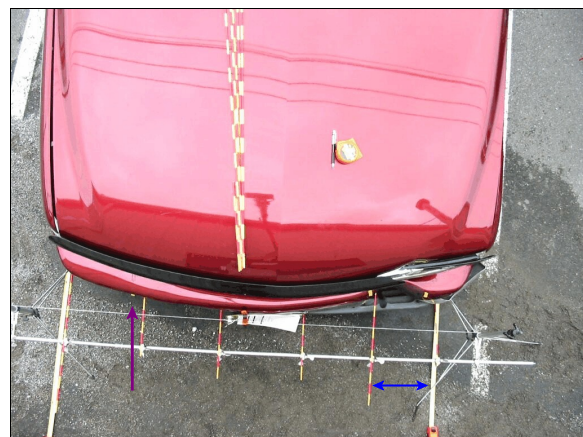
Figure 19: Overhead view of case vehicle's frontal impacts (i.e., post-blue arrows, bench-grape arrow) with contour gauge positioned at bumper level (case photo #23)

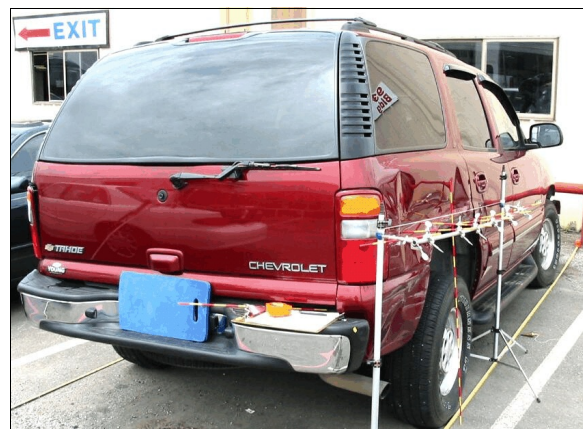
Figure 20: Case vehicle's right quarter panel damage (6th event) most likely from impact with bus stop sign post viewed from right of back (case photo #38)

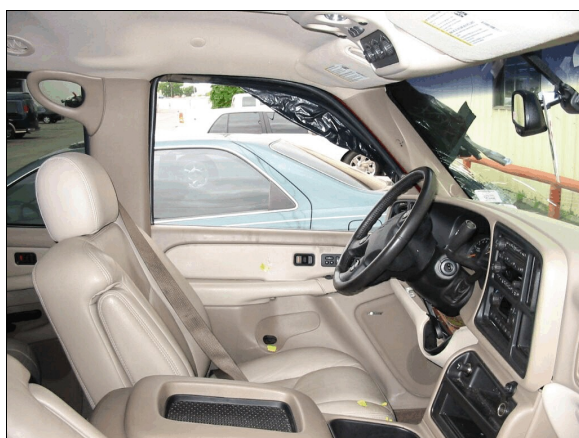
Figure 21: Case vehicle's driver seating area viewed from right showing contact evidence on driver's door (yellow tape) and blood on driver's seat (case photo #51)

Interior Damage: Inspection of the case vehicle's interior revealed contacts to the left front door (Figure 21). It appears as if there is some type of fluid on the left front door panel (Figure 22) and the door handle was broken off (Figures 23 and 24), most likely by the left hip or thigh of the

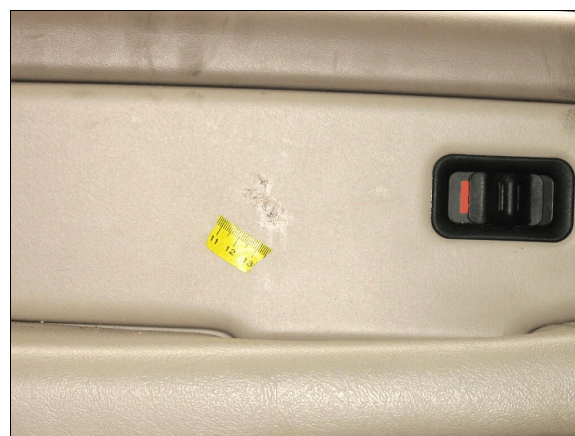
Figure 22: Close-up of possible body fluid and/or contact on case vehicle's driver door (case photo #52)

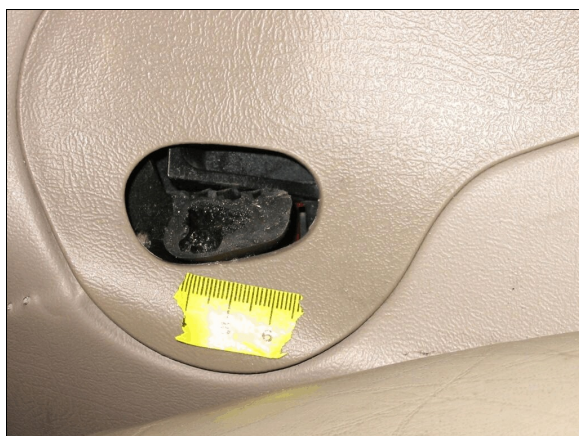
Figure 23: Close-up of area where case vehicle's driver door handle was broken off driver's door (case photo #55)

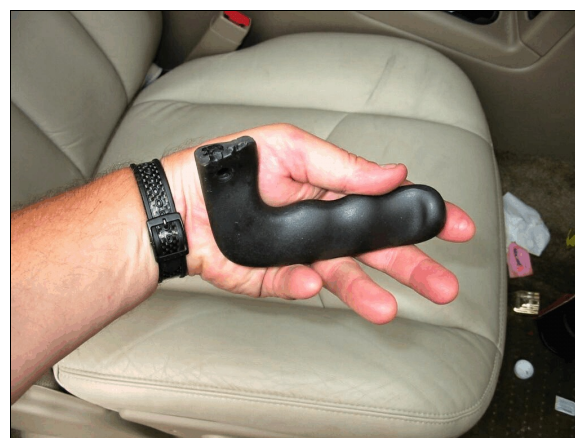
Figure 24: Broken off door handle from case vehicle's driver door (case photo #57)

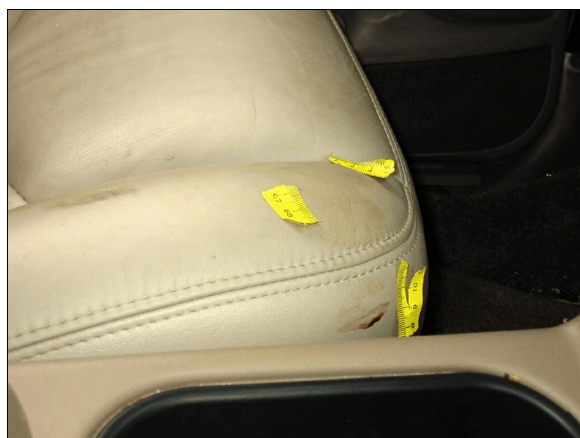
driver as she moved leftward along a path opposite the case vehicle's 300 degree Direction of Principal Force. Furthermore, blood stains were found on the front right portion of the driver's seat (Figures 25 and 26). The case vehicle sustained multiple intrusions the driver's seating area. There were lateral intrusions to the interior surface of the driver's door, the side panel forward of the left "A"-pillar, and to the left instrument panel/driver's knee bolster. Furthermore, there was a longitudinal intrusion to the toe pan area, and a vertical intrusion to the driver's knee bolster. The greatest intrusion was measured as 19 centimeters (7.5 inches) laterally to the driver's door. Finally, there was no evidence of compression of the energy absorbing shear capsules in the base of the steering column and no deformation to the steering wheel rim.

Figure 25: Blood stains on front right portion of case vehicle's driver seat (case photo #53)

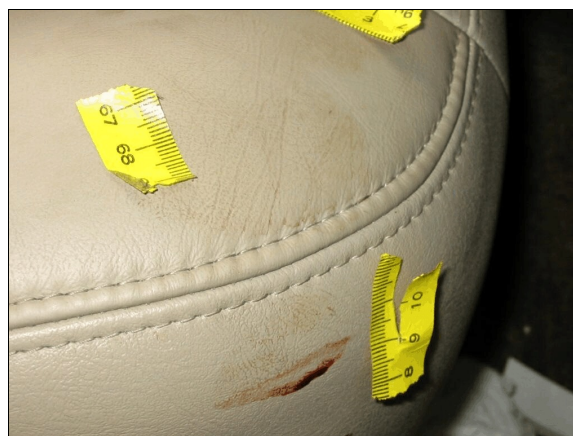
Figure 26: Close-up of blood stains on front right and right front portions of case vehicle's driver seat (case photo #53a)

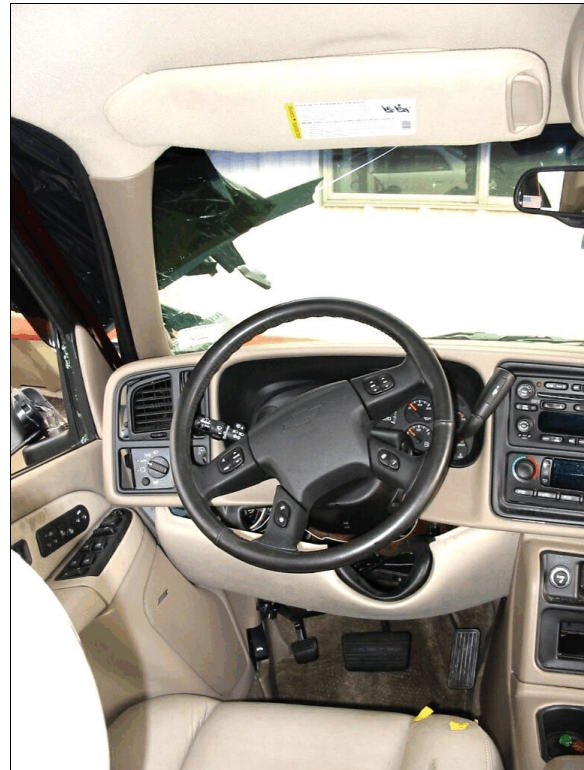
Figure 27: Vertical view of case vehicle's driver seating area showing non-deployed driver air bag, intrusion to lower instrument panel, and blood on front right edge of driver's seat (case photo #48)

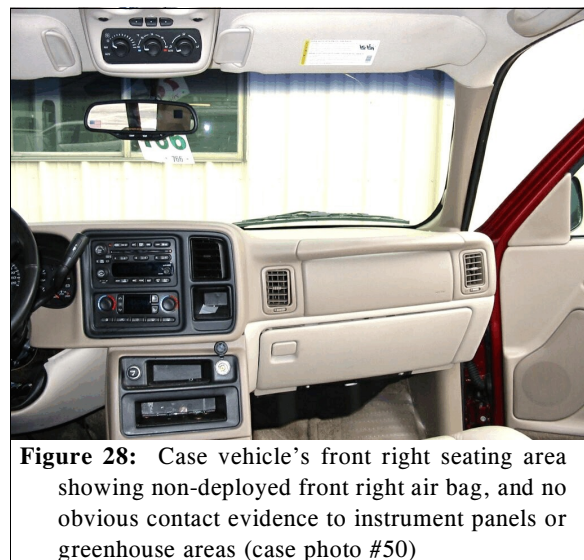
Figure 28: Case vehicle's front right seating area showing non-deployed front right air bag, and no obvious contact evidence to instrument panels or greenhouse areas (case photo #50)

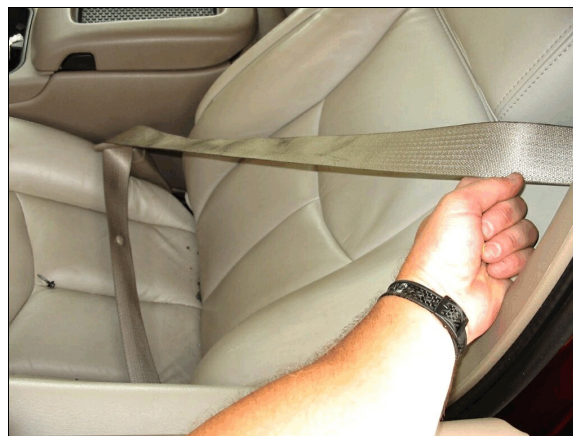
Based on this contractor's vehicle inspection and supported by the **EDR** data, the case vehicle's driver was restrained by her available, active, three-point, integral lap-and-shoulder, safety belt system. Inspection of the driver's seat belt webbing, shoulder belt guide, and latch plate showed only trace evidence (i.e., waffling) of loading (**Figure 29**).

Figure 29: Case vehicle's driver seat belt webbing showing loading evidence-waffling (case photo #61)

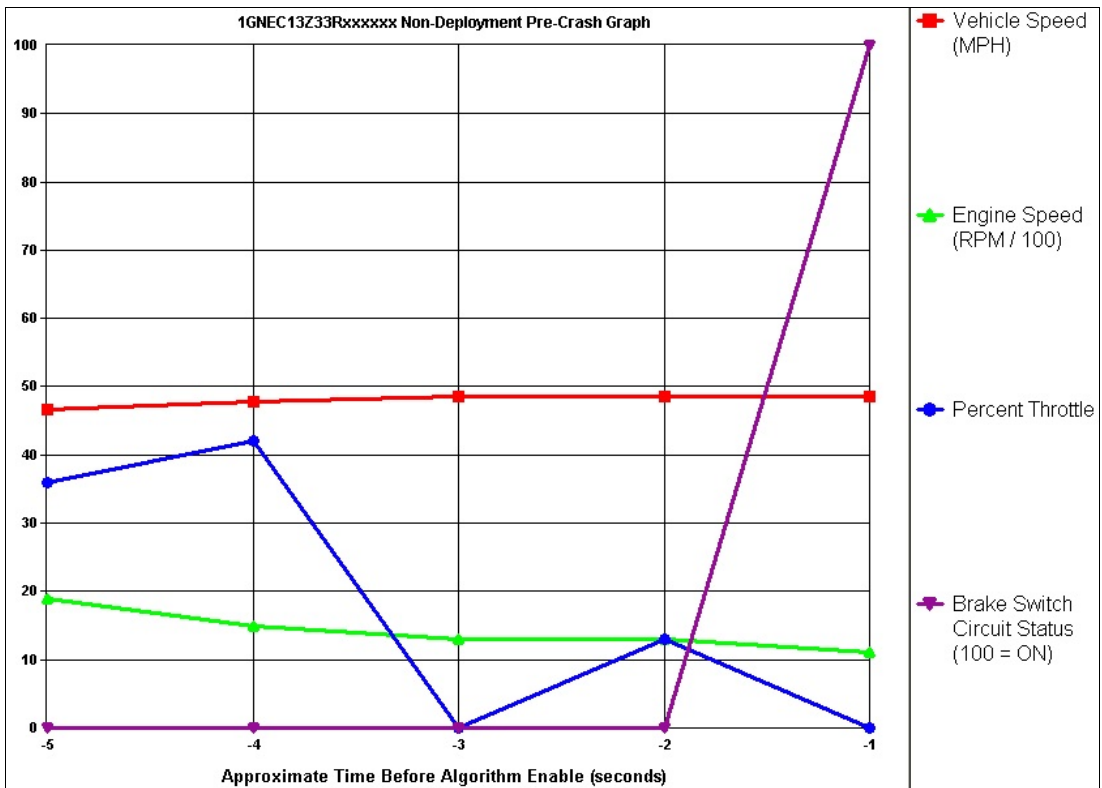
Figure 31: Case vehicle’s pre-crash speed and brake switch circuit status showing that the vehicle’s speed was recorded at 77 km.p.h. (48 m.p.h.) when the brake was activated approximately 1 second prior to algorithm enable.

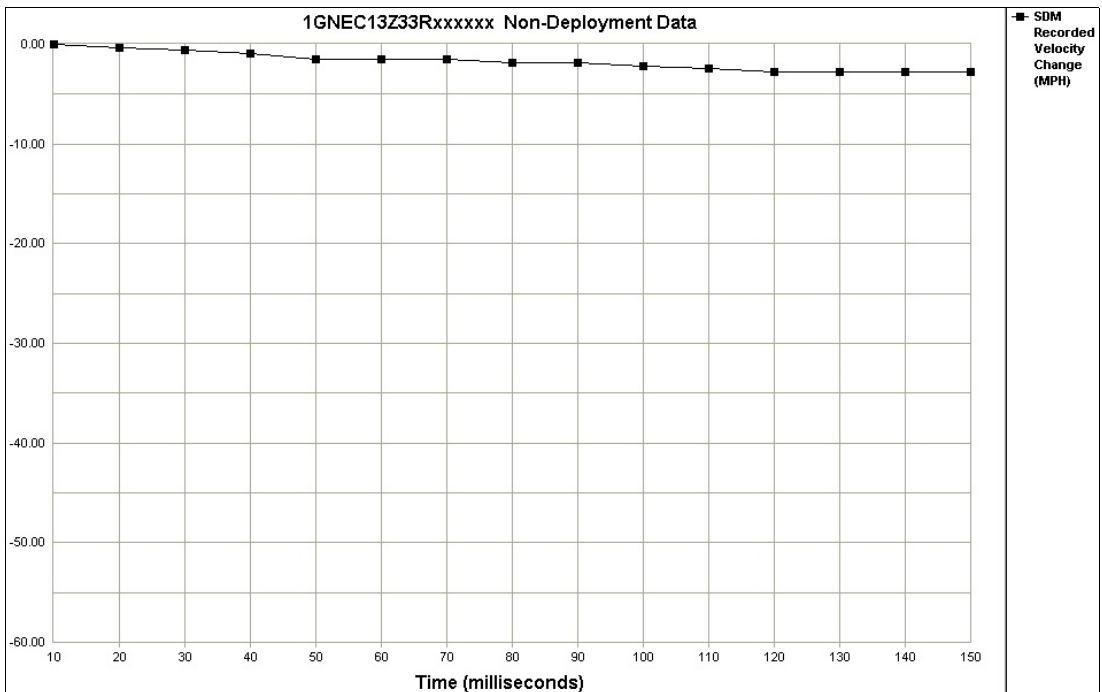
and the Delta V was 4.49 km.p.h. (2.79 m.p.h.) at the 150 millisecond mark of recorded data; see **EVENT DATA RECORDER DATA (Figures 30 through 32)** below. This contractor believes that the recorded Delta V seems reasonable considering the primary amount of deformation was to the case vehicle's left side.

Figure 32: The case vehicle sustained a velocity change of approximately 4.5 km.p.h. (2.8 m.p.h.) during the first 150 milliseconds after the algorithm was enabled; maximum velocity change was recorded as 4.9 km.p.h. (3.1 m.p.h.) at 145 milliseconds
