Certified Advanced 208 Compliant Investigation / Vehicle to Object
Dynamic Science, Inc. / Case Number: DS04023
2004 Chevrolet Silverado
Washington
October, 2004

1. Report No. DS04023	2. Government Accession No.		3. Recipient Catalog No.	
4. Title and Subtitle Certified Advanced 208 Compliant Investigation			5. Report Date March 5, 2005

Dynamic Science, Inc.
Crash Investigation
Case Number: DS04023

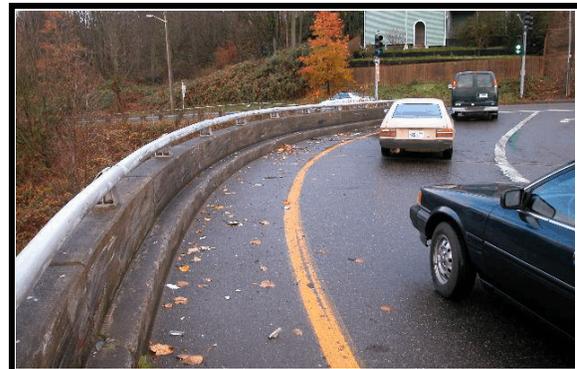
Figure 1. Area of impact with concrete wall--north

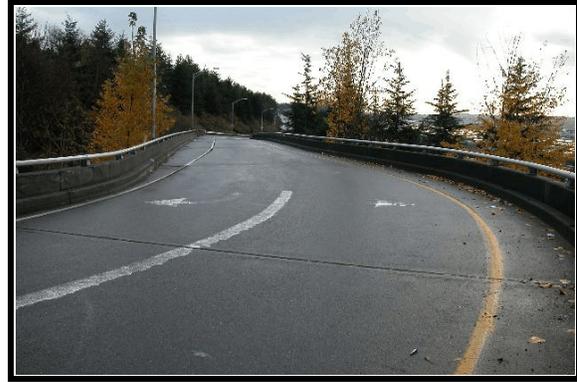
Figure 2. Looking back view from area of impact-south

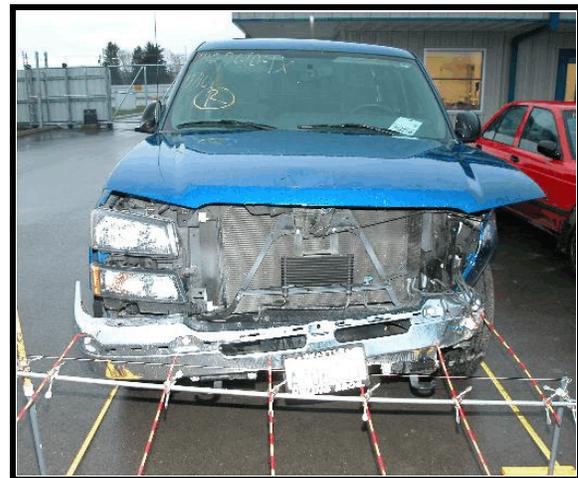
Figure 3. Front, 2004 Chevrolet Silverado

The Chevrolet Silverado sustained moderate front end damage as a result of the initial impact with the concrete wall. The direct damage began the left bumper corner and extended laterally 44.0 cm (17.3 in). The combined direct and induced damage measured 176.0 cm (69.3 in) and involved the entire front bumper. Six crush measurements were documented at the bumper level as follows: C1=37.0 cm (14.6 in), C2=18.0 cm (7.1 in), C3=7.0 cm (2.8 in), C4=1.0 cm (0.4 in), C5=0 cm (0 in), C6=0 cm (0 in).

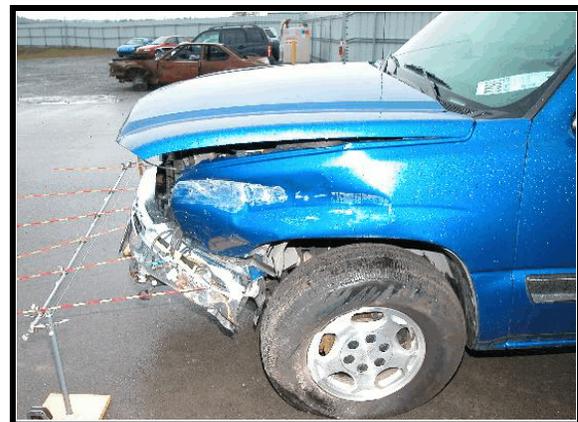
Figure 4. Left, 2004 Chevrolet Silverado

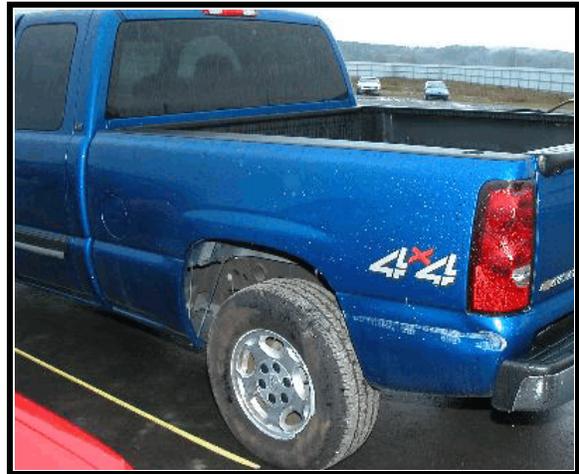
The case vehicle entered the right hand curve too fast and the vehicle departed the roadway to the left. It first struck the concrete wall with its front left (12FLEW2). The total velocity change for the case vehicle as calculated by the barrier algorithm of the WinSmash collision model was 20.6 km/h (12.8 mph). The longitudinal and lateral delta V components were -20.5 km/h (-12.7 mph) and 1.8 km/h (1.1 mph), respectively. Both front air bags deployed at this time. The case vehicle glanced off the wall slightly and then lightly engaged the wall with its left rear tire and the left rear most portion of the pickup box (12LBES1).

Figure 5. Left side, impact 2

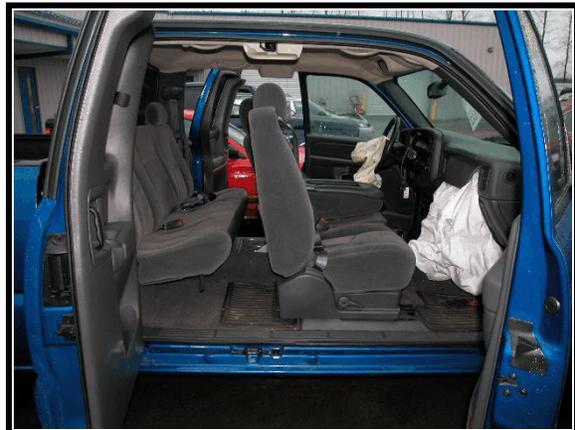
Figure 6. Overview of vehicle interior

The interior damage to the Chevrolet Silverado was limited to the residual damage from air bag deployments. There was no intrusion. All the doors remained closed and operational. All the glazing remained in place. There was a U shaped fracture to the windshield which based out below the level of the mirror. There was no steering wheel rim deformation. There were no visible occupant contacts.

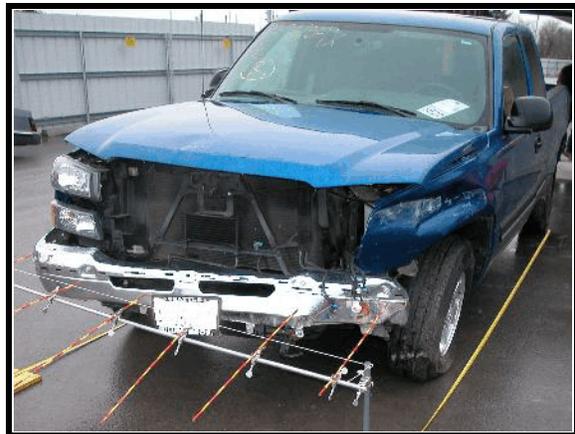
Damage Description:	Moderate front end damage. Rearward crush damage to the left bumper, left grille, and left fender. Direct damage extends 83.0 cm (32.6 in) down left side and includes rim damage.	
CDC:	Impact 1: 12FLEW2 Impact 2: 12LBES1	
Delta V (impact 1):	Total	20.6 km/h (12.8 mph)
	Longitudinal ²	-20.5 km/h (-12.7 mph)
	Latitudinal	1.8 km/h (1.1 mph)
	Energy	37,622 joules (27,748 ft lbs)

Figure 7. Front left, Chevrolet Silverado

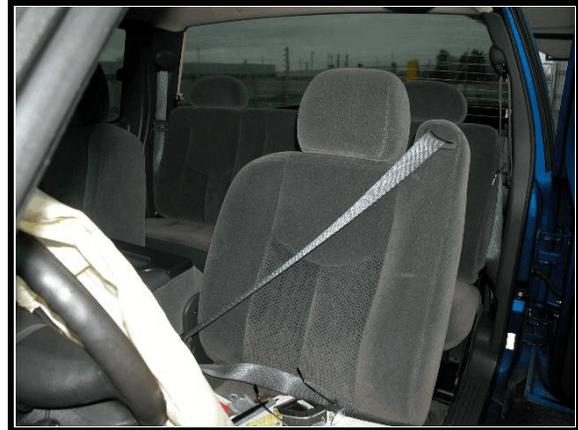
Figure 8. Integral driver's lap and shoulder belt

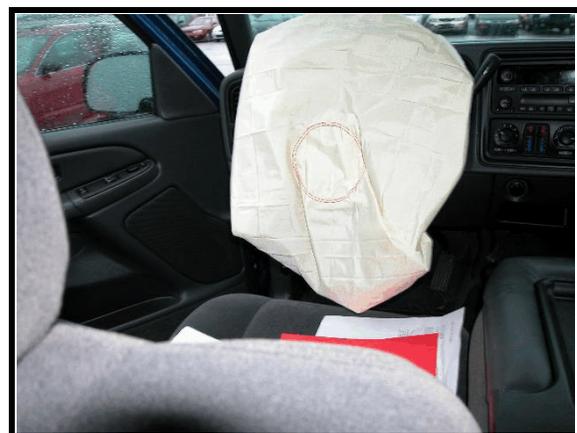
The case vehicle was equipped with advanced, dual stage driver and front right passenger air bags. The driver's air bag was mounted in the steering wheel hub. The deployed driver's air bag was vaguely oblong and measured 65.8 cm (25.9 in.) high by 50.0 cm (19.7 in) wide. It was equipped with one internal tether strap and two vent ports (11 and 1 o'clock positions). The dual module cover flaps opened in an "I" type configuration. There were no indications of any damage to driver's air bag or the module cover flaps. There were 20 horizontal folds and 9 vertical folds. The front right passenger air bag was a mid instrument panel mount. The deployed front right passenger air bag was generally rectangular and measured 61.0 cm (24.0 in) high by

Figure 9. Deployed driver's air bag

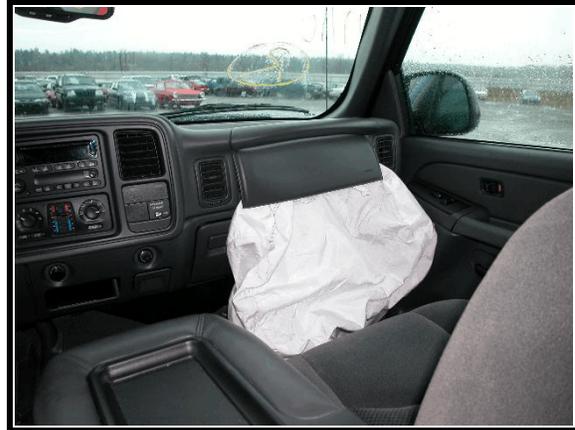
50.0 cm (19.7 in) wide. There was a single module cover that measured 38.5 cm (15.2 in) wide by 12.0 cm (4.7 in) high. There were two vent ports (3 and 9 o'clock positions). There were no tethers. There was no damage nor any contacts to either the air bag or the module cover.

Figure 10. Deployed front right passenger air bag
