**CALSPAN ON-SITE CHILD SAFETY SEAT
CRASH INVESTIGATION**

CASE NO: CA04-023

VEHICLE: 2003 FORD E-250 CARGO VAN

CRASH DATE: APRIL 2004

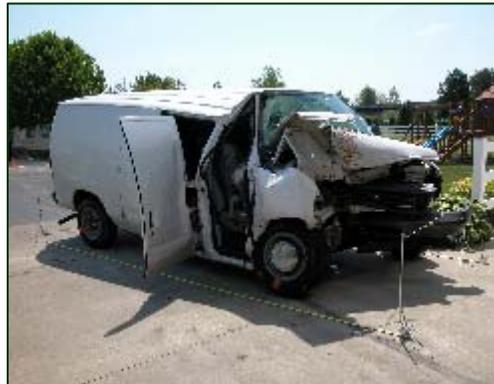
Figure 1. Front right view of the tree impact damage to the Ford E-250 cargo

forward and impacted a large diameter tree with the front right area which resulted in severe frontal crush (**Figure 1**) and intrusion of the front right occupant space. The van rotated clockwise and came to rest near the struck tree. The redesigned frontal air bag system in the Ford van deployed during the crash. Loose cargo in the rear of the van was displaced forward into a sheet metal partition that spanned the B-pillars of the vehicle. This contact resulted in forward displacement of the front seat backs. The front right child passenger sustained a complex liver laceration, closed head injuries, and a left rib fracture with bilateral pulmonary contusions and was transported to a local trauma center. He was later transferred to a regional pediatric trauma center where he expired three days following the crash. The belted driver sustained a forehead laceration and was treated at a local hospital and released. A 12-year old female passenger was seated on an inverted bucket in the right side cargo area of the van. She sustained a fractured right femur, a left lung contusion and multiple soft tissue injuries and was admitted to a local hospital for treatment. The van sustained severe frontal damage and was towed from the scene of the crash and impounded by the investigating police agency pending a criminal investigation.

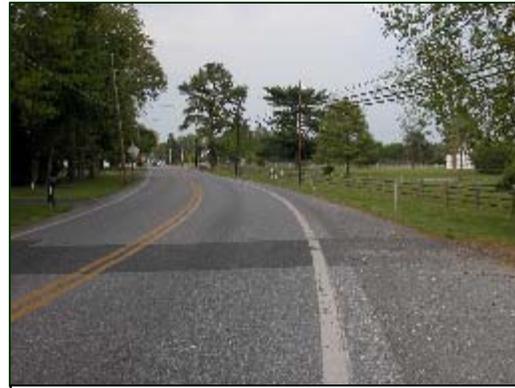
The crash occurred on a two-lane state road during evening hours. At the time of the crash, the asphalt road surface was dry and the conditions were police reported as dark, but lighted. **Figure 2** is an approach view of the crash site from the van's eastbound trajectory. On an eastbound approach to the crash site, the road curved to the left. The curve terminated to a straight segment 27.6 m (90.5') west of the initial point of impact with a utility pole. The travel lanes were separated by a double yellow center line and bordered by white edge lines. The right (south) road edge consisted of a 1.1 m (3.6') wide asphalt shoulder paralleled by a shallow negative grass slope that transitioned onto a level grass area for a park. A wood rail fence paralleled the road and was located 7.7 m (25.3') south of the edge line. A utility pole, a telephone terminal box, and a large diameter tree were located within this grassy area. The pole and telephone box were replaced following the crash and were located 4.5 m and 5.1 m (14.8' and 16.7') south of the south edge line respectively. The 83.8 cm (33.0") diameter tree was centered 3.2 m (10.5') south of the referenced edge line. The posted speed limit was 64 km/h (40 mph) for the roadway.

Figure 2. Overall view of the crash site.

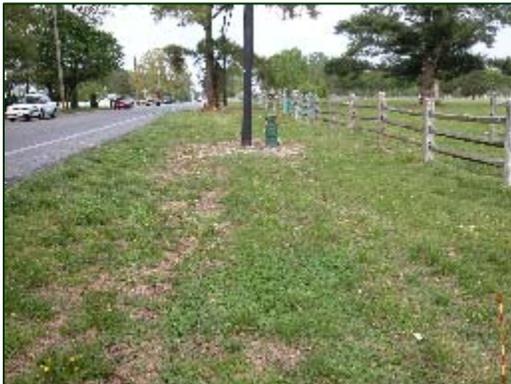
The front right area of the Ford E-250 van impacted a wooden utility pole and a composite telephone terminal box (**Figure 3**). The 12 o'clock direction of force impact sheared the pole and the terminal box. The replacement pole was located 4.5 m (14.8') south of the road edge line while the terminal box was located adjacent to the pole, 5.1 m (16.7') south of the referenced edge line. These simultaneous impacts did not alter the vehicle's trajectory. The frontal air bag system probably deployed as a result of the pole impact. This vehicle was not equipped with an Event Data Recorder (EDR), therefore the specific deployment parameters are unknown. The damage profile from this impact was masked by a subsequent impact with a large diameter tree.

Figure 3. Trajectory of the Ford van to impact with the utility pole and the terminal box.

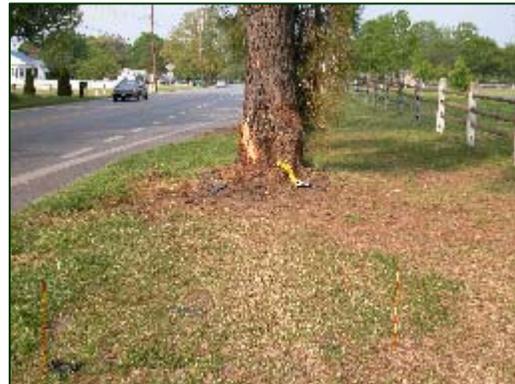
Figure 4. Struck tree.

The front right area of the van impacted an 84 cm (33.0") diameter tree (**Figure 4**) that was located 26.9 m (88.3') east of the initial impact with the struck pole. The 12 o'clock direction of force impact crushed the frontal structure of the van to a maximum depth of 93 cm (36.6"). An impact speed of 68 km/h (42 mph) was computed by the Damage and Trajectory Algorithm of the WinSMASH program. The total delta V computed by WinSMASH was 60 km/h (37 mph) with a longitudinal component of -60 km/h (-37 mph) and a lateral of 0 km/h. Although the vehicle sustained overlapping impact damage to the front right area, the damage profile from the tree impact was not significantly enhanced by the pole damage. Therefore, the delta V for this impact should be considered a reasonable reconstruction of the event.

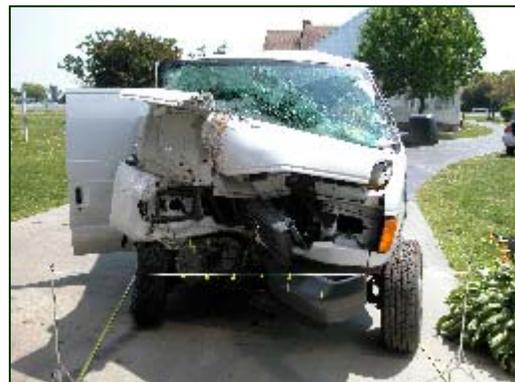
The front right impact damage from the utility pole was masked by the subsequent tree impact (**Figure 5**). The creosote pole transfer on the fiberglass hood began on the vehicle’s centerline and extended 43 cm (16.75”) to the right. It should be noted that the fiberglass hood fractured and flattened out, resulting in a wider than actual direct contact damage width. The impact fractured the hood and crushed the frontal area to an unknown depth. Although

Figure 5. Frontal damage from the overlapping impacts.

the cargo van continued forward as it sheared the pole, there was no pole damage to the greenhouse or roof areas. This impact probably deployed the vehicle's redesigned frontal air bag system. The van was not equipped with an EDR to support this assumption. The CDC for this impact was 12-FZEN-9 (9 representing an unknown extent zone).

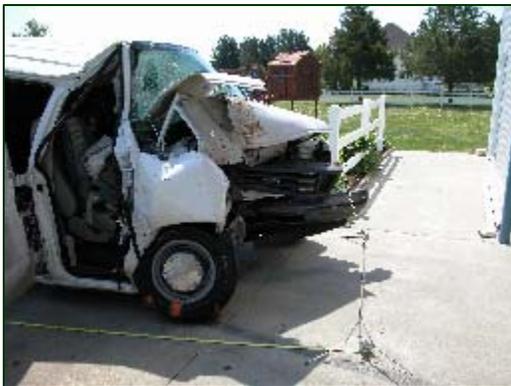
The subsequent impact with the large diameter tree resulted in severe damage to the front right area, forward of the child passenger's position. The direct contact damage began on the bumper 9 cm (3.5") right of center and extended 68 cm (26.75") to the right corner. The direct contact damage at the grille level began 16 cm (6.25") right of center and extended 71 cm (27.75") to the (deformed) leading edge of the right front fender. Maximum crush was measured at 93 cm (36.6") located 63 cm (24.75") right of center. The impact deformed the entire frontal width of the vehicle resulting in a combined direct and induced damage length of 70 cm (27.4") at bumper level. A single crush profile was documented for the overlapping damage that resulted from the utility pole and tree impacts. The crush profile at bumper level was as follows: C1 = 0 cm [-26 cm (-10.1")], C2 = 8 cm (3.1"), C3 = 90 cm (35.5"), C4 = 93 cm (36.6"), C5 = 82 cm (32.4"), C6 = 65 cm (25.5"). The CDC for this impact was 12-FZEW-6. **Figures 6 and 7** document the extent of frontal crush.

Figure 6. Lateral view documenting the extent of frontal crush.

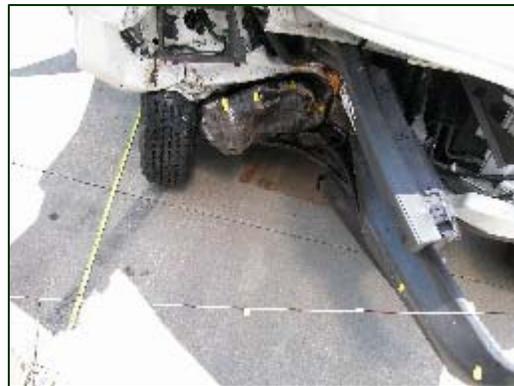
Figure 7. Maximum crush located inboard of the right corner.

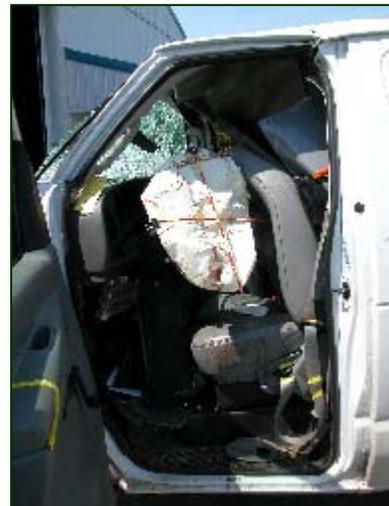
The interior damage to the Ford E-250 cargo van was rated as severe and was primarily associated with intrusion of frontal components. The restrained front occupants loaded interior components and the manual belt systems. The driver loaded the belt webbing which resulted in frictional abrasions to the seat back recline lever, the latch plate, and the D-ring. His knees loaded the knee bolster which intruded into the driver's compartment. The left knee scuffed and abraded the bolster panel 23-28 cm (9-11") inboard of the left edge of the plastic panel and 1-10 cm (0.5-3") below the top edge of the bolster. The driver's right knee scuffed and abraded the bolster 43-56 cm (17-22") inboard of the

Figure 8. Lateral view of the driver's contact points and interior deformation.

left edge and 5-17 cm (2-6.5") below the top edge. There were no fractures of the bolster panel. The driver loaded through the deployed and deflated air bag as the E-250 impacted the large diameter tree. His loading of the steering wheel rim resulted in 2 cm (0.6") of forward rim deflection at the lower aspect of the wheel. His loading force was transmitted into the energy absorbing steering column which compressed the column and separated the shear brackets from the blocks. A fabric impression (woven pattern) with a scuff mark was noted to the aft aspect of the left door panel above the armrest. The probable left elbow/arm contact point was located 67-79 cm (26.5-31.25") rearward of the leading edge of the door panel and 2-12 cm (0.6-4.75") below the beltline. **Figure 8** is a view of the driver's contact points and interior damage.

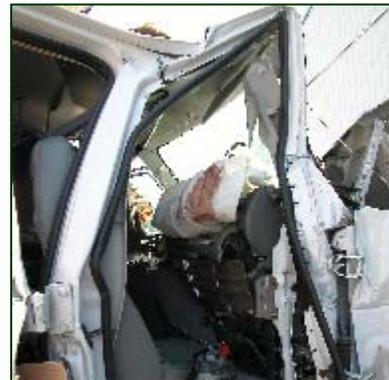
The front right child passenger contacted the intruding knee bolster. The plastic panel separated from the sheet metal backer panel due to the severe intrusion at this location. A large right knee/leg scuff mark was located 18 cm (7") inboard of the right edge of the bolster and measured 23 cm (9.1") in length vertically. Two small scuff marks were visible on the left side of the panel. The mid scuff mark was located 24-27 cm (9.5-10.6") inboard of the right edge and 10-14 cm (3.75-5.5") below the top edge of the panel. The left scuff mark was located 38-41 cm (14.9-16.25") left of the referenced edge and 13-18 cm (5-7.25") below the top edge. There was no distinct deformation of the bolster's sheet metal backer panel. **Figure 9** is a lateral view of the intrusion of the front right occupant's space.

Figure 9. Lateral view of the intrusion into the front right occupant's space.

Maximum intrusion involved 37 cm (11.5") of rearward displacement of the right toe pan. The intrusions of the front passenger compartment are identified in the following table:

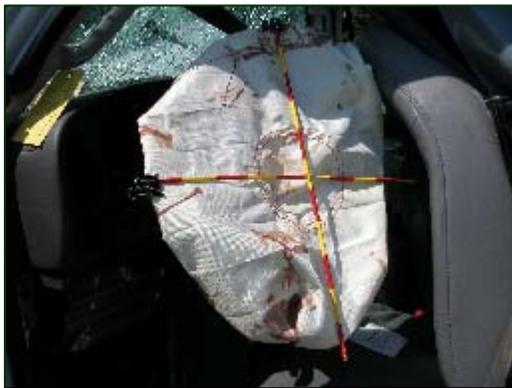
Figure 10. Deployed driver’s air bag.

The driver’s air bag (**Figure 10**) deployed from an H-configuration module that was contained within the four-spoke steering wheel rim. The driver air bag membrane was approximately 61 cm (24”) in diameter in its deflated state and was tethered internally by two tethers at the 12 and 6 o’clock positions. The tethers were sewn to the face of the air

bag with two rows of stitching in the 17 cm (6.75") diameter reinforcement. The bag was directly vented to the passenger compartment by two 3 cm (1") diameter ports located at the 12 o'clock position. The ports were centered 8 cm (3") forward of the peripheral seam. Although the driver's air bag was not damaged by the deployment or the crash related damage, the bag was covered with blood as the driver slumped over the bag post-crash. Due to the extensive amount of blood, there was no discernable contact evidence on the bag membrane.

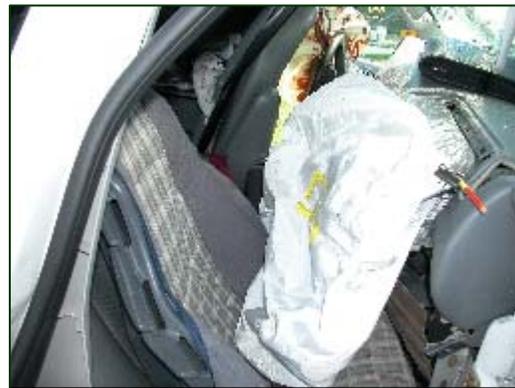
Figure 11. Deployed front right passenger’s air bag.

The front right passenger air bag (**Figure 11**) was concealed by a single cover flap in the top and mid aspect of the right instrument panel. The cover flap was hinged at the top surface and opened at the mid instrument panel, in an upward direction. The cover flap measured 38 cm (14.75") in width and 28 cm (10.9") in height. The passenger air bag deployed from the mid mount module. The air bag membrane was not tethered and was vented by two 7 cm (2.75") diameter ports located at the lateral aspects of the bag, 22 cm (8.75") forward of the peripheral seam.

There was no damage to the deployed passenger air bag. A tissue transfer was noted to the face of the bag, located 22-27 cm (8.5-10.5") below the top apex of the bag and 12-22 cm (4.6-8.6") inboard of the right vertical seam. Blood stains were noted to the top panel of the bag.

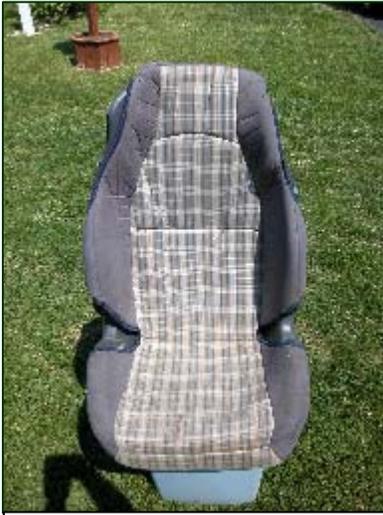
There was no other damage or loading evidence visible to the Cosco seat.

Figure 12. Frontal view of the Cosco high-back booster seat.

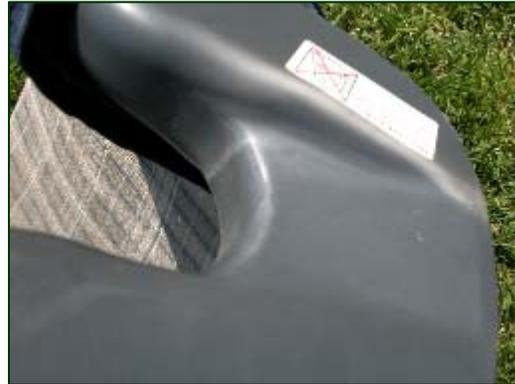
Figure 13. Belt abrasion to the right belt path of the CSS.

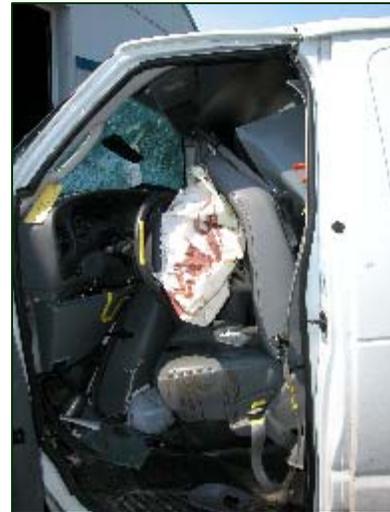
Based on the vehicle's arcing trajectory back toward the travel lanes, the driver was presumed to be in an upright posture, attempting to regain control of the vehicle. The initial impact with the utility pole probably deployed the frontal air bag system and fired the safety belt buckle pretensioners. The impact did not alter the trajectory of the van as it continued in an easterly direction on the roadside. In response to the frontal 12 o'clock impact force, the driver initiated a forward trajectory and loaded the manual belt system and the deployed air bag. The combination of restraint systems prevented the driver from potential injury.

Figure 14. Driver loading of the belt system and steering wheel rim.

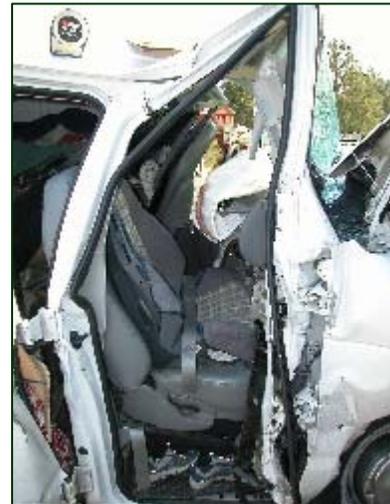
The child passenger loaded through the deflated front right air bag and contacted the intruding lower, mid and upper instrument panel. This contact sequence resulted in the closed head injuries that included the right subdural hematoma and the diffuse cerebral edema. The head contact hyperextended the head resulting in minimal subluxation of the C2/C3. **Figure 15** is a lateral view on the passenger’s position against the intruding frontal components.

Figure 15. Position of the child passenger with respect to the deployed air bag and frontal intrusion.

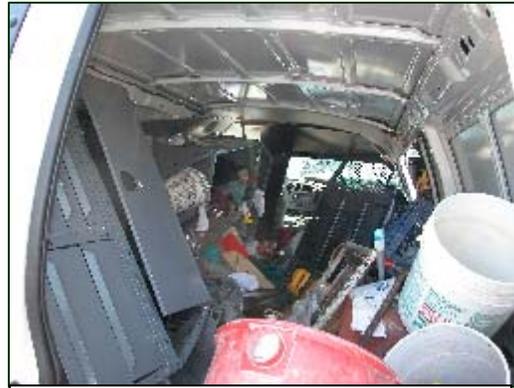
The 12-year old child passenger was seated on an inverted plastic bucket in the right rear area of the cargo compartment of the van. This was not a designated seated position; therefore, there were no restraints available to this passenger. At impact, she initiated a forward trajectory in response to the 12 o'clock direction of force. She loaded the aftermarket partition and was probably struck by loose cargo. She sustained a right mid-shaft femur fracture and a left lung contusion, in addition to multiple soft tissue injuries from loading the partition. **Figure 16** is a view from the rear of the cargo area of the van.

Figure 16. View of the cargo area, loose construction equipment, and passenger position.

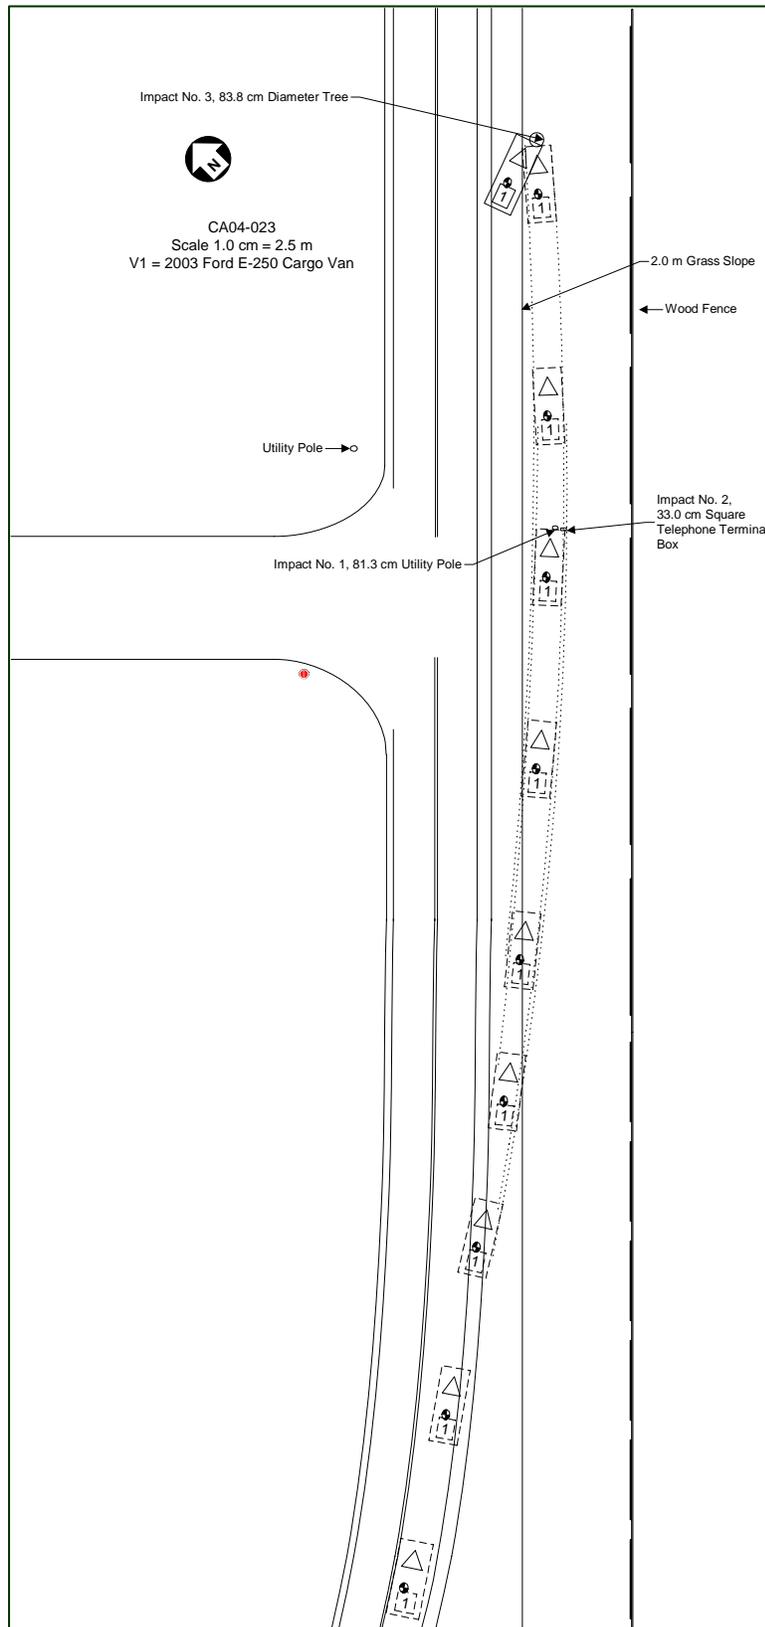
Figure 17: Scene Schematic.

The driver of the Ford cargo van was intoxicated with a BAC of .254. He was transporting his children to his residence in his commercial cargo van that was equipped with two designated seated positions. The 5-year old male was positioned in a Cosco belt positioning booster seat in the front right position and was restrained by the vehicle's 3-point lap and shoulder belt system. The driver's 12-year old daughter was seated unrestrained on an inverted bucket on the right side of the cargo area, behind the passenger's seat. The driver was restrained by the manual belt system. The crash schematic is attached as **Figure 17** of this report.
