**CALSPAN ON-SITE ADVANCED OCCUPANT PROTECTION  
SYSTEM CRASH INVESTIGATION  
SCI CASE NO: CA04-028**

**VEHICLE: 2004 NISSAN PATHFINDER  
LOCATION: NORTH CAROLINA**

**CRASH DATE: MAY 2004**

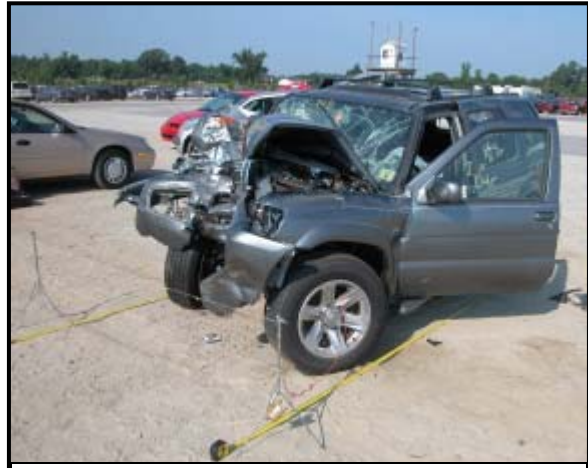
This on-site investigation focused on the performance of the Advanced Occupant Protection System (AOPS) in a 2004 Nissan Pathfinder, **Figure 1**. The Nissan was involved in a road side departure and a severe frontal impact with a 99 cm (39 in) diameter tree. The Nissan Pathfinder was equipped with an AOPS that consisted of advanced dual stage frontal air bags, front seat belt retractor pretensioners, and front seat belt buckle switch sensors. The Nissan was also equipped with the optional side impact air bags that consisted of front seat back mounted thorax bags and inflatable side curtains. The 16 year old male driver suffered facial abrasions, safety belt related abdominal abrasions, a left lower extremity contusion, and fractures of the right third and fourth metacarpals in the crash. He was transported to a regional trauma center and hospitalized for two days.

**Figure 1: Front left oblique view.**

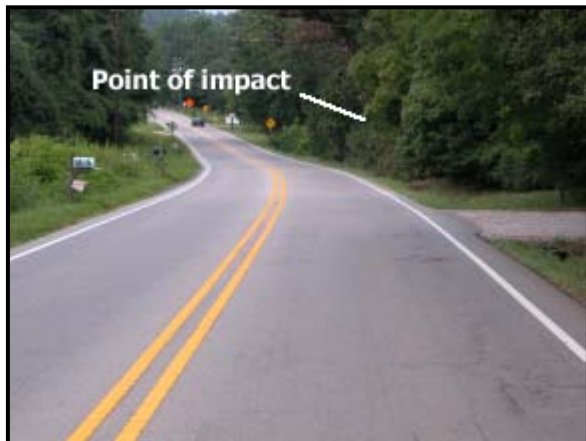
This single vehicle crash occurred during the afternoon hours in May 2004. At the time of the crash, it was daylight and the weather was not a factor. The crash occurred on a two lane north/south road in a rural setting. At the crash site, there was a left curve for northbound traffic. The radius of the curve measured 579 m (1900 ft). There was a 9 percent negative grade in the northbound direction. The respective travel lanes were separated by solid double yellow lines. The 3.2 m (10.5 ft) traffic lanes were bordered by white fog lines and narrow 0.4 m (1.5 ft) wide shoulders. A 0.3 m (1.0 ft) deep ditch ran parallel to the east road edge and was centered 1.4 m (4.0 ft) east of the pavement edge. East of the ditch, the elevation of the terrain along back slope of the ditch increased 0.7 m (2.3 ft) over a lateral dimension of 1.5 m (5.0 ft) and then leveled. Numerous small diameter trees and brush populated the terrain east of the ditch. A 99.0 cm (39.0 in) diameter hardwood tree located (11.0 ft) east of the road edge was the point of impact. **Figure 2** is a northbound trajectory view at the crash site. **Figure 3** is a view of the point of impact. The speed limit in the area of the crash site was 64 km/h (40 mph).

**Figure 2: Northbound trajectory view.**

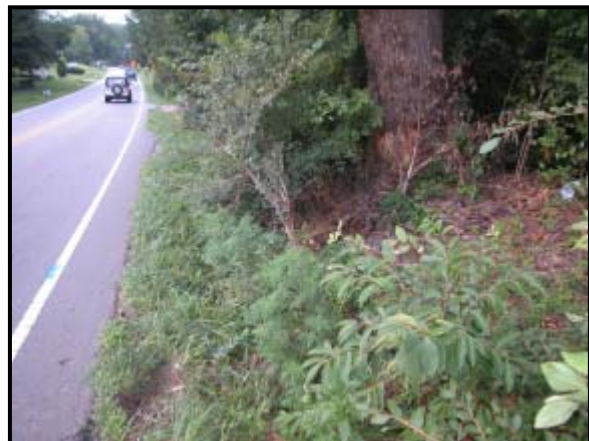
**Figure 3: Point of impact.**

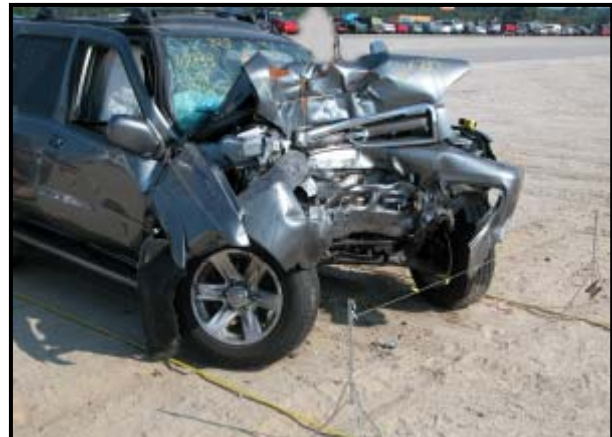
The 2004 Nissan Pathfinder, **Figure 4**, was northbound and was driven by a 16 year old male driver. The driver was restrained by the vehicle's manual safety belt. He was the vehicle's sole occupant. For unknown reasons, the driver failed to negotiate the left curve and departed the right road edge at the approximate apex of the curve. There was no physical evidence that indicated the exact point of road side departure. The driver had no recollection of the crash.

**Figure 4: Front right oblique view of the Nissan.**

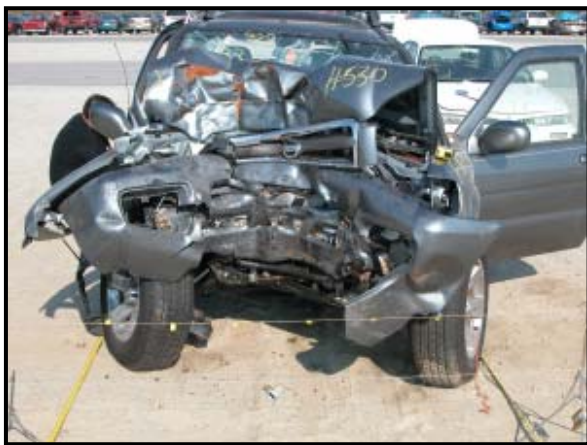
**Figures 5 and 6** are the front and right side views of the Nissan. The front plane of the Nissan Pathfinder sustained severe damage as a result of the impact. The width of the direct and induced damage extended across the vehicle's entire 165 cm (65 in) end width. The direct

contact damage measured 97 cm (38 in) and began 41 cm (16 in) left of center. The direct contact damage ended 56 cm (22 in) right of center. The frontal structures crushed rearward and wrapped around the circumference of the tree. The front wheels towed inward. The hood buckled and folded. The impact was biased slightly to the right of center. The crush profile measured across the front bumper was as follows: C1 = 19 cm (7.5 in), C2 = 51 cm (20.1 in), C3 = 84 cm (33.1 in), C4 = 98 cm (38.6 in), C5 = 85 cm (33.5 in), C6 = 67 cm (26.4 in). The maximum crush was located 21 cm (8.3 in) right of center at the C4 crush measurement. The left front, left rear, and right rear doors were operational post-crash. The right front door was jammed shut. The windshield was in place and fractured. The front right window glazing and then backlight disintegrated. The left wheelbase measurement was unchanged. The right wheelbase was reduced 12 cm (4.8 in). The Collision Deformation Classification (CDC) was 12-FDEW4.

Figure 5: Front view of the Nissan.

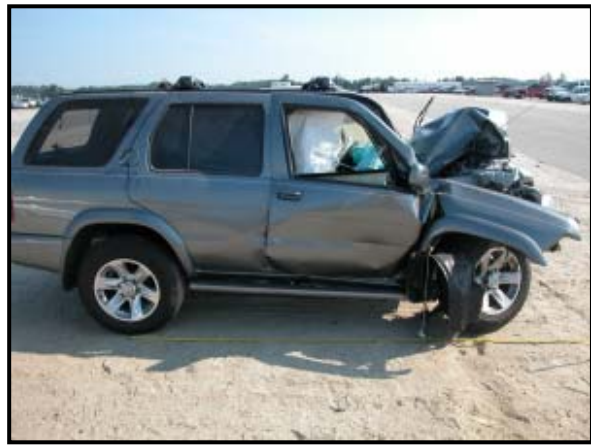
Figure 6: Right side view.

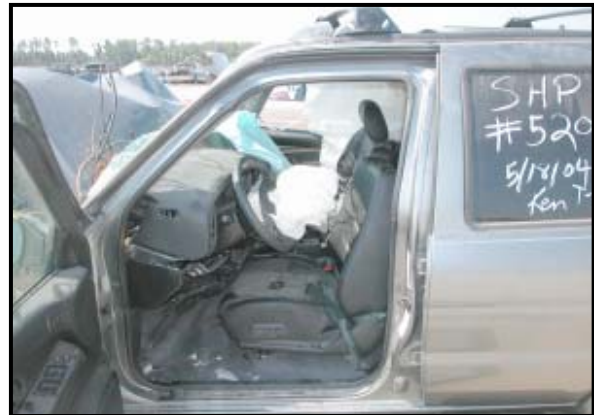
The interior damage to the Nissan consisted of moderate toe pan and instrument panel intrusion, deployment of the frontal air bags, deployment of the right side impact inflatable protection and the driver interior contact points. The toe pan intrusion measured 13 cm (5 in). The left instrument panel intruded 8 cm (3 in). The right instrument panel intruded 15 cm (6 in). **Figure 7** is a left view of the driver's interior. Minor intrusions of the center instrument panel and the left floor pan were also documented.

Figure 7: Left interior view.

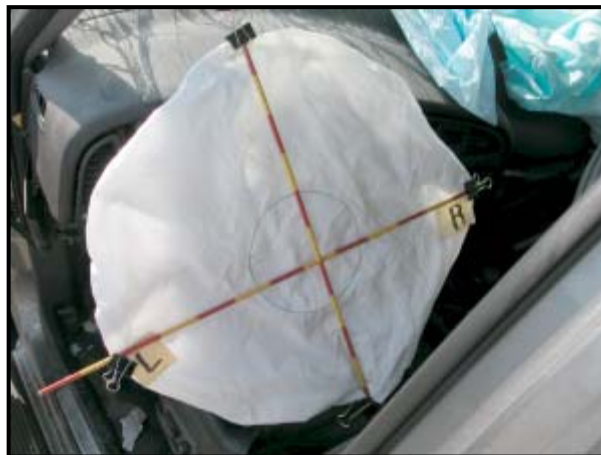
The Nissan Pathfinder was equipped with an Advanced Occupant Protection System (AOPS) that consisted of dual stage driver and front right passenger air bags. The frontal air bags deployed as a result of the tree impact. The driver air bag deployed from a tri-flap design module located in the center hub of the steering wheel. The upper half of the cover flap consisted of two 5 cm x 8 cm (2 in x 3 in) flaps that separated along a vertical center seam. The lower flap measured 15 cm x 11 cm (5.8 x 4.5 in), width by height, and separated from the upper flaps at the horizontal seam. There was no occupant contact evidence to the cover flaps. The driver air bag, **Figure 8**, measured 58 cm (23 in) in its deflated state. It was tethered by two internal straps and vented by two ports located on the back side of the bag in the 11/1 o'clock sectors. There was no evidence of occupant contact to the face of the driver air bag. The only noted physical evidence was the presence of a post-crash blood transfer to the 3 o'clock sector on the back side of the bag.

**Figure 8: Driver air bag.**

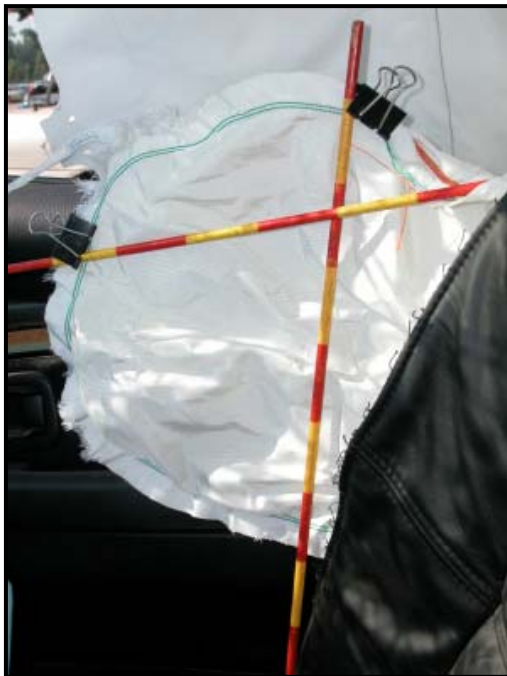
The thorax bag, **Figure 9**, deployed from a module mounted in the outboard bolster of the front right seat back. During the deployment, the fabric seam of the bolster separated over a 36 cm (14 in) length creating a deployment path for the air bag. The air bag deployed in a forward direction and measured 33 cm x 30 cm (13 in x 12 in), length by height.

**Figure 9: Thorax bag.**

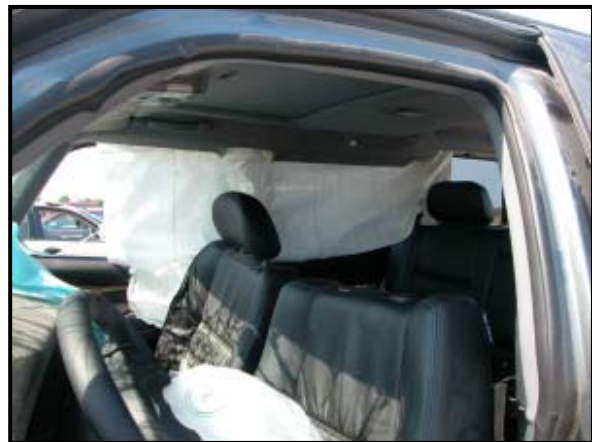
The inflatable side curtain deployed vertically downward from its mounting in the right roof rail. The air bag was rectangular in shape and measured 145 x 41 cm (57.3 in x 16 in), length by height. The air bag provided coverage from a point approximately 53 cm (21 in) forward of the B-pillar (center) rearward to the C-pillar (beyond the second row). **Figure 10** is an interior view of the deployed side curtain.

**Figure 10: Deployed side curtain.**

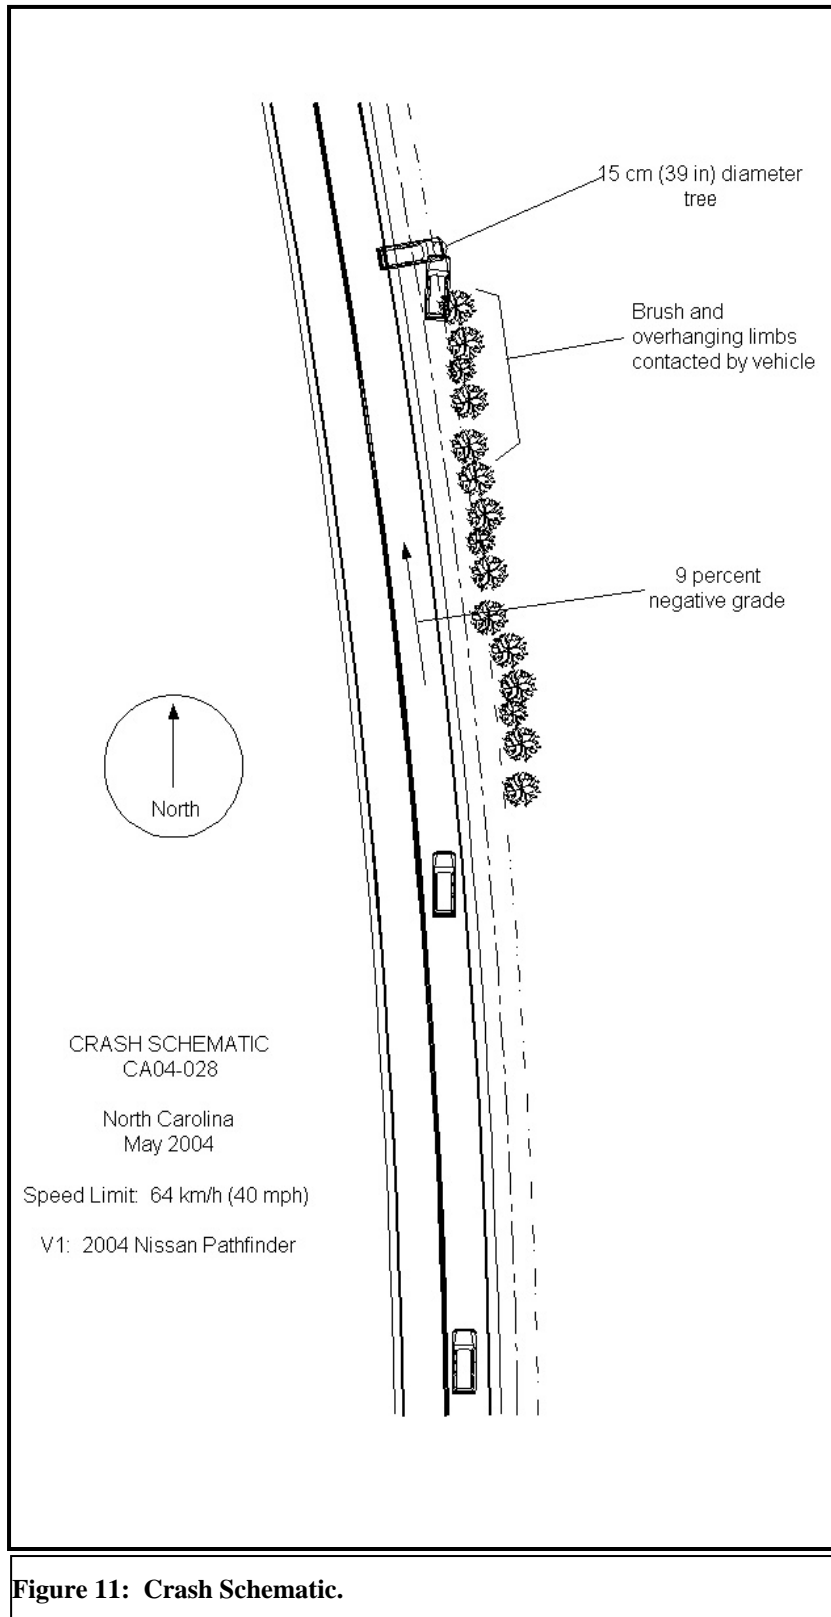
The Nissan departed the right edge of the road at a shallow angle (estimated between 5 to 10 degrees relative to the road). The Nissan traveled along the road shoulder an estimated 15 to 18 m (50 ft to 60 ft). The right side of the vehicle contacted and sheared the overhanging branches and brush along the road side. This contact began 13 m (43 ft) south of the point of impact. The Nissan traveled through the road side ditch, climbed the embankment, and impacted the 99 cm (39 in) diameter hardwood tree with its front plane. A 76 cm x 61 cm (30 in x 24 in) area of bark was removed from the tree during the impact. The area of removed bark began 23 cm (9 in) above the ground. The front plane of the vehicle deformed into a U-shaped pattern around the tree. The Nissan then rotated approximately 90 degrees and came to rest facing east. The delta V of the impact calculated by the Damage Algorithm of the WINSMASH model was 61 km/h (38 mph). The longitudinal and lateral components of the delta V were -61 km/h (-38 mph) and 0 km/h (0 mph), respectively. A schematic of the crash is included at the end of this report as **Figure 11**.

**Figure 11: Crash Schematic.**
