**CRASH DATA RESEARCH CENTER**

**CALSPAN ON-SITE CERTIFIED ADVANCED 208-COMPLIANT  
VEHICLE CRASH INVESTIGATION**

**CASE NO: CA04-029**

**VEHICLE: 2003 CHEVROLET TAHOE**

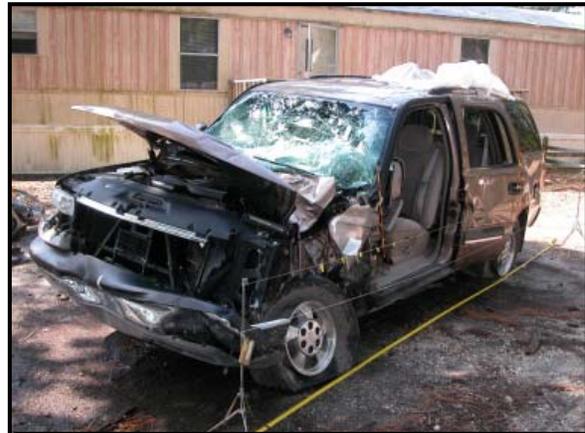
**Figure 1: Left front view of the 2003 Chevrolet Tahoe.**

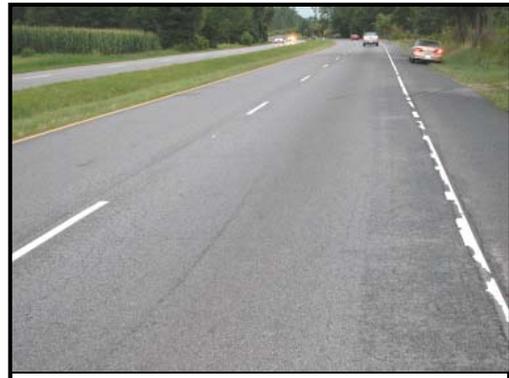
**Figure 2: Eastbound trajectory view.**

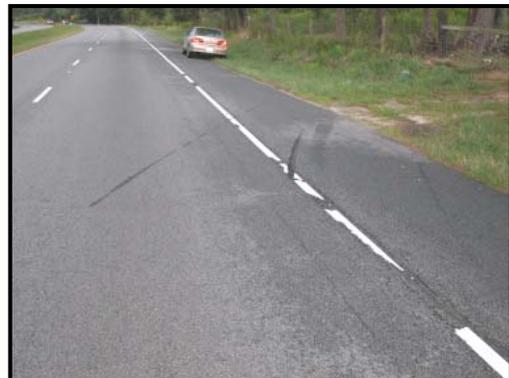
The physical road evidence documented at the crash scene identified the trajectories of the Isuzu and Chevrolet, as the vehicles departed the right side of the roadway. **Figure 3** is a southeastward view of the road evidence. The vehicles departed the road at an angle of approximately 30 degrees relative to the eastbound travel direction. The road evidence consisted of a gouge attributed to the right front rim of the Isuzu, and a set of marks (a tire scuff and a pair of gouges) attributed to the left front tire, left rear rim and right rear rim of the Chevrolet, respectively. The Isuzu's rim gouge measured 11.5 m (37.6 ft) long, 3 cm (1 in) wide and 1 cm (0.5 in) deep and is depicted on the left side of Figure 3. The set of marks attributed to the Chevrolet are depicted on the center and right side of Figure 3. The left front tire mark measured 6.2 m (20.2 ft) long and 24 cm (9.5 in) wide. The gouge caused by the left rear rim measured 3.7 m (12.3 ft) long, 5 cm (2.0 in) wide and 3 cm (1 in) deep. The right rear rim gouge measured 4.9 m (16.2 ft) long, and was a surface abrasion. The orientation of the marks revealed the Chevrolet departed the road with a clockwise rotation and was off-tracking approximately 10 degrees.

**Figure 3: Physical road evidence of the vehicles' trajectories.**

The Isuzu departed the road along the trajectory defined by the 11.5 m (37.6 ft) long rim gouge depicted on the left side of **Figure 3** above. It was probable that the gouge was related to one of the right tires that deflated during the vehicle to vehicle interaction. The Isuzu rotated clockwise and came to rest facing northwest on the road shoulder. A 1 m (3.2 ft) gouge mark defined the vehicle's probable final rest location.

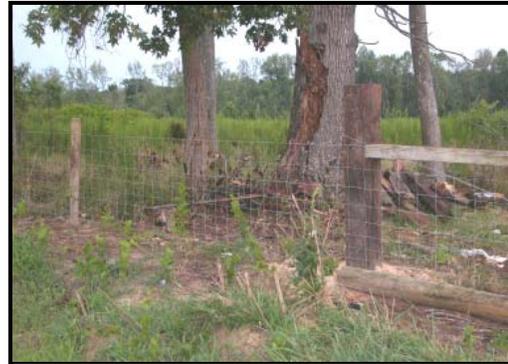
A fence line located approximately 5.1 m (16.6 ft) south of the pavement edge was impacted and taken down by the Chevrolet Tahoe during its off-road trajectory. The fence was repaired prior to SCI inspection. An 81 cm (32 in) diameter tree and a 28 cm (11 in) diameter tree were located

2.8 m (9.3 ft) and 1.4 m (4.6 ft) south of the fence, respectively. The trees are depicted in **Figure 4** and were the Tahoe's point of impact.

**Figure 4: Fence and trees impacted by the Tahoe.**

The front plane of the Chevrolet engaged and fractured the 10 cm (4 in) diameter fence post (depicted in **Figure 4**) and passed through the fence line (Event 3). At the time of the fence impact, the Tahoe had rotated approximately 65 degrees clockwise relative to its original travel direction. The Tahoe continued along this southeastward trajectory and the left corner of the vehicle's front bumper engaged the 81 cm (32 in) diameter tree (Event 4). This impact crushed the left corner of the bumper (outboard the frame) rearward deflating the left front tire. The direction of force for the frontal impacts was in the 11 o'clock sector at an estimated 320 degrees. The WINSMASH calculated total delta V of the Tahoe based on the combined frontal damage of Events 3 and 4 was 11 km/h (6.6 mph). The longitudinal and lateral delta V components were -8 km/h (-5 mph) and 7 km/h (4.2 mph), respectively.

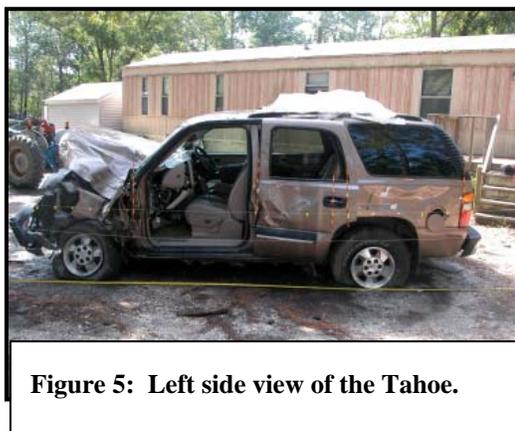
The 2003 Chevrolet Tahoe sustained impact damage to the front and left side planes during the multiple impact crash sequence. **Figure 5** is an overall left side view of the Tahoe. At the time of the inspection the front left door was missing, therefore contact damage to exterior door panel could not be documented. However, it was probable that the front left door was also damaged during the vehicle to vehicle impact (Event 1). The left rear door was forced open during the extrication process and would not close. The rearward shift of the door measured 4 cm (1.5 in) at the striker. There was no measurable change in the wheelbase dimensions. The windshield was fractured in multiple locations from the exterior impact in the tree (Event 5). None of the side windows were damaged.

**Figure 5: Left side view of the Tahoe.**

The left side plane damage began 81 cm (32 in) rearward of the left rear axle and extended forward to the left B-pillar location 119 cm (47 in) forward of the left rear axle. The direct damage throughout the contact pattern consisted of abrasions and minor deformation of the body panels. The maximum measured deformation was 5 cm (2.0 in). The maximum deformation was located on the left rear quarterpanel 36 cm (14 in) aft of the left rear axle. The Collision Deformation Classification (CDC) of this impact was 09-LZEN1.

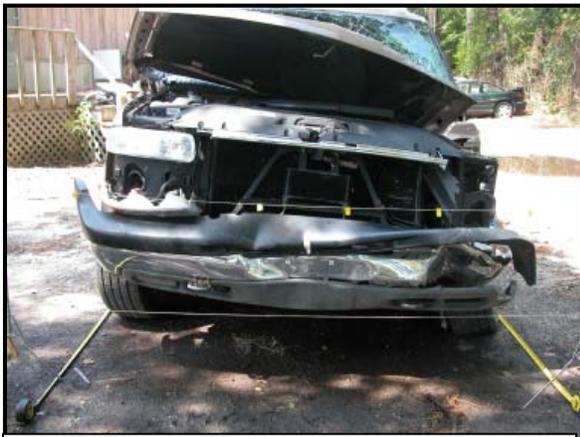
**Figure 6** is a front view of the damaged Tahoe. The front plane of the Tahoe sustained 168 cm (66 in) of direct and induced damage that extended across the entire end width of the vehicle as a result of the impacts to the fence and 81 cm (32 in) diameter tree (Events 3 and 4). The direct contact began 51 cm (20.1 in) right of center and extended 134 cm (52.9 in) to the left front bumper corner. The residual crush profile measured along the front bumper was as follows: C1 = 14 cm (5.7 in), C2 = 4 cm (1.8 in), C3 = 9 cm (3.5 in), C4 = 10 cm (3.8 in), C5 = 2 cm (1.0 in), C6 = 0. The maximum crush was located at C1. The maximum crush occurred outboard the frame and was consistent with contact to the tree. The CDC of the overlapping damage was 11-FDEW1.

**Figure 6: Front view of the Tahoe.**

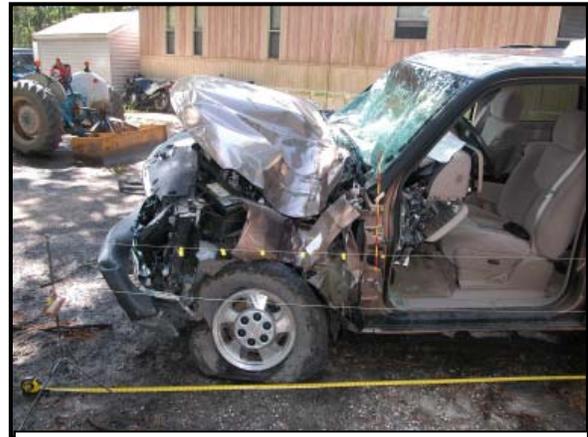
The Tahoe engaged the 28 cm (11 in) diameter tree (Event 5) with the left front fender, **Figure 7**. The direct contact began 4 cm (1.5 in) forward of the left front axle and ended 24 cm (9.5 in) rearward of the axle. The combined length of the direct and induced damage measured 89 cm (35 in). The direction of impact force was an estimated 290 degrees. The fender deformed laterally and shifted rearward. The direct contact with the tree wrapped onto the horizontal surface of the hood to the centerline. This deformation pattern indicated that the vehicle rolled to left approximately 45 degrees during the interaction. The residual crush profile measured along the top edge of the fender was as follows: C1 = 0, C2 = 47 cm (18.5 in), C3 = 46 cm (18.1 in), C4 = 28 cm (11.0 in), C5 = 13 cm (5.1 in), C6 = 6 cm (2.4 in). The CDC of the damage was 10-LFEN3.

**Figure 7: Residual crush at the left front fender.**

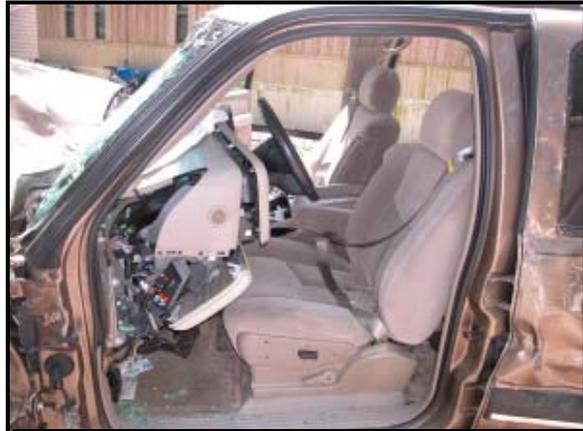
The interior damage to the Chevrolet Tahoe consisted of intrusion into the driver's interior space and interior driver contacts. **Figure 8** is an interior view of Row 1. The impact with the 28 cm (11 in) diameter tree (Event 5) resulted in intrusion of the upper instrument panel and knee bolster. The left upper instrument panel intrusion measured at the outboard corner was 16 cm (6.2 in). The bolster intrusion at the outboard aspect measured 15 cm (6 in). There was no intrusion into the front right occupant space.

**Figure 8: Interior view across Row 1.**

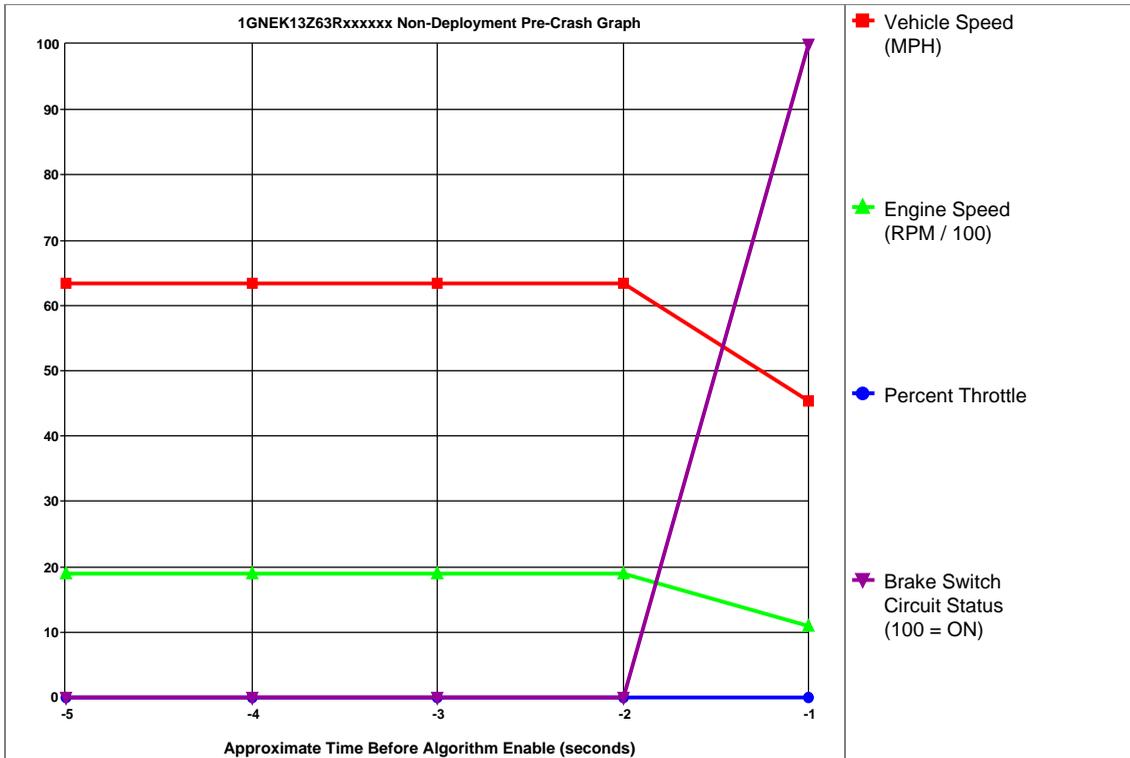
Seconds Before AE	Vehicle Speed (MPH)	Engine Speed (RPM)	Percent Throttle	Brake Switch Circuit Status
-5	63	1856	0	OFF
-4	63	1856	0	OFF
-3	63	1856	0	OFF
-2	63	1856	0	OFF
-1	45	1088	0	ON

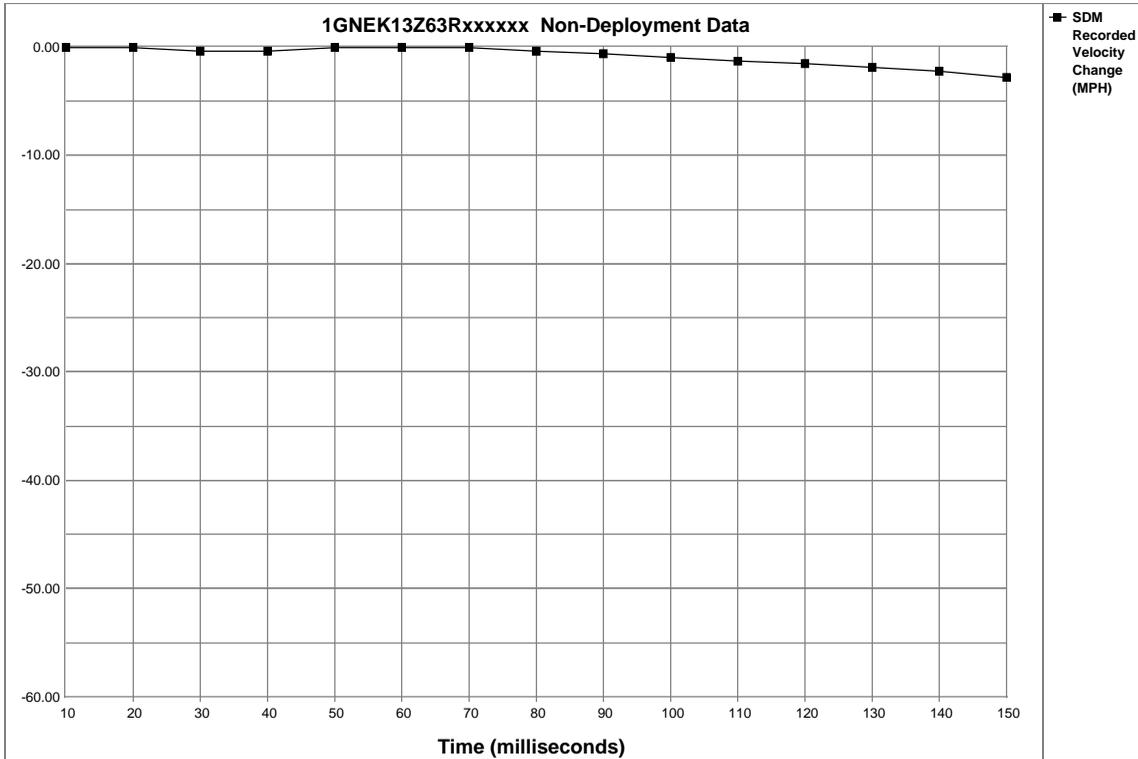
Time (milliseconds)	10	20	30	40	50	60	70	80	90	100	110	120	130	140	150
Recorded Velocity Change (MPH)	0.00	0.00	-0.31	-0.31	0.00	0.00	0.00	-0.31	-0.62	-0.93	-1.24	-1.55	-1.86	-2.17	-2.79
