**CALSPAN ON-SITE ALTERNATIVE FUEL VEHICLE CRASH
INVESTIGATION**

CASE NO.: CA04-036

VEHICLE: 2003 HONDA CIVIC HYBRID

CRASH DATE: AUGUST 2004

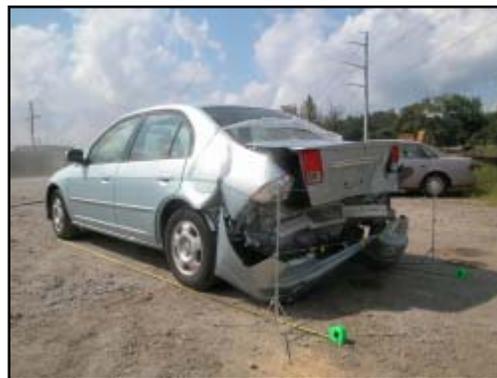
This on-site investigative effort focused on the performance of the gasoline/electric hybrid fuel system that was present in a 2003 Honda Civic (**Figure 1**). The hybrid Civic was occupied by a 43-year-old female driver, a 14-year-old male front right passenger, a 14-year-old female rear left passenger, and a 14-year-old male rear right passenger. All of the occupants were restrained by the manual lap and shoulder belts. The driver of the hybrid Civic was operating the vehicle in the outboard lane of a four-lane roadway during daylight hours in heavy traffic conditions. Traffic came to an abrupt stop for a right-turning non-contact vehicle. As the driver of the hybrid Civic stopped her vehicle, it was struck in the back by a 1991 Honda Civic. The front-to-rear impact was slightly offset to the left of the hybrid Civic. The front right passenger was transported by ambulance to a local hospital for evaluation and released. The driver was taken to a local hospital in a private vehicle at a later time the same day for evaluation and released. Both front seat occupants sustained muscle strains. The rear-seat occupants were not injured. The hybrid fuel/battery system was not compromised by the crash.

Figure 1. Damaged 2003 hybrid Honda Civic

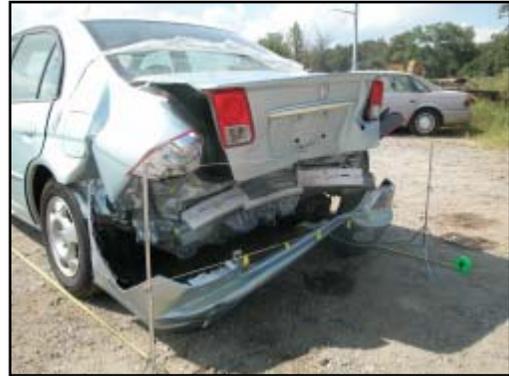
The 2003 hybrid Honda Civic sustained moderate rear damage (**Figure 3**) as a result of the impact with the 1991 Civic. The direct damage began on the rear bumper fascia 41 cm (16.0”) right of the centerline and extended 118 cm (46.5”) laterally to the rear left bumper corner. The bumper fascia was partially separated and sustained black transfers from direct contact with the bumper of the 1991 Civic. Minor abrasions were present on the lower edge of the trunk lid from direct contact with the leading edge of the hood of the 1991 Civic. The maximum crush measured 48 cm (18.9”) and was located 2 cm (0.8”) right of the centerline on the bumper beam. The crush displaced the bumper beam and rear wall of the trunk forward, which resulted in the disengagement of the trunk lid from the latch. At the time of the vehicle inspection, the longitudinal distance between the latch on the rear wall of the trunk and the receiver on the trunk lid measured 23 cm (9.0”). The combined direct and induced damage measured 104 cm (41.0”) across the rear bumper beam. The left rear quarter panel was buckled slightly rear of the fuel filler door. It was crushed forward, and the rear aspect deflected downward due to the bumper crush (**Figure 4**). Due to the slight forward displacement of the left rear quarter panel, the rear aspect of the left rear door overlapped the quarter panel by 1 cm (0.4”). Six crush measurements (**Figure 5**) were documented along the rear bumper beam as follows: C1 = 33 cm (12.9”), C2 = 38 cm (15.1”), C3 = 42 cm (16.6”), C4 = 47 cm (18.4”), C5 = 27 cm (10.6”), C6 = 7 cm (2.6”). The Collision Deformation Classification (CDC) for the impact with the 1991 Civic was 06-BDEW-4.

Figure 3. Rear damage to the 2003 hybrid Civic

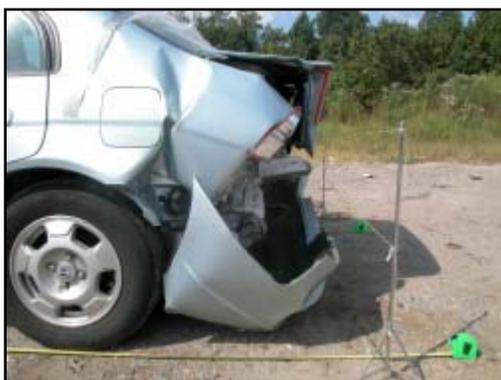
Figure 4. Lateral view of the crush and damaged left rear quarter panel

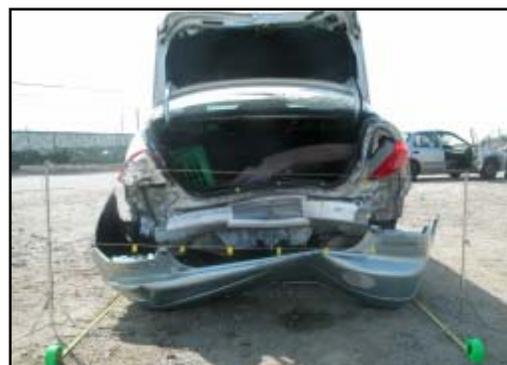
Figure 5. View of crush profile along bumper beam and trunk lip

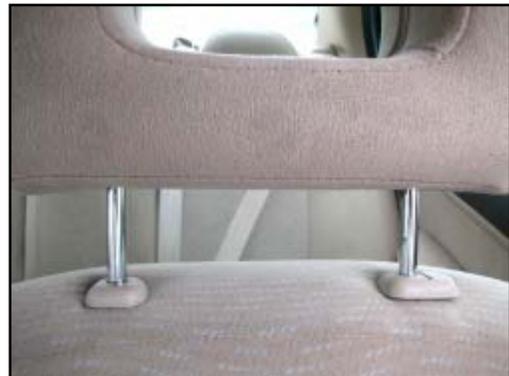
Interior damage to the hybrid Civic was minor and attributed to occupant contact. The plastic trim covers around the driver's head restraint posts were displaced due to the loading of the head restraint by the driver. The driver's head restraint was in the full-down position at the time of the vehicle inspection, and was adjusted vertically by the SCI investigator to reveal the plastic covers (**Figure 6**). The outboard plastic cover was displaced vertically 1 cm (0.4") and the inboard plastic cover was displaced 1 cm (0.4") rearward. The loading to the head restraint did not deform the posts or affect the performance of the vertical adjustment. Neither front seat back sustained damage as a result of the crash, and both front seat recline mechanisms were operational.

Figure 4. Close-up of driver's head restraint and displaced plastic covers

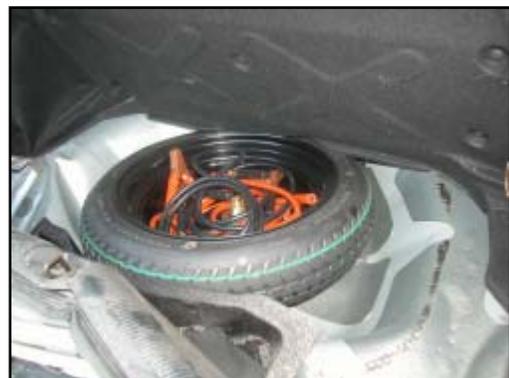
The trunk contained a plastic milk crate, which was crushed between the rear and left side aspects of the trunk. At the time of the vehicle inspection, there were no additional cargo items found in the trunk. The OEM T125/70D15 spare tire was properly mounted in the floor of the trunk. The longitudinal crush deformed the trunk structure, and the rear aspect of the spare tire was deflected slightly upward with the trunk floor. The spare tire remained in position and was not restricted against the forward trunk wall (**Figure 7**). The driver indicated that a case of bottled water, a bottle of motor oil, and a small knitting bag were present in the trunk at the time of the crash. There was no damage to the items in the trunk, which were removed prior to the SCI vehicle inspection.

Figure 7. View from rear right corner showing the post-crash position of the spare tire

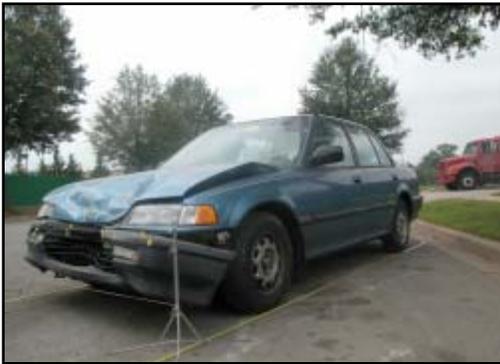
The 1991 Honda Civic sustained moderate frontal damage as a result of the impact with the hybrid Civic (**Figure 8**). The maximum crush measured 24 cm (9.3”) at the front right corner of the bumper. The direct contact damage began 29 cm (11.8”) left of the centerline on the front bumper and extended laterally 99 cm (39.0”) to the front right bumper corner. The front bumper was separated at both outboard aspects. Direct contact abrasions extended 17 cm (6.3”) longitudinally from the leading edge of the hood on the center aspect. The combined direct and induced damage measured 146 cm (57.5”) across the entire front bumper. The hood was buckled rearward. There was no damage to the left front fender; however, the right front fender sustained induced damage from the crash. In addition, prior damage was noted to the right front fender that was not related to this crash (**Figure 9**). Residue from tape and red paint transfers were present aft of the right headlamp and extended rearward to the right front axle. Six crush measurements were documented across the front bumper beam as follows: C1 = 0.0 cm, C2 = 4 cm (1.8”), C3 = 21 cm (8.3”), C4 = 20 cm (7.9”), C5 = 17 cm (6.6”), C6 = 24 cm (9.3”). The CDC for the frontal impact with the hybrid Civic was 12-FDEW-2.

Figure 8. Damaged 1991 Honda Civic

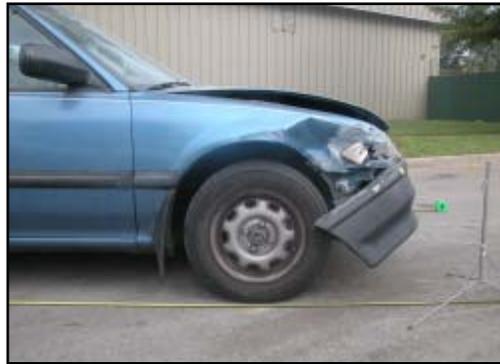
Figure 9. View of previous damage to the right front fender

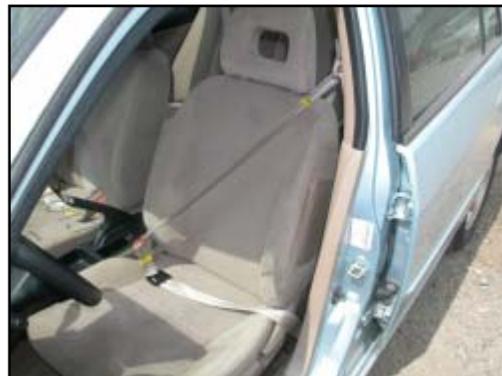
Figure 10. View of driver's safety belt

The driver's safety belt sustained minor damage from occupant loading. A slight crease from the latch plate was present on the webbing 71 cm (28.0") above the lower anchor. Some minor ripples were noted on the driver's safety belt webbing that began 65 cm (25.5") above the lower anchor and extended 69 cm (27.3") up the webbing.

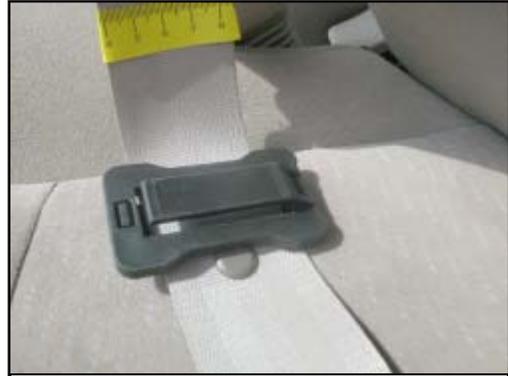
A plastic after-market safety belt adjuster (**Figure 11**) was present on the driver's lap belt. The specific make/model was not known. The adjuster measured 7 cm (2.6") in width, 4 cm (1.6") in length, and was located near the safety belt's stop button at the time of the vehicle inspection. A lateral 2 cm (0.8") wide clip was present on the top portion, which was designed to receive the shoulder belt in order to re-position the belt on the occupant. A lateral hinged clip was located on the bottom aspect that snapped together on the side opposite the hinge, which was used to secure the adjuster to the vehicle's lap belt webbing. There was no damage to the safety belt adjuster. The driver stated that it was used to re-position the shoulder belt across her shoulder, as the shoulder belt tended to ride against her neck. The adjuster was regularly placed approximately 5 cm (2") away from the latch plate on the lap belt. She further stated that she did not realize that the Civic was equipped with adjustable-height D-rings.

Figure 11. Close-up of after-market safety belt adjuster

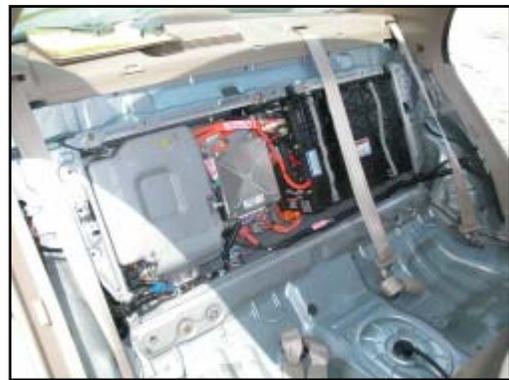
Figure 12. View of IPU compartment (rear seat and IPU cover removed)

The IPU compartment did not sustain damage as a result of the crash.

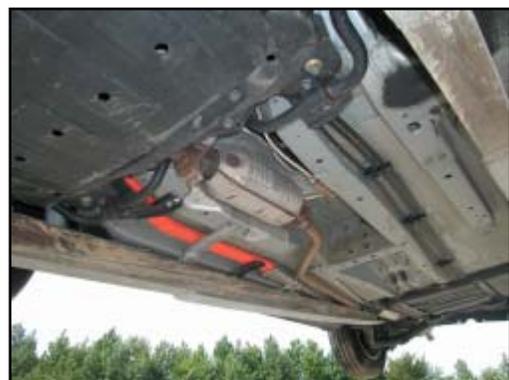
Electricity between the battery module and electric motor was conducted through three heavy-duty, electrically shielded orange cables. The cables were routed longitudinally along the right aspect of the undercarriage and were protected by an orange plastic shield (**Figure 13**). The cables were further protected by a thermal shield near the exhaust pipe. There was no damage to the electric cables or shields as a result of the crash.

Figure 13. View of undercarriage from front left showing orange electric cables (right side)
