ON-SITE CHILD SAFETY SEAT INVESTIGATION

CASE NUMBER - IN-04-037

VEHICLE - 2002 GMC ENVOY

CRASH DATE - October 2004

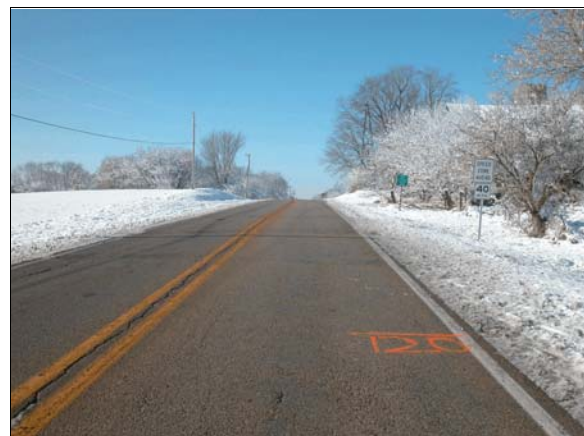
Pre-Crash: The case vehicle was traveling west in the westbound lane up an approximate 3% grade (**Figure 1**). The driver was intending to continue westbound and turn right (north) onto a county road, which was located at the top of the hill. The case vehicle's driver stated that she momentarily fell asleep, and the right side wheels drifted off the north side of roadway (**Figure 2** below). The driver awoke, steered left, crossed the westbound lane and traveled into the eastbound lane. The driver steered right to avoid an oncoming car, and the case vehicle crossed the westbound lane and approached the north side of the roadway (**Figure 3** below). The driver stated she then steered left to avoid a car parked in the grass as the case vehicle departed the north side of the roadway. The scene evidence shows the driver did steer left, and the case vehicle began to rotate counterclockwise as it traveled down the approximate 17% negative front slope of a

Figure 1: Approach of case vehicle westbound up hill, number shows distance to roadway departure

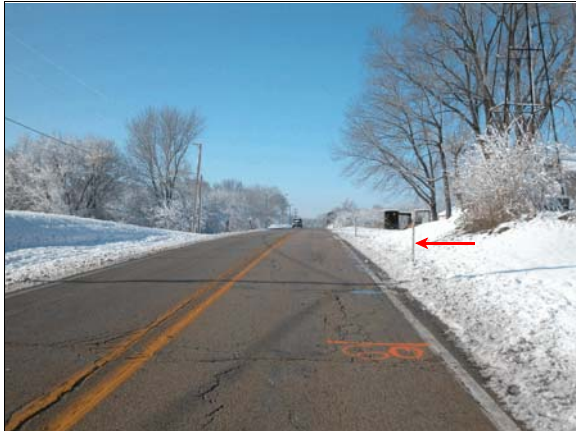
Figure 2: Case vehicle first departed north side of roadway near reflector, indicated by arrow

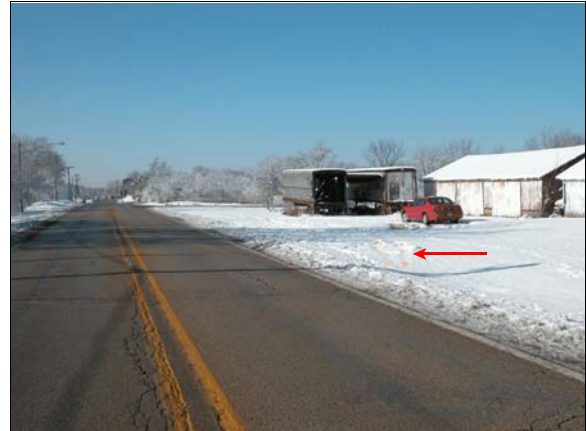
Figure 3: Location where case vehicle departed north side of roadway, arrow shows tire impressions under the snow

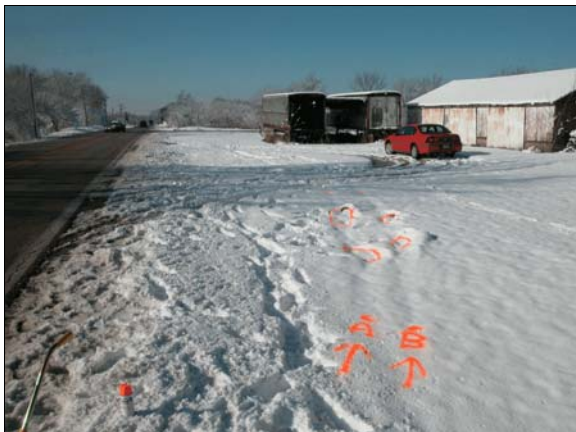
shallow ditch (Figure 4). The case vehicle traveled through the ditch and up the approximate 10% positive back slope of the ditch, across the east leg of a U-shaped gravel driveway, and into the grass between the east and west legs of the driveway. The case vehicle continued to rotate counterclockwise and was nearly broadside as it approached the west leg of the U-shaped driveway (Figure 5). The driver was unsure if she applied the brakes at any time prior to the rollover. The EDR pre-crash data indicated no brake application during the five seconds prior to algorithm enable. The rollover occurred on the north side of the roadway at the east edge of the west leg of the U-shaped driveway.

Figure 4: Approach of case vehicle to first driveway, orange paint shows tire impressions under the snow

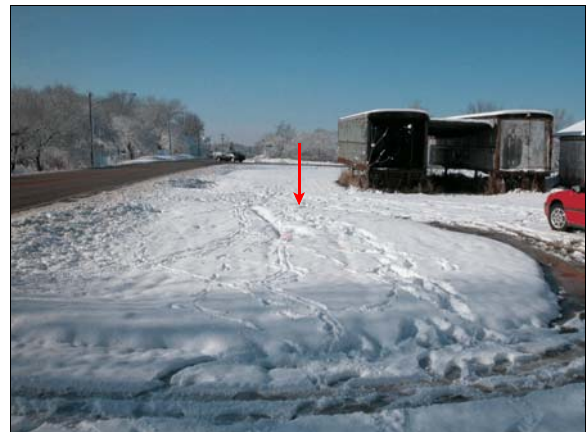
Figure 5: Approach of case vehicle to area of rollover initiation, indicated by arrow

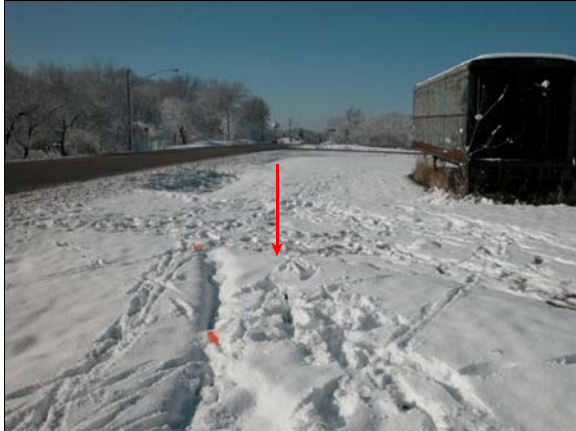
Crash: As the case vehicle approached the west leg of the driveway, it rotated counterclockwise to a near broadside orientation. The right side wheels furrowed into the ground, and the case vehicle tripped and began to roll over passenger side leading. The area of rollover initiation was on an approximate 2% positive grade at the east edge of the west leg of the U-shaped driveway (Figure 6 below). The case vehicle rolled over a total of six quarter turns (i.e., one-and-one-half rolls) on primarily level ground across a distance of approximately 16 meters (52.5 feet). Using a rollover deceleration range from the published literature of -0.36g to -0.61g, the calculated speed

Figure 6: Area of case vehicle’s rollover initiation at east edge of west leg of driveway, shown by arrow

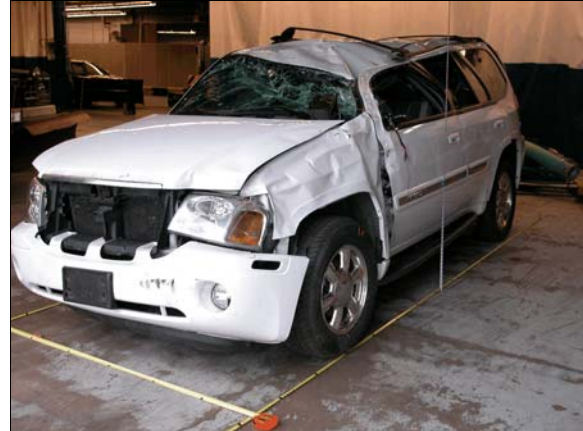
Figure 7: Overview of rollover damage to case vehicle’s front, top and left side

Exterior Damage: The case vehicle’s rollover involved the top and both sides of the vehicle. There was direct damage to the hood, windshield, roof, both front fenders, front and back doors on both sides, both right and left quarter panels and both right side wheels. In addition, the backlight, left front, left rear, and right front windows were broken out, and the left rear wheel had a large amount of grass and dirt jammed in the tire bead. The most severe crush occurred to the roof and roof side rail over the driver’s seat position, and secondarily to the roof and roof side rail over the back left seat position. The maximum roof crush over the driver’s seat position was 36 centimeters (14.2 inches). The maximum roof crush over the back left seat position was 25 centimeters (9.8 inches). The right side wheelbase was reduced by 5.0 centimeters (2.0 inches) and the left side wheelbase was reduced by 3.0 centimeters (1.2 inches). Induced damage involved the entirety of the case vehicle.

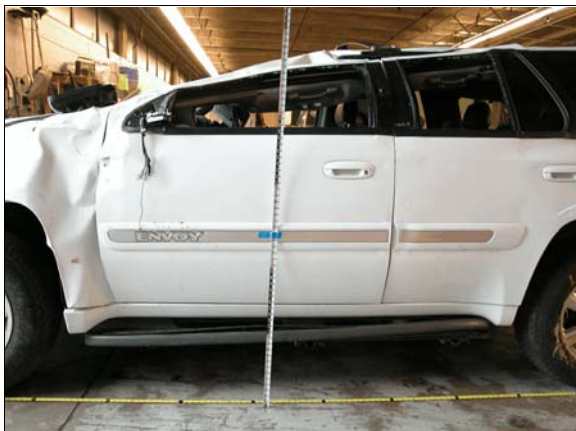
Figure 8: Crush to case vehicle’s left front roof, each black mark on yellow tape and black/white section on vertical scale=0.31 meter (1 ft)

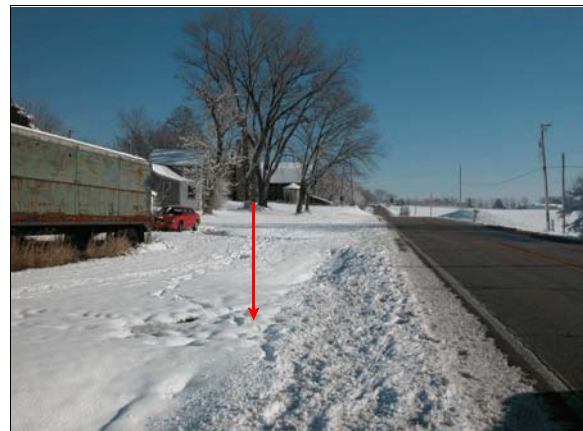
Figure 9: View east back through area of case vehicle’s final rest (indicated by arrow) to area of rollover and approach

Post-Crash: The case vehicle came to rest on its top facing southeast partially in the ditch near the roadway (**Figure 9**).

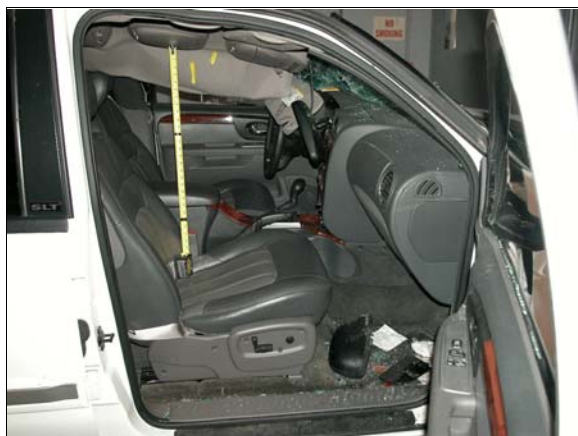
Figure 10: Overview of front right seating area and roof intrusion into driver’s seating area, each black mark on tape measure = .31 meter (1 ft)

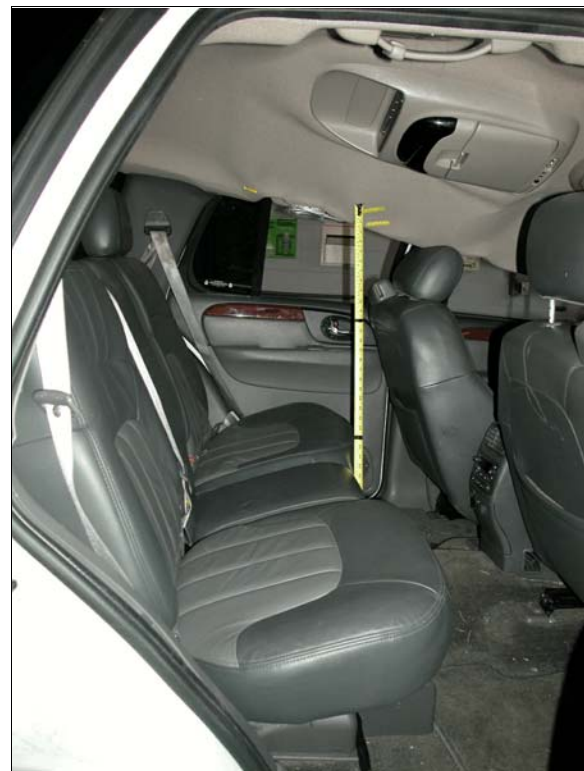
Figure 11: Overview of back seat and roof intrusion to back left seat position

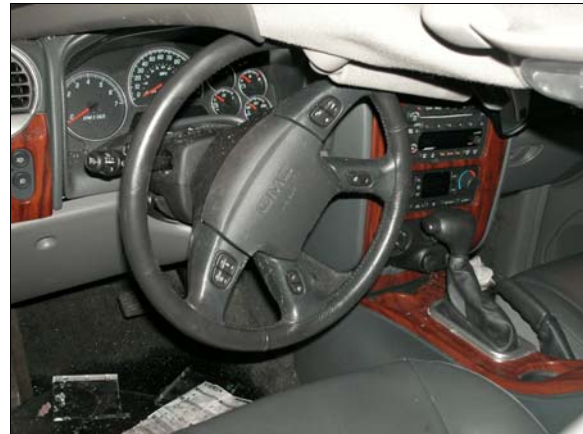
Vehicle Interior: Inspection of the case vehicle’s interior revealed a few hairs and a scuff on the roof in the driver’s seat position and one hair and a few white flecks on the roof over the back left seat position. No other evidence of occupant contact was observed to any other interior surfaces or components. There were numerous intrusions to the passenger compartment. The most severe intrusions occurred in the driver’s seat position and the back left seat position. The most severe intrusions in the driver’s seat position were: 47 centimeters (18.5 inches) of vertical roof intrusion (**Figure 10**), 34 centimeters (13.4) of vertical windshield intrusion, 31 centimeters (12.2 inches) of vertical left A-pillar intrusion, 27 centimeters (10.6 inches) of vertical windshield header intrusion and 25 centimeters (9.8 inches) of vertical left roof side rail intrusion. The most severe intrusions in the back left seat position were: 25 centimeters (9.8 inches) of vertical roof intrusion (**Figure 11**), 21 centimeters (8.3 inches) of vertical left roof side rail intrusion and 7 centimeters (2.8 inches) of vertical left rear window frame intrusion. There was no evidence of compression of the energy absorbing steering column or deformation of the steering wheel rim (**Figure 12** below).

Figure 12: Overview of case vehicle's steering wheel and steering column, and intrusion of left A-pillar, roof side rail and roof

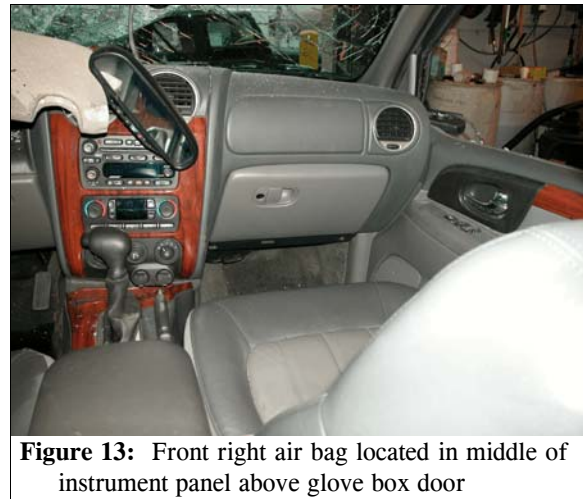
The case vehicle's driver air bag was located in the steering wheel hub and the front right passenger air bag was located in the middle of the front right instrument panel (**Figure 13**). Neither of these air bags deployed because there was no front impact. In addition, the driver and front right passenger seat back-mounted side impact air bags did not deploy because there was no significant side impact.

Figure 13: Front right air bag located in middle of instrument panel above glove box door

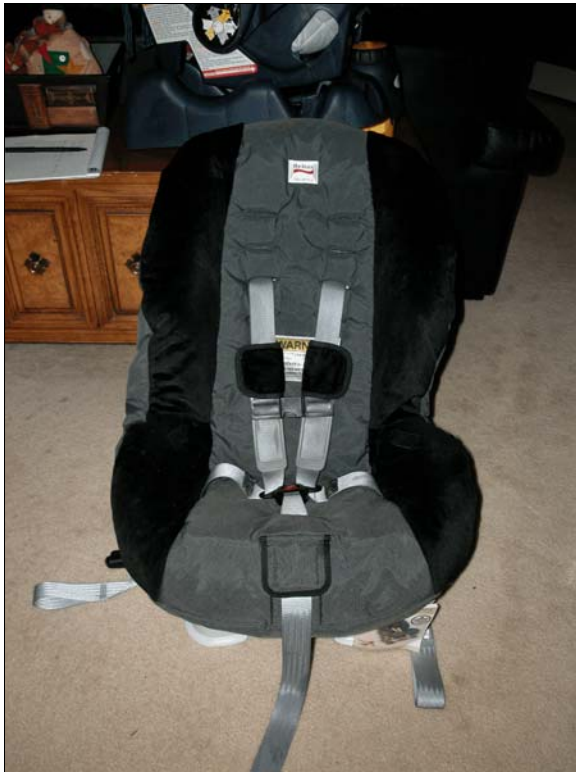
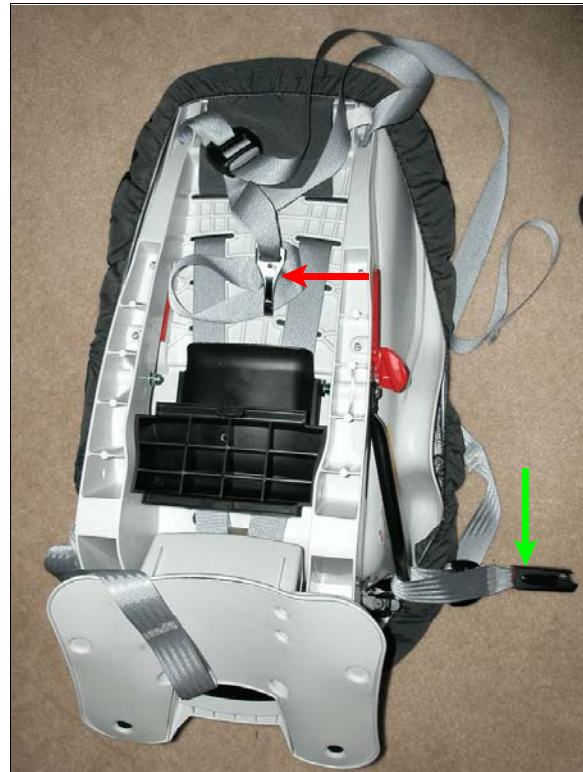
Figure 14: Back left passenger’s convertible child safety seat, a Britax, “Marathon” with 5-point harness

Figure 15: Back of child safety seat, red arrow shows tether strap and clip, green arrow shows right LATCH anchor buckle assembly

Inspection of the child safety seat revealed no apparent damage or fractures to the shell. In addition, the harness assembly, tether strap, tether clip, and the lower anchor buckles and straps showed no signs of loading. There was a manufacturer’s warning label affixed to both sides of the child seat giving the seat’s weight limitations as follows: “use only in rear-facing position with infant up to 10 kilograms (22 pounds)”, “use only with children who weigh between 2.3 and 29 kilograms (5 and 65 pounds) and whose height is 124 centimeters (49 inches) or less, rear facing 2.3 to 15 kilograms (5 to 33 pounds) and forward facing max 29 kilograms (65 pounds)”. There was also a warning label on both sides of the child seat that indicated to use the vehicle seat belt and not the LATCH connectors for children weighing more than 21 kilograms (48 pounds) and illustrations that showed the proper seat belt routing for both rear and forward facing installations.

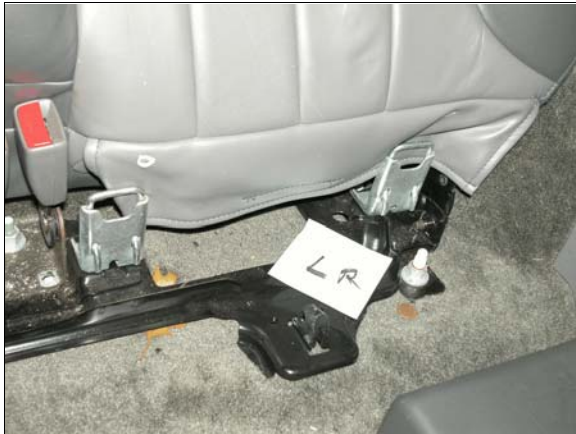
Figure 16: Lower anchors of case vehicle’s LATCH system at back left seat position, seat cushion has been folded forward

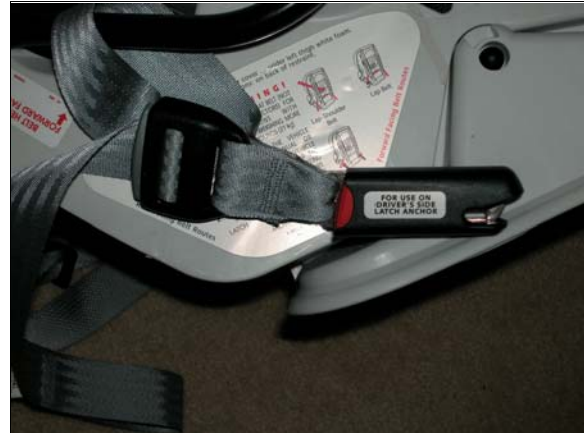
Figure 17: Child seat’s right LATCH anchor buckle and strap

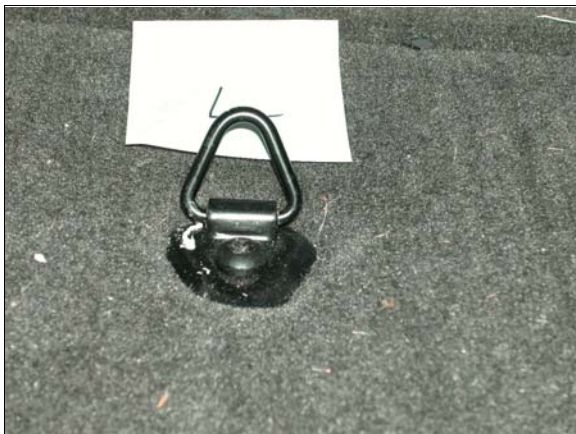
Figure 18: Case vehicle’s back left tether anchor, its located in cargo area behind back left seat

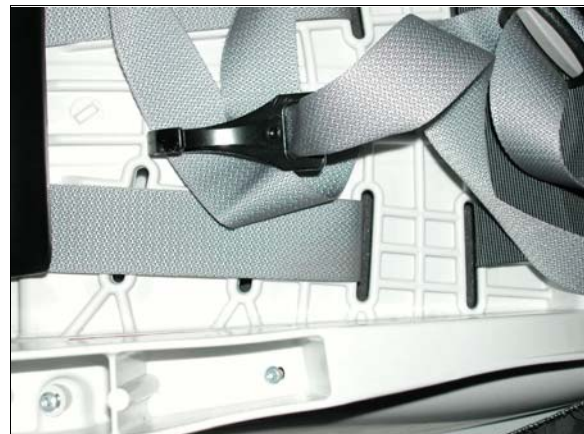
Figure 19: Close view of back left child safety seat’s tether clip and strap

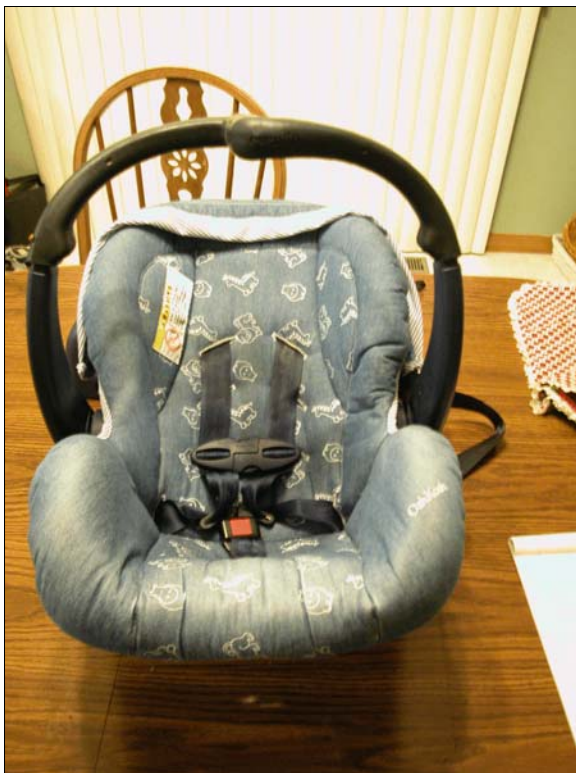
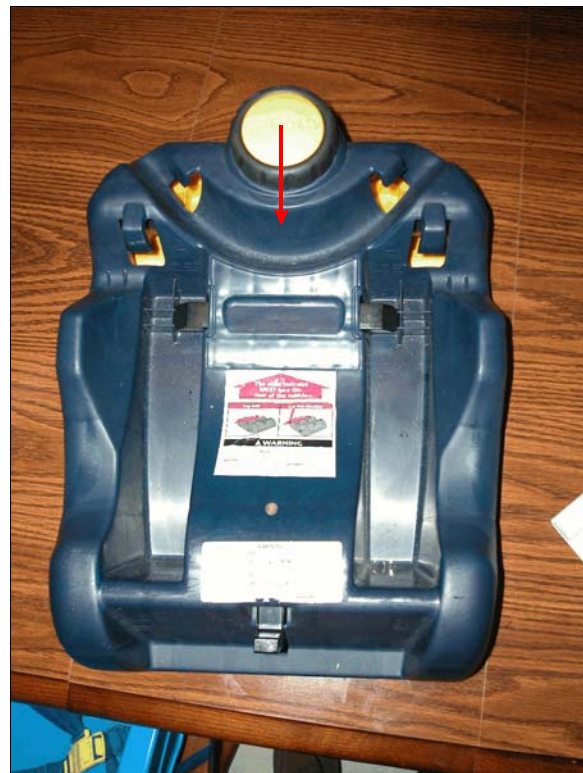
Figure 20: Back right passenger’s infant seat, an Evenflo “Cozy Carry” with 5-point harness, the infant seat locks to the base

Figure 21: The infant seat base, an Evenflo model number 639004P1, arrow shows route for separate “LATCH belt”

Inspection of the infant seat and base revealed no apparent damage or fractures to the seat or the base. In addition, the infant seat harness assembly, and the separate LATCH belt assembly for the base showed no signs of loading. There was a manufacturer’s warning label affixed to both sides of the infant seat illustrating how to secure the infant seat using a vehicle’s lap or lap-and-shoulder safety belt. In addition, the warning stated to place the seat in a rear-facing position and not to place it in the front seat of a vehicle with a passenger side air bag. A similar warning label was placed on top of the infant seat base.

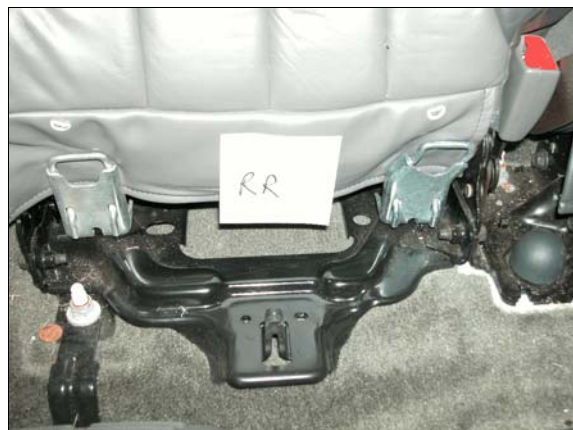
Figure 22: Lower anchors of case vehicle’s LATCH system at the back right seat position, seat cushion has been folded forward

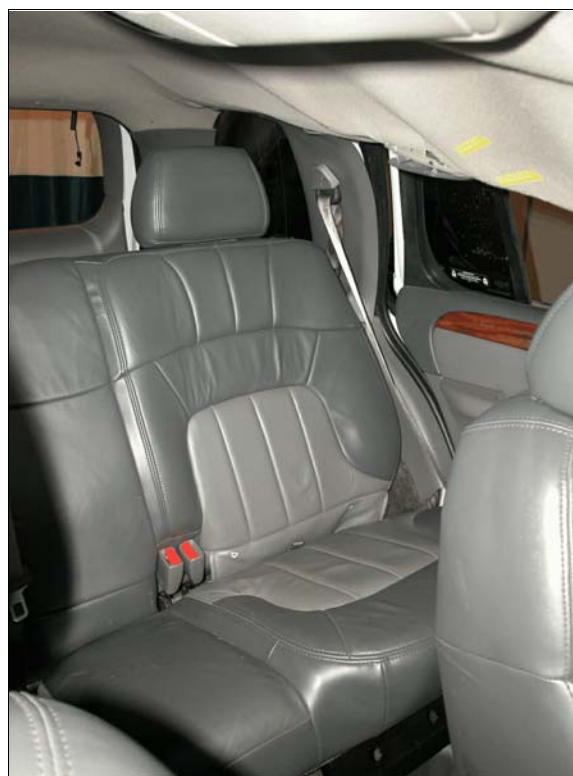
Figure 23: Overview of back left seat position, child safety seat was secured in this position by the case vehicle’s LATCH system

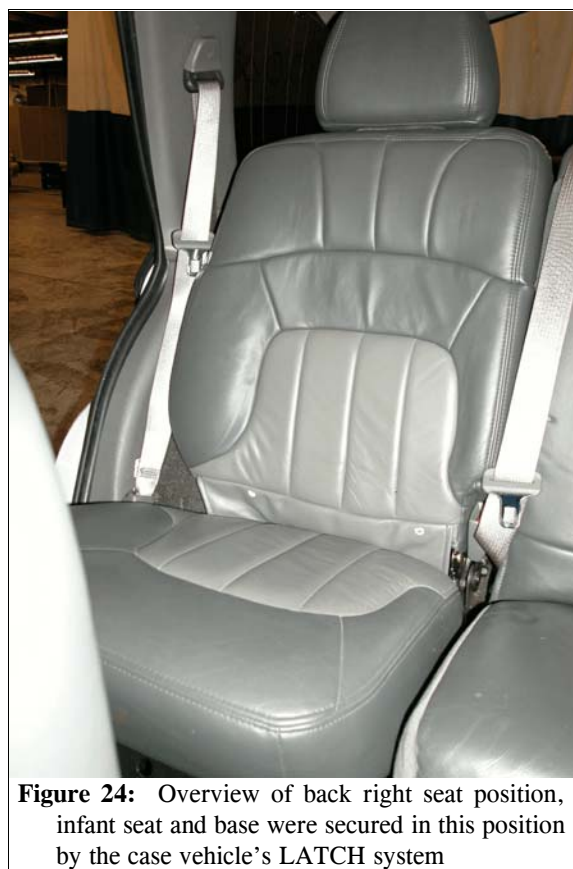
Figure 24: Overview of back right seat position, infant seat and base were secured in this position by the case vehicle’s LATCH system

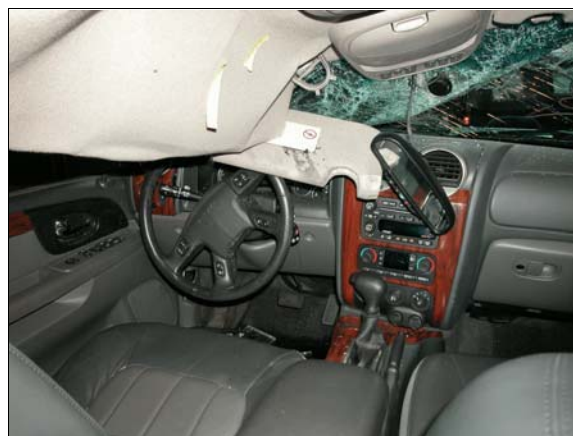
Figure 25: Overview of driver’s seating area and roof intrusion, yellow tape shows area of driver’s head contact

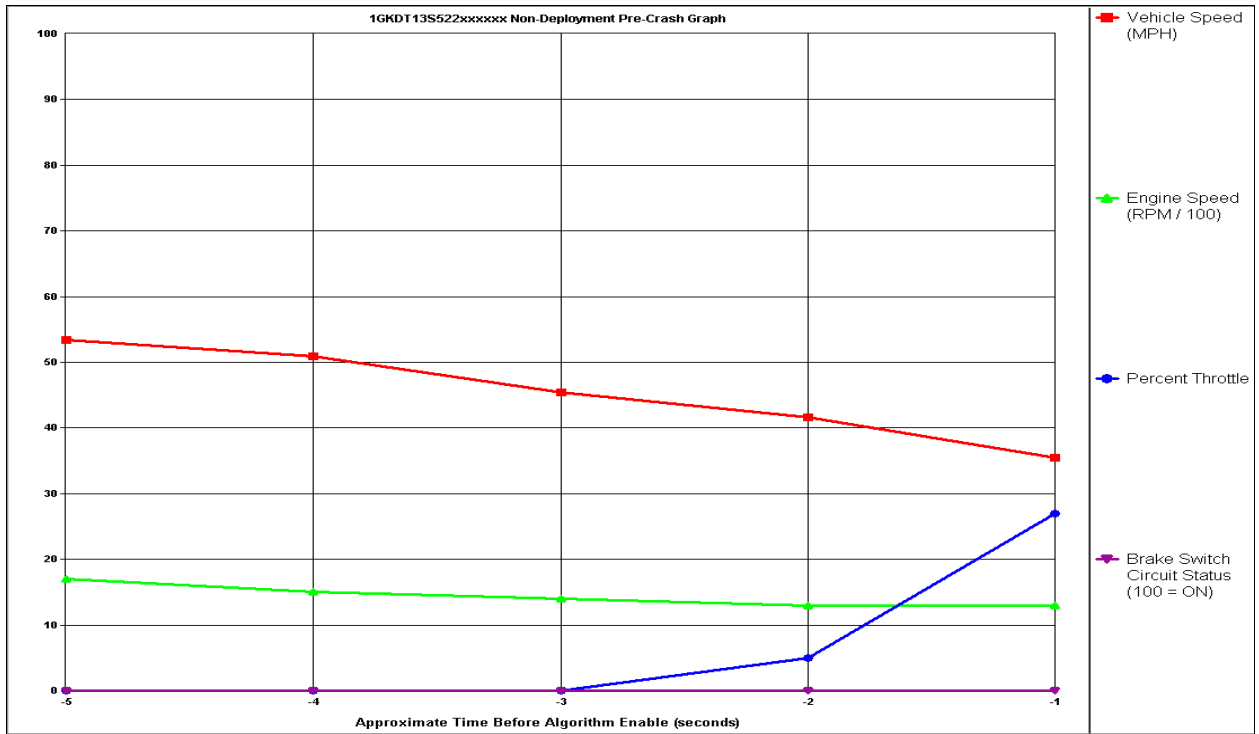
Figure 27: Case vehicle's Non-Deployment Pre-Crash Graph

The pre-crash data graph indicate that the case vehicle was traveling 85 km.p.h. (53 mph) five seconds prior to AE slowing to 56 km.p.h. (35 mph) one second prior to AE. The brake switch circuit was recorded as off for the entire five seconds prior to AE. The pre-crash data also indicates zero percent throttle at the five, four and three second sample periods prior to AE. The percent throttle then increases from five percent at two seconds to 27 percent throttle at one second prior to AE.
