CALSPAN ON-SITE CHILD SAFETY SEAT CRASH INVESTIGATION

CASE NO: CA04-038

VEHICLE: 1998 CHRYSLER SEBRING CONVERTIBLE

CRASH DATE: SEPTEMBER 2004

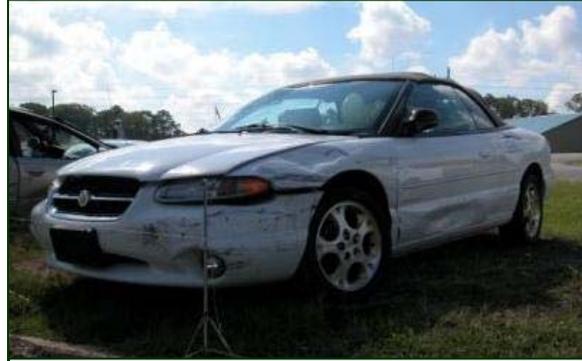
Figure 1. 1998 Chrysler Sebring convertible

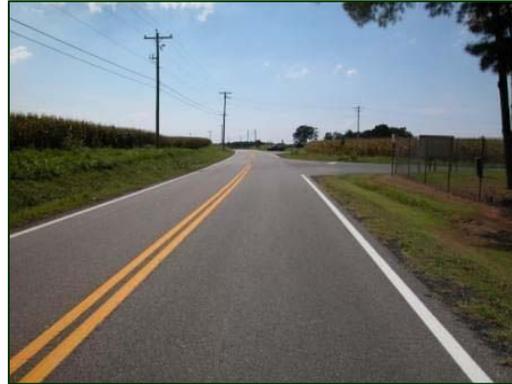
The crash occurred during daylight hours at a rural three-leg intersection. The crash site consisted of a two-lane east/west roadway that was 6.4 m (21') in width and was intersected by a north/southbound two-lane roadway that formed a Y-intersection (**Figure 2**). The roadways were surfaced with asphalt and were dry at the time of the crash. No defects were present in the road surfaces. The east/west roadway curved left for westbound traffic flow and was bordered by narrow stone shoulders. The radius of curvature was measured at 666.8 m (2,188').

Figure 2. Westbound view of the crash site

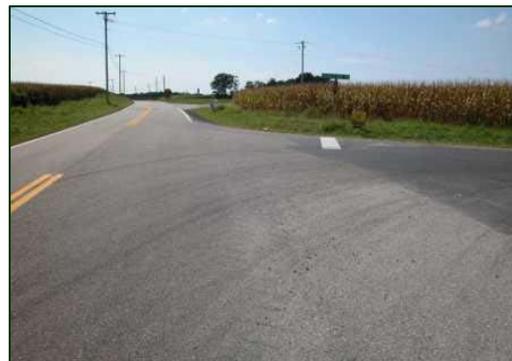
The full frontal area of the Chevrolet pickup truck impacted the left front side area of the Sebring in an L-configuration impact. **Figure 3** is a view of the intersection at the location of the crash. The resultant directions of force were 1 o'clock for the Chevrolet and 11 o'clock for the struck Sebring. The initial contact involved the center frontal area of the pickup truck

Figure 3. Area of impact at the intersection.

against the left side surface of the front bumper fascia of the Sebring. The license plate frame of the Chevrolet transferred onto the corner aspect of the bumper fascia. The right aspect of the trucks bumper engaged the left front tire and wheel of the Sebring. The crush to the Sebring was minimal as the impact forces were distributed through the body, bumper, and left front suspension. A damage (with CDC only) algorithm of the WinSMASH program computed total velocity changes of 25 km/h (15.5 mph) for the Chrysler and 22 km/h (13.7 mph) for the Chevrolet. The specific longitudinal and lateral components were -22 km/h (-8.7 mph) and 13 km/h (5.1 mph) for the Sebring and -21 km/h (-13.1 mph) and -8 km/h (-5.0 mph) for the pickup. As a result of the initial impact, the redesigned frontal air bags in both vehicles deployed.

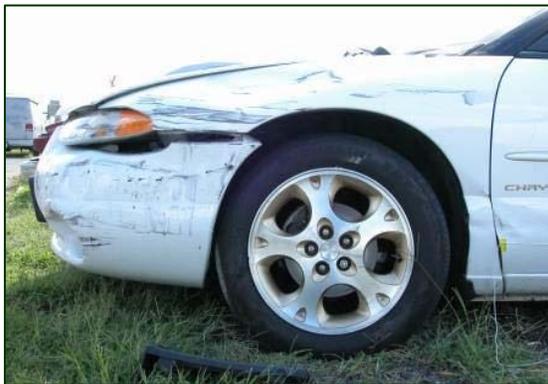
The initial impact was located on the left front corner area of the Sebring (**Figure 4**). The black center mounted license plate frame of the Chevrolet pickup truck transferred onto the side aspect of the front bumper fascia of the Sebring. This contact began 39 cm (15.25”) forward of the left front axle and extended 44 cm (17.25”) forward to the corner area of the fascia. This impact compressed the side surface of the bumper fascia, but did not result in residual crush to this location. As the side surface of the fascia compressed, the front bumper of the pickup truck engaged the left front tire and wheel assembly of the Sebring. This contact altered the camber of the axle position and probably resulted in transaxle/constant velocity joint damage as the wheel assembly was compressed laterally into the driveline components. The aftermarket air/bug deflector that was mounted to the hood face of the pickup truck engaged the upper surface of the left front fender, crushing the upper surface of the fender to a maximum depth of 5.1 cm (2.0”). Horizontal transfers for the hood edge were present on the fender of the Sebring. The combined direct contact damage of the left front fender began 83 cm (32.5”) forward of the left front axle position and extended 131 cm (51.6”) rearward to the left A-pillar which involved the full length of the fender (**Figure 5**). The crush of the pickup front bumper and the compliant left side surface of the Sebring resulted in the hood of the truck contacting the top surface of the Sebring’s hood. A black paint transfer extended 12 cm (4.625”) laterally onto the rear third of the Chrysler’s hood. Due to the various components involved in this initial contact sequence, a crush profile was not documented. The Collision Deformation Classification (CDC) for this event was 11-LFEW-2.

Figure 4. Initial impact damage to the left front fender area.

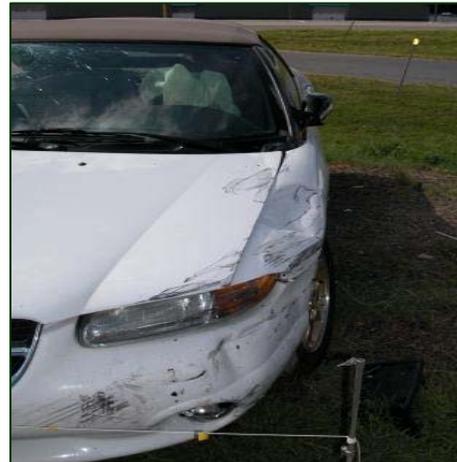
Figure 5. Longitudinal view documenting the lateral extent of crush.

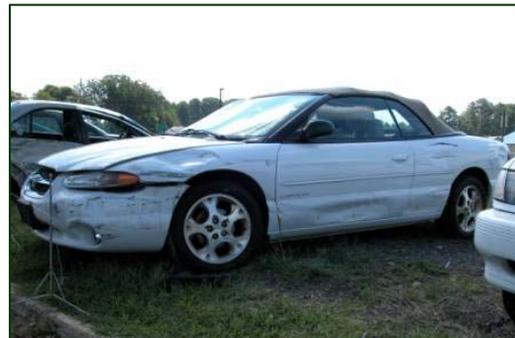
This secondary engagement resulted in the pickup truck's hood contacting the left outside rear view mirror and upper A-pillar of the Sebring. The deformed right corner area of the truck's front bumper contacted the lower aspect of the left front fender and the left door of the Sebring (**Figure 6**). This area of damage began 58 cm (23.0") aft of the left front axle position and extended 196 cm (77.0") to the forward edge of the left rear wheel opening. The crush profile for this damage was as follows: C1 = 0 cm, C2 = 3 cm (1.125"), C3 = 1 cm (0.5"), C4 = 4 cm (1.625"), C5 = 2 cm (0.75"), C6 = 0 cm.

Figure 6. Right side damage from the secondary engagement.

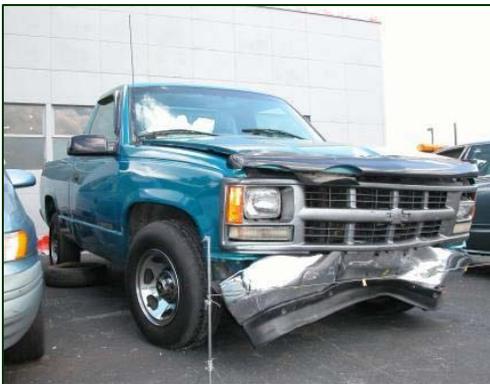
The frontal area roof the Chevrolet pickup truck sustained moderate severity damage as a result of the initial engagement against the front left side area of the Chrysler Sebring. The direct contact damage began 43 cm (16.75”) right of center and extended 131 cm (51.5”) to the right. The damage bowed the full length of the front bumper and resulted in a combined direct and induced damage length of 173 cm (68.0”) that extended from corner-to-corner. Maximum crush was 34.0 cm (13.4”) located on the front bumper, located 20 cm (7.75”) left of the vehicle’s centerline. The crush profile at bumper level (**Figure 8**) was as follows: C1 = 28 cm (11.1”), C2 = 29 cm (11.4”), C3 = 33 cm (13.0”), C4 = 31 cm (12.1”), C5 = 18 cm (7.2”), C6 = 5 cm (2.0”). There was no reduction of the pickup truck’s wheelbases. The CDC for this impact event was 01-FDEW-2.

Figure 7. Front right view of the frontal damage to the 1998 Chevrolet pickup truck.

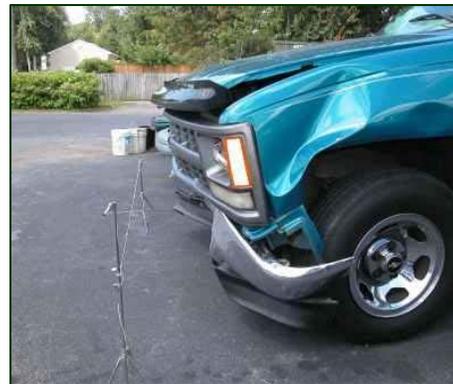
Figure 8. Lateral view documenting the extent of frontal crush.

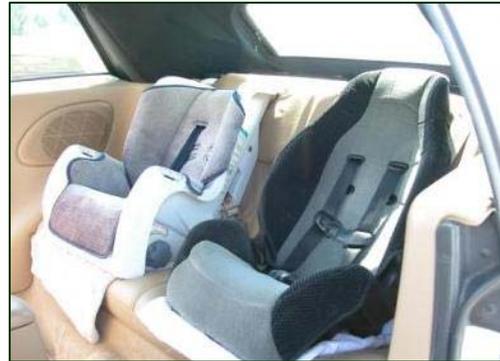
Two forward facing child safety seats (CSS) were installed in the rear seat positions of the Chrysler Sebring and secured by the manual 3-point lap and shoulder belts systems (**Figure 9**). A four-year old female was restrained in a Cosco Ventura CSS in the rear left position, while the rear right CSS was not occupied at the time of the crash.

Figure 9. Installed child safety seats in the rear of the Sebring.

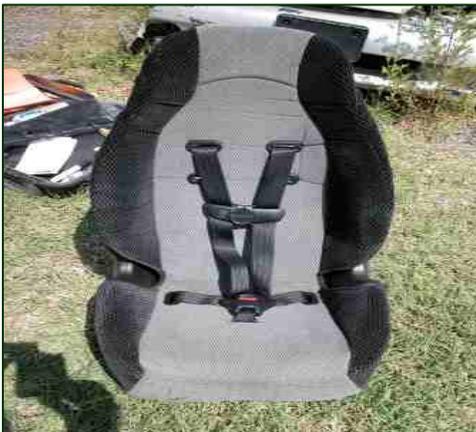
Figure 10. Frontal view of the Cosco CSS.

The CSS shell was constructed of a molded plastic with a single belt path in the back lower aspect of the shell. This belt path was used for this installation and is the proper routing of the vehicle's safety belt when using the CSS as a forward facing CSS with the five-point harness system. Two adjustment slots for the integrated harness system were molded into the shell. The driver used the top slots, which routed the integrated harness straps over a formed reinforcement in the back of the shell. A center detachable chest clip was present on the harness straps and used at the time of the crash. The driver had this clip positioned at the level of the child's armpits. The CSS was covered with a typical foam/cloth cover that concealed the seated area and wrap-around aspects of the shell (**Figure 10**).

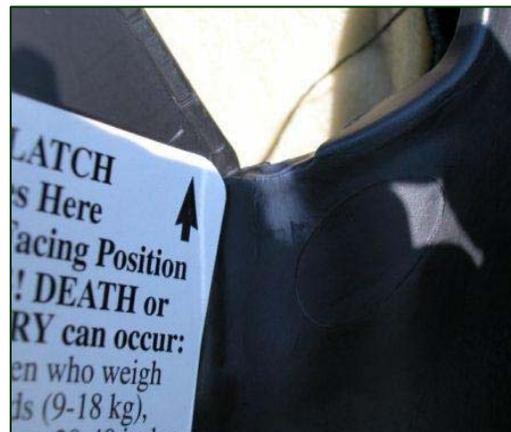
Figure 11. Vehicle safety belt loading at the right belt path of the CSS.

Subtle loading evidence was visible on the right side of the CSS belt path. This abrasion pattern was located at the lower forward aspect of the belt path. Surrounding the abrasion was an area of loading (whitish stretch discoloration) to the plastic shell (**Figure 11**). There was no other damage or loading evidence to this CSS.

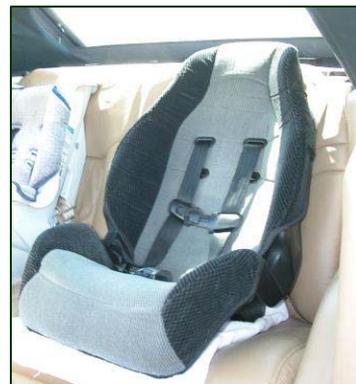
The child passenger was restrained in a Cosco forward facing child safety seat by the integral 5-point harness system in the rear left position of the Chrysler Sebring (**Figure 12**). The CSS was secured to the vehicle by the manual 3-point lap and shoulder belt system. Tension to the manual belt system was maintained by the lightweight locking latch plate of the belt system. The child was restrained in the CSS by the integrated 5-point harness system. During this on-site investigation, the CSS was removed from the Chrysler Sebring and the child was repositioned in the CSS. The

Figure 12. Installed CSS in the rear left of the Sebring.
