**GENERAL DYNAMICS ON-SITE CERTIFIED ADVANCED 208-COMPLIANT
VEHICLE CRASH INVESTIGATION**

SCI CASE NO. – CA04-041

SUBJECT VEHICLE – 2005 GMC YUKON DENALI

CRASH DATE – SEPTEMBER 2004

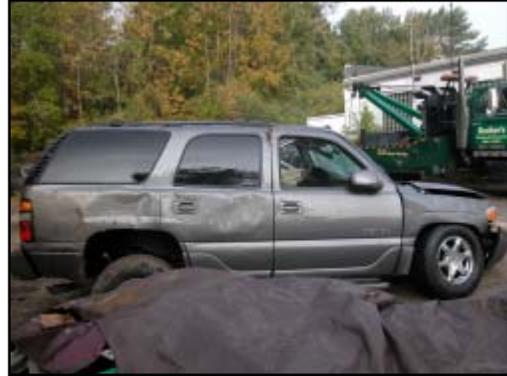
This on-site investigation focused on the performance of the Certified Advanced 208-Compliant (CAC) safety system in a 2005 GMC Yukon Denali (**Figure 1**). The manufacturer of this vehicle has certified that this 2005 GMC Yukon Denali meets the advanced air bag requirements of the Federal Motor Vehicle Safety Standard (FMVSS 208) No. 208. The safety system included dual stage frontal air bags, seat track position sensors for the front seats, safety belt buckle switch sensors, and an occupant detection sensor for the front right seat. In addition, the GMC was equipped with

Figure 1. Subject 2005 GMC Yukon.

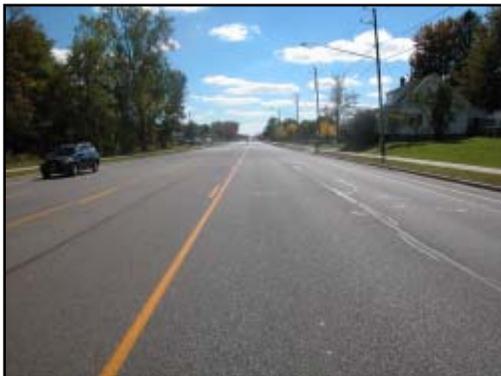
The restrained 18-year-old male driver of the 2005 GMC Yukon was operating the vehicle southbound on the inboard lane of the four-lane roadway (**Figure 2**). The driver of the GMC stated to the SCI investigator that he traveling in the left through lane with the cruise control on and set at 72 km/h (45 mph). The restrained 19-year-old male driver of the Eagle was operating the vehicle northbound on the inboard lane of the same roadway (**Figure 3**). It was police reported that the driver of the Eagle was operating the vehicle with excessive speed in order to catch up to a friend that was ahead of him. As the driver of the Eagle continued northbound, the driver lost directional control of the vehicle and began to rotate counterclockwise (CCW). The Eagle entered the center left turn median lane and then entered the inboard southbound lane. The driver of the GMC stated to the SCI investigator that he observed the Eagle as it entered the center left turn median lane. As the Eagle entered the left through lane, the driver of the GMC steered right just prior to the impact.

Figure 2. Southbound approach for the GMC.

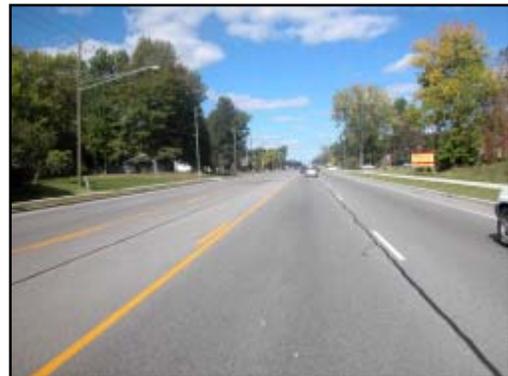
Figure 3. Northbound approach for the Eagle.

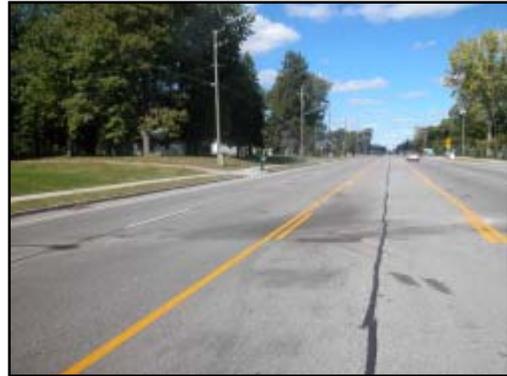
The front of the Eagle impacted the front left aspect of the GMC on the inboard southbound lane (**Figure 4**). The resulting directions of force were within the 11 o'clock sector for the GMC and the 1 o'clock sector for the Eagle. The Eagle penetrated and engaged the undercarriage and left side structure of the GMC. At maximum engagement, the undercarriage of the GMC snagged the Eagle's frontal structure. As the Eagle began to rotate counterclockwise (CCW), the lateral forces exerted on the left side structure resulted in the separation of the unibody chassis. The left sill and the floor/toe pan separated forward of the driver's seat. The engine separated from the transmission bell housing and was thrown from the vehicle. As a result of the gross deformation, a crush profile could not be obtained from the Eagle. Due to the lack of crush measurements, the WINSMASH missing vehicle algorithm was used to calculate a delta V for this impact. The total delta V for the GMC was 16.0 km/h (9.9 mph). The longitudinal and lateral components were -15.0 km/h (-9.3 mph) and 5.5 km/h (3.4 mph), respectively. The total delta V for the Eagle was 29.0 km/h (18.0 mph). The longitudinal and lateral components were -27.3 km/h (-16.9 mph) and -9.9 km/h (-6.2 mph), respectively. The EDR recorded a maximum delta V of -16.9 km/h (-10.5 mph). As a result of this impact the frontal air bag deployed in the GMC. It should be noted that the delta V's were calculated using the frontal crush of the GMC, therefore the computed delta V's were not representative of the total crush damage to the GMC.

Figure 4. Northbound view of the area of impact between the GMC and the Eagle.

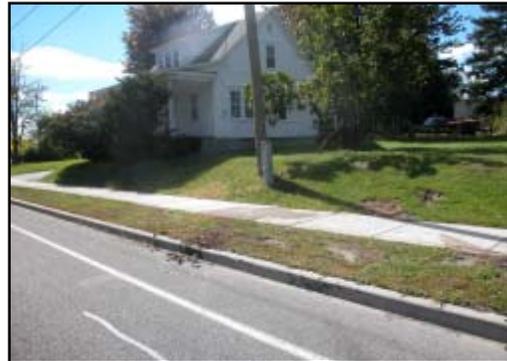
As a result of the frontal impact, the GMC was redirected in a southwest direction and began a CCW rotation. The GMC departed the west roadside and impacted the concrete barrier curb with its right side tires (**Figure 5**). The curb was located approximately 5.0 m (16.4 ft) west of the initial area of impact. This impact resulted in the de-beading and deflation of the right rear tire and minor damage to the concrete barrier curb. A delta V for this impact could not be calculated.

Figure 5. West roadside curb impact.

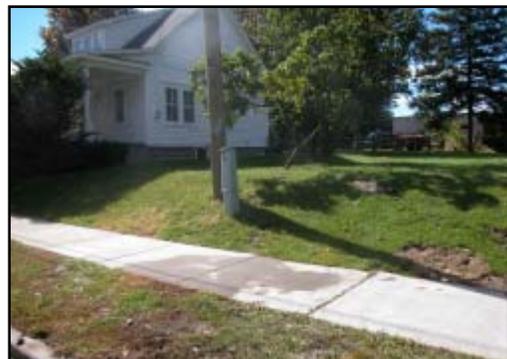
Figure 6. Area of rollover and impact to the utility box and utility pole.

The GMC rolled beyond its right side; however, prior to the second quarter turn the left roof side rail impacted a 29.6 cm (11.7") diameter wooden utility pole (**Figure 6**) that was located adjacent to the utility box. Therefore, the GMC only completed one-quarter turn during the off-road crash sequence. Although a crush profile was obtained, this impact was non-horizontal and outside the scope of the WINSMASH program.

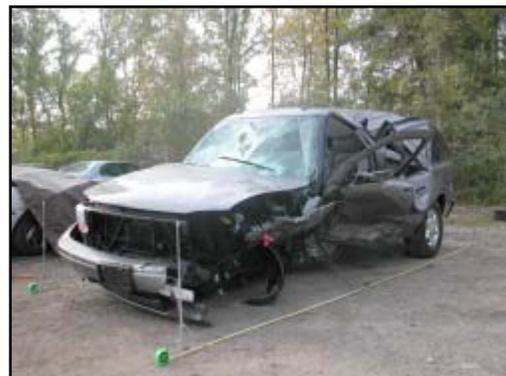
The 2005 GMC Yukon Denali sustained severe damage as a result of the frontal impact with the Eagle (**Figure 7**). The Eagle penetrated through the front left corner and engaged the left front suspension, and the left side frame of the vehicle. The direct damage measured 30.5 cm (12.0") which began 58.4 cm (23.0") left of the centerline and extended left. The maximum crush was located at the front left end of the bumper reinforcement beam and measured 32.5 cm (12.8"). The front left corner of the fiberglass bumper beam was fractured at impact, therefore the crush profile began approximately 14.0 cm (5.5") inboard of the bumper beam corner. The damage involved longitudinal displacement of the front

Figure 7. Damage from the impact with the Eagle.

bumper, left front fender, left front door, lateral displacement of the left side frame rail, and fractured left front axle. Six equidistant measurements were used to document the crush at the bumper support using a combined direct and induced damage width of 127.0 cm (50.0") and were as follows: C1 = 32.5 cm (12.8"), C2 = 20.4 cm (8.0), C3 = 13.2 cm (5.2"), 4.6 cm (1.8"), C5 = 0.0 cm, C6 = 0.0 cm. The Collision Deformation Classification (CDC) for this impact was 11-FLEE-9.

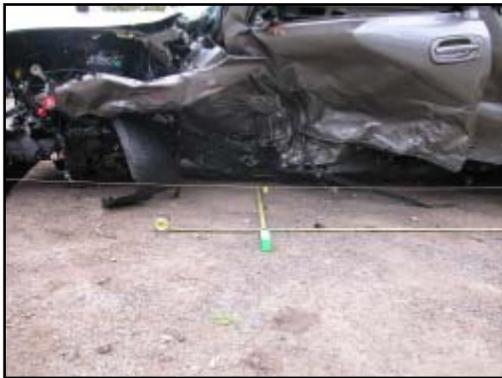
The Eagle penetrated into the left side of the GMC, deforming the sheet metal and engaging the frame of the Denali. The lateral crush to the left frame rail was measured at two locations. The first location was 201.9 cm (79.5") forward of the left rear axle (**Figure 8**) which measured 42.0 cm (16.5") of lateral crush. The second location was 17.3 cm (44.0") forward of the left rear axle (**Figure 9**) and measured 20.0 cm (7.9") of lateral displacement.

Figure 8. Forward aspect of the left frame rail crush.

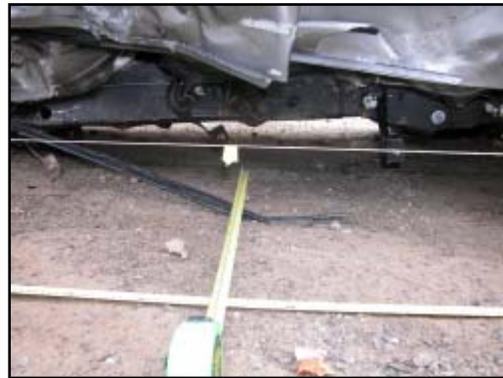
Figure 9. Rear aspect of the left frame rail crush.

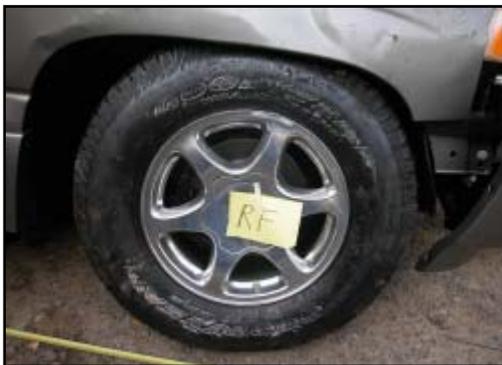
The GMC sustained minor damage as result of the impact with the concrete barrier curb. The damage consisted of an abraded right front tire (**Figure 10**) and de-beaded right rear tire (**Figure 11**). A crush profile was not obtained for this impact. The CDC's for this impact was 03-RFWW-1 and 03-RBWW-1.

Figure 10. Right front tire damage. Note damage consisted of abrasions to the sidewall.

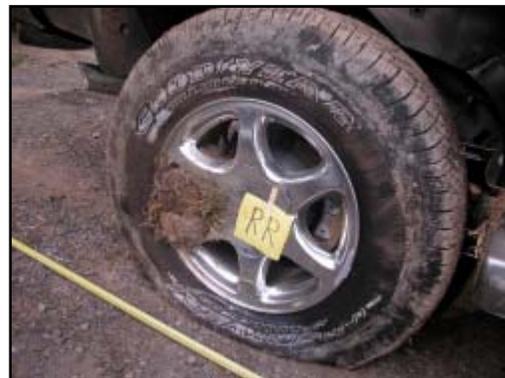
Figure 11. Right rear tire damage.

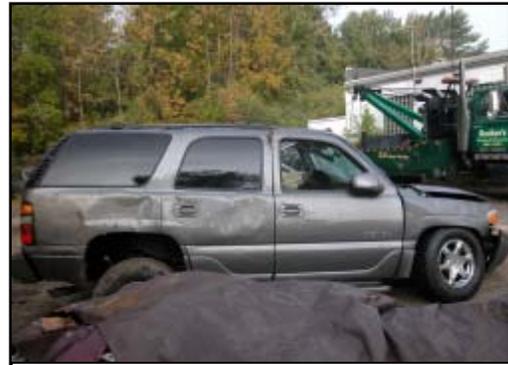
The GMC sustained moderate damage as a result of the rollover event (**Figure 12**). Although the GMC rolled onto its roof, the maximum area of damage was to the right side plane. The direct damage consisted of longitudinal and lateral abrasions and lateral deformation to the right side. Also noted was dirt and grass that was embedded in the upper right front door edge and the right side luggage rack. The direct damage on the right front fender measured 82.0 cm (32.3") in width and began at the forward edge extending rearward. No direct contact damage was noted to the right front door; however, the right side mirror (glass) was fractured. Lateral deformation was noted to the right rear door which measured 91.0 cm (35.8") in width and began at the rear door edge terminating 5.0 cm (2.0") rear of the forward edge. The deformation to the right rear door was approximately 3.0 cm (1.0") in depth. The right rear quarter panel sustained lateral deformation that began rear of the right rear door edge and measured 55.0 cm (21.7") in width and was approximately 3.0 cm (1.0") in depth. The height of the damage to the right side was 67.0 cm (26.4"). The CDC for this impact was 00-RDAO-2.

Figure 12. Right side rollover damage.

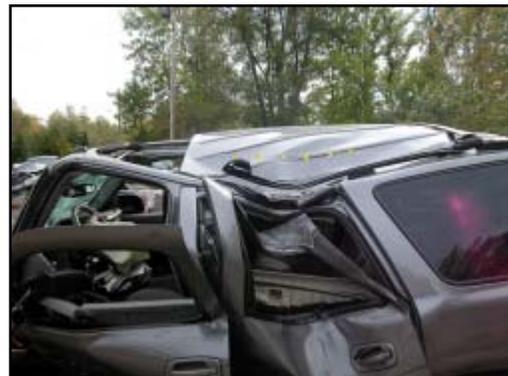
The GMC sustained moderate damage as a result of the roof impact with the utility pole (**Figure 13**). The direct contact damage measured 30.0 cm (11.8") on the left roof side rail and was contained within the B- and C-pillars. The direct contact damage also extended vertically onto the left rear door. The direct contact damage measured 40.0 cm (15.7") on the top of the left rear doorframe. Although the damage was non-horizontal a crush profile was documented along the roof side rail. The crush was documented using six equidistant points on the top aspect of the left roof side rail using a combined direct and induced damage width of 54.0 cm (21.3") and were as follows: C1 = 15.0 cm (5.9"), C2 = 20.0 (7.9"), C3 = 26.0 cm (10.2"), C4 = 25.5 cm (10.0"), C5 = 22.0 cm (8.7"), C6 = 16.5 cm (6.5"). The CDC for this impact was 00-TPLN-4.

Figure 13. Left roof and roof side rail damage.

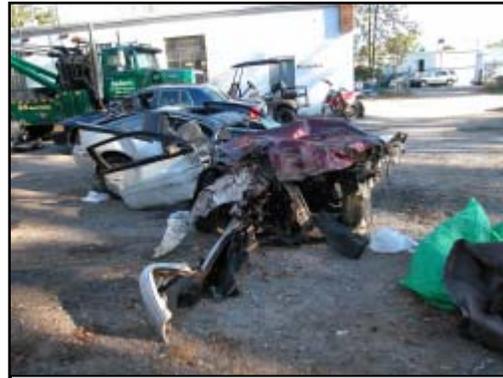
The 1991 Eagle Talon sustained severe damage as a result of the frontal impact with the GMC (**Figure 14**). The Talon's engine was separated from the vehicle. The bell housing of the transmission fractured allowing the engine to rotate counterclockwise, separating from its mounts and from the vehicle. Due to the gross deformation to the vehicle a crush profile could not be obtained. The direct damage on the bumper fascia measured 168.0 cm (66.1") and 82.5 cm (32.5") on the hood. The force of the impact tore the left side structure beginning at the left A-pillar and extending to the left B-pillar, exposing the passenger compartment (**Figure 15**). The front of the Talon remained attached at the right A-pillar. A pivot point that was located 30.5 cm (12.0") forward of the right B-pillar was where the front of the vehicle shifted right approximately 90-degrees in relation to the passenger compartment of the Talon. The CDC for this impact was 61-FDEW-9 (9 = unknown), with an incremented shift value of 60.

Figure 14. Frontal damage from the impact with the GMC.

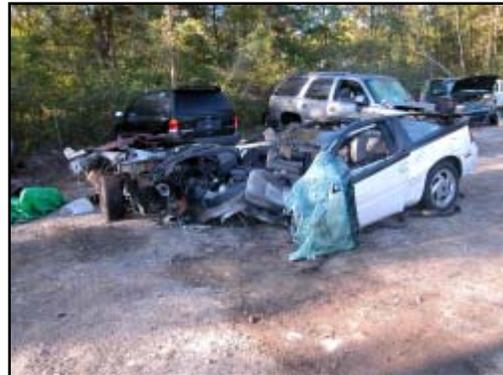
Figure 15. Left side structure torn from at impact.

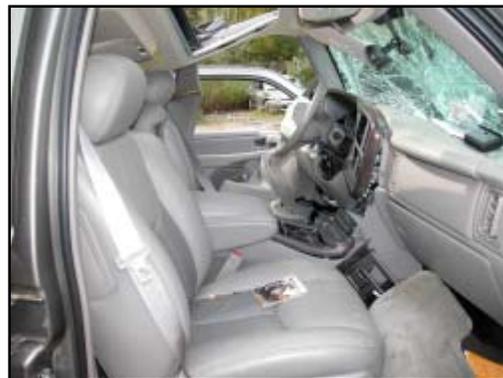
The 2005 GMC Yukon Denali sustained moderate interior damage as result of occupant contacts. At impact with the Eagle, the driver initiated a forward and left trajectory. The driver loaded the lap belt portion of the safety belt which was evidenced by a transfer. The driver's left knee contacted the knee bolster as it intruded which was evidenced by a scuffmark. The GMC began a counterclockwise rotation as it traveled to the west roadside. The driver's left shoulder contacted the left B-pillar resulting in a scuffmark to the B-pillar plastic trim panel. The GMC departed the road and began to rollover right side leading.

Figure 16. Overall view of the first row.

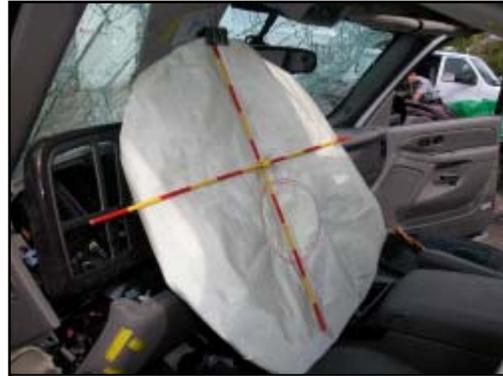
Figure 17. Deployed driver's frontal air bag.

The SDM deploys the appropriate safety component(s) dependant on occupant presence, occupant size, belt usage, seat track position and crash severity. In the subject crash, the SDM commanded a stage two deployment of the driver's air bag. The driver's air bag module was located in the center of the steering wheel hub (**Figure 17**). Two symmetrical I-configuration cover flaps concealed the air bag and measured 12.2 cm (4.8") in height and 8.4 cm (3.3") in width at the top and 6.4 cm (2.5") in width at the bottom. The air bag measured 59.7 cm (23.5") in diameter in its deflated state and contained two tethers. Two vent ports at the 11 and 1 o'clock positions on the rear aspect vented the air bag.

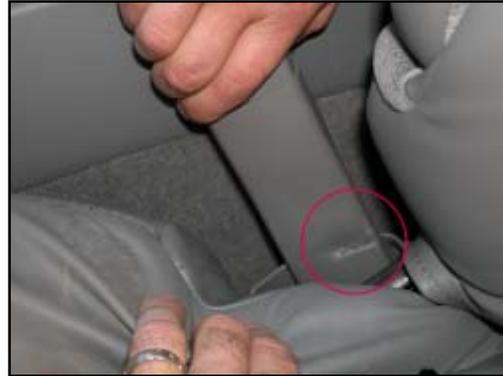
The 2005 GMC Yukon Denali was equipped with integrated manual 3-point lap and shoulder safety belts for the front seating positions. The driver safety belt was configured with a sliding latch plate and an Emergency Locking Retractor (ELR). The driver utilized his safety belt in the crash which was evidenced by a transfer on the lap portion of the safety belt from the driver loading the belt system. Also noted was a laceration to the belt buckle sleeve from the sleeve loading against the edge of the seatback bracket (**Figure 18**). Furthermore, the EDR data indicated that the driver's safety

Figure 18. Laceration to safety belt sleeve from loading against seatback

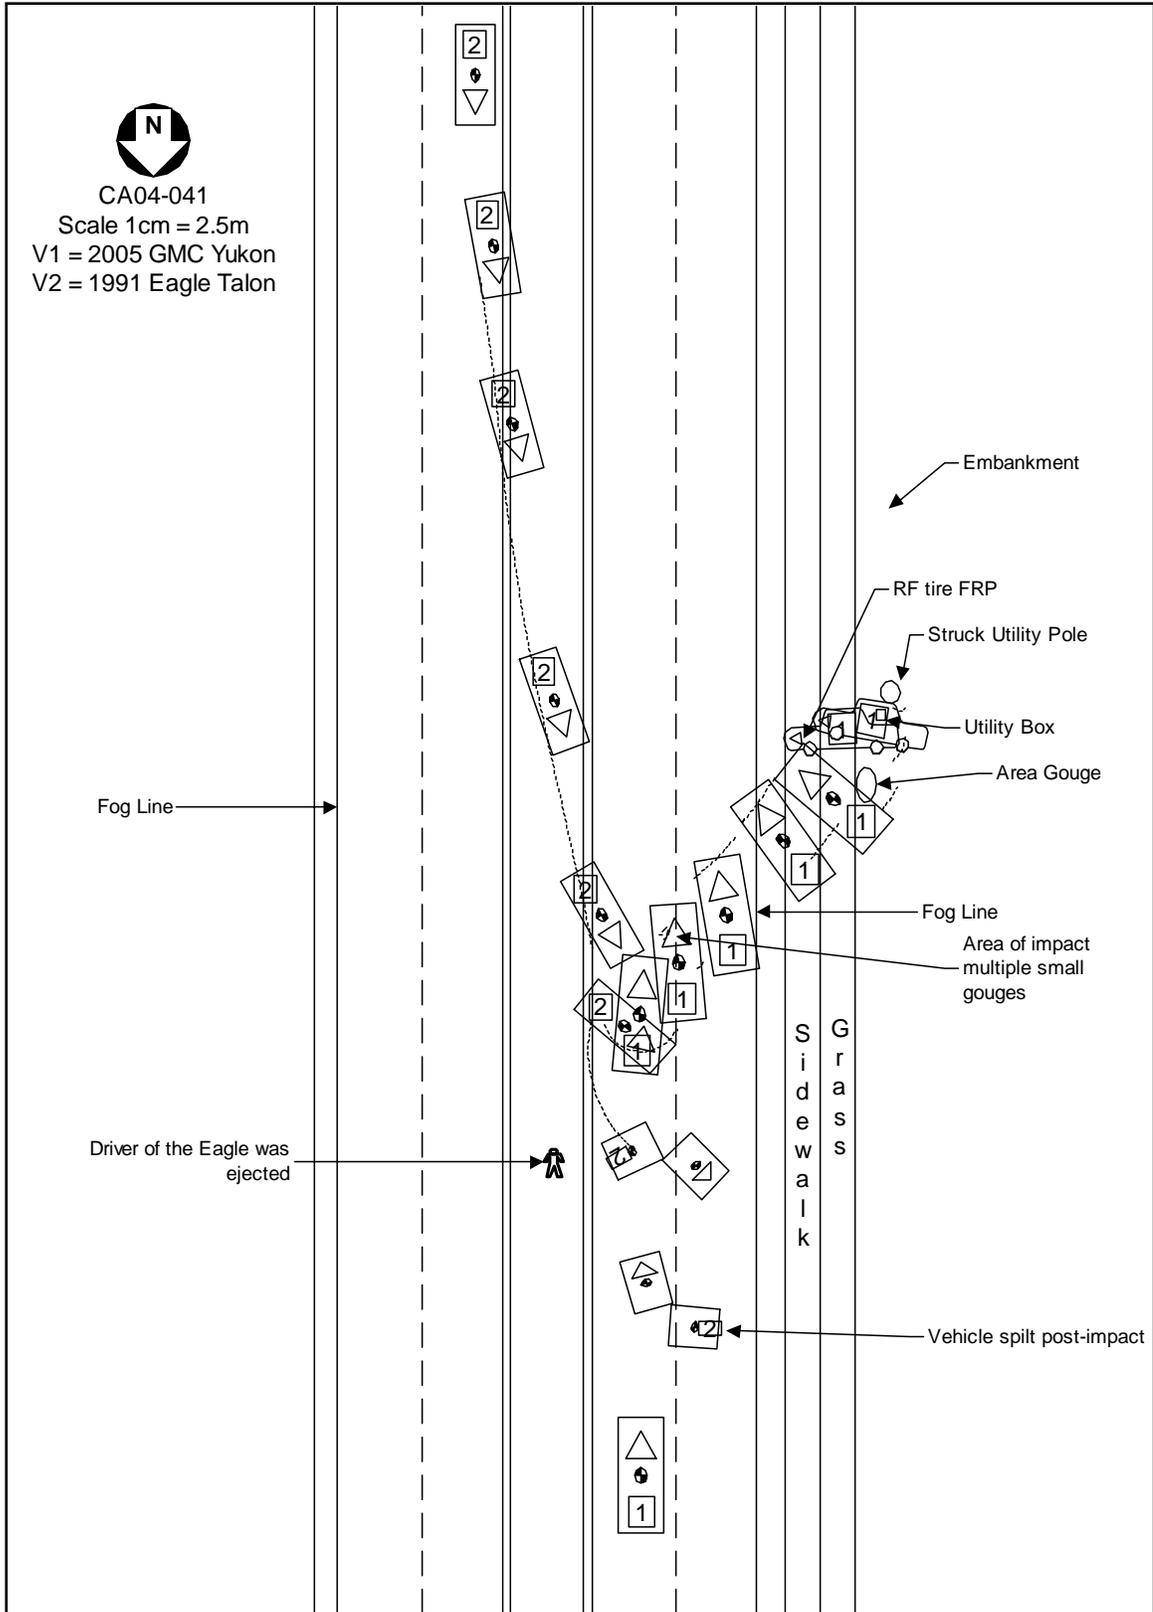
Figure 19. Scene schematic

This multiple event crash occurred during the evening hours of September 2004. At the time of the crash, it was daylight and the weather was clear with no adverse conditions. The crash occurred in the southbound lanes and the west roadside of a four-lane north/southbound roadway. The north/southbound roadway was configured with two travel lanes in each direction and was delineated by a painted center left turn lane/median. The roadway was constructed of worn asphalt and was bordered by concrete barrier curbs. The west roadside consisted of a curb, earth embankment, utility box, and a utility pole. The utility box and the utility pole were located 4.5 m (14.8 ft) west of the curb. The posted speed limit for the north/southbound traffic was 72 km/h (45 mph). The scene schematic is included as (**Figure 19**) of this report.
