CALSPAN ON-SITE CHILD SAFETY SEAT CRASH INVESTIGATION

CASE NO: CA04-054

VEHICLE: 2003 SATURN ION

CRASH DATE: NOVEMBER 2004

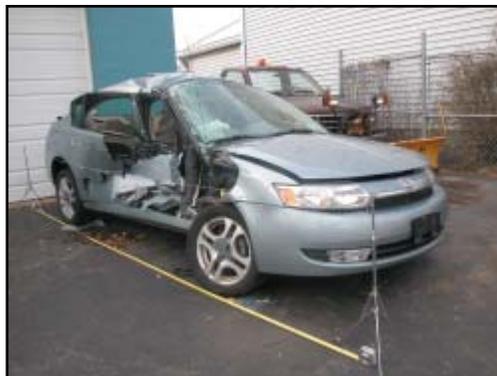
Figure 1. Damaged 2003 Saturn Ion

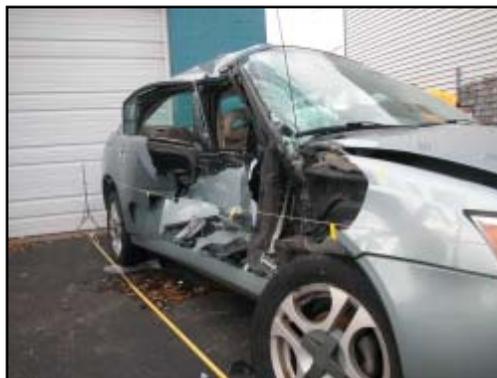
The 2003 Saturn Ion sustained moderate right side damage as a result of the impact with the large truck (**Figure 5**). The direct damage began 51 cm (21.3") forward of the right rear axle, extended 228 cm (89.8") forward along the right side plane, and terminated 20 cm (8.0") forward of the right front axle. The maximum lateral crush was located 156 cm (61.3") forward of the right rear axle and measured 43 cm (17.0") at the mid-door level. A rubber scuff mark was present 64 cm (25.0") forward of the right rear axle from direct contact with the front left tire of the truck. The composite body panels on the right side doors and right front fender sustained multiple fractures as a result of the impact. Both right side doors were deformed and jammed shut. The direct contact damage extended vertically to the upper aspect of the right side door frames, below the right roof side rail, which was supported by the approximate height of 145 cm (57") of the front hood of the tank truck. The combined direct and induced damage began 18 cm (7.0") forward of the right rear axle, extended 262 cm (103.0") forward, and terminated 20 cm (8.0") forward of the right front axle (**Figure 6**). The front aspect of the right sill was rotated inward and displaced vertically. The right roof side rail sustained induced lateral crush as a result of the right side door and B-pillar crush.

Figure 5. Right side damage

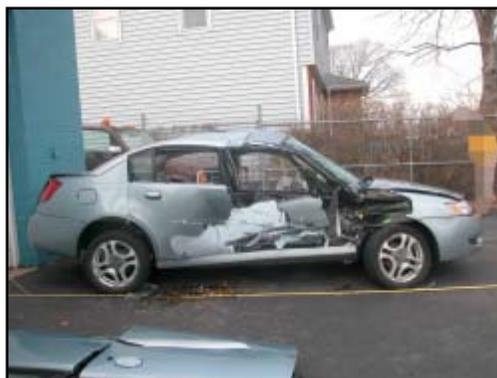
Figure 6. Lateral view of right side crush profile

The composite trim on the forward aspect of the roof side rail and the right A-pillar was fractured and separated. The windshield header and roof sustained lateral buckling and the windshield was fractured from impact forces. There was no reduction of the right side wheelbase. Six crush measurements were documented at the mid-door level as follows: C1 = 2 cm (0.8”), C2 = 8 cm (3.0”), C3 = 35 cm (13.6”), C4 = 34 cm (13.5”), C5 = 22 cm (8.8”), C6 = 11 cm (4.5”). The Collision Deformation Classification (CDC) for the impact with the truck was 03-RYAW-3.

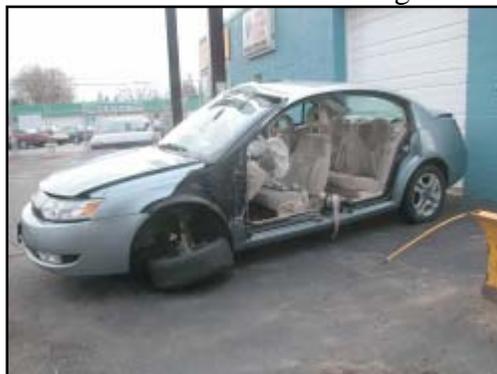
Figure 7. Left side view showing damaged left front wheel

The left front spindle fractured and separated as a result of the lateral friction from the post-impact travel across the intersection. The suspension components remained intact, but the left front wheel collapsed during the post-impact travel (**Figure 7**). The inboard edge of the alloy wheel also sustained a gouge.

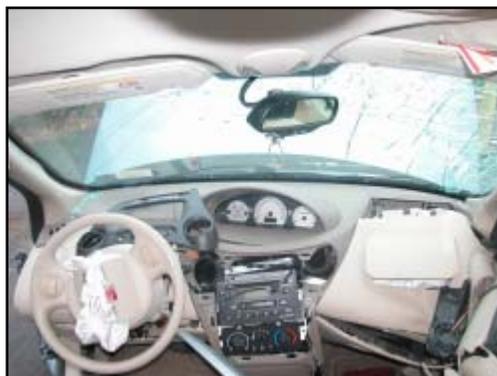
Figure 8. View of damaged instrument panel

The driver’s knee bolster exhibited faint scuff marks on the left aspect, although it could not be confirmed if they were related to occupant contact. The center instrument panel trim was separated and the rear view mirror deflected counterclockwise (CCW) against the windshield. The right and center aspects of the instrument panel were fractured, deformed, and deflected left due to the intrusion of the left front door (**Figure 8**). The right interior door panel was fractured and partially separated.

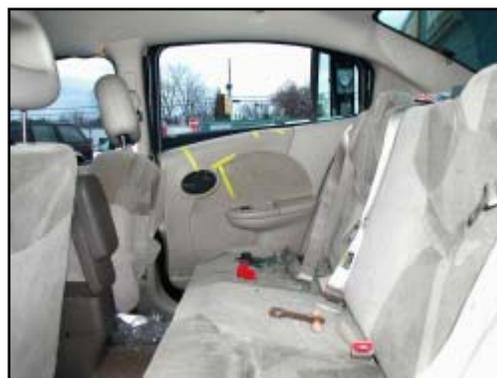
The right rear door interior sustained minor damage as a result of the engagement against the right aspect of the rear-facing CSS due to the lateral intrusion (**Figure 9**). A vertically oriented scuffmark with impression that measured 15 cm (6.0") in height and 3 cm (1.0") in width, began 3 cm (1.0") above the armrest and 5 cm (2.0") rear of the forward aspect of the armrest. A 4 cm (1.5") vertical scuffmark from engagement with the CSS was present 5 cm (2.5") below the top aspect of the interior door panel and 15 cm (5.8") rear of the forward aspect of the door. A 8 cm (3.0") semi-circular black transfer was present on the apex of the top door panel (at the beltline) and located 42 cm (16.5") rear of the forward edge of the door. Based on the rear-facing orientation of the CSS, it was not likely a result of contact with the CSS.

Figure 9. View of damaged right rear door and intrusion

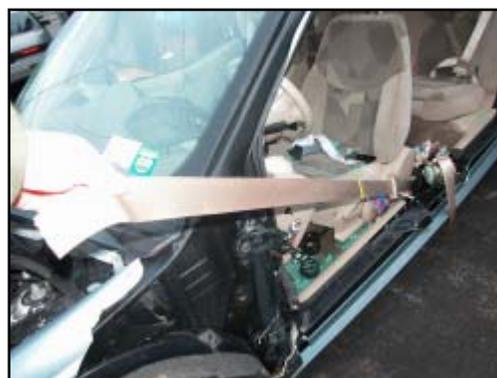
The 2003 Saturn Ion was configured with manual 3-point lap and shoulder belts for each seating position. Both front seat safety belts were equipped with retractor pretensioners and adjustable D-rings that were in the full-down positions. The driver's safety belt was configured with a sliding latch plate and an Emergency Locking Retractor (ELR). At the time of the vehicle inspection, the driver's retractor was restricted in the used position as a result of pretensioner actuation. Rescue personnel had cut the webbing. The cut section of webbing measured 169 cm (66.5") in length from the lower anchor (**Figure 10**). A linear plastic transfer from the plastic-covered latch plate was located 85 cm (33.5") above the lower anchor and extended across the entire width of the webbing. The residual length of webbing that extended from the locked retractor measured 43 cm (17.0"). Although the driver's D-ring did not exhibit abrasions, the bottom aspect sustained two areas that were "polished" from probable engagement with the shoulder belt webbing. The driver's plastic-covered latch plate sustained abrasions from the loading of the driver.

Figure 10. View of cut driver's safety belt

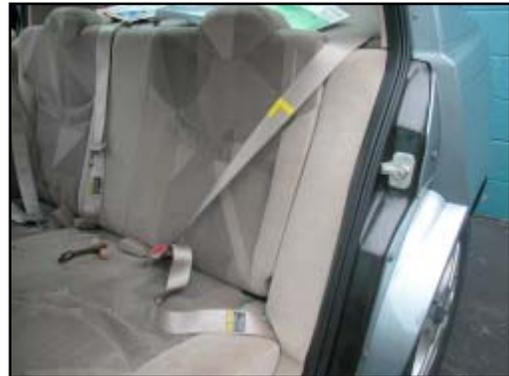
The rear left safety belt was used to secure an unoccupied forward-facing booster CSS. The safety belt was found in the stowed position with a locking clip installed adjacent to the latch plate at the time of the vehicle inspection. The booster CSS was not with the vehicle. Lateral creases in the webbing from engagement with the booster CSS belt path were located at the following positions from the lower anchor: 16 cm (6.5"), 22 cm (8.5"), 50 cm (19.5"), 52 cm (20.5"). The locking clip was positioned 55 cm (21.5") above the lower anchor. A faint body fluid (blood) transfer that measured 1 cm (0.4") in diameter was present on the safety belt webbing 95 cm (37.3") above the lower anchor. The source of the transfer was not known. The location of the transfer supported the fact that the safety belt was extended to install the unoccupied booster seat at the time of the crash.

Figure 11. Rear left safety belt

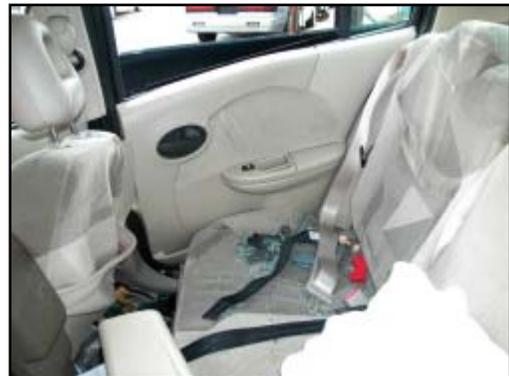
The rear right safety belt was found extended at the time of the vehicle inspection (**Figure 12**). Based on the inspection of the belt, it appears that it was used in addition to the LATCH system to restrain the rear-facing convertible CSS. A lateral crease in the webbing was located 34 cm (13.5") from the lower anchor from the sliding latch plate. Based on the position of the latch plate, the lap belt webbing measured 34 cm (13.5") in length from the lower anchor, and the shoulder belt measured 104 cm (43.8") between the latch plate and the belt exit on the rear package shelf.

Figure 12. Rear right safety belt as found during the vehicle inspection

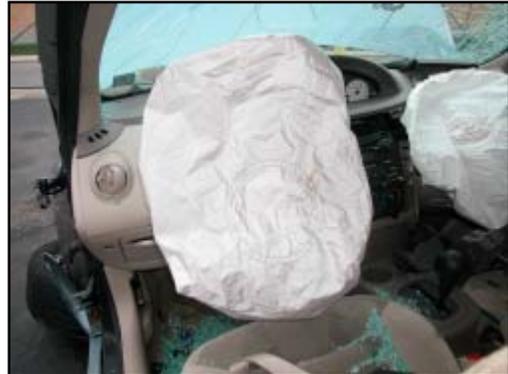
The driver's air bag deployed from the center of the steering wheel hub through symmetrical H-configuration module cover flaps. Each flap measured 13 cm (5.3") in height and 9 cm (3.5") in width. The deployed driver's air bag (**Figure 13**) measured 53 cm (21.0") in diameter in its deflated state. The air bag was tethered by two internal straps that measured 13 cm (5.0") in width and were located at the 12 and 6 o'clock aspects of the air bag. The tethers were attached to a 17 cm (6.5") diameter circular stitch in the center of the air bag face. Two circular vent ports that measured 3 cm (1.0") in diameter were located at the 11 and 1 o'clock aspects on the rear of the air bag. A light circular body fluid (blood) transfer that measured 4 cm (1.5") was present on the air bag face. The transfer was located 5 cm (2.0") above the horizontal centerline and 8 cm (3.3") right of the vertical centerline.

Figure 13. Deployed driver's air bag

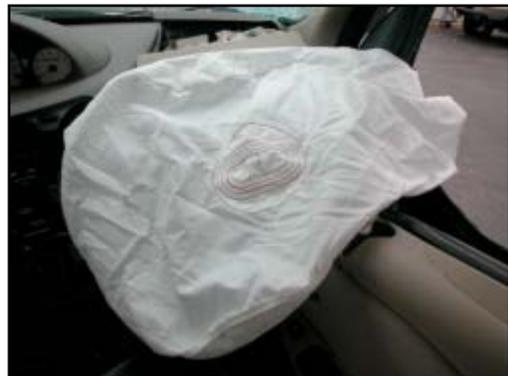
The front right passenger's air bag deployed from a top-mount module with a rectangular cover flap that was hinged at the forward aspect. The module cover flap measured 22 cm (8.8") in width and 14 cm (5.5") in height. The deployed front right passenger's air bag (**Figure 14**) measured 43 cm (17.0") in width and 38 cm (15.0") in height. The air bag was tethered by two internal straps that measured 13 cm (5.0") in width. The tether straps were fixed at the 3 and 9 o'clock aspects to a circular stitch pattern on the center aspect of the air bag that measured 13 cm (5.0") in diameter. Two circular vent ports that measured 5 cm (2.0") in diameter were located at the 3 and 9 o'clock aspects of each side panel of the air bag.

Figure 14. Deployed front right passenger's air bag

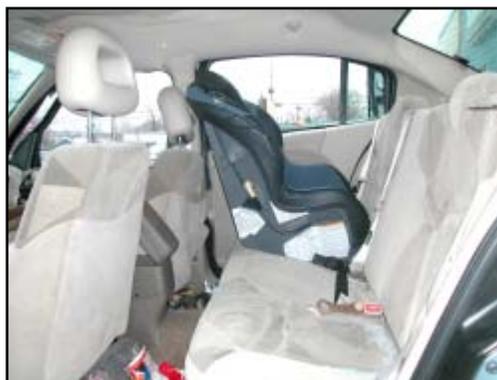
The CSS was installed in a rear-facing orientation, (**Figure 16**), restrained by the vehicle’s lap and shoulder belt and LATCH attachment system, which was provided with the CSS. At the time of the vehicle inspection, the cut LATCH belt was still engaged with the anchors. The outboard aspect of the LATCH attachment was secured with the hook facing upward and the inboard aspect secured with the hook facing downward. In this orientation, the LATCH webbing exhibited one-half twist between the outboard aspect of the CSS and the outboard anchor. The Saturn’s manual 3-point lap and shoulder belt was utilized in addition to the LATCH system through the rear-facing belt path to restrain the CSS. It was unknown if the switchable retractor was engaged. The CSS was taken back to the subject vehicle in an attempt to replicate the CSS placement. These replication attempts using the LATCH installation resulted in an approximate 8 cm (3”) gap between the cut ends of the LATCH belt when pulled taut. Although not designed for rear-facing use, the CSS tether strap was attached to the bottom aspect of the rear right seat cushion frame. Based on the post-crash position of the CSS, it appeared that the tether strap may have been used to achieve the recommended 45 degree angle. Post-crash, the seat back angle measured approximately 65 degrees from horizontal when placed unrestrained on the rear right seat. Attempts to replicate the tether adjustment resulted in a 15 cm (6”) gap between the cut ends when they were pulled taut (**Figure 17**).

Figure 16. Post-crash position of the CSS during vehicle inspection

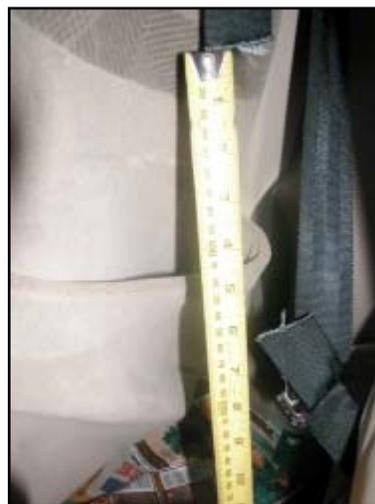
Figure 17. Post-crash gap between tether cuts

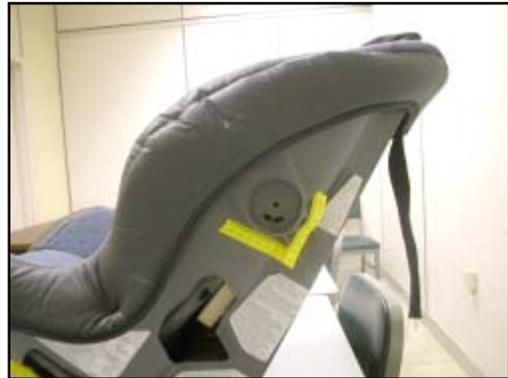
The CSS sustained minor damage as a result of the crash. The left side plastic circular tray shield housing integrated into the plastic shell (this CSS model not equipped with a tray shield) sustained minor deformation from engagement against the right rear door interior (**Figure 18**). The damaged plastic was located 5 cm (2.0”) forward of the rear aspect of the CSS and 19 cm (7.5”) below the top of the CSS seat back. Two very small and faint stress marks were present on the outboard aspect of the left side of the CSS under the fabric cover. The forward aspects (in relation to the CSS) of the inboard and outboard rear-facing belt path sustained minor deformation of the plastic from loading against the LATCH webbing. The harness straps did not exhibit any deformation from the crash, although historical wear was evident.

Figure 18. Left side damage to CSS
