**CALSPAN REMOTE ADULT AIR BAG RELATED
SERIOUS INJURY CRASH INVESTIGATION**

NASS/SCI CASE NO: 2005-48-020C

VEHICLE: 2005 NISSAN ALTIMA

CRASH DATE: FEBRUARY 2005

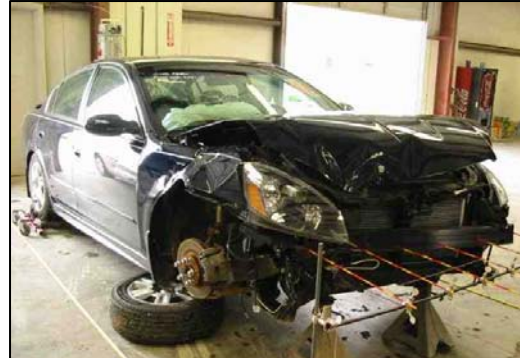
This remote investigation focused on the injury sources to a 45-year old restrained female driver of a 2005 Nissan Altima (**Figure 1**). The Nissan was equipped with an Advanced Occupant Protection System (AOPS) that consisted of dual stage frontal air bags and front safety belt pretensioners. The Nissan was involved in a moderate severity crash with a pine tree. The vehicle departed the roadway and descended down a slope where it bottomed out as the roadside leveled, and then continued

Figure 1 - Damaged 2005 Nissan Altima.

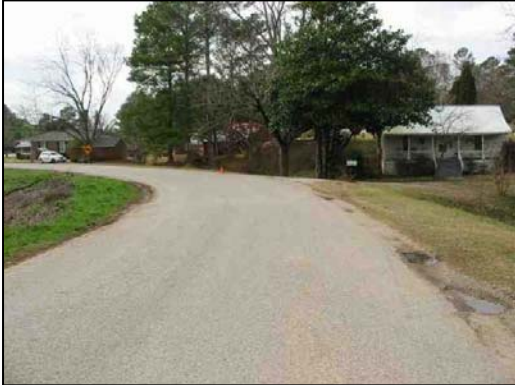
The 45-year old female driver of the 2005 Nissan Altima was traveling westbound on the two-lane roadway and was negotiating a sharp left curve (**Figure 2**). As the vehicle was negotiating the curve, it drifted off the right roadside and down a slope approximately 3 m (10’) in height (**Figure 3**). There was no pre-crash evidence of braking or attempted avoidance maneuvers.

Figure 2 - Westbound approach of Nissan Altima.

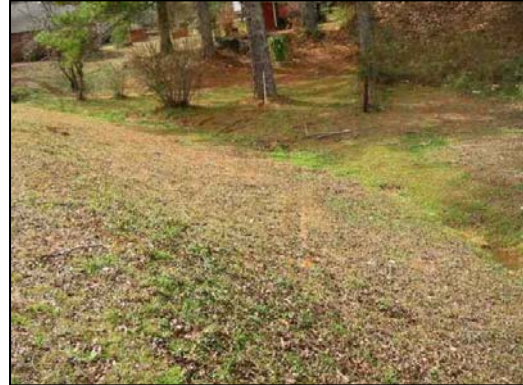
Figure 3 - Slope leading to point of impact.

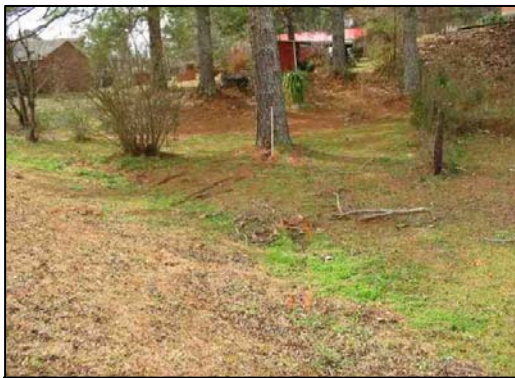
The Nissan traveled in a northwesterly direction approximately 25 meters (75') descending down the slope until it bottomed out as the roadside environment leveled (**Figure 4**). The front aspect of the undercarriage struck the ground in a non-horizontal configuration. The vehicle continued tracking in a northwesterly direction on the wooded roadside an additional 5 meters (15') before striking a large pine tree of an unreported diameter with its front right corner (**Figure 5**). The direction of force for the impact with the tree was 12 o'clock. An SCI revised damage algorithm of the WinSMASH program computed a total delta-V of 27 km/h (16.8 mph). The specific longitudinal and lateral velocity change was -27 km/h (-16.8 mph) and 0 km/h, respectively. Following the impact, the Nissan rotated clockwise around the tree approximately 90 degrees and came to rest facing in a northerly direction. The impact deployed the frontal air bag system and actuated the pretensioners in the Nissan.

Figure 4 - Foot of slope; area of undercarriage impact.

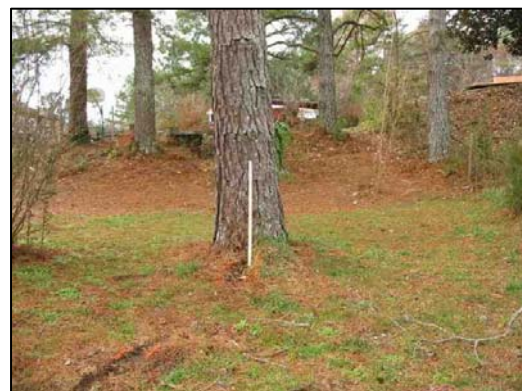
Figure 5 - Point of impact with pine tree.

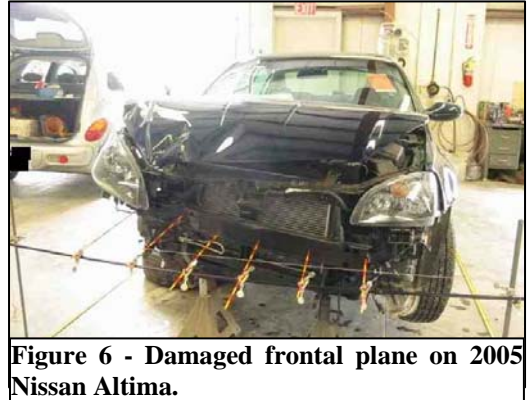
The 2005 Nissan Altima sustained moderate damage as a result of the impact with the pine tree (**Figure 6**). The direct contact damage began at the right front bumper corner and measured an SCI revised 51 cm (20") in length.* The combined direct and induced damage encompassed the width of the front bumper and measured 160 cm (63"). The NASS investigation revealed that the maximum crush was located 33 cm (13") right of the vehicle's centerline and measured 34 cm (13.4") in depth. The damage profile was measured to the bumper beam and was adjusted for the missing bumper cover and energy absorption material. The crush profile consisted of six equidistant crush measurements that were as follows: C1 = 0 cm, C2 = 6 cm (2.4"), C3 = 17 cm (6.7"), C4 = 25 cm (9.8"), C5 = 34 cm (13.4"), C6 = 23 cm (9.1"). The SCI revised Collision Deformation Classification (CDC) was 12-FREW-2.*

Figure 6 - Damaged frontal plane on 2005 Nissan Altima.

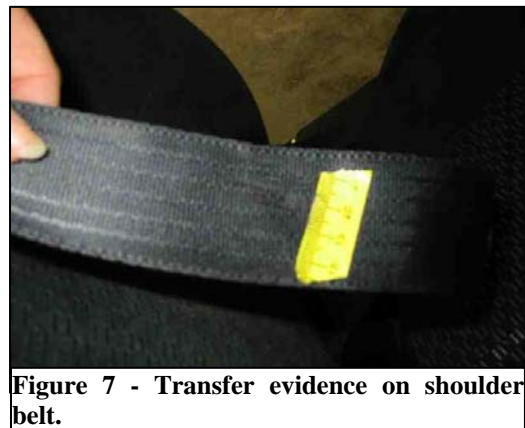
The 2005 Nissan Altima was configured with manual 3-point lap and shoulder belts and sliding latch plates for all five seating positions. The driver's belt exhibited loading evidence in the form of minor scuffing and stretching on the webbing indicating that the restraint was in use during the crash (**Figure 7**). The driver's seat was equipped with an Emergency Locking Retractor (ELR), a retractor pretensioner, and an adjustable D-ring, which was in the full-up position. The front right seat was equipped with a retractor pretensioner and adjustable D-ring, which was in the full-up position. The

Figure 7 - Transfer evidence on shoulder belt.

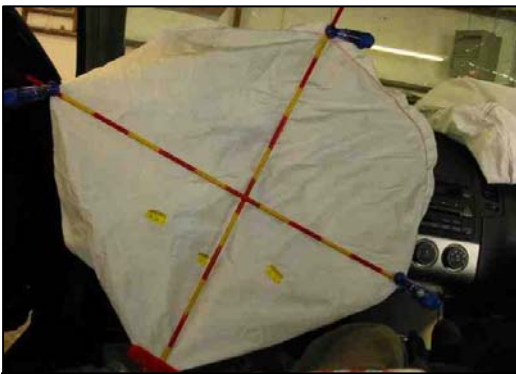
The 1995 Nissan Altima was equipped with dual-stage frontal air bags for the driver and front right seating positions. The driver's air bag was housed in the center of the steering wheel hub (**Figure 8**). The driver's air bag deployed through trapezoidal-shaped cover flaps. The upper flap measured 14 cm (5.5") in width and 5 cm (2") in height. The top aspect of the lower flap was 13 cm (5.1") in width and the lower aspect was 10 cm (3.9") in width. The lower flap was 7 cm (2.8") in height. The driver's air bag measured 60 cm (23.6") in diameter in its deflated state. The air bag was vented by two circular ports located in the 11 and 1 o'clock positions on the back aspect of the air bag. The air bag was not tethered. It should be noted that the steering wheel was rotated 180 degrees at the time of the NASS inspection.

Loading evidence in the form of three red clothing transfers were identified evenly distributed along the top aspect of the air bag membrane. Based on a review of images, the transfers were approximately 2 cm (0.8") in length. The first transfer was located 20 cm (7.9") inboard of the outer left edge and 15 cm (5.9") below the top edge of the deployed air bag. The second transfer straddled the mid-line of the air bag 13 cm (5.1") below the top edge. The third transfer was located 17 cm (6.7") inboard of the right outer edge and 15 cm (5.9") below the top edge of the air bag.

Figure 8 - Driver's air bag.

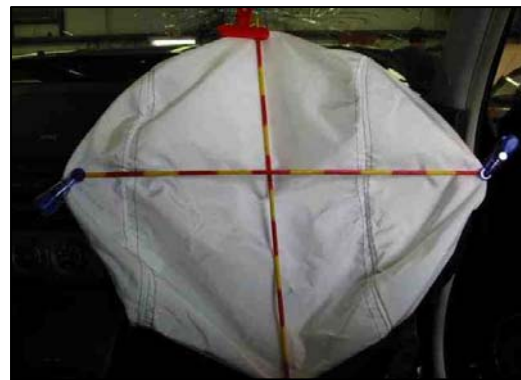
The front right air bag deployed from a top-mount module configured with a single rectangular vinyl cover flap hinged at the top aspect (**Figure 9**). The cover flap measured 28 cm in width and 6 cm (2.4") in height. The air bag measured 60 cm (23.6") in height and 65 cm (25.6") in width in its deflated state. The air bag was vented by two circular ports located in the 3 and 9 o'clock positions. The air bag was not tethered and no loading evidence was identified on the air bag membrane.

Figure 9 - Front right air bag.
