### SCI/NASS COMBINATION DRIVER AIR BAG- RELATED SERIOUS INJURY INVESTIGATION

CASE NUMBER - 2005-50-175J  
LOCATION - Texas  
VEHICLE - 2004 VOLVO S60  
CRASH DATE - December 2005

Submitted:  
December 6, 2006  
Revised:  
April 21, 2008

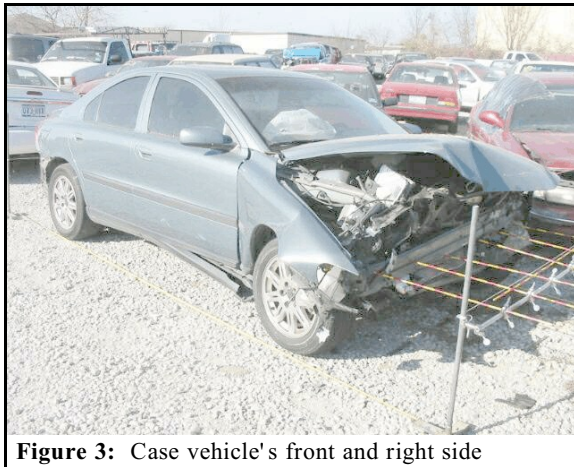
Figure 3: Case vehicle's front and right side

The case vehicle sustained direct contact damage across its entire front from the impact with the concrete wall (event #2). The ground leading from the roadway to the wall had a positive slope and the case vehicle's bumper was crushed rearward to the leading edges of the front tires while the upper radiator support and the leading edge of the hood had lesser crush, reflecting the up-sloping angle at which the case vehicle engaged the wall (**Figures 3 and 4**). The bumper cover was torn off and the grille and both headlamp/turn signal assemblies were shattered and broken away. The leading edge of the hood had slight direct contact and was bent downward and creased, more so on the right. The leading edges of both fenders were crushed rearward. The right fender was also bent outward and had induced damage extending to the right A-pillar. The rocker panel below the right front door was displaced. The wheelbase was shortened by 9 centimeters [3.5 inches] on the right and lengthened by 5 centimeters [2.0 inches] on the left. The left rear tire was deflated, the right front tire was restricted by deformed body panels and there was no other wheel or tire damage. There was no glazing damage.

The entire front bumper cover was torn off and the crush profile was measured from the steel bumper. Maximum crush was 46 centimeters [18.1 inches] at C5. The CDC was determined to be **11-FDEW-3 (330 degrees)**. The WinSMASH reconstruction program, barrier algorithm, was used on the case vehicle's most severe (second) impact. The total, longitudinal and lateral delta-Vs are, respectively: 37 km.p.h. [23.0 m.p.h.], -32 km.p.h. [-19.9 m.p.h.] and + 18 km.p.h. [+ 11.2 m.p.h.]. These results appear reasonable. This was an impact of moderate severity (24-40 km.p.h. [15-25 m.p.h.]) for the case vehicle.

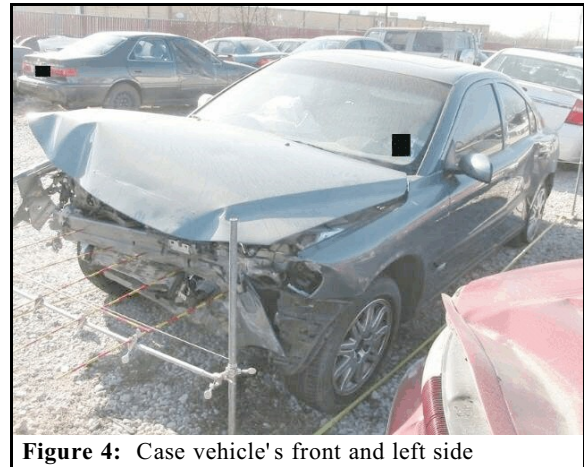
Figure 4: Case vehicle's front and left side

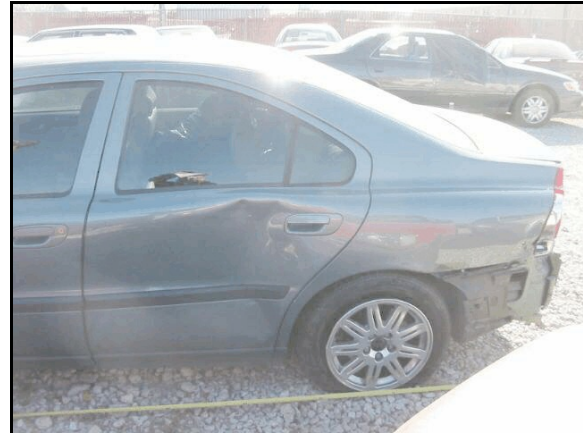
The case vehicle's first impact, with the tractor-trailer, involved minor denting and scraping on the left rear door panel. Maximum crush was measured as 5 centimeters [2 inches] at C3, slightly forward of the left rear door handle. The rear bumper cover was torn off, perhaps as a result of snagging on the tractor-trailer's right side components. The CDC was determined to be **09-LPEW-1 (270 degrees)**. This impact is out of scope for the WinSMASH reconstruction program. This was an impact of minor severity (1-13 km.p.h. [1-8 m.p.h.]) for the case vehicle.

**Figure 5:** Case vehicle's left rear door, showing minor damage from first impact

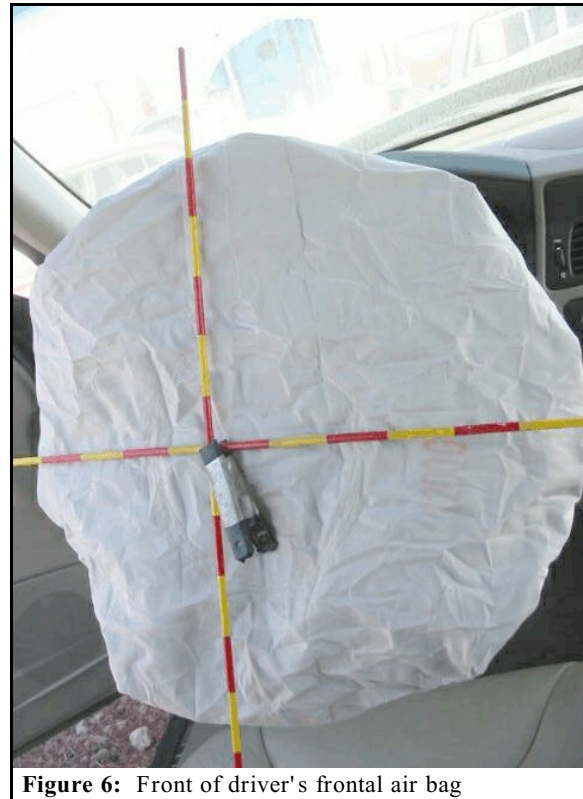
The driver's air bag was located in the steering wheel hub (**Figure 6**). This air bag had a two-stage inflation system, but, because the case vehicle did not have a downloadable Event Data Recorder, it is not known if this was a first or second stage deployment. The module cover flap opened at the designated tear points and there was no damage to the cover flaps or the adjacent structures. The deployed driver's air bag was round (diameter unknown) with two vent ports located on the back surface, slightly above the horizontal centerline, on either side of the vertical centerline. The air bag fabric was not damaged and there was no obvious evidence of occupant contact.

**Figure 6:** Front of driver's frontal air bag

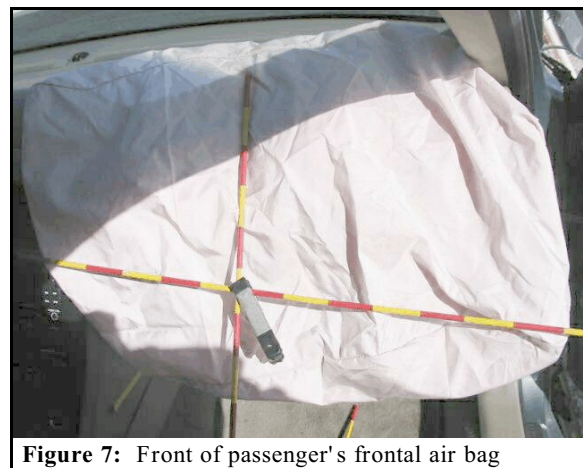
The front right passenger's air bag was located in the top of the instrument panel on the right (**Figure 7**). This air bag had a two-stage inflation system, but, because the case vehicle did not have a downloadable Event Data Recorder, it is not known if this was a one-stage or a two-stage

**Figure 7:** Front of passenger's frontal air bag

deployment. The module cover flaps opened at the designated tear points and there was no damage to the cover flaps or the adjacent structures. The deployed front right passenger's air bag was rectangular (dimensions unknown), with two vent ports on the left and right side panels, respectively, of the fabric. The air bag fabric was not damaged and there was no obvious evidence of occupant contact.

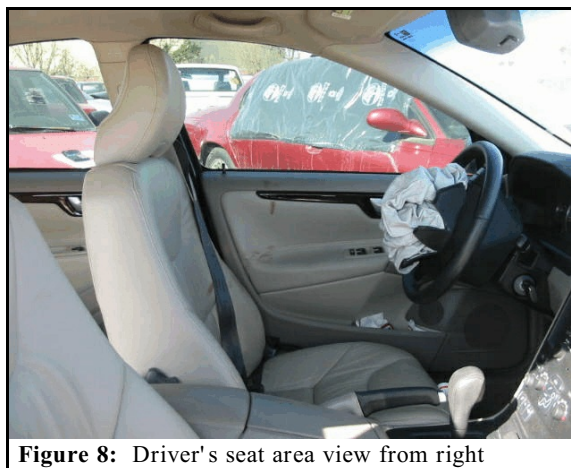
**Figure 8:** Driver's seat area view from right

The case vehicle's driver (66-year-old female, white, unknown if Hispanic, 165 centimeters, 77 kilograms [65 inches, 170 pounds]) was restrained by her available manual, three-point, lap-and-shoulder safety belt system, with the retractor pretensioner actuated and the steering wheel air bag deployed (**Figures 8 and 9**). The safety belt webbing was stretched and the driver had chest injuries consistent with safety belt use. The tilt adjustment on the steering wheel was set between the center and full-up positions and the telescoping adjustment was set between the middle and full-forward positions.<sup>3</sup> The active head restraint was not adjustable.<sup>4</sup> The seat track was adjusted at the middle position and the seat back incline was adjusted at the upright position. Her seated posture is not known, but she was operating the foot controls and had at least one hand on the steering wheel.

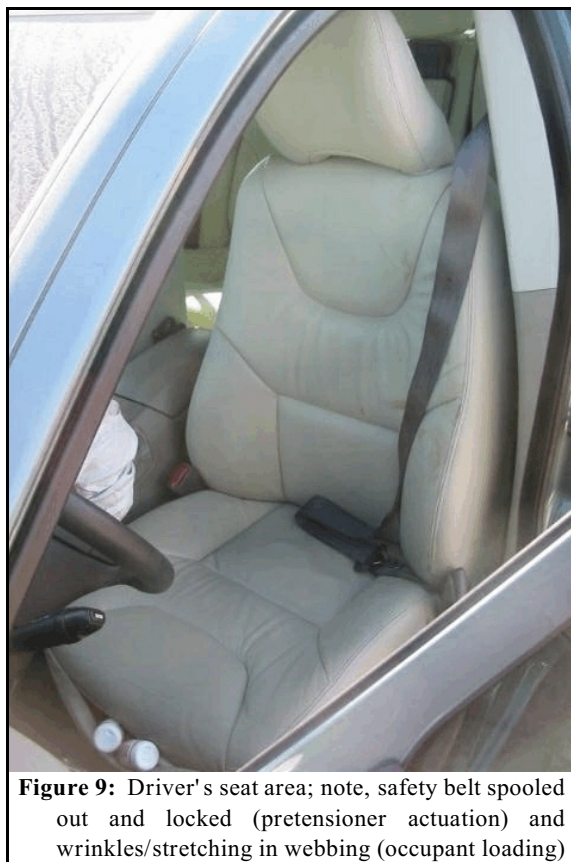
**Figure 9:** Driver's seat area; note, safety belt spooled out and locked (pretensioner actuation) and wrinkles/stretching in webbing (occupant loading)
