**CALSPAN ON-SITE CHILD SAFETY SEAT CRASH INVESTIGATION  
CENTURY CONVERTIBLE CHILD SAFETY SEAT  
SCI CASE NO: CA05-004**

**VEHICLE: 2004 CHRYSLER TOWN & COUNTRY  
LOCATION: MARYLAND  
CRASH DATE: NOVEMBER, 2004**

**CALSPAN ON-SITE CHILD SAFETY SEAT CRASH INVESTIGATION**  
**SCI CASE NO: CA05-004**  
**VEHICLE: 2004 CHRYSLER TOWN & COUNTRY**

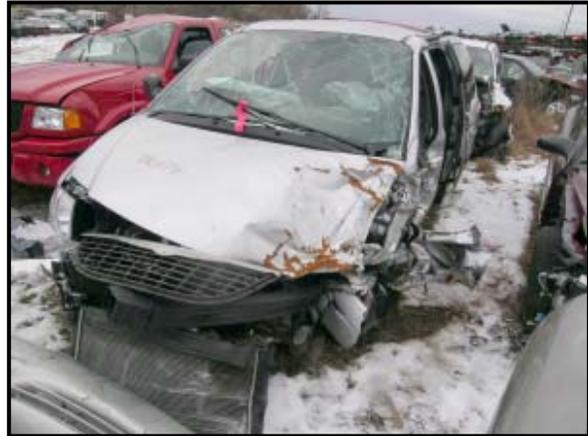
**Figure 1: Left front oblique view of the Chrysler.**

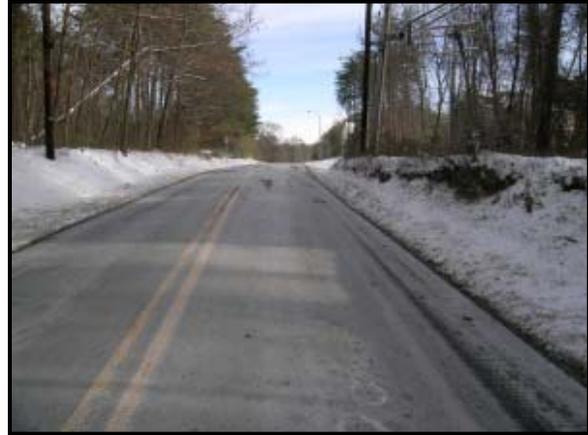
The crash occurred during the nighttime hours of November 2004. At the time of the crash it was dark and the area was illuminated by overhead artificial street lighting. It was raining and the asphalt road surface was wet. The crash occurred on a two lane east/west road in a residential setting. **Figure 2** is an eastbound trajectory view. The width of the each travel lane measured 3.4 m (11.4 ft). The travel lanes were separated by solid double yellow centerlines and delineated by white edge lines. The width of the respective road shoulders measured 1 m (3 ft). The road was straight and level in the area of the impact. A hillcrest was located approximately 25.9 m (85 ft)

**Figure 2: Eastbound trajectory view at the crash site.**

west of the point of impact. The grade of the road was a positive five percent in the eastbound direction leading into the crash site. At the time of the SCI investigation, there was no physical evidence at the crash site that was identified the point of impact and there was no documented evidence reported in the police crash report. The speed limit in the area of the crash was 48 km/h (30 mph). A schematic of the crash is included as **Figure 15** at the end of this report.

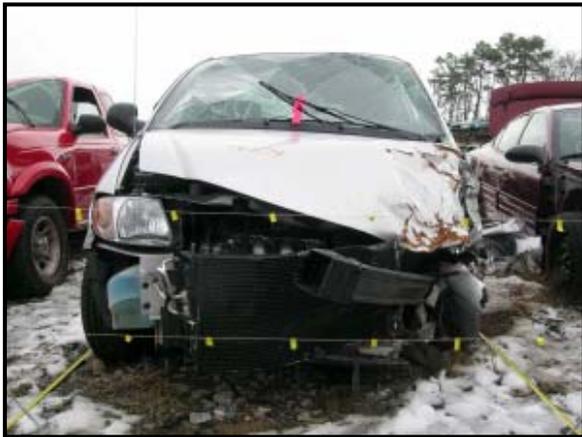
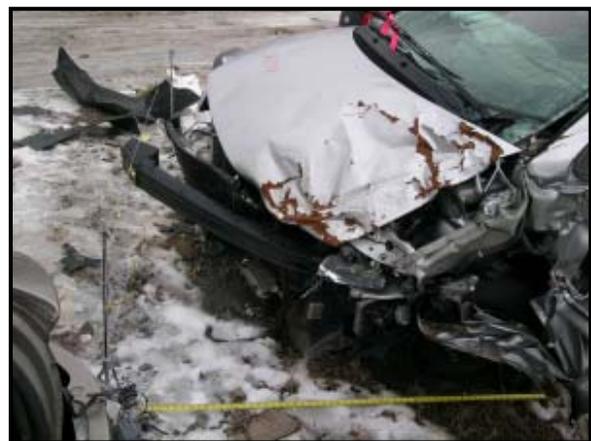
**Figures 3 and 4** are the front and left lateral views of the Chrysler. The front plane of the Chrysler sustained a combined width of direct and induced damage that extended across the entire 163 cm (64 in) of the vehicle. The direct damage began 41 cm (16 in) left of center and extended 41 cm (16 in) to the left corner. The fascia fractured and separated from the bumper reinforcement in the impact. The right side of the bumper reinforcement separated from the right sub-frame due to an induced overload as a result of the crush of the reinforcement's left aspect. The residual crush was measured along the lower radiator support due to the bumper separation. The residual deformation along the lower radiator support was as follows: C1 = 44 cm (17.3 in), C2 = 24 cm (9.4 in), C3 = 10 cm (4.0 in), C4 = 1 cm (0.5 in), C5 = 0, C6 = 0.

**Figure 3: Front view**

**Figure 4: Left lateral view.**

The impact crushed the left fender and deformed the left front suspension and wheel assembly rearward into the lower cowl and left A-pillar. The left front tire deflated and was captured within the damage. The left wheelbase was reduced 23 cm (9.1 in). There was no dimensional change of the right wheelbase. The left and center aspects of the windshield fractured due to the

exterior force of the impact. The right aspect of the windshield fractured due to the deployed front right passenger air bag. The left front door was removed by extrication. The sliding left rear and right rear doors were operational. The right front door was jammed. The Collision Deformation Classification (CDC) was 12-FLEW3

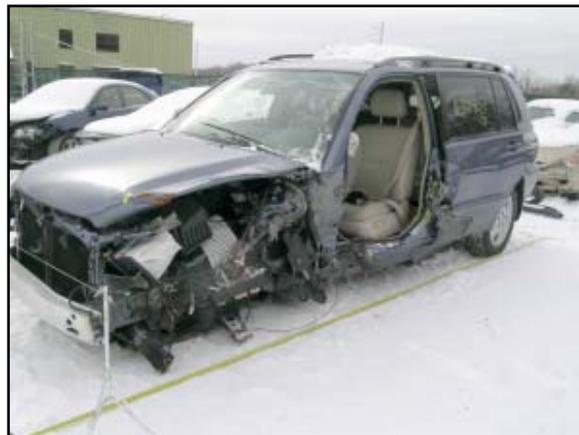
**Figure 5** is a left front oblique view of the damaged Toyota Highlander. It had been disassembled prior to the SCI inspection for insurance purposes. The vehicle sustained an impact to the left corner, immediately outboard of the bumper reinforcement bar. The direct contact damage began 61 cm (24 in) left of center and extended 20 cm (8 in) to the left corner. The front bumper fascia fractured at its left end and separated. The extreme left end of the reinforcement bar was deflected 2 cm (0.8 in). The damage pattern then extended along the left side of the vehicle (outboard of the frame rail) to the forward aspect of the front door opening.

**Figure 5: Left oblique view of the Toyota.**

There was no deformation of the left frame rail. The left front door had been removed and missing. The left sill was buckled from direct contact. The direct contact to the sill ended 61 cm (24 in) forward of the left B-pillar. The left front fender crushed and separated. The left front suspension deformed rearward into the cowl and the wheel assembly separated at the lower control arm. The left front wheel assembly was missing. The rearward displacement of the upper shock tower measured 22 cm (8.5 in). The left A-pillar and left roof rail were buckled. The windshield was fractured from the exterior crash force. The left rear door was open but could not be latched due to distortion of the vehicle's body. The right doors were operational. The right wheelbase was unchanged. The CDC of the Toyota was 12-FLEE6.

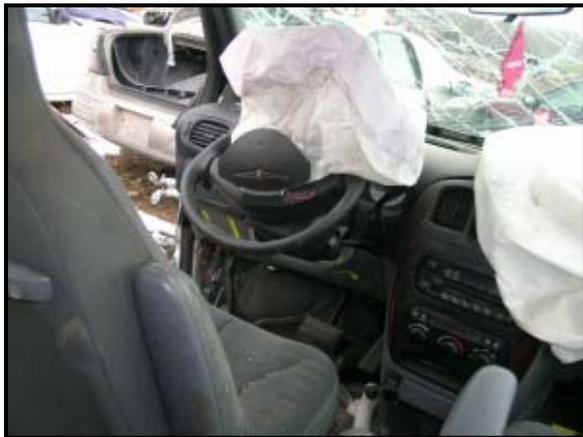
The interior damage to the Chrysler Town & Country consisted of minor intrusion into the driver's position, occupant contacts and the deployment of the frontal air bags. The intrusion of the left corner of the instrument panel measured 8 cm (3 in). The outboard aspect of the toe pan intruded 19 cm (7.5 in). **Figures 6 and 7** are front interior views of the Chrysler.

The four-spoke steering wheel rim was turned 180 degrees clockwise at inspection. The tilt adjustment of the steering wheel was jammed. The lower half of rim was deformed forward. The maximum deflection measured 4 cm (1.5 in) in the 5 o'clock sector. The steering column had completely separated from the shear capsules. The displacement measured 3 cm (1 in).

The driver's knee bolster exhibited two scuff marks indicative of contact from the driver's lower extremities. The left lower extremity contact measured 5 cm x 5 cm (2 in x 2 in) and was located 25 cm (10 in) left of the steering column center line. A 5 cm x 16 cm (2 in x 6 in) abrasion attribute to contact from the right lower extremity was located 8 cm (3 in) right of the steering column center line.

**Figure 6 Driver's interior.**

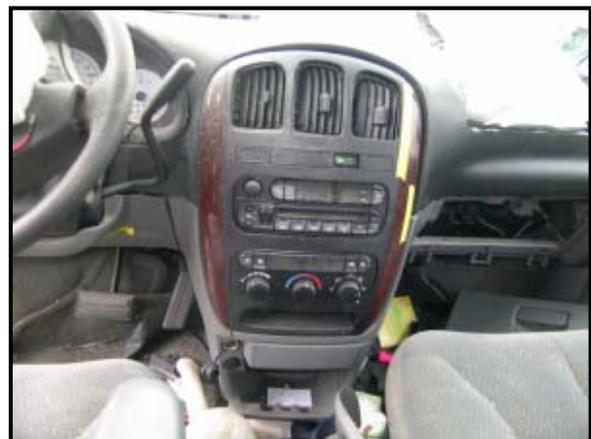
The only noted physical evidence to the front right interior consisted of abrasions to the trim surrounding the right aspect of the center instrument panel. The two areas of abrasion were located 51 cm to 56 cm (20 in to 22 in) and 64 cm to 67 cm (25 in to 26.5 in) above the floor, respectively. The abrasions resulted from frictional contact with the deployed front right passenger air bag as the unrestrained front right passenger rode down the crash force. The glove box disengaged from the lower right instrument panel and was found in the right foot well. There was no evidence of contact to the door.

**Figure 7: Center and front right interior.**

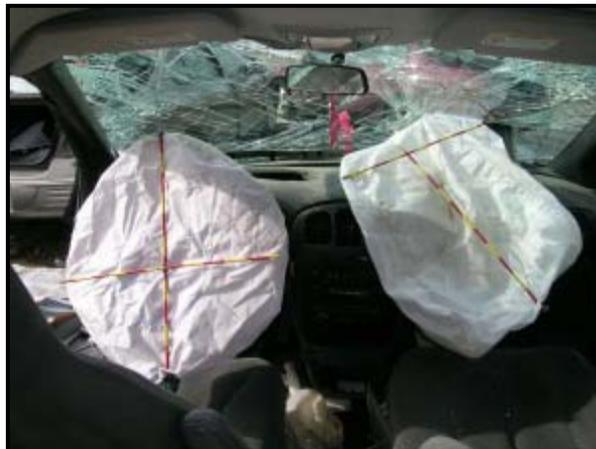
The Frontal Air Bag System in the 2001 Chrysler Town & Country consisted of driver and front right passenger air bags that deployed as a result of the crash, **Figure 9**. The driver air bag module was designed in the typical manner and located in the center hub of the steering wheel rim. The driver air bag module had a single semi-circular flap that was hinged along its top aspect. The vinyl cover flap measured 20 cm (8 in) in diameter. There was no contact evidence on the cover flap. The diameter of the deployed driver air bag measured 66 cm (26 in) in its deflated state. It was tethered by four internal straps sewn to the face of the bag and vented internally. There was no contact evidence on the face of the bag

The front right passenger air bag was a mid-mount design located in the right aspect of the instrument panel. The single cover flap measured 30 cm x 20 cm (12 in x 8 in), width by height, and conformed to the contoured shape of the instrument panel. The passenger air bag was internally vented and was not tethered. The face of the deflated bag measured 46 cm x 66 cm (18 in x 26 in), width by height. There was no residual contact evidence on the face of the bag. A 20 cm (8 in) section of the outboard side panel and top surface of the bag was captured between the rotated cover flap and the windshield. It was not unlikely that the captured position of the air bag was an artifact of the crash. The air bag probably was placed in this position post-crash for unknown reasons.

**Figure 9: Frontal air bags in the Chrysler.**

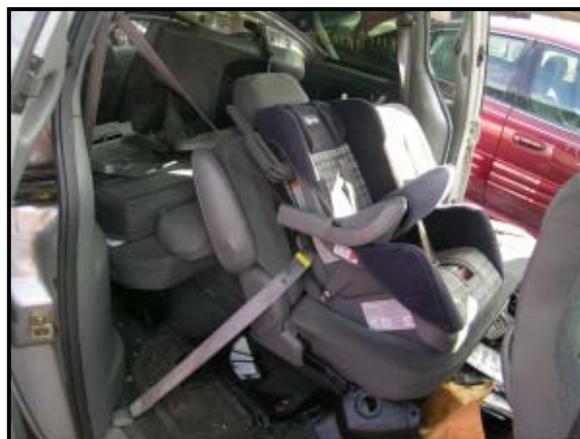
The two year old child was restrained a Century convertible Child Safety Seat (CSS) in the right rear position at the time of the crash, **Figure 10**. The CSS was manufactured on August 29, 2002 and had the following model and serial numbers: 3500 STE MG, 44339EL1. The convertible CSS was labeled for use an infant from 2.3 kg to 10 kg (5 to 22 lb) in a rear facing mode and for a forward facing child 9 kg to 18 kg (20 to 40 lb). The CSS had a height requirement for a child 48 cm to 102 cm (19 in to 40 in). The CSS was designed with a three-point harness and a tray shield. The CSS was designed for LATCH. Neither the lower anchor belt nor the tether were in use. The seat was restrained by the vehicle's

**Figure 10: View of the Century convertible Child Safety Seat.**

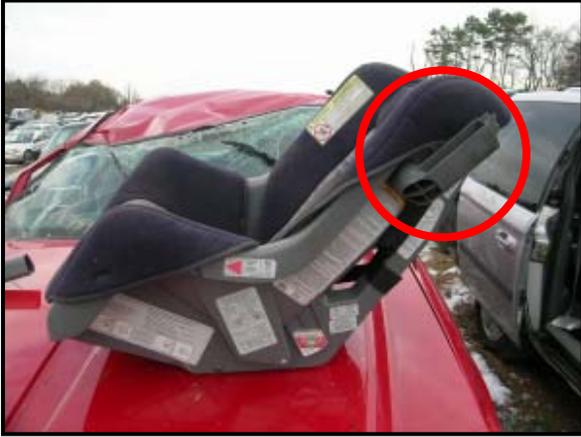
**Figure 11:** Left side view of the CSS.

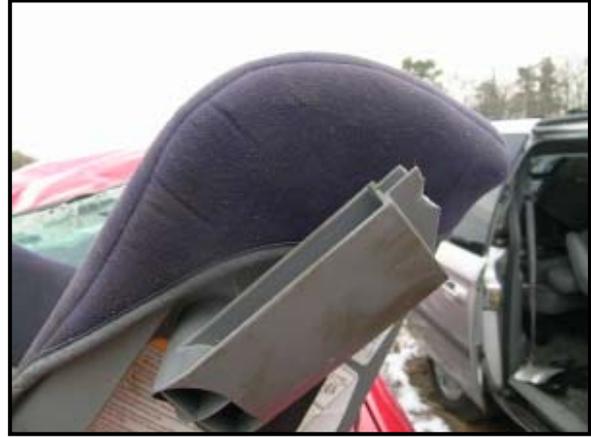
Initial inspection of the CSS found that the tray shield was separated from the seat. Inspection of the components revealed loading evidence to the tray shield by the child occupant. The left side support arm of the tray shield was fractured, **Figures 11 and 12**. The right support arm of the tray shield was intact. Both harness straps were cut by EMS and the tray shield had been removed from the seat. The tray shield did not appear to be damaged. The straps of the three-point internal harness were routed through the top slots. The straps were roped and creased,

**Figure 12:** Fractured tray shield support.

the child translated forward. The child loaded the tray shield with her chest as she rode down the force of the crash. Her loading to the tray shield caused a fracture of the left side support arm (internal to the assembly). The tray shield did not separate during the crash. The child then rebounded back into the shell and came to rest.

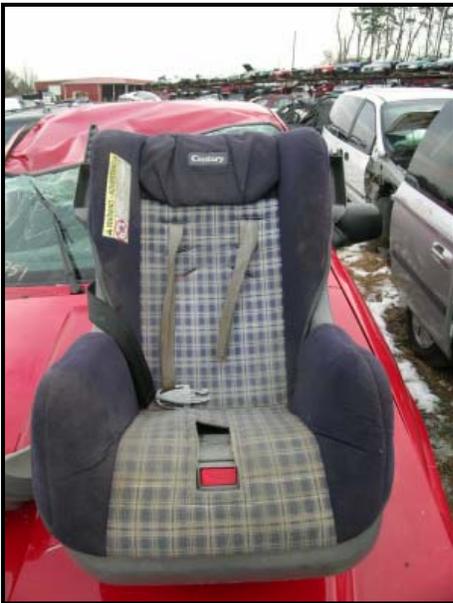
**Figure 13.** The chest restrainer clip was adjusted to the lowest position and the straps were roped within the clip, **Figure 14.** There were no noted fractures or damage to the shell.

**Figure 13:** CSS front view.

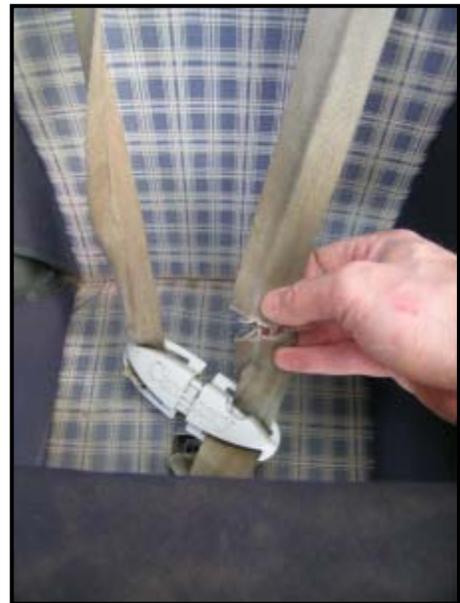
**Figure 14:** Close-up view of the harness straps and retainer clip.

The 2 year old female was seated in a forward facing mode in a convertible child safety seat and was restrained by the child seat's internal three-point harness straps and tray shield. The harness straps were routed through the top slots and the chest retainer clip was adjusted to the lowest position. Upon impact, the child exhibited a forward trajectory in response to the 12 o'clock direction of the impact force. The child began to load the harness straps with her shoulders, however, the low adjustment of the chest retainer clip allowed the straps to separate laterally and

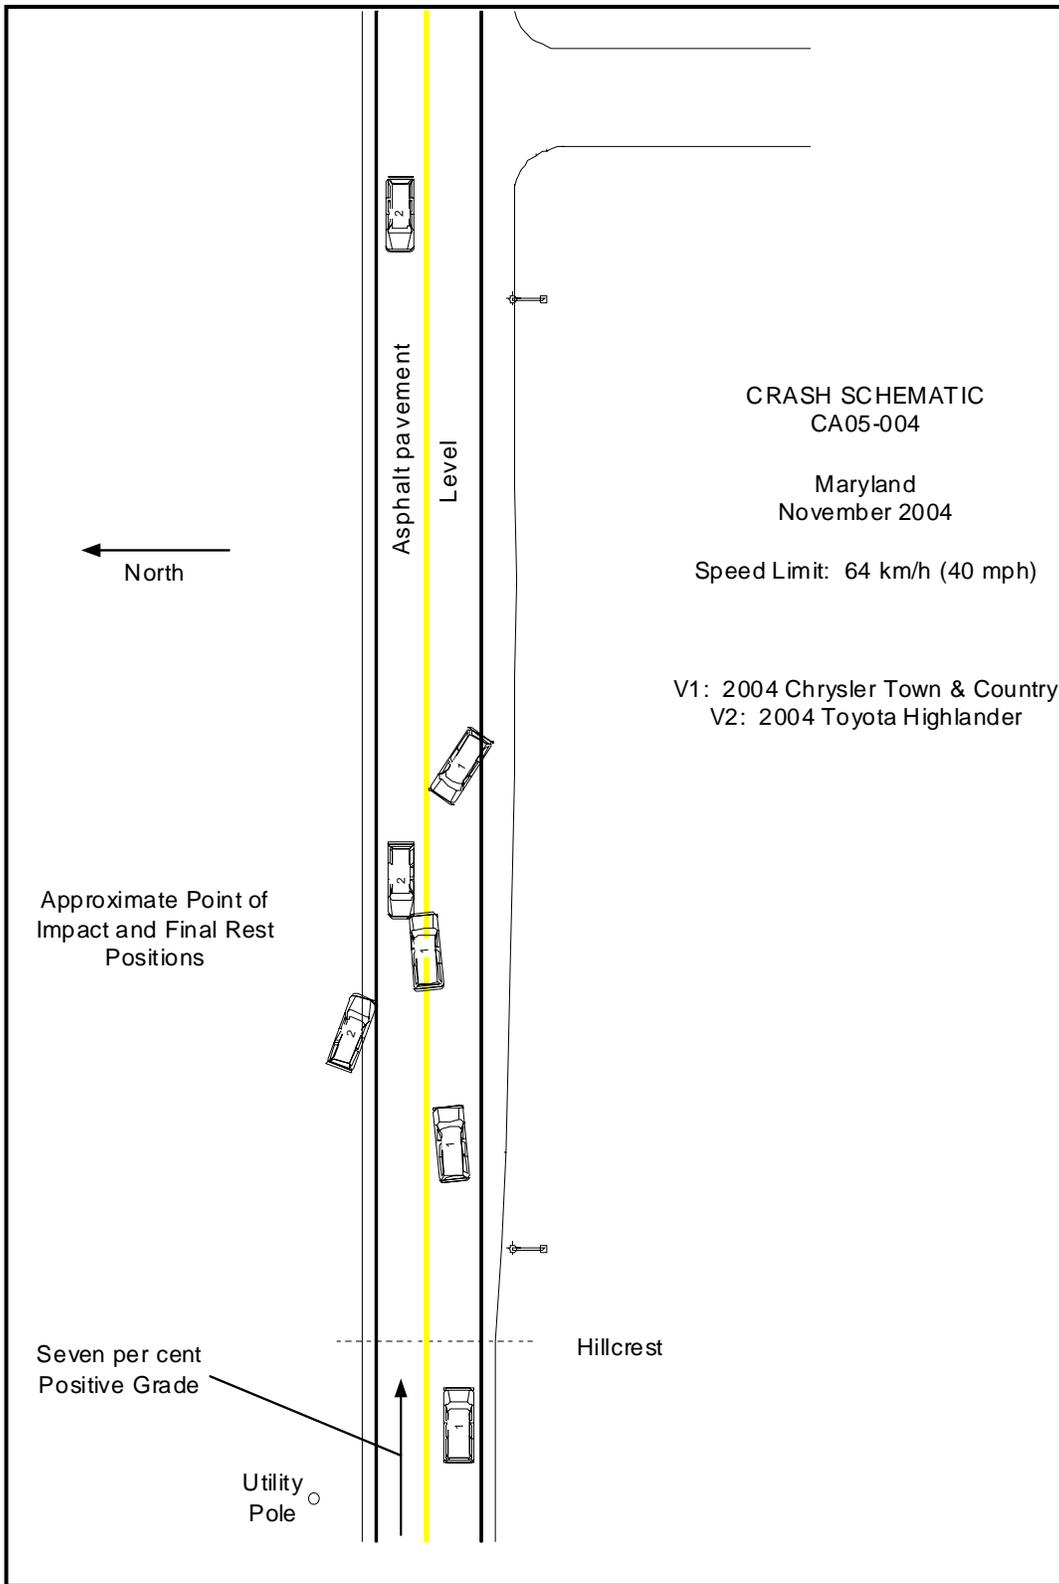
Figure 15: Crash Schematic.
