TRANSPORTATION RESEARCH CENTER

ON-SITE CERTIFIED ADVANCED 208- COMPLIANT VEHICLE INVESTIGATION

CASE NUMBER - IN-05-008
LOCATION - OHIO
VEHICLE - 2005 CADILLAC ESCALADE
CRASH DATE - January 2005

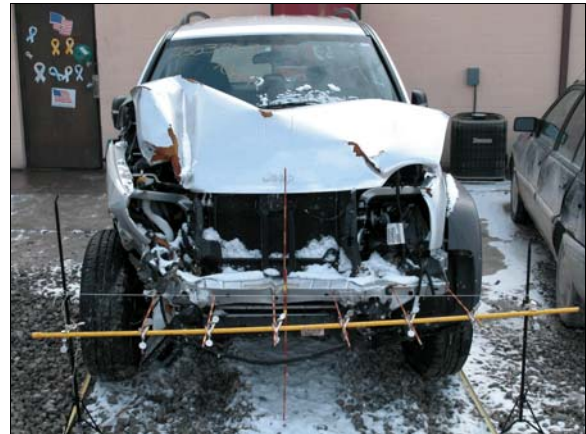
Figure 3: Damage to the front of Jeep due to impact with the left side of the case vehicle

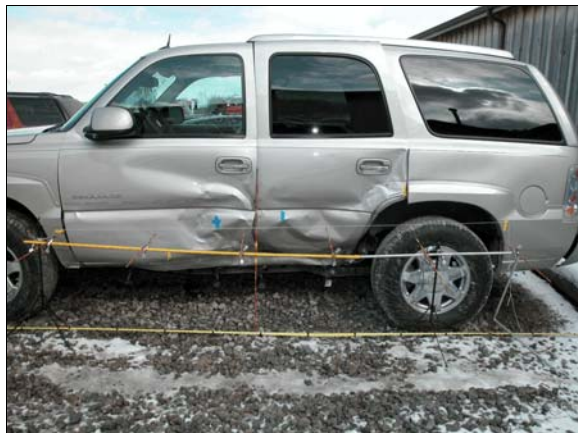
Figure 4: Damage to case vehicle's left side, each black mark on tape is 0.31 meter (1 foot), each increment on rod is 5 cm (2 in)

Exterior Damage: The case vehicle’s impact with the Jeep involved the left front and rear doors and the left sill. The doors and sill were directly damaged and crushed inward. The direct damage began 25 centimeters (9.8 inches) forward of the left rear axle and extended 148 centimeters (58.3 inches) forward along the left side of the vehicle. Crush measurements (**Figure 7**) were taken at the lower door level, and maximum crush was measured as 26.0 centimeters (10.2 inches). Maximum crush was located 45 centimeters (17.7) forward of C₃. The table below shows the case vehicle’s crush profile.

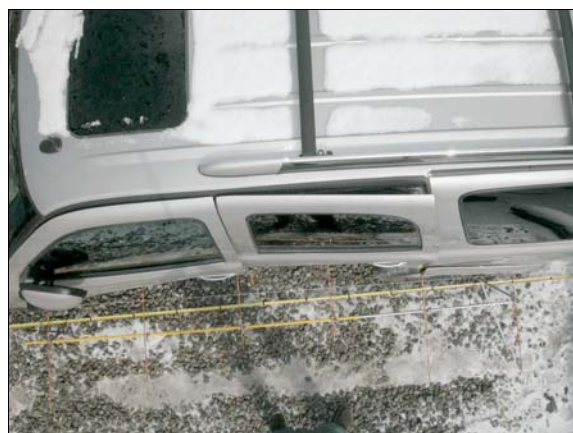
Figure 7: Top view of crush to left side of case vehicle

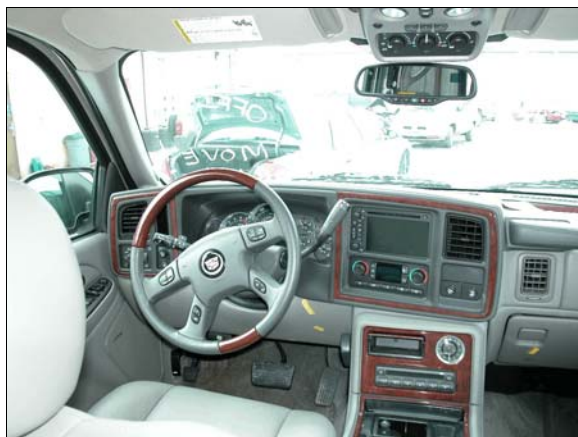
Vehicle Interior: Inspection of the case vehicle’s interior (**Figures 8 and 9**) revealed three small possible occupant contact scuffs on the driver’s right knee bolster. Two small possible occupant contact scuffs were observed on the glove box door, and one small scuff was observed on the right rear door armrest. In addition, there was a scuff on the left front window (**Figure 10** below) that appeared to be due to contact by the deploying seat back-mounted side impact air bag.

Figure 8: Overview of steering wheel, windshield and instrument panel, yellow tape shows possible occupant contact scuffs on driver’s knee bolster

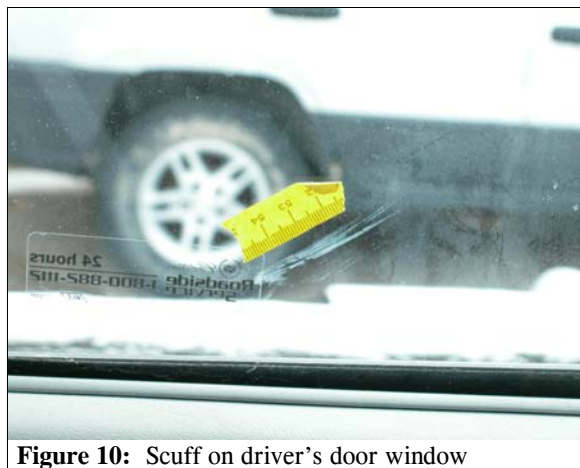
Figure 10: Scuff on driver's door window

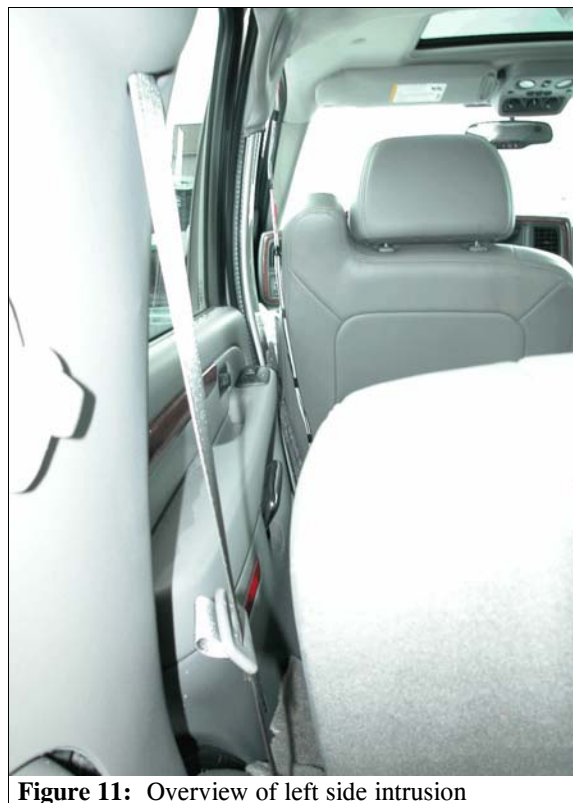
The case vehicle sustained six intrusions (**Figure 11** below) due to the impact with the Jeep. There were three intrusions into the driver’s occupant space as follows: the left front sill intruded laterally 15 centimeters (5.9 inches); the left front door intruded laterally 4 centimeters (1.6 inches); and the upper left B-pillar intruded laterally 1 centimeter (0.4 inches). There were also

three intrusions into the second seat row, left occupant's space as follows: the left sill intruded laterally 15 centimeters (5.9 inches); the left rear door intruded laterally 9 centimeters (3.5 inches); and the left B-pillar intruded laterally 9 centimeters (3.5 inches). There was no compression of the energy absorbing steering column, and no deformation of the steering wheel rim was observed (**Figure 12**).

Figure 11: Overview of left side intrusion

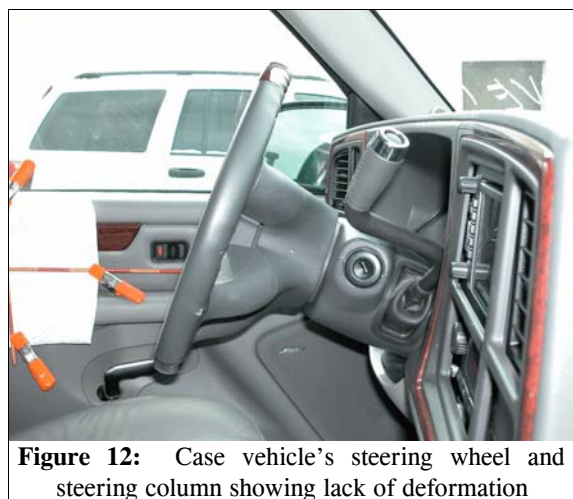
Figure 12: Case vehicle's steering wheel and steering column showing lack of deformation

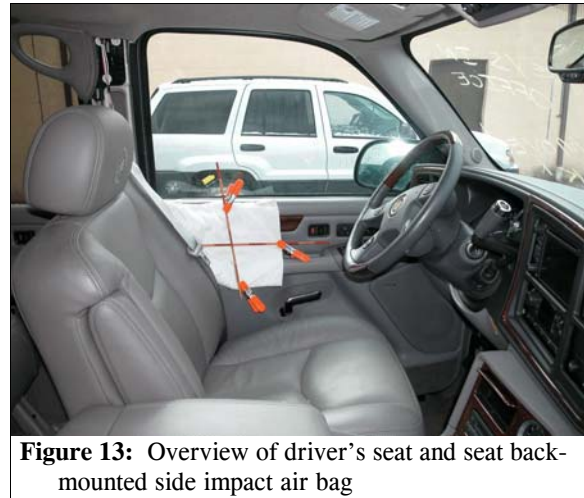
The driver's seat back-mounted side impact air bag was located in the outboard side of the driver's seat back. An inspection of the single air bag module cover flap and the air bag fabric revealed that the cover flap opened at the designated tear points. The air bag module cover flap was rectangular in shape and was 6 centimeters (2.4 inches) in width and 16 centimeters (6.3 inches) in length. There was no evidence of damage during the deployment to the air bag module cover flap or the air bag fabric. However, there were a few dark colored areas on the air bag that appeared to be related to the deployment. In addition, it appeared that the air bag had contacted and scuffed the left front window during the deployment (**Figure 10** above). No occupant contact evidence was observed on the air bag. The deployed seat back-mounted side impact air bag (**Figure 13**) was rectangular in shape with a length of approximately 34 centimeters (13.4 inches) and a height of 24 centimeters (9.4 inches). The air bag was designed without tethers or vent ports.

Figure 13: Overview of driver's seat and seat back-mounted side impact air bag

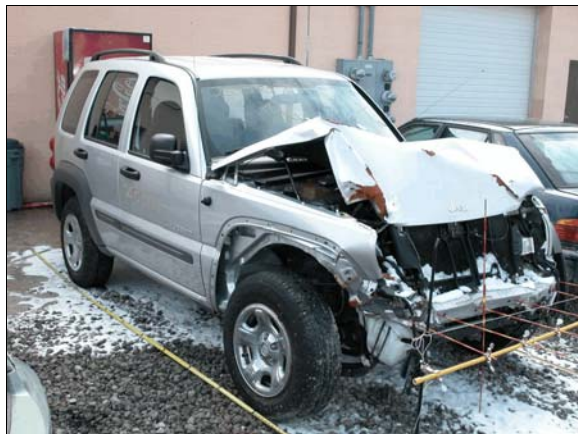
Exterior Damage: The Jeep's impact with the case vehicle involved the entire front end of the Jeep (**Figure 17**). The Jeep's front bumper cover was not present at the inspection. The direct damage began at the front right corner and extended 118 centimeters (46.5 inches) across the front end. Based on the damage to both vehicles, the direct damage most likely involved the full width of the Jeep's front bumper. Crush measurements were taken at the bumper level (**Figure 18** below), and maximum crush was measured as 17.0 centimeters (6.7 inches) occurring at C₅. The table below shows the Jeep's crush profile.

Figure 17: Right front view of damage to front of Jeep due to impact with the case vehicle

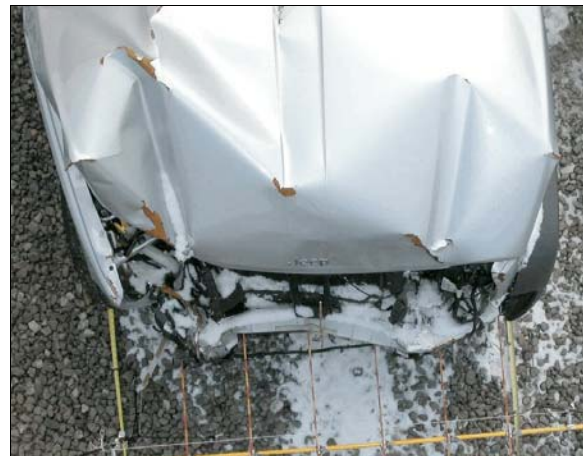
Figure 18: Top view of crush to front of Jeep
