ON-SITE CHILD SAFETY SEAT INVESTIGATION

CASE NUMBER - IN-05-009

LOCATION - WISCONSIN

VEHICLE - 2004 CHEVROLET VENTURE

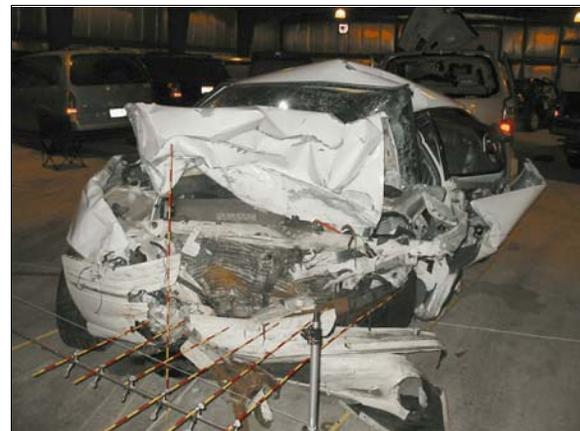
Figure 4: Damage to Pontiac from impact with case vehicle, each increment on rods is 5 cm (2 in)

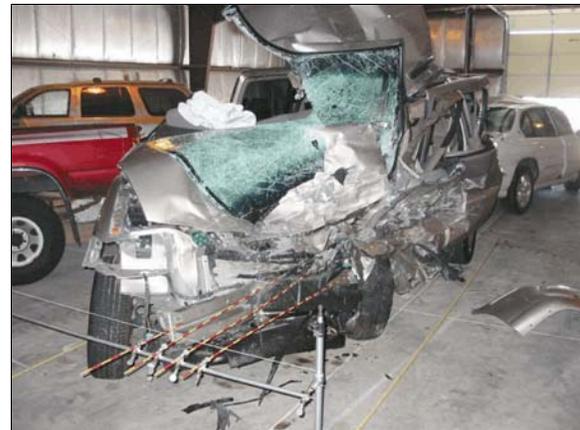
Figure 5: Damage to case vehicle from impact with the Pontiac

Exterior Damage: The case vehicle's impact with the Pontiac involved the front plane (**Figure 5** above) and as the impact progressed, the left front and rear doors (**Figure 8**). The case vehicle's

front bumper, bumper fascia, grille, radiator, hood, left headlamp/turn signal assemblies, left front tire, left fender, windshield, and left front and rear doors were directly damaged and crushed rearward. The direct damage started at the left bumper corner and extended 150 centimeters (59 inches) along the bumper. The Field-L was very short, only 29 centimeters (11.4 inches), due to the extent of crush at the front left corner, and required only four C-measurements to define the crush profile. Residual maximum crush (Figure 9) was measured as 148 centimeters (58.3 inches) occurring at C₁. The direct D value was based on the initial impact overlap. The table below shows the case vehicle's crush profile.

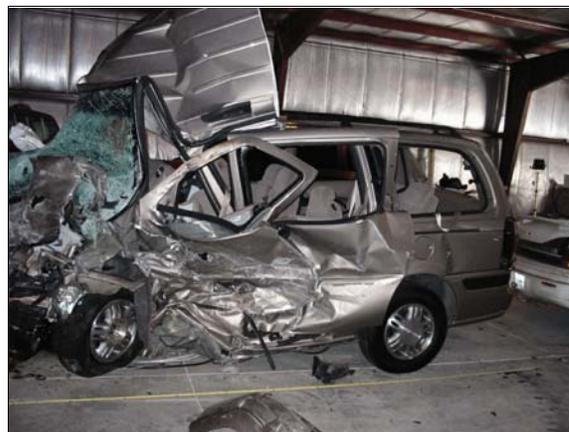
Figure 8: Damage to case vehicle's left side doors from impact with the Pontiac

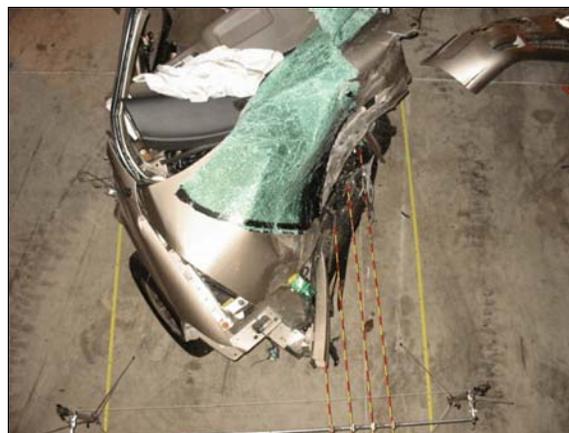
Figure 9: Top view of crush to front of case vehicle

The case vehicle's left side wheelbase was shortened 107 centimeters (42.1 inches) while the right side wheelbase was extended 17 centimeters (6.7 inches). Induced damage involved the roof, right fender and the left quarter panel. The right B-pillar was cut away, the right front door was removed and the roof was cut laterally at approximately the second seat row area by rescue personnel to facilitate extrication of the occupants.

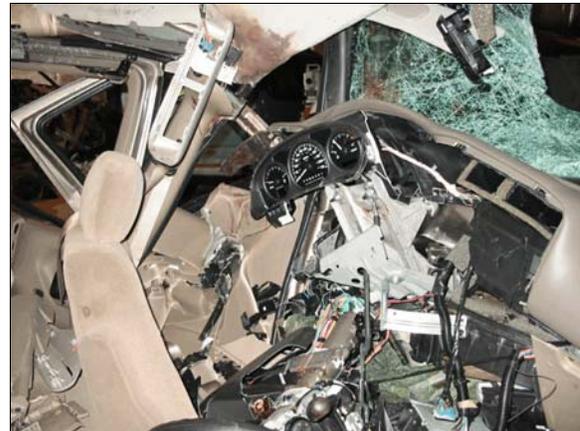
Vehicle Interior: Inspection of the case vehicle's interior revealed evidence of occupant contact to both front air bags, the steering wheel rim, driver's knee bolster, both front safety belts, both outboard third seat row safety belts, and the roof of the case vehicle. There was significant intrusion into the driver's occupant space (**Figure 10**), the front right occupant space and the second seat left occupant space. The primary intrusions into the driver's occupant space were: 115 centimeters (45.3 inches) of longitudinal toe pan intrusion, 82 centimeters (32.3 inches) of longitudinal instrument panel intrusion and 72 centimeters (28.3 inches) of longitudinal steering wheel intrusion. The primary intrusions into the front right occupant space were: 76 centimeters (29.9 inches) of longitudinal toe pan intrusion and 22 centimeters (8.7 inches) of longitudinal instrument panel intrusion. The primary intrusion into the second seat left occupant space was 37 centimeters (14.6 inches) of lateral door panel intrusion. Lastly, there was significant deformation of the upper half of the steering wheel rim and the energy absorbing steering column (**Figure 11**).

Figure 10: Intrusion into driver's occupant space

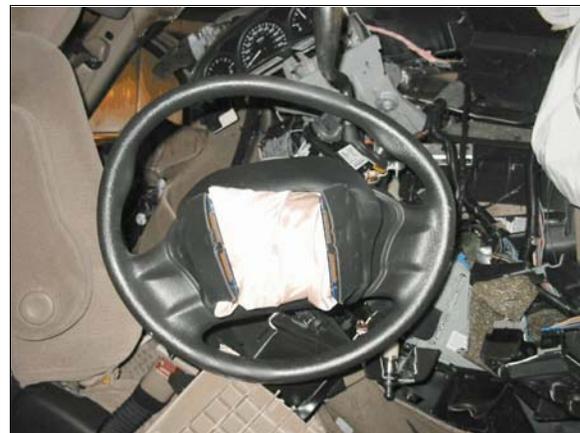
Figure 11: Deformation to case vehicle's steering wheel and overview of air bag module flaps

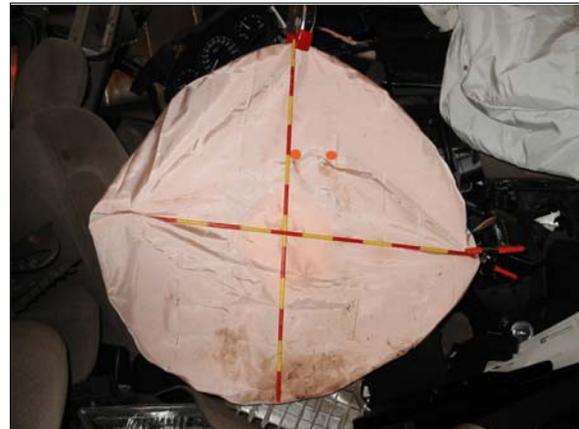
The case vehicle's driver air bag was located in the steering wheel hub. An inspection of the air bag module cover flaps and the air bag fabric revealed that the cover flaps opened at the designated tear points. There was no evidence of damage during the deployment to the air bag or the cover flaps (**Figure 11** above). The air bag module cover consisted of symmetrical "I"-configuration cover flaps constructed of thick vinyl. Each cover flap was 9 centimeters (3.5 inches) in width and 11 centimeters (4.3 inches) in height along the center tear seam. The deployed driver's air bag (**Figure 12**) was round with a diameter of approximately 65 centimeters (25.6 inches). It was designed with four tethers, each approximately 7 centimeters (2.8 inches) in width. The driver's air bag had two vent ports (**Figure 13**), each approximately 2 centimeters (0.8 inches) in diameter, located at the 11 and 1 o'clock positions. An inspection of the air bag revealed blood and body fluid from the driver on the air bag fabric on the lower half (front and back) and the upper right quadrant of the air bag. The on-scene police photographs show this was due to the driver coming to rest on the air bag following the crash and bleeding on the air bag from a head injury. In addition there were two small holes in the front of the air bag in the upper right quadrant (**Figure 14**). The source of these holes was not determined. They did not appear related to the deployment.

Figure 12: Case vehicle's driver air bag, orange dots show small holes in air bag

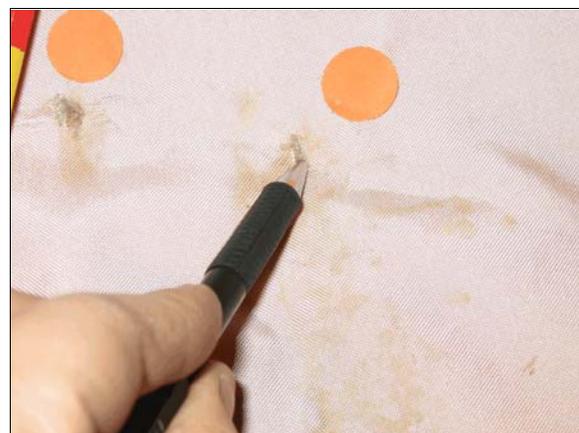
Figure 14: Close view of small holes in driver's air bag

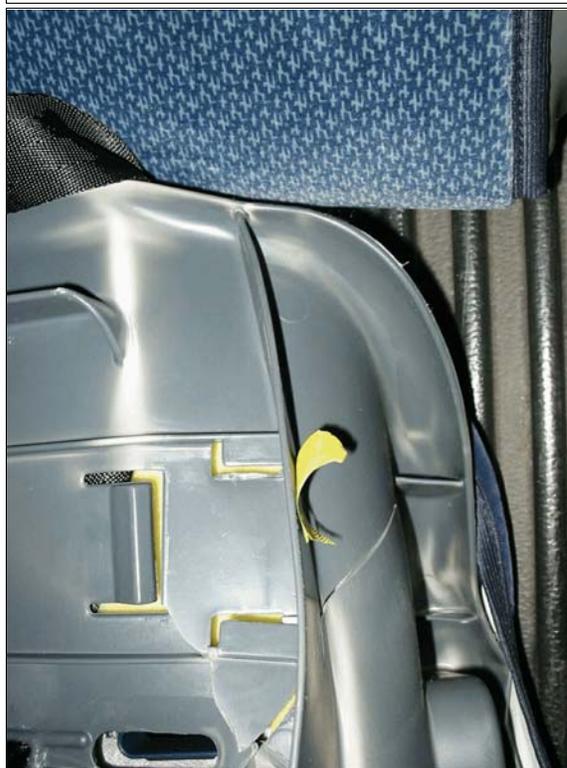
Inspection of the child seat revealed evidence it had been compressed between the intruding driver's seat back and the back of the seat in which the child seat was secured. The back, upper right portion of the child seat had extensive stress marks and cracks in the plastic shell (**Figure 18**), and contact marks were observed on the back right portion of the driver's

Figure 18: Stress marks and cracks to back, upper right portion of 2nd seat center child seat

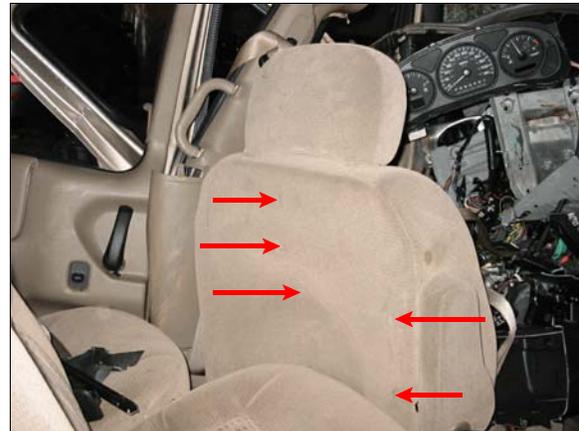
seat back (**Figure 19**). Stress marks were also observed in the harness guides (**Figure 20**) located in the back of the child seat and along the entire length of the right side of the child seat (**Figure 21** below) due to the buckling of the child seat from contact with the driver's seat back (**Figure 22** below) during impact. In addition, the right shield arm was pulled out of its socket. The right side of the plastic shell (**Figure 21** below) was also cracked open vertically at about mid-level, below the shield arm's attachment socket. Just above this point was a crack in the shell running diagonally upward. Also found on the right side of the child seat were abrasions to the lower outer portion of the seat. This was likely due to contact with the child seat located in the second seat left position. The left side of the child seat was largely unremarkable. However, there were some minor abrasions to the left edge of the child seat. All the harness webbing appeared in good condition; however, it had been cut by rescue personnel. Lastly, the latch clip for the right lower anchor connector was deformed and would not close (**Figure 23** below).

Figure 19: Overview of child seat contact marks (arrows) on the case vehicle driver's seat back, arrows on right show second seat center child seat marks, arrows on left show second seat left child seat marks

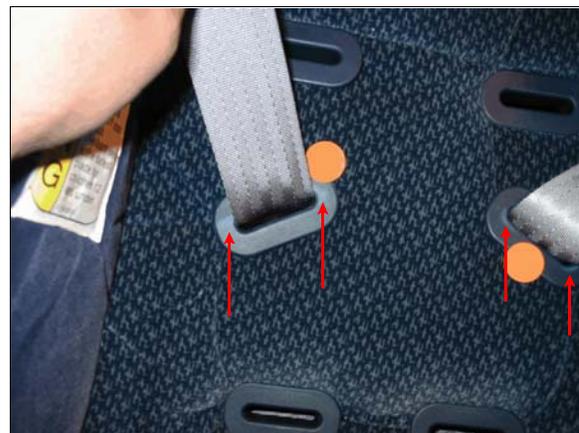
The stress marks in the harness belt guides and the deformation and stress marks observed on the child seat indicate that as the child seat back was crushed rearward and twisted to the left, the harness belts were pulled tight loading the plastic harness guides and most likely pulling the belt tightly against the child. In addition, the deformation of the back of the child seat most likely compressed the child between the back of the child seat, the tray-shield and the case vehicle's seat back.

Figure 20: Close view of stress marks in harness guides (arrows) of 2nd seat row, center child seat

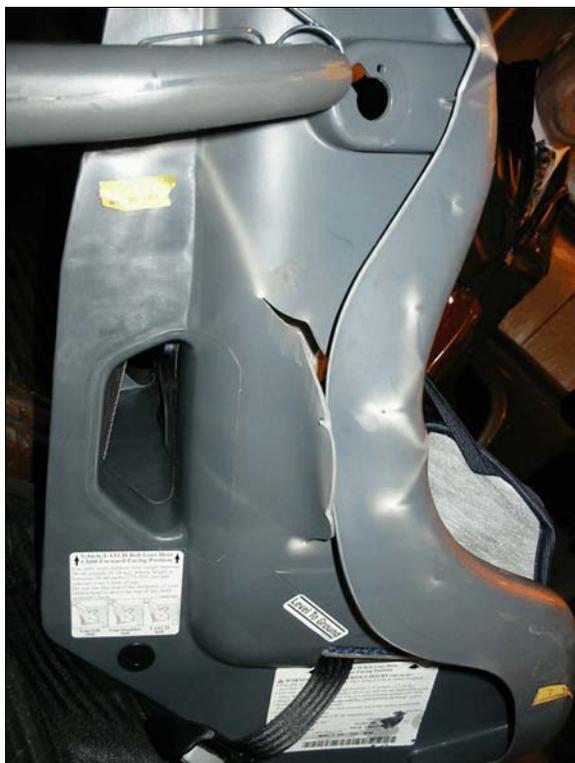
Figure 21: Stress marks and damage to right side of 2nd seat center child seat

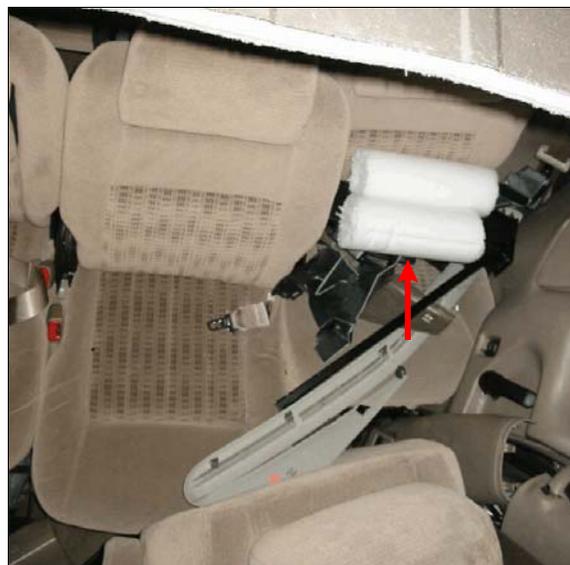
Figure 22: Intrusion of the case vehicle driver's seat into the 2nd seat center and left seat positions; arrow shows pool noodles used to position child seats

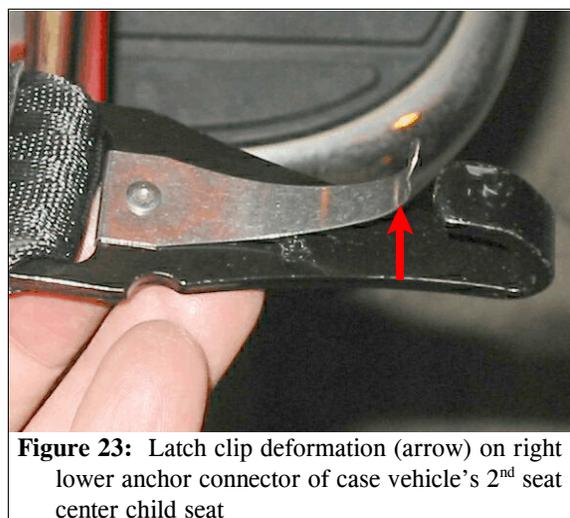
Figure 23: Latch clip deformation (arrow) on right lower anchor connector of case vehicle's 2nd seat center child seat

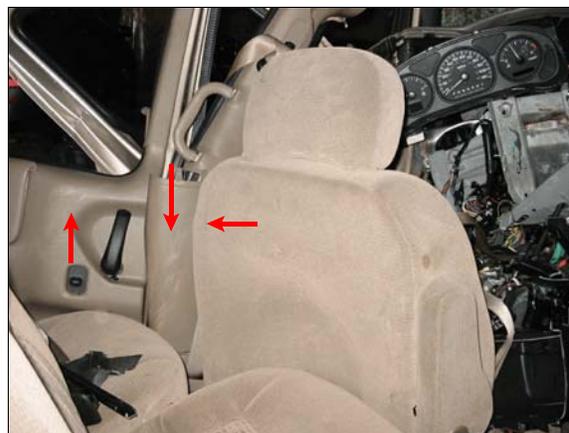
seat back as well as the intruding left rear door and B-pillar (**Figure 26** and **Figure 22** above). The child seat's contact with these components produced contact scuffs and small tears in the back left of the driver's seat back, as well as scuffs on the left rear sliding door and B-pillar. The child seat most likely sustained some deformation due to this interaction. As the case vehicle separated from impact and rotated counterclockwise, the child most likely moved to the right within her child seat and then to the left as the case vehicle rolled over onto its left side to final rest. The child seat remained secured in the vehicle and the child remained restrained in her child seat following the crash. The child was subsequently removed from the vehicle by rescue personnel.

Figure 26: Overview of contact marks (arrows) on the case vehicle driver's seat back, B-pillar and left rear door from 2nd seat row, left child seat

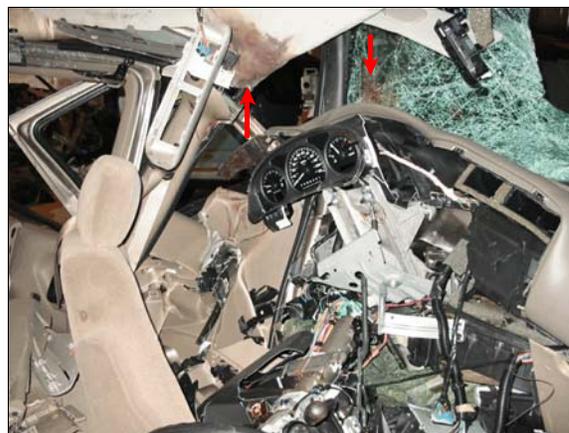
Figure 27: Arrows show driver contact to windshield and roof

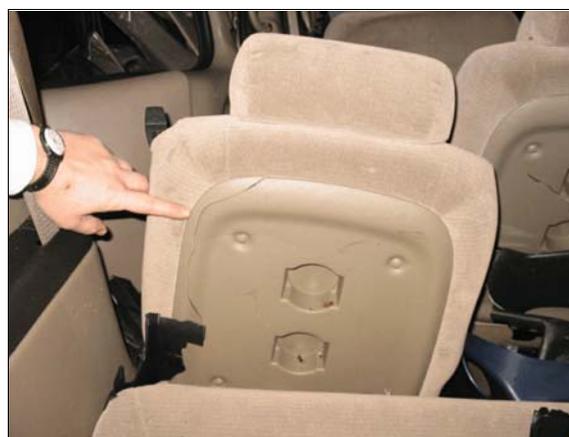
Figure 28: Crack in the plastic drink holder panel on the back of the seat in front of the 3rd seat left passenger

that was under his left arm and he possibly impacted his head on the back of the seat in front of him. The plastic drink holder panel on the back of the seat in front of him was observed to cracked and scuffed (**Figure 28** above). As the case vehicle separated from impact and rotated counterclockwise, the passenger most likely moved right and then left as the case vehicle rolled over onto its left side. As the case vehicle rolled over, the passenger's left side impacted the case vehicle's left side surface. Following the crash, the passenger remained restrained in his seat laying against the left side of the case vehicle. He was removed from the case vehicle by rescue personnel.

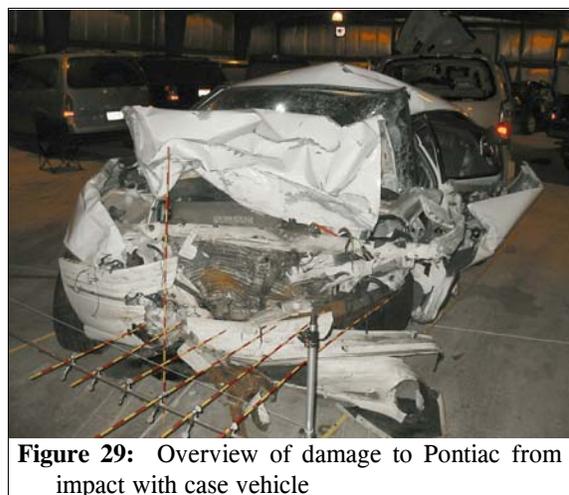
Figure 29: Overview of damage to Pontiac from impact with case vehicle

Exterior Damage: The Pontiac’s impact with the case vehicle involved the front of the vehicle (Figures 29 above). The front bumper, grille, hood and left fender were directly damaged and crushed rearward. The direct damage began at the Pontiac’s front left bumper corner and extended 144 centimeters along the bumper. The residual maximum crush was measured as 142 centimeters (55.9 inches) occurring at C₁ (Figure 30). The direct D value is based on the initial impact overlap. The table below shows the Pontiac’s front crush.

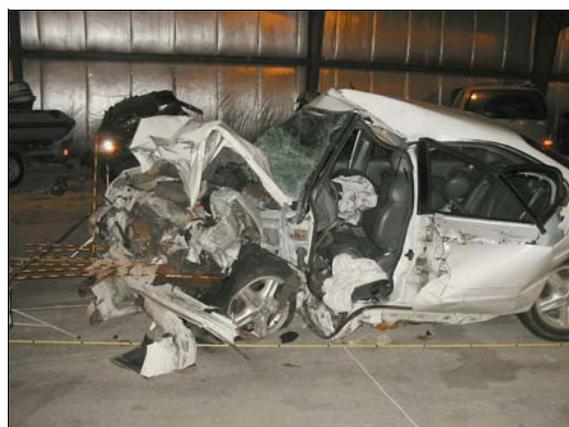
The Pontiac’s left side wheelbase was reduced 76 centimeters (29.9 inches). The right side wheelbase was extended 8 centimeters (3.1 inches). Induced damage involved the roof, back of the hood, windshield, right fender, right front door, left front and rear doors and the left quarter panel.

Figure 30: Left side view of front crush to Pontiac
