**CALSPAN ON-SITE CERTIFIED ADVANCED 208-COMPLIANT  
VEHICLE CRASH INVESTIGATION**

**SCI CASE NO: CA05-009**

**VEHICLE: 2004 NISSAN TITAN  
LOCATION: MARYLAND  
CRASH DATE: DECEMBER 2004**

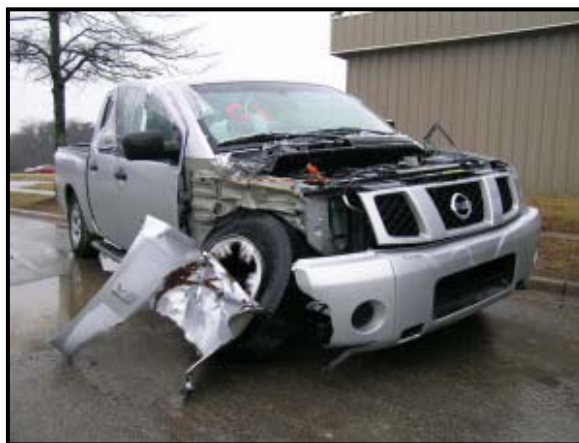
**Figure 1: Front right oblique view of the Nissan Titan.**

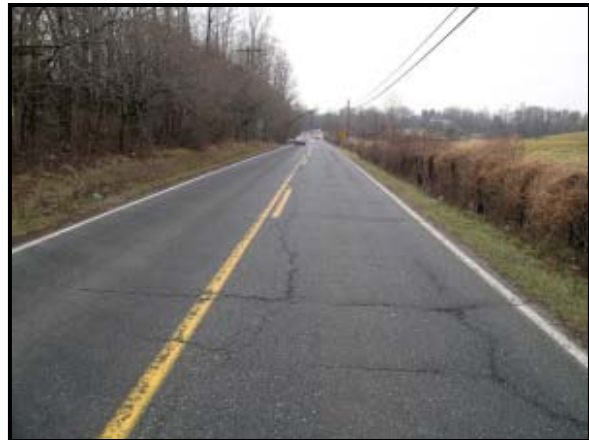
**Figure 2: View of the Nissan’s trajectory.**

scene inspection, there was no physical evidence within the area of the crash that identified the point of impact. **Figure 2** is a view of the Nissan Titans southbound trajectory.

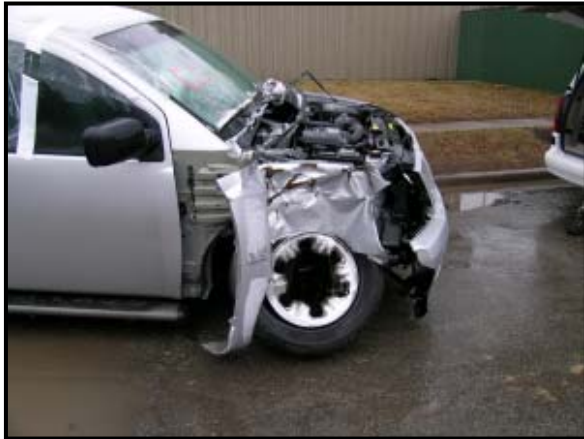
The forward aspect of the Nissan's right side sustained 60 cm (23.5 in) of direct and induced damage as a result of the tree impact, **Figure 3**. The direct damage began 36 cm (14.1 in) aft of the right front axle location and extended forward 52 cm (20.5 in). The impact was approximately centered on the right front tire. The seven spokes of the alloy wheel rim fractured in the impact and the wheel rim separated from the center hub. The components damaged in the impact included the right front inner and outer fender, right front tire and suspension and the right headlamp assembly. There was no visible damage to the front bumper system, upper radiator support or frame of the Nissan. **Figure 4** depicts the method used to document the residual deformation of the right front fender. The longitudinal dowel rod represented the original location of the inner fender. Its location was determined by referencing the undamaged left side

of the vehicle. The lateral crush was then directly measured from the dowel rod to the crushed component. The residual crush profile was as follows: C1 = 0, C2 = 2 cm (0.6 in), C3 = 6 cm (2.5 in), C4 = 11 cm (4.3 in), C5 = 12 cm (4.8 in), C6 = 6 cm (2.5 in). The maximum crush was located 7 cm (2.9 in) forward of the right front axle location and measured 14 cm (5.6 in). There was no measurable change in the wheelbase dimensions. The left front, left rear, and right rear doors remained closed during the crash and were operational at the time of the SCI inspection. The right front door remained closed during the impact and was opened by the first responders. It could not be latched at the time of the inspection due to deformation of the right side body panels. There was no damage to the windshield or side windows. The Collision Deformation Classification (CDC) of the front impact was 02-RFEW2.

**Figure 3: Right exterior view of the damaged Nissan**

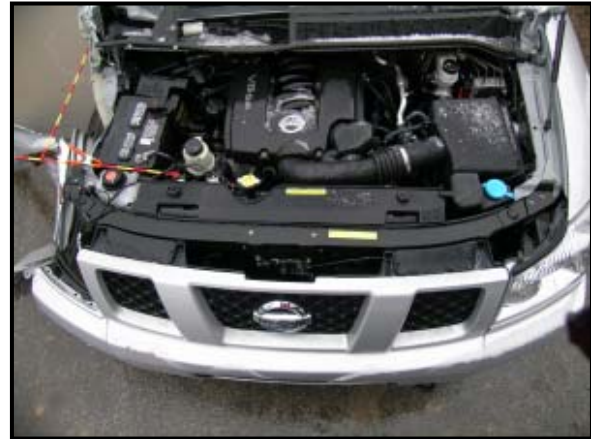
**Figure 4: Overhead view of the engine compartment and right front damage.**

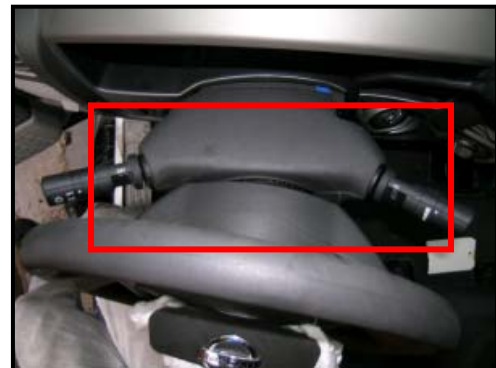
The three-spoke tilt steering wheel was adjusted to the center position. The steering wheel mounting flange was deformed throughout the 7 to 10 o'clock sector. The deformed flange closed the manufactured clearance between the steering wheel assembly and steering column on the left and opened that clearance gap to 2 cm

**Figure 5: Overhead view depicting the deformed steering wheel mounting flange.**

(0.6 in) on the right. Refer to **Figure 5**. The deformation resulted from the unrestrained loading by the driver. There was no deformation of the steering wheel rim and there was no displacement of the steering column's shear capsules.

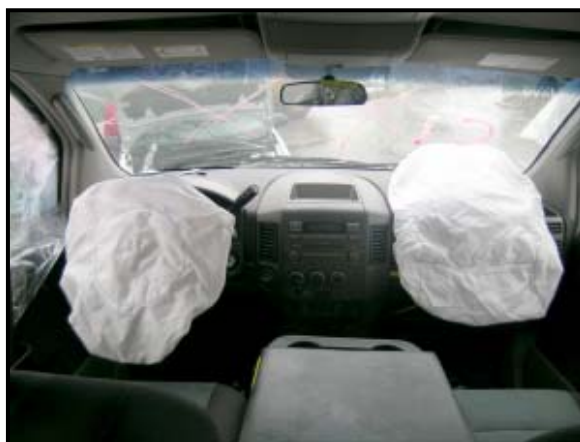
The driver and front right passenger air bags deployed as a result of the frontal crash, **Figures 7**. The driver air bag deployed from a tri-flap configuration module that was located in the center hub of the steering wheel rim. The upper flap dimensions measured 15cm x 6 cm (6 in x 2.3 in), width by height. The symmetrical lower flaps each measured 5 cm x 5 cm (2 in x 2 in). The flaps opened at the designed tear seams during the deployment sequence and were free from occupant contact. The deployed driver air bag measured 55 cm (21.5 in) in diameter. The bag was tethered by two 11 cm (4.3 in) wide straps in the 6/12 o'clock sectors. The bag was vented by two 2 cm (0.8 in) ports located 14 cm (5.5 in) forward of the perimeter seam in the 11/1 o'clock sectors. There was no residual evidence of occupant contact to the face of the bag. The following manufacture's nomenclature identified the driver air bag:

**Figure 7: View of the deployed frontal air bags.**

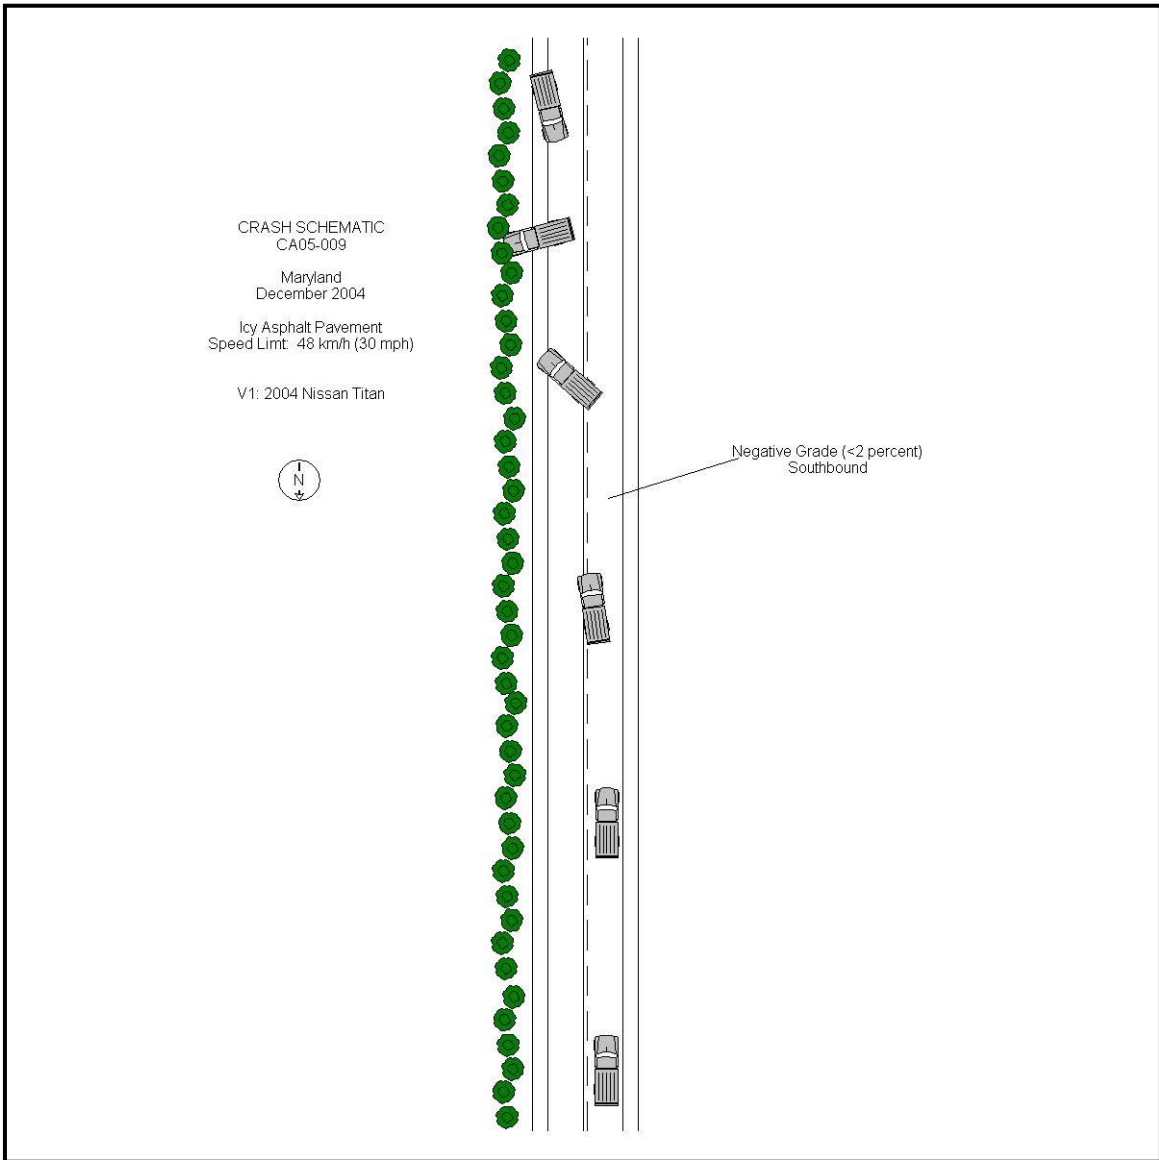
Figure 8: Crash Schematic.

The 2004 Nissan Titan was southbound driven by a 30 year old unrestrained male. A 52 year old unrestrained male was the vehicle's front right passenger. Due to a combination of excessive speed and poor road conditions, the driver lost directional control of the Nissan on the icy road and the rear tires of the vehicle lost traction. The Nissan began to rotate counterclockwise, crossed the center line of the road and departed the east roadside. A schematic of the crash is included at the end of this report as **Figure 8**.
