ON-SITE ADVANCED OCCUPANT PROTECTION SYSTEM INVESTIGATION

CASE NUMBER - IN-05-010

VEHICLE - 2005 VOLKSWAGEN JETTA

CRASH DATE - January 2005

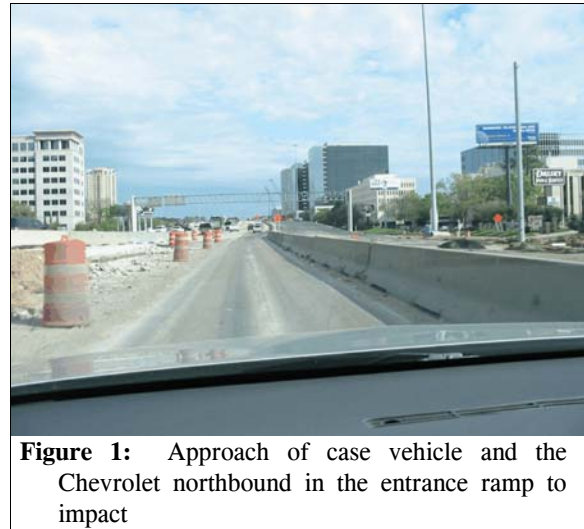
Crash Environment: The trafficway on which the case vehicle was traveling was a one-lane entrance ramp to an Interstate highway, traversing in a northerly direction (**Figure 1**). The entrance ramp was under construction and had been narrowed to 2.4 meters (7.9 feet) in width by orange traffic barrels and concrete jersey barriers placed on the right side of the lane. The case vehicle's approach to the crash location was uncontrolled and the police reported speed limit was 97 km.p.h. (60 m.p.h.). At the time of the crash the light condition was dawn, the atmospheric condition was clear, and the roadway pavement was dry, level bituminous. Traffic density was heavy and the site of the crash was urban. See the Crash Diagram at the end of this report.

Figure 1: Approach of case vehicle and the Chevrolet northbound in the entrance ramp to impact

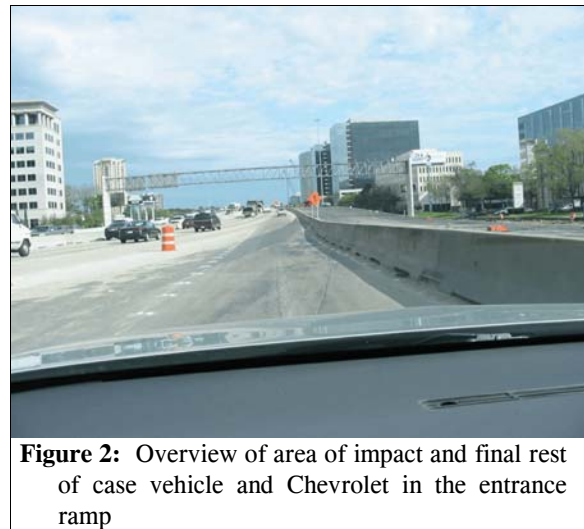
Pre-Crash: The case vehicle was traveling north in the entrance ramp in heavy traffic. The case vehicle's driver was intending to merge onto the expressway. The Chevrolet was just ahead of the case vehicle. Its driver was also intending to merge onto the expressway. The Chevrolet was behind a vehicle that braked suddenly for an accident that just occurred in front of it. The Chevrolet braked to avoid a collision with the vehicle ahead of it. The underride damage to the front of the case vehicle indicates the case vehicle's driver braked to avoid a collision with the Chevrolet. The crash occurred in the entrance ramp (**Figure 2**) as the case vehicle was braking.

Figure 2: Overview of area of impact and final rest of case vehicle and Chevrolet in the entrance ramp

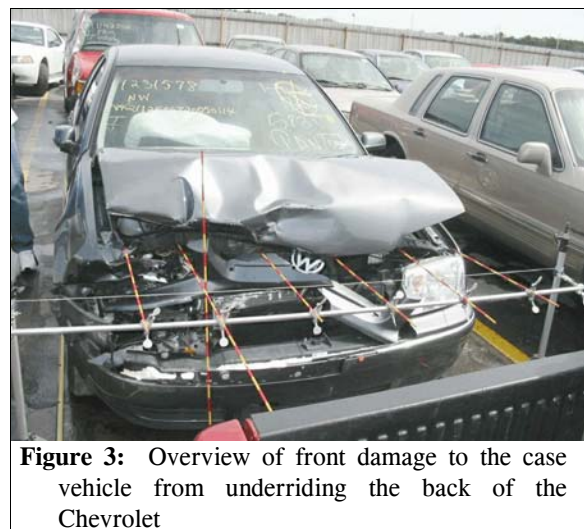
Crash: The front of the case vehicle (**Figure 3**) impacted and underrode the back of the Chevrolet. The damage to the case vehicle indicates that the impact was offset, with the front right two-thirds of the case vehicle making contact with the back left two-thirds of the Chevrolet. The impact caused the case vehicle's driver and front right air bags to deploy.

Figure 3: Overview of front damage to the case vehicle from underriding the back of the Chevrolet

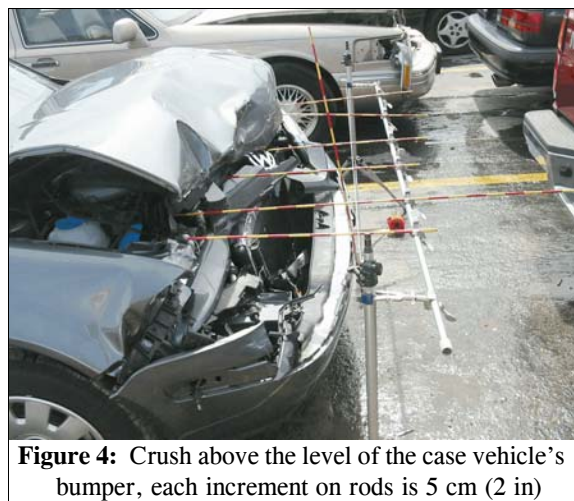
Exterior Damage: The case vehicle’s impact with the back of the Chevrolet involved the front bumper, grille, hood, right fender and the right headlamp/turn signal assembly. The grille, hood and right fender were crushed rearward. Direct damage began at the right corner of the front bumper and extended 83 centimeters (32.7 inches) along the bumper. Crush measurements were taken at the bumper and above bumper levels. There was no crush at the bumper level. Crush above the bumper level was measured at the radiator frame. The maximum crush at this level was determined to be 24 centimeters (9.4 inches) occurring at C₅ (Figure 4). The table below shows the average of the bumper and above bumper crush.

Figure 4: Crush above the level of the case vehicle’s bumper, each increment on rods is 5 cm (2 in)

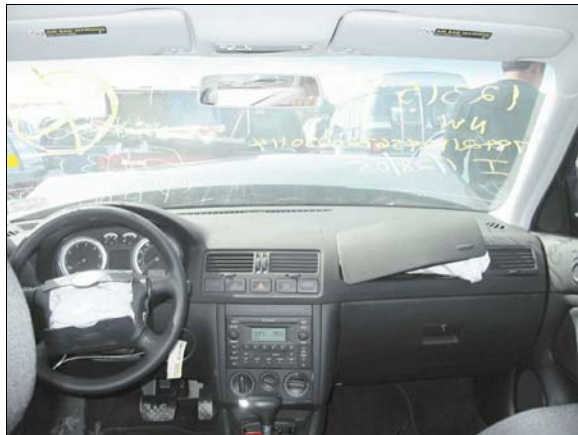
Vehicle Interior: Inspection of the case vehicle’s interior (**Figure 5**) revealed a possible occupant contact to the center portion of the driver’s air bag. No evidence of occupant contact was observed to any of the other interior surfaces or components. In addition, there was no evidence of compression of the energy absorbing steering column, and no deformation of the steering wheel rim was observed (**Figures 6**).

Figure 5: Overview of case vehicle’s steering wheel and instrument panel

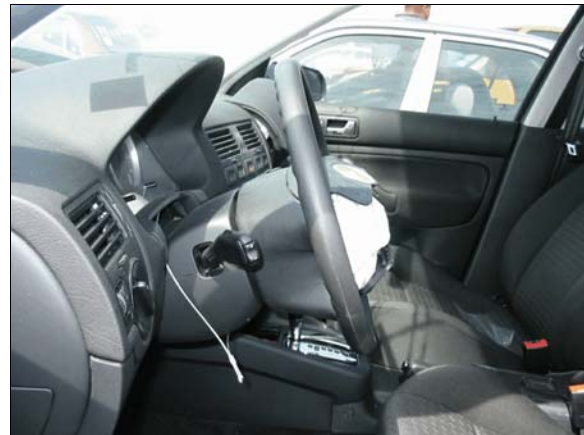
Figure 6: Left side view of case vehicle’s steering assembly showing lack of deformation

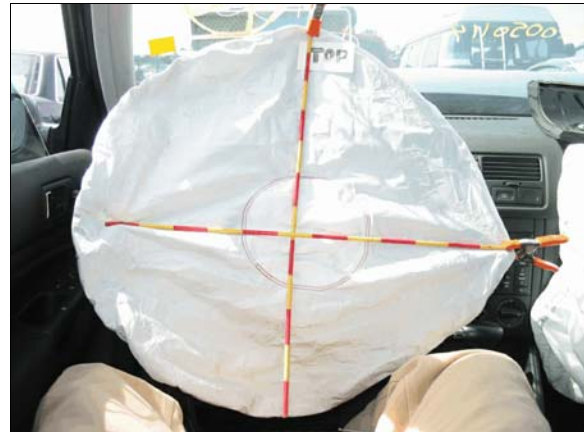
The case vehicle's driver air bag was located in the steering wheel hub. An inspection of the air bag module cover flaps and the air bag fabric revealed that the cover flaps opened at the designated tear points. There was no evidence of damage during the deployment to the air bag module cover flaps or the air bag. The deployed driver's air bag (**Figure 7** below) was round with a diameter of approximately 68 centimeters (26.8 inches), and the air bag was designed with four tether straps. The size of the tether straps could not be determined because there was no access to them, since the air bag was designed without vent ports. There were two air bag module cover flaps (**Figure 8** below). Each flap was approximately rectangular in shape. The upper flap was 17 centimeters (6.7 inches) in width and 5.5 centimeters (2.2 inches) in height. It had a small semi-circular contour at the center bottom of the flap to accommodate the "VW" emblem. The lower flap was also 17 centimeters (6.7 inches) in length, and was 6 centimeters (2.4 inches) in height. It had a corresponding semi-circular cut-out that mated to the "VW" emblem on the upper flap. A few small scuffs and a spot, which appeared to be possible occupant contact, were observed on the center portion of the air bag (**Figure 9**). The distance between the mid-center of the driver's seat back, as positioned at the time of the vehicle inspection (i.e., slightly reclined, seat at rear most track position) and the front surface of the air bag's fabric at approximate full excursion was 39 centimeters (15.4 inches).

Figure 7: Case vehicle's driver air bag

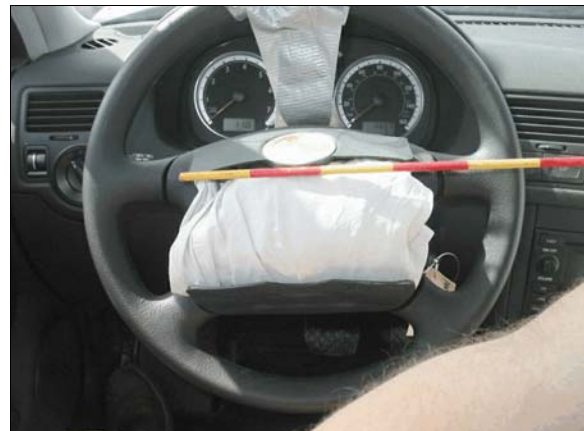
Figure 8: Case vehicle's driver air bag module flaps

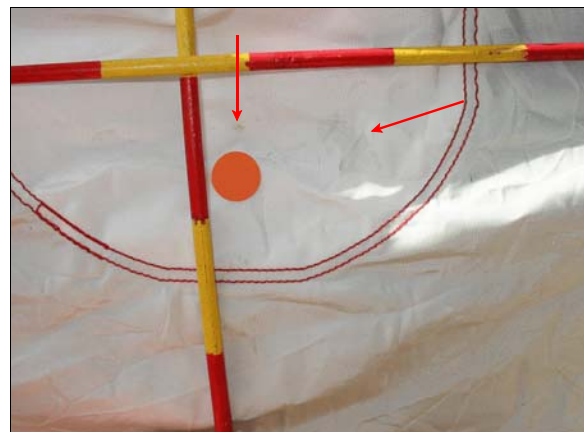
Figure 9: Close view of light scuffs and a small spot (arrows) on the driver's air bag indicating possible occupant contact

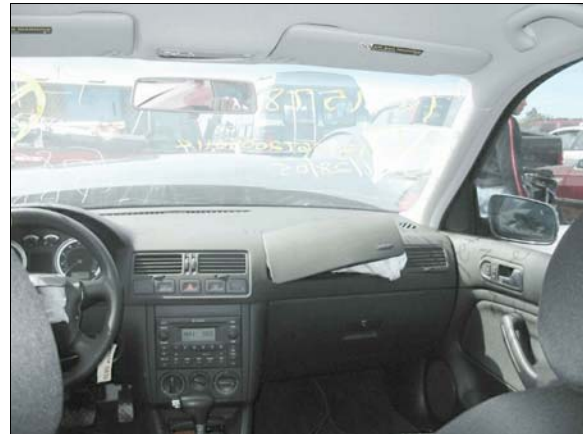
The front right passenger air bag was located in the middle of the instrument panel (**Figure 10** below). An inspection of the air bag module cover flap and air bag fabric revealed that the cover flap opened at the designated tear points. The deployed front right air bag (**Figure 11** below) was approximately oval in shape with a height of approximately 70 centimeters (27.6 inches) and a width of approximately 72 centimeters (28.3 inches). The front right passenger's air bag was designed with one tether that was 37 centimeters (14.6 inches) in width and had two

Figure 10: Overview of case vehicle's front right instrument panel and location of front right passenger air bag

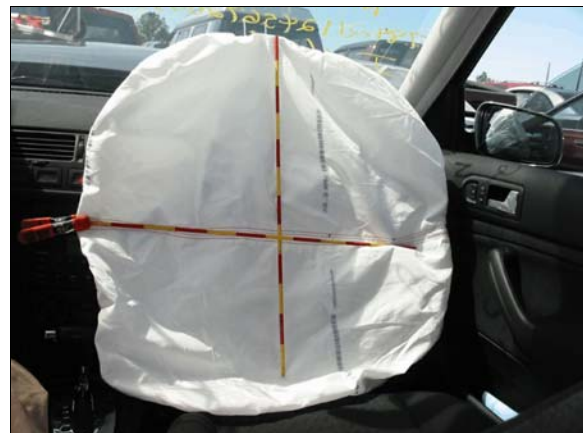
Figure 11: Case vehicle's front right passenger air bag

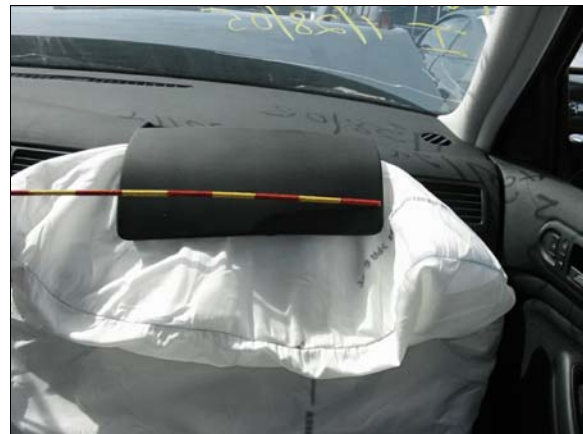
vent ports, each approximately 6 centimeters (2.4 inches) in diameter, located at the 3 and 9 o'clock positions. The single air bag module cover flap (**Figure 12**) was approximately rectangular in shape and was 31 centimeters (12.2 inches) in width at the top, 32 centimeters (12.4 inches) in width at the bottom and was 17 centimeters in height. The air bag was unremarkable. There was no occupant seated in the front right seat position at the time of the crash.

Figure 12: Case vehicle's front right passenger air bag cover flap
