Side Air Curtain Investigation / Vehicle Rollover
Dynamic Science, Inc. / Case Number: DS05014
2001 Volkswagen Jetta
Colorado
August 2005

14. Sponsoring Agency Code		
15. Supplemental Notes				
16. Abstract This on-site investigation focused on the performance of the Side Curtain Protection air bag system installed in a 2001 Volkswagen Jetta four-door sedan. The air bags extend from front pillar to the rear seat pillar. The 2001 Volkswagen Jetta GL four-door sedan was being driven by a restrained 19-year-old male. The front right seat was occupied by a restrained 20-year-old male. The second row right seat was occupied by an unrestrained 19-year-old male. The Jetta was traveling eastbound on an interstate roadway at an unknown speed. For unknown reasons, the Jetta drifted off the right side of the roadway. The driver corrected and steered back onto the roadway. The driver overcorrected to the right and the vehicle began a clockwise rotation. The vehicle left the roadway and began a lateral skid with the left side leading. The vehicle tripped at some point and overturned eight quarter turns before coming to rest on its wheels. During the rollover sequence the rear seat occupant was

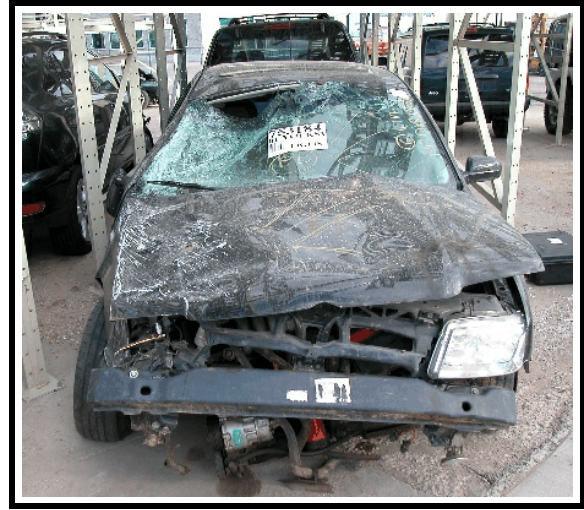
Figure 1. Case vehicle, 2001 Volkswagen Jetta

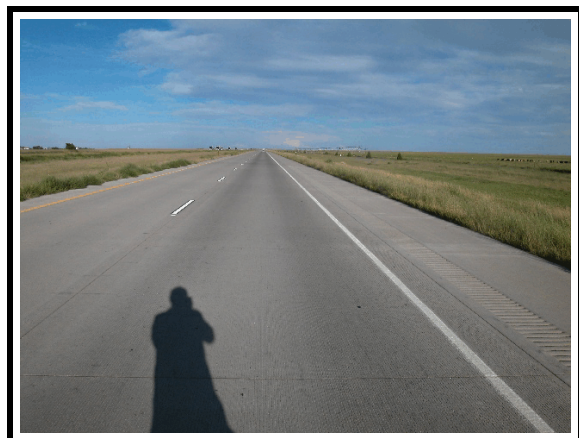
This single vehicle crash occurred on the roadside of a divided two-lane interstate highway. The asphalt roadway was straight and level. There were no roadway defects. The roadway is bordered on the right by a solid white line followed by a concrete shoulder that has a formed in rumble strip. A depressed, grass covered median separates the eastbound and westbound lanes. South of the roadway there is a slight inclined, grass covered embankment. The speed limit is 121 km/h (75 mph).

Figure 2. Overview of vehicle travel path—looking east

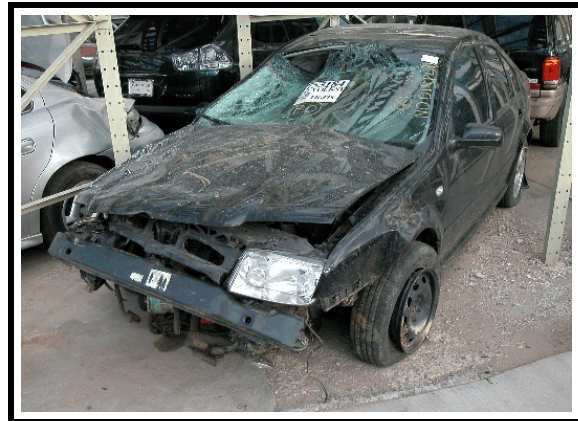
Damage Description: The 2001 Volkswagen Jetta sustained moderate rollover damage to the left side, right side and top of the vehicle. There was direct contact to the hood, windshield, roof, right quarter panel and left quarter panel. There was 5.0 cm (1.9 in) crush at the right A pillar. The front bumper fascia had come off and the bumper backing bar was rotated upward. Both front tires were flattened. Grass was found in the bead of the left rear tire.

Figure 3. Front left, 2001 Volkswagen Jetta

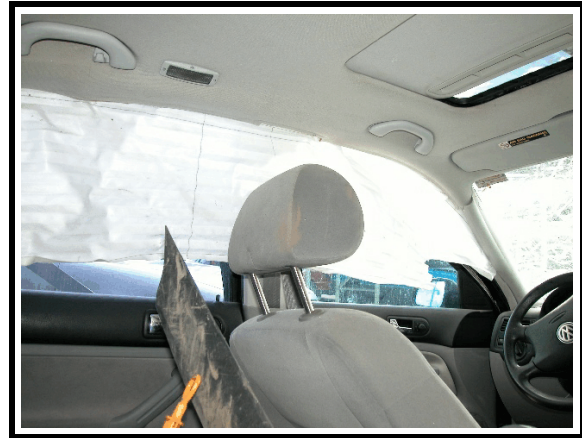
The Jetta was also equipped with side impact head protection air curtains for the front and rear seat positions and side torso protection air bags for the front seat positions. Both the side air curtains and side air bags deployed during the rollover sequence. The side air curtains deployed from the roof rail cladding and extended from the A pillar to the C pillar. The curtain was 185.0 cm (72.8 in) long and measured 33.0 cm (12.9 in) high at its highest point. There were three stitches at the top of the curtain that ran its entire length. There were a total 21 folds at the highest point.

Figure 4. Driver's side air curtain

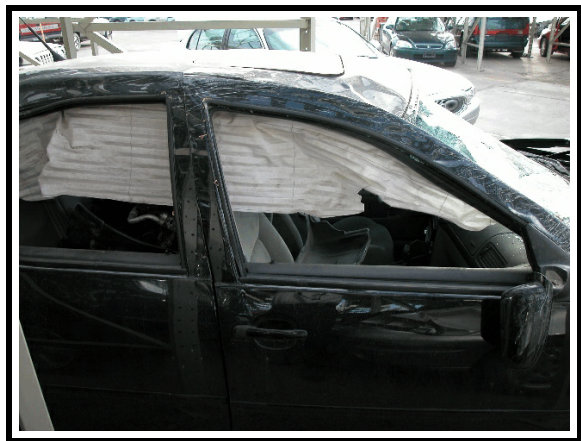
The side air bags were mounted in the respective front seat backs. The air bags measured 27.0 cm (10.6 in) forward from the seat back and were 55.0 cm (21.6 in) in height. There was no damage to either the curtains or the air bags.

Figure 5. Exterior view, right side air curtain for front and rear seats

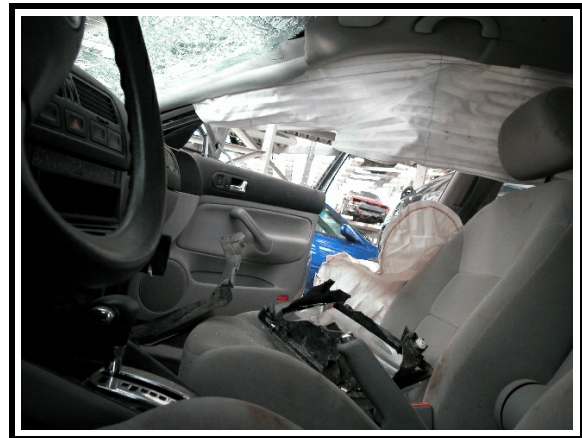
Figure 6. Front right occupant's side air curtain and side air bag

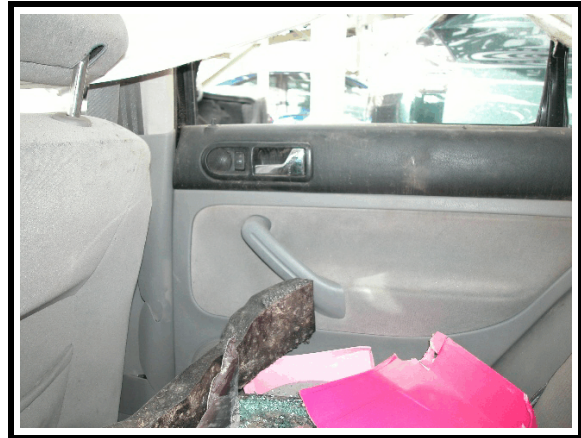
The 2001 Volkswagen Jetta sustained moderate interior damage as a result of passenger compartment intrusion and occupant contacts. The right side A pillar, roof, and windshield header sustained vertical intrusion. The windshield was broken and holed. The right side windows were all disintegrated. The center console was dislodged by occupant contact. The control stalk on the right side of the steering wheel was broken off. The right rear door/window frame was deformed outward due to occupant ejection.

Figure 7. Right rear door, interior view

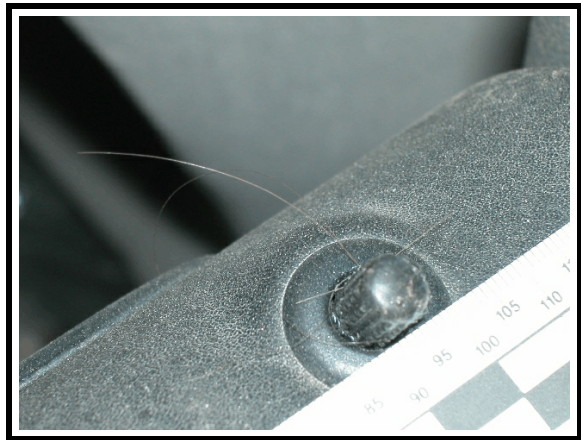
Figure 8. Hair trapped in door lock

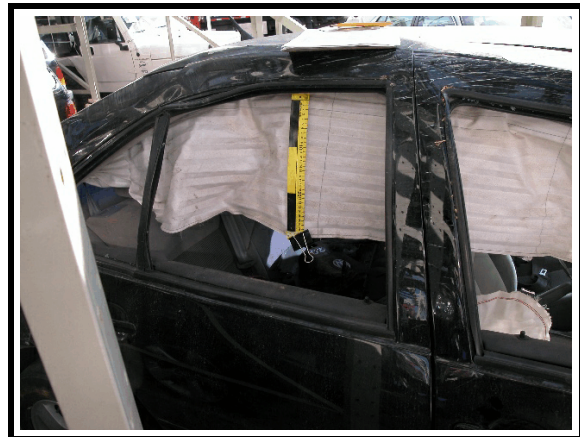
Figure 9. Exterior view of right rear door

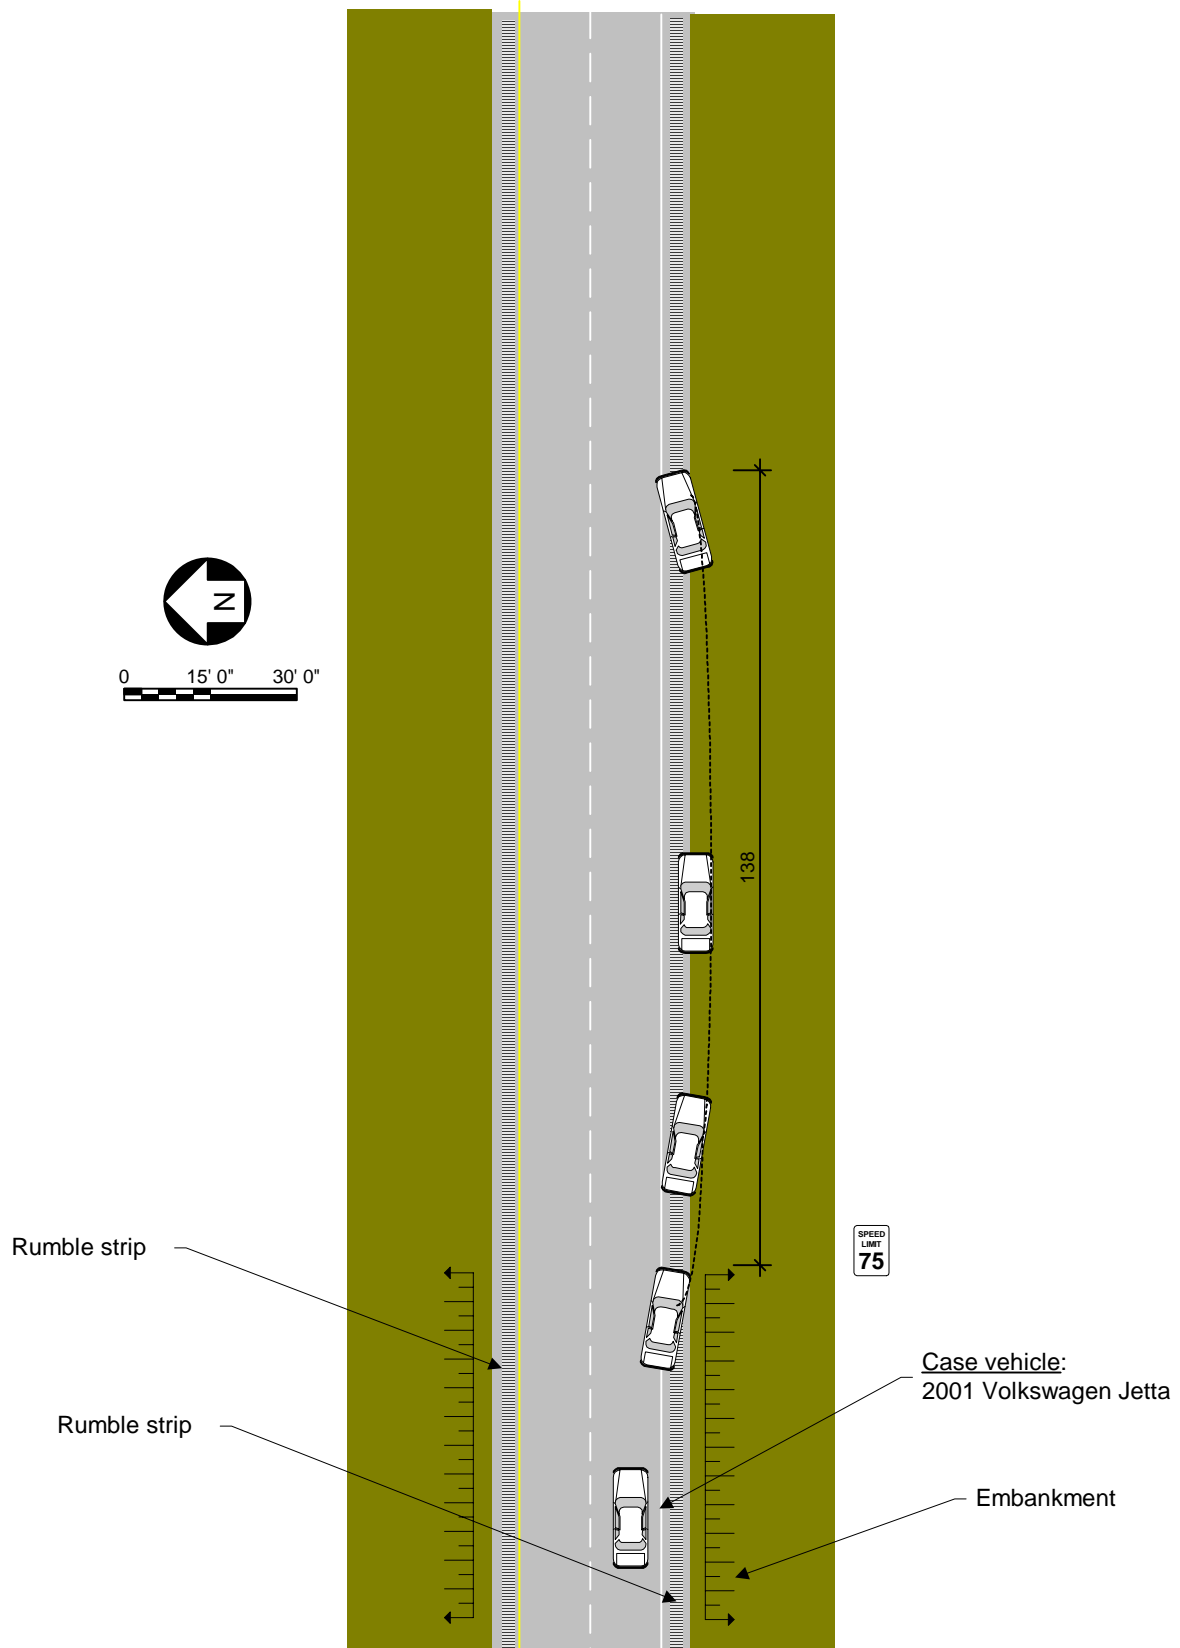
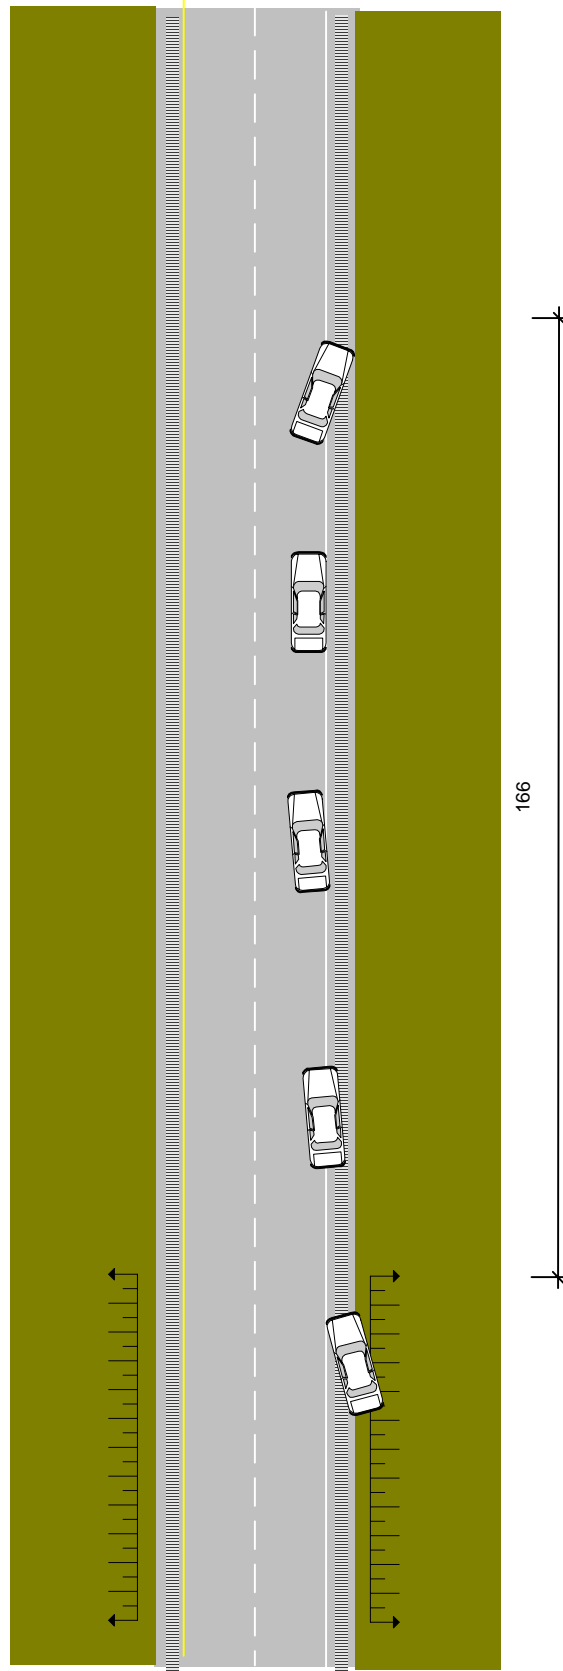
Attachment 1. Scene Diagram

The vehicle traveled 42 m (138 ft) before the driver corrected and steered back onto the roadway. The vehicle then traveled 51 m (166 ft) as the driver overcorrected to the right and the vehicle began a clockwise rotation. The vehicle left the roadway and began a lateral skid with the left side leading—leaving a 26 m (85 ft) furrow. The vehicle tripped at some point and overturned eight quarter turns while traveling 35 m (115 ft) in a southwest direction off the roadway (CDC=00TDDO2). During the rollover sequence, the rear seat occupant was ejected. Both front, seat-back mounted side air bags and both roof-rail mounted side air curtains deployed at this time. Both front seat belt pretensioners actuated during the rollover sequence. The frontal air bags did not deploy. The vehicle then came to rest facing west on its wheels.
