**CALSPAN ON-SITE CERTIFIED ADVANCED 208-COMPLIANT
VEHICLE CRASH INVESTIGATION**

SCI CASE NO: CA05-019

**VEHICLE: 2005 FORD FOCUS
LOCATION: KENTUCKY
CRASH DATE: JANUARY 2005**

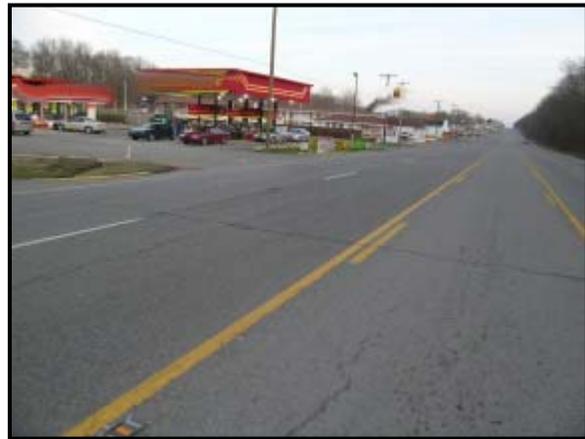
Figure 2: Southbound trajectory view of the Ford.

This two vehicle crash occurred during the nighttime hours in January, 2005. At the time of the crash, it was dark without overhead street lighting. The weather was cloudy and the asphalt road surface was wet. This opposite direction crash occurred on a five lane north/south road in a commercial setting. The 18 m (60 ft) wide straight and level road was configured with two lanes in each respective direction and a center turn lane. The travel lanes were bordered by 3 m (6 ft) wide shoulders and delineated by white edge lines. A service station/convenience store was located on the east side of the road. There were two entrance/exit driveways that led into the parking area surrounding the fuel island. The crash occurred in the outboard northbound lane at the mouth of the north-most entrance to the service station. The speed limit in the area of the crash was 89 km/h (55 mph). **Figure 2** is a southbound trajectory view of the Ford. The point of impact and final rest locations of the vehicles were not documented by the police investigation. There was no documented physical evidence at the scene that supported pre-crash maneuvers by either vehicle.

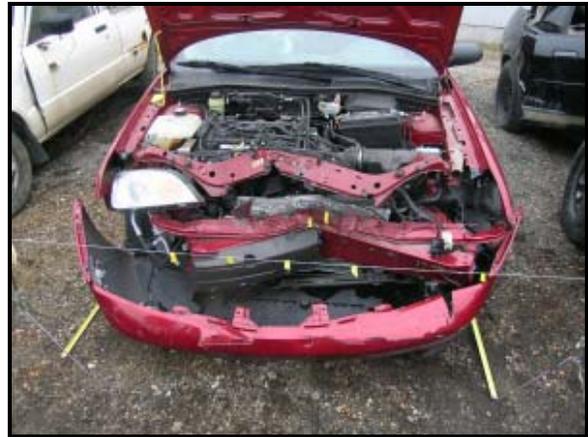
Figure 3: Front view of the Ford.

The exterior damage to the Ford Focus consisted of direct contact damage to the vehicle's front plane that extended across its entire 127 cm (50 in) front end width, **Figure 3**. The left corner of the Pontiac contacted the center aspect of the bumper deforming the bumper reinforcement rearward into a "V" pattern. The reinforcement bar crushed rearward into the air conditioner condenser and radiator. The bumper fascia fractured and separated across the width of the bumper reinforcement. The impact force deformed the left front fender rearward and outboard. There was direct contact to the leading edge of the hood that extended 8 cm (3 in) rearward. The residual crush profile measured along the bumper reinforcement was as follows:

C1 = 1 cm (0.4 in), C2 = 15 cm (5.9 in), C3 = 31 cm (12.2 in), C4 = 31 cm (12.2 in), C5 = 16 cm (6.3 in), C6 = 1 cm (0.4 in). The maximum crush was located 3 cm (1.2 in) right of the vehicle's

centerline and measured 36 cm (14.2 in). The left wheelbase dimension was reduced 3 cm (1.1 in). The right wheelbase was reduced 2 cm (0.6 in). All the doors remained closed throughout the crash and were operational during the post-crash inspection. The right aspect of the windshield was fractured by the deploying front right passenger air bag. The Collision Deformation Classification (CDC) of the front impact was 01-FDEW2.

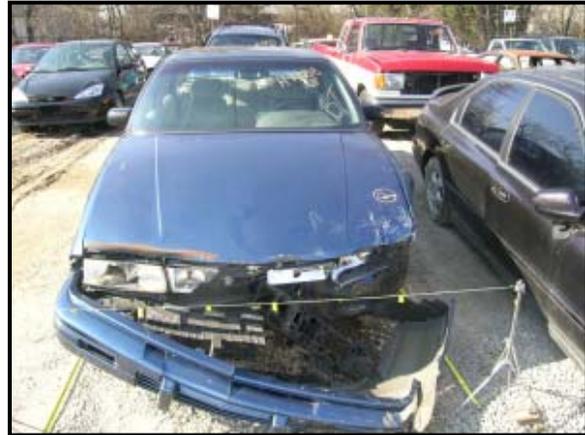
Figure 4: Front view of the Pontiac.

Figure 4 is a front view of the damaged Pontiac. The vehicle sustained direct contact and induced damage that extended across the entire 147 cm (58 in) front end width. The direct contact damage at the bumper elevation began 37 cm (14.5 in) right of center and extended 110 cm (43.5 in) to the left front corner. The bumper fascia was fractured at its centerline and had separated at the left side. The leading edge of the hood sustained direct contact damage that began at its centerline and extended to its left corner. The damage profile was biased to the left indicative of the angular impact configuration.

The residual crush profile measured along the bumper reinforcement was as follows: C1 = 12 cm (4.7 in), C2 = 28 cm (11.0.in), C3 = 24 cm (9.4 in), C4 = 16 cm (6.3 in), C5 = 5 cm (2.0 in), C6 = 0 cm (0 in). The left wheelbase dimension was reduced 2 cm (0.7 in). The right wheelbase was unchanged. The left front fender crushed rearward and jammed the left front door closed. All the other doors remained closed during the impact and were operational post-crash. The windshield was intact and there was no damage to the side windows. The CDC of the front impact was 12-FDEW1.

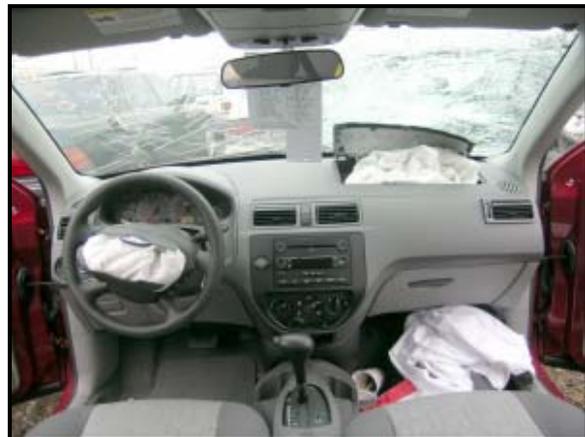
Figure 5: Front interior view.

Figure 5 is a view of the front interior of the Ford Focus. The interior damage to the Ford was limited to the deployment of the vehicle's safety systems. The occupant compartment remained intact and there was no reduction in occupant space. There were no identified occupant contacts to the hard structures of the interior.

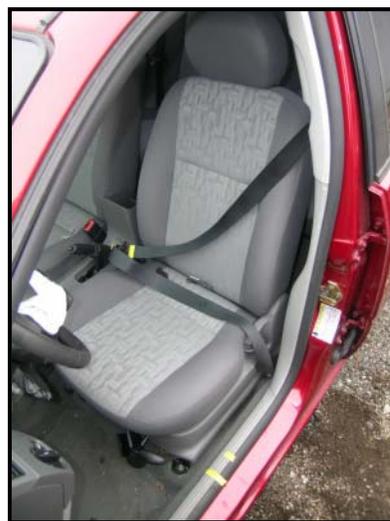
Figure 6: Driver's position and the manual restraint.

The manual restraint systems in the Ford Focus consisted of three-point lap and shoulder belts in all five seat positions. The driver's restraint, **Figure 6**, consisted of continuous loop webbing, sliding latch plate, adjustable D-ring and a dual mode Emergency Locking Retractor (ELR) located in the base of the B-pillar. The retractor was equipped with a pretensioner that fired as a result of the impact. The webbing was locked in the worn position. The extended length of the webbing measured 177 cm (69.8 in). Examination of the webbing revealed it was creased and abraded in the area of the buckled latch plate. The creased webbing section measured 6 cm (2.3 in) in length and began 96 cm (37.8 in) above the outboard floor anchor. Examination of the latch plate revealed a corresponding minor abrasion to the friction surface of the hardware. There was minor evidence of historical use. The adjustable D-ring was in the full down position. The D-ring's friction surface did not reveal any evidence of loading. The evidence observed during the SCI inspection indicated the driver was restrained at the time of the crash.

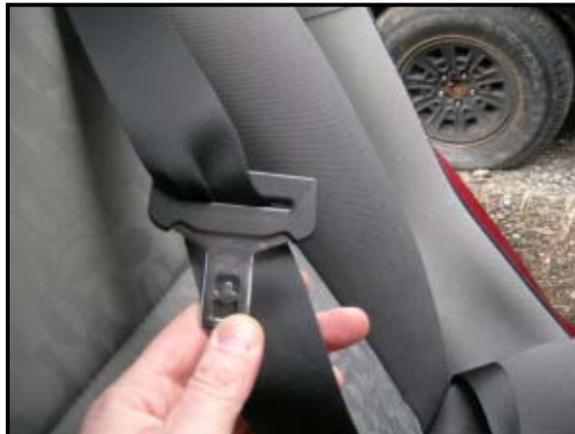
The left rear manual restraint consisted of continuous loop webbing, a sliding latch plate and a switchable ALR/ELR attached to the left C-pillar. The webbing extended through a guide in the C-pillar trim. Upon initial inspection, the webbing was extended from the retractor and the latch plate was inserted into the buckle. Examination of the restraint revealed the webbing was gathered and trapped in the latch plate, **Figure 7**. The latch plate was located 89 cm (35 in) from the anchor and could not be moved along the webbing. The gathered condition of the webbing was an indicator that the restraint was in use at the time of the crash. As the occupant

Figure 7: Left rear restraint webbing gathered in the latch plate.

loaded the webbing during the ride down of the crash, the webbing gathered in the corner of the latch plate hardware and became trapped. The latch plate revealed minor evidence of historical use.

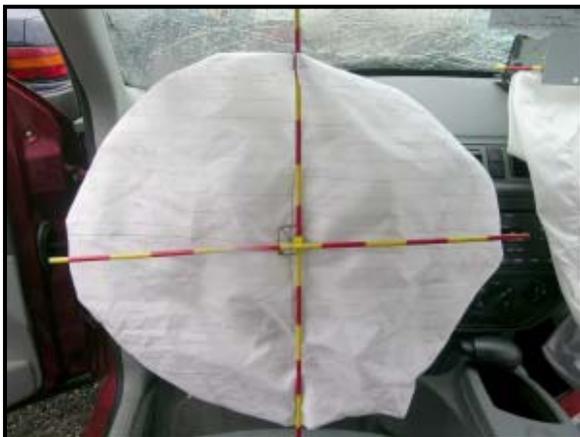
Figure 8: Deployed driver air bag.

The driver and front right passenger air bags deployed as a result of the frontal crash, **Figures 8 and 9**. The driver air bag deployed from an H-configuration module that was located in the center hub of the steering wheel rim. The width of the asymmetrical upper and lower flaps measured 18 cm (7 in), The height of the upper and lower flaps measured 5 cm (2 in) and 8 cm (3.2 in), respectively. The flaps opened at the designed tear seams during the deployment sequence and were free from occupant contact. The deployed driver air bag measured 56 cm (22 in) in diameter. The bag was not internally tethered. A series of broken red stitching was observed across the face of the bag. This stitching was probably used to package the bag and also to control the path of the air bag during deployment. The air bag was vented by semi-circular “fish gill” vents located in the 10 and 2 o’clock sectors. The diameter and height of each vent measured 3 cm (1 in) and 1 cm (0.5 in), respectively. There was no residual evidence of occupant contact to the face of the bag. The following manufacture’s nomenclature identified the driver air bag:

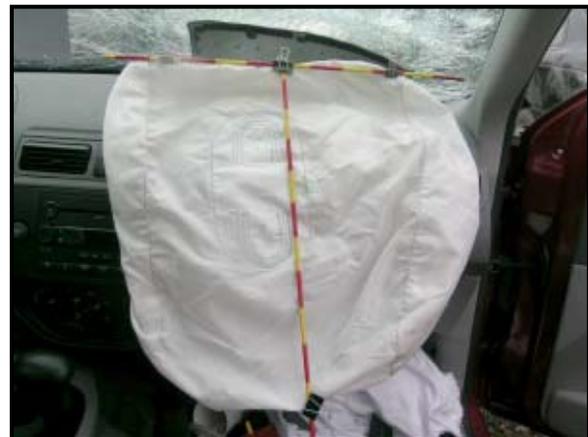
Figure 9: Deployed front passenger air bag.

The front right passenger air bag was a top mount design located in the right aspect of the instrument panel. The module was a rectangular design. The cover flap measured 42 cm x 20 cm (16.5 in x 8 in), width by height. The flap was constructed of sheet vinyl and had a sheet metal backer that deformed forming a hinge during the deployment sequence. The cover flap contacted and fractured the windshield during its rotation at deployment. The deflated passenger air bag measured 43 cm x 57 cm (17 in x 22.5 in). The excursion of the face of the bag measured 43 cm (17 in) from the edge of the module. The air bag was vented by two 3 cm (1 in) diameter ports on the bag’s side panels. It was tethered by a single 9 cm (3.5 in) wide internal strap. The tether strap was sewn to face of the bag and reinforced by a 25 cm x 14 cm (10 in x 5.5 in) elliptical stitch pattern. The elliptical stitch pattern was positioned 5cm (2 in) off-center to the left. There was no residual evidence of occupant contact to the air bag.

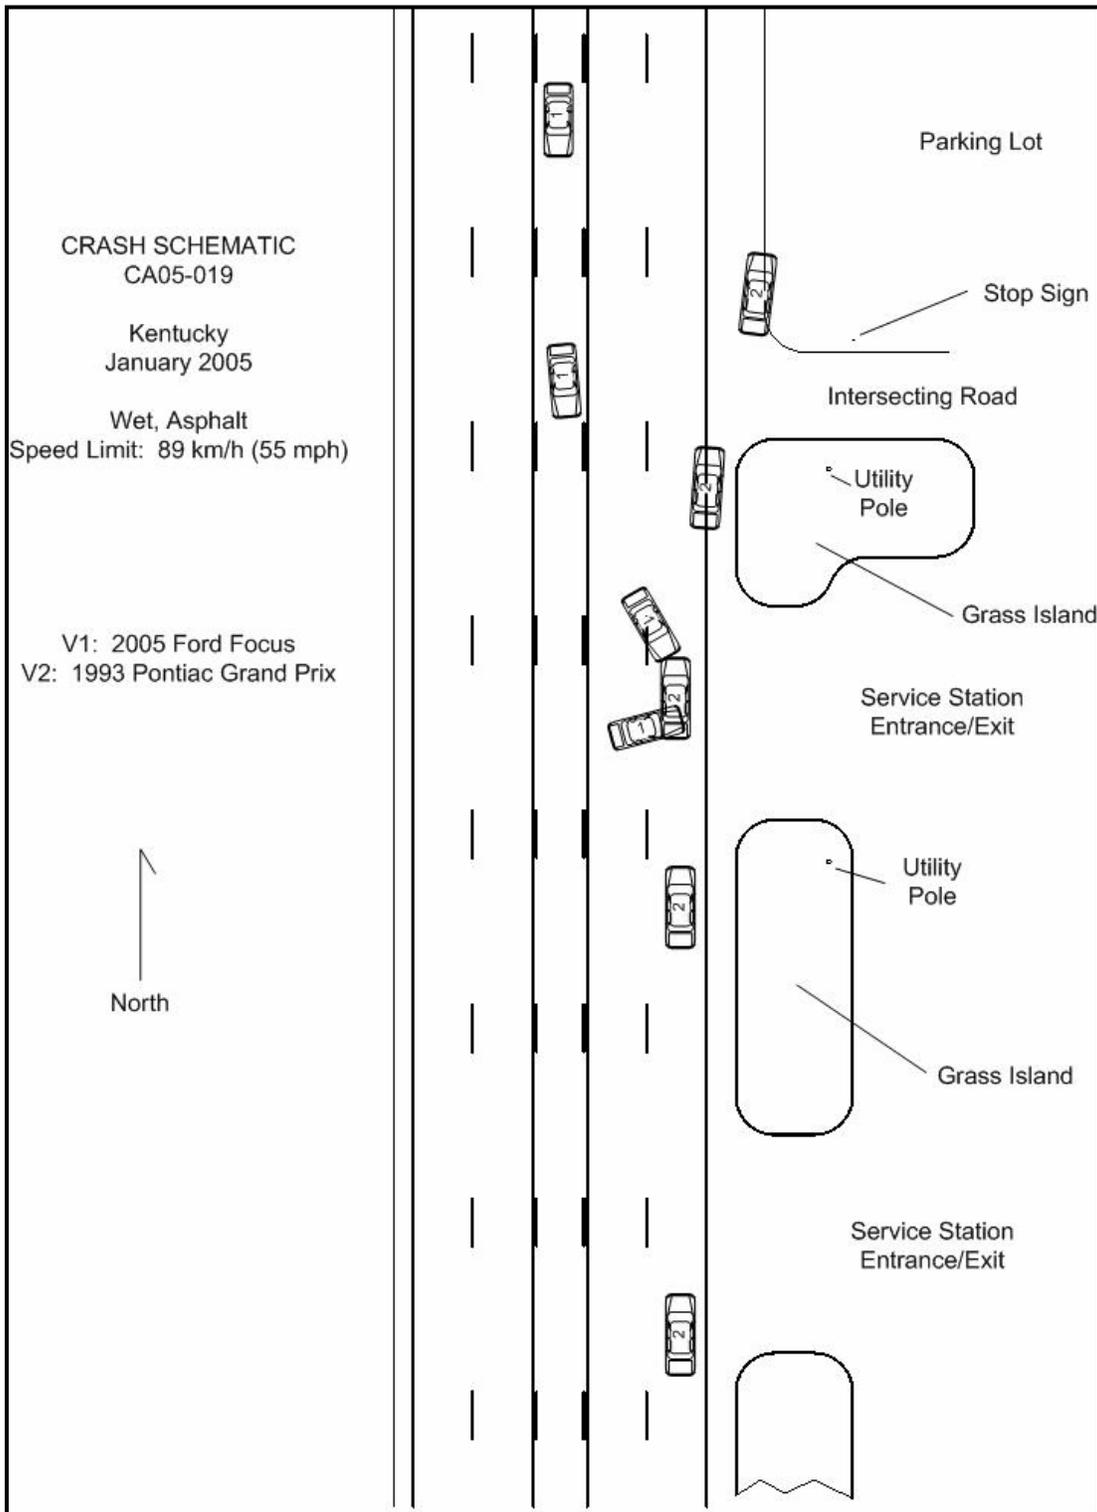
Figure 10: Crash Schematic.

The 2005 Ford Focus was southbound in the center turn lane of the road intending to turn left into a service station. The vehicle was driven by a 63 year old restrained male. Additionally, the Ford was occupied by a 35 year old unrestrained female front right passenger, an 11 year old restrained female left rear passenger, and a 9 year old restrained male right rear passenger. The 1993 Pontiac Grand Prix was northbound in the outboard (right) lane of the road. The Pontiac was driven by a restrained 21 year old female. For unknown reasons, the driver of the Ford failed to yield the right-of-way and initiated a left turn directly across the path of the Pontiac. It was the Ford driver’s intention to enter the parking lot of the service station. A schematic of the crash is attached to the end of this report as **Figure 10**.

The crash occurred with the front plane of the Pontiac impacting the front plane of the Ford in an angled head-on impact configuration. The directions of force were in 12/1 o'clock sectors for the Pontiac and Ford, respectively. The force of the impact resulted in the deployment of the advanced frontal air bags in the Ford. The angular impact configuration resulted in a counterclockwise rotation of the Focus as it separated from the impact. The Ford came to rest straddling the northbound traffic lanes facing east. The precise final rest location of the Ford was unknown. The northbound momentum of the Pontiac caused the vehicle to drive through the impact. The vehicle came to a controlled rest facing north on the east road shoulder approximately 24 m (80 ft) north of the impact. The Damage Algorithm of the WINSMASH model was used to calculate the severity (delta V) of the impact. The total delta V of the Ford was 24 km/h (14.9 mph). The longitudinal and lateral components of delta V were -21 km/h (-13.0 mph) and -12 km/h (-7.5 mph), respectively. The total delta V of the Pontiac was 22 km/h (13.7 mph). The longitudinal and lateral components were -22 km/h (-13.7 mph) and 0, respectively.
