Side Curtain and Side Air Bag Investigation/Vehicle to Vehicle
Dynamic Science, Inc./Case Number: DS05024
2005 Acura MDX
Washington
October 2005

1. Report No. DS05024	2. Government Accession No.		3. Recipient Catalog No.	
4. Title and Subtitle Side Curtain and Side Air Bag Investigation		5. Report Date July 5, 2006

This on-site investigation focused on the performance of the side curtain and side air bag systems in a 2005 Acura MDX.

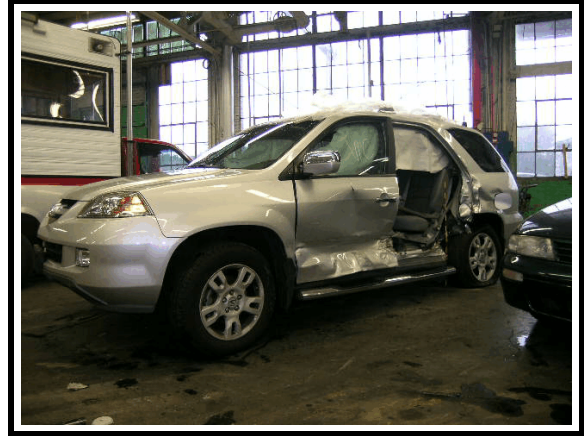
Figure 1. Left side impact damage - 2005 Acura MDX

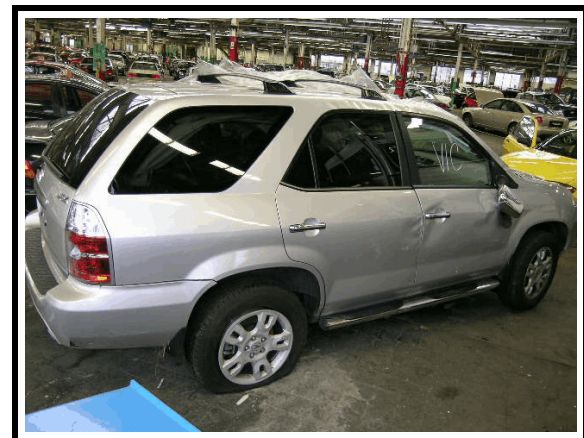
Figure 2. Right side rollover damage - 2005 Acura MDX

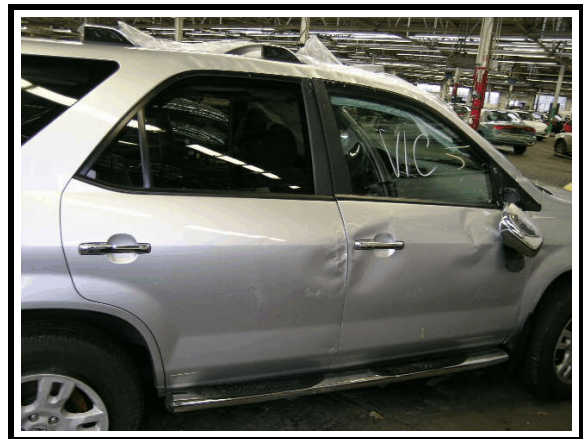
Figure 6. Right side rollover damage - 2005 Acura MDX

The case vehicle also sustained moderate left side damage as a result of the rollover event. The Acura sustained 2.0 cm (0.8 in) of lateral crush at the max crush location, 52.0 cm (20.5 in) aft of the right front axle. There was no vertical crush as a result of the rollover event.

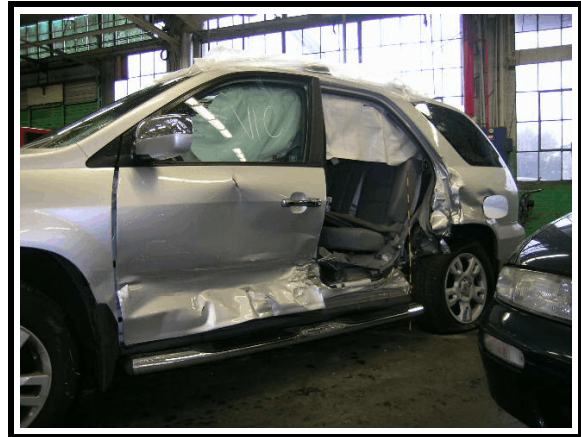
The 2005 Acura MDX sustained moderate left side damage as a result of the impact with the Toyota Camry. The Acura sustained 252.0 cm (99.2 in) of direct damage along the left side beginning 37.0 cm (14.6 in) aft of the left front axle, extending rearward. According to the police report, the force of this impact “partially tore off” the left rear door. At the vehicle inspection, the left rear door was found completely separated from the vehicle, laying in the rear cargo area. It appears that the door striker had been cut, possibly so the door panel could be stowed in the cargo area. It is possible that the Toyota Camry’s right front bumper corner snagged on the Acura, causing the left rear door to partially tear off at the hinge area. A crush profile could not be obtained because the area of max crush was to the lower door area and could not be documented on the damaged left rear door due to the separation and damage to the door itself. There was virtually no crush to the sill.

Figure 7. Left side - 2005 Acura MDX

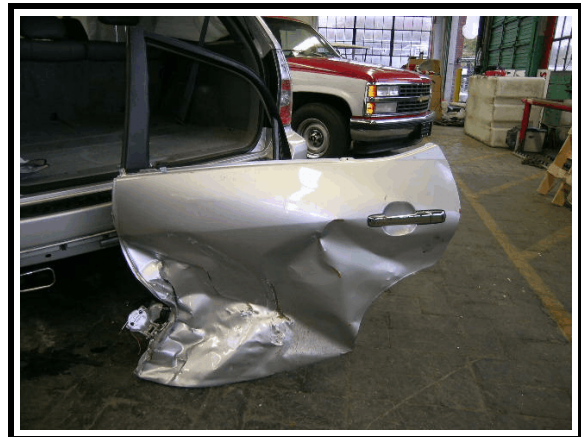
Figure 8. Left rear door damage - 2005 Acura MDX

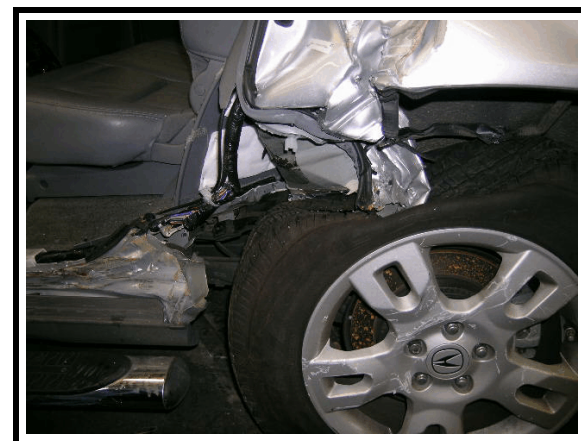
Figure 9. Damage to left rear door, snagged sheet metal damage intruding into the left rear tire area

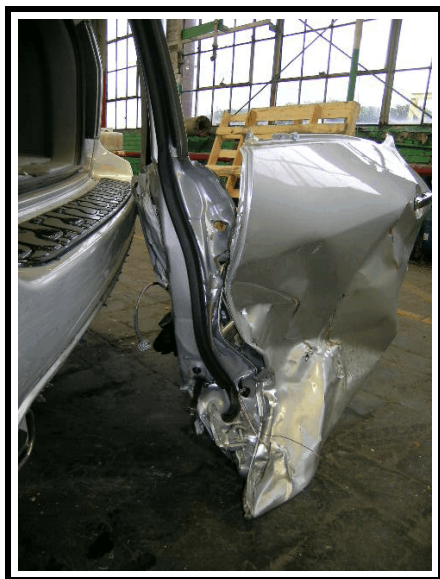
Figure 11. Left rear door, lower hinge still attached

There was integrity loss at the left rear door area. The upper door hinge was found still attached but damaged. The lower hinge was separated from the frame, but still attached to the left rear door panel. The striker area was damaged and the striker was also separated from the vehicle and was found in the door latch. It appears the striker was cut and did not shear due to damage forces.

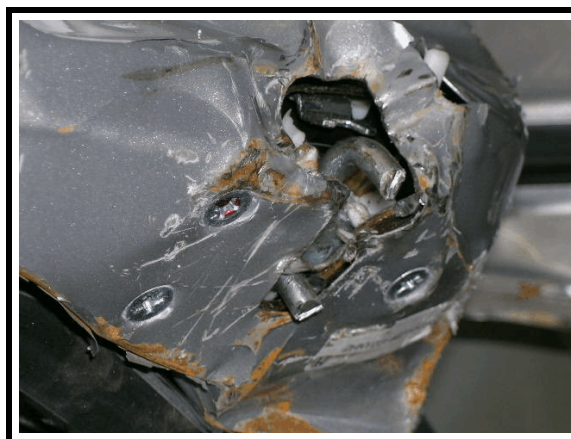
Figure 10. Close-up of left rear door striker, still in latch

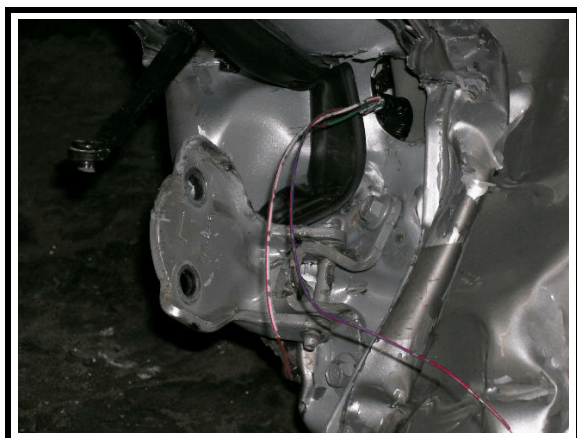
Figure 12. Closeup of left rear lower door hinge

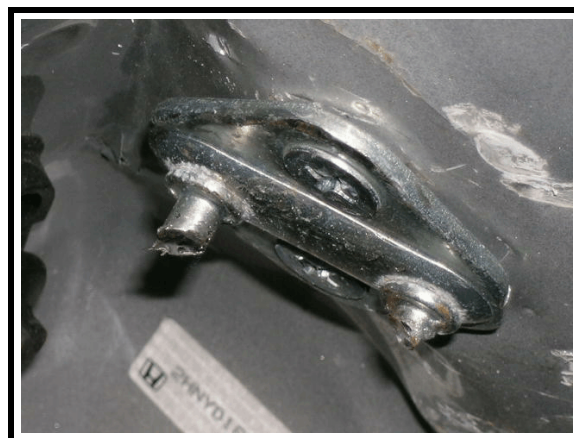
Figure 13. Close-up of left rear door striker attachment area

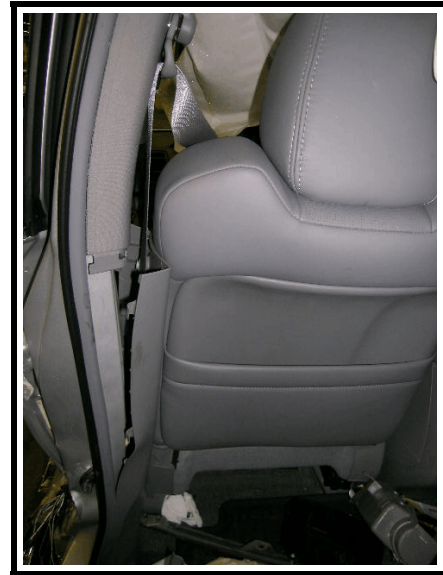
Figure 14. Left B pillar and cover intrusion

There was lateral intrusion into the driver's area and in the second row left seating area. The left B-pillar intruded laterally into the left front and left rear seating positions, but the B pillar's plastic cover intruded an additional 3.0 cm (1.2 in) laterally into the left front and an additional 6.0 cm (2.4 in) laterally into the left rear area. The right front, right rear door and rear hatch remained closed and operational. The left front door was jammed shut post crash. According to the police report, the left rear door was partially torn off during the collision and at the inspection was found completely separated from the vehicle, laying in the rear cargo area. The windshield was cracked and in place post crash. The left rear glazing disintegrated, most likely due to the left side impact. The specific passenger compartment intrusions were documented as follows:

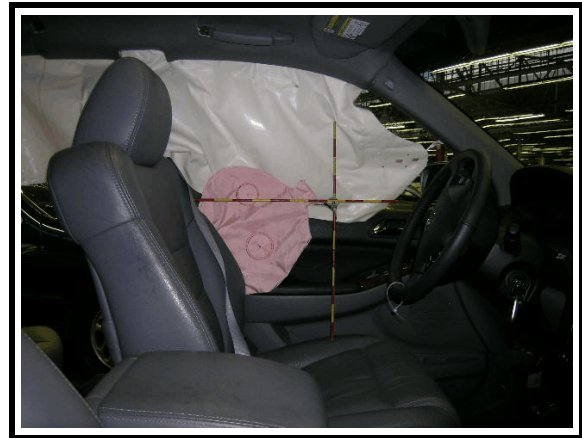
Figure 15. Driver's side air bag and side curtain

Both of the deployed seat mounted side air bags were semi-circular in shape with a height of 30.0 cm (11.8 in) and an excursion of 33.0 cm (13.0 in) in their deflated state. They each had one internal tether and one vent port. The vent port consisted of an opening located at the 2 o'clock position as viewed from the right side of the bag. On the driver's side air bag, there were two circular stitched areas located at the 11 and 5 o'clock positions as viewed from the right. Although there was some lateral intrusion of the B pillar and its plastic cover, it appears that the driver's side air bag deployed properly.

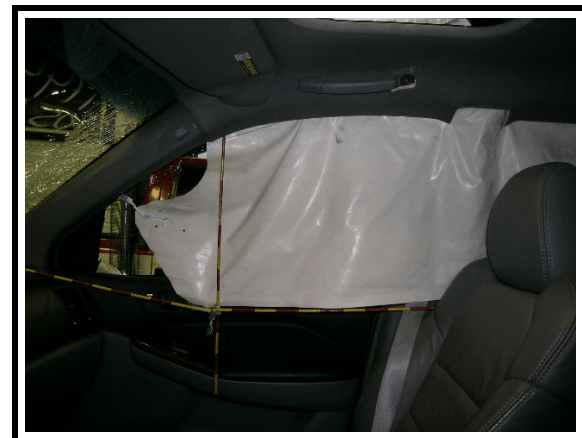
Figure 16. Right front section of the deployed right side curtain

The deployed left and right side curtain air bags extended from the A pillars to the D pillars. There was a small coverage gap present at both A pillars. The side curtains were rectangular in shape and in their deflated state, measured 253.0 cm (99.6 in) in length. The height of both side curtains was 38.0 cm (15.0 in). The curtains had two external tethers, located at the A and D pillars. The side curtains deployed from the roof side rails. There were no visible signs of occupant contact to the side curtains. Both curtains had a few deployment streaks and were slightly dirty.

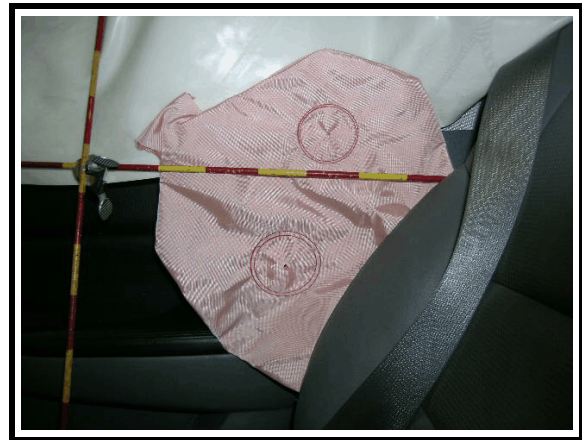
Figure 17. Right front deployed side air bag

On the front passenger's side air bag, the two circular stitched areas were located at the 11 and 5 o'clock positions as viewed from the left side of the bag. The vent port opening was located at the 10 o'clock position as viewed from the left. There were no visible signs of occupant contact or damage to either side air bag.

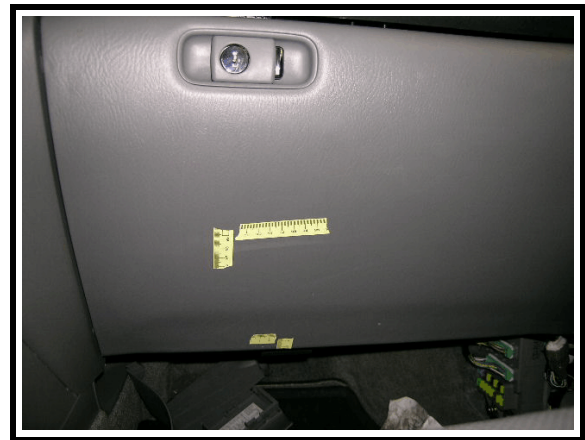
There were scuffs to the shoulder portions of the driver and front right passenger seat belts due to the actuation of the B pillar pretensioners. Both belts were found to be locked in place post crash. There were signs of occupant contact to the glove compartment door, possibly from the passenger's lower left leg.

Figure 19. Glove compartment door, front right occupant contact points
