**CALSPAN ON-SITE CERTIFIED ADVANCED 208-COMPLIANT VEHICLE  
CRASH INVESTIGATION**

**CALSPAN CASE NO: CA05-026**

**VEHICLE: 2005 NISSAN PATHFINDER**

**CRASH DATE: MARCH 2005**

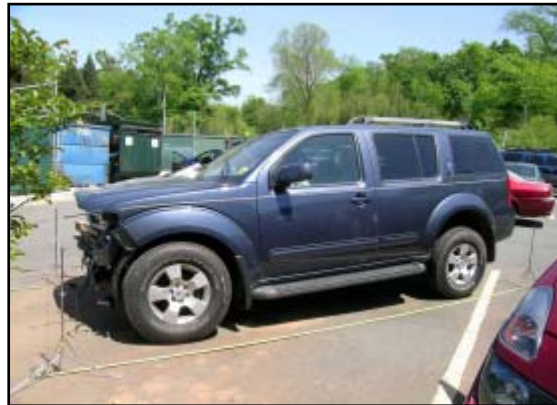
**Figure 1. Subject vehicle 2005 Nissan Pathfinder.**

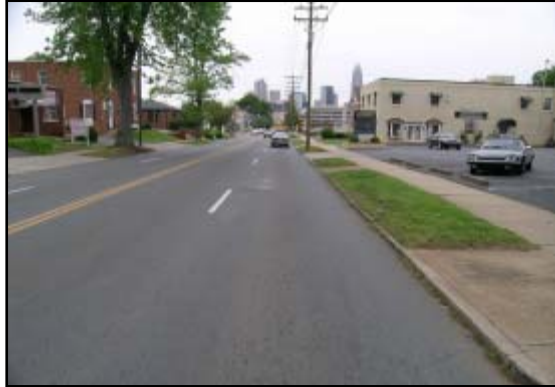
The restrained 31-year-old male was operating the 2005 Nissan Pathfinder. The driver had left a local hospital where he received a steroid injection. As he exited the parking lot and traveled eastbound (**Figure 2**) on the four-lane roadway he apparently blacked out due to a reaction to the injection. The driver stated to the SCI investigator that he suspected that his foot probably slid from the brake pedal onto the gas pedal causing the vehicle to accelerate and depart the roadway.

**Figure 2. Nissan's eastbound travel.**

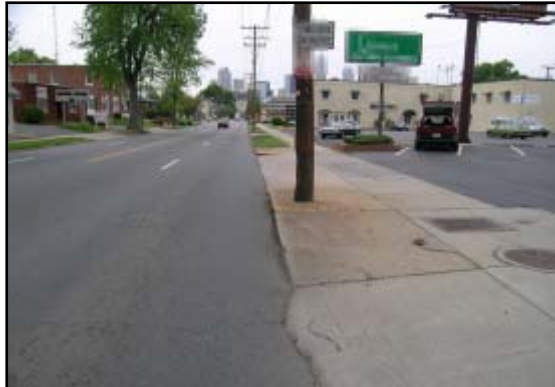
The front right corner area of the Nissan impacted a wooden utility pole (**Figure 3**). This impact configuration resulted in a damage pattern, which included the front, right side, and the right front tire and wheel. Due to the corner impact, the vehicle did not reach a common velocity. The damage also involved two planes and was outside the scope of the WINSMASH program.

**Figure 3. First utility pole impact.**

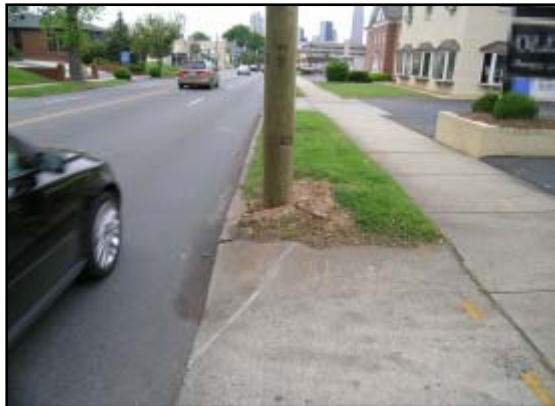
The Nissan continued its easterly trajectory and reentered the right eastbound lane and traveled approximately 33.0 meters (108.0 feet) where it departed the right roadside and impacted a second utility pole with the front center aspect (**Figure 4**). The second utility pole was located 42.3 meters (138.7 feet) east of the initial impact. A gouge mark that measured 4.4 meters (14.4 feet) was located prior to the second utility pole impact. The frontal components, which included the bumper cover, bumper beam, and the upper and lower radiator supports were removed by a repair facility to obtain a repair estimate. Therefore, a partial crush profile was obtained and used to calculate a delta V for this impact using the damage algorithm of the WINSMASH program. The total calculated delta V for this impact was 11.0 km/h (6.8 mph). The longitudinal

**Figure 4. Second utility pole impact.**

and lateral components were -11.0 km/h (-6.8 mph) and 0.0 km/h respectively. As a result of the crash, the driver's frontal air bag deployed and the front safety belt pretensioners fired. The EDR was capable of recording only one event; therefore, it was unknown which impact deployed the CAC system.

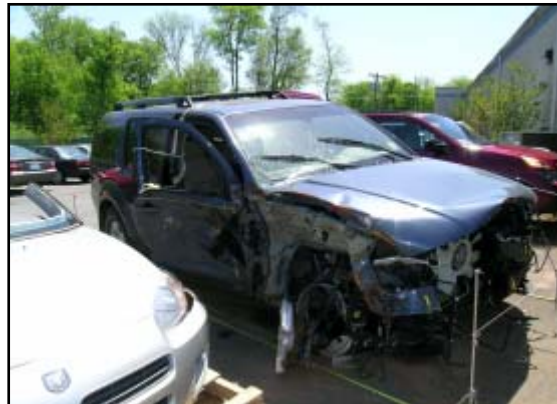
The 2005 Nissan Pathfinder sustained moderate damage to the front and right side planes as a result of the impact with the first utility pole (**Figure 5**). The direct contact damage measured 16.5 cm (6.5") and began 64.8 cm (25.5") right of the centerline and extended to the front right corner. The damage to the right side plane began at the front right corner and extended 217.2 cm (85.5") rearward, terminating 5.8 cm (2.3") forward of the right B-pillar. Additionally, the right front tire and wheel contacted the utility pole, which shattered the alloy wheel, fractured the brake rotor, steering spindle, outer tie rod, and separated the ball joint.

**Figure 5. Front and right damage from the first utility pole impact.**

Due to the corner damage pattern, a crush profile was not obtained for this impact. The Collision Deformation Classification (CDC) for this impact was 12-FREE-6.

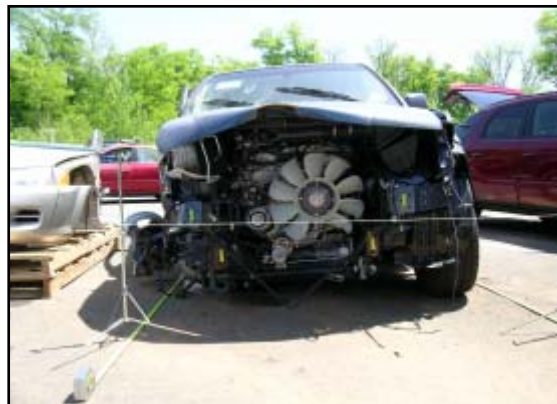
The Nissan sustained moderate center frontal damage as a result of the impact with the second utility pole (**Figure 6**). The bumper cover, bumper beam, and the upper and lower radiator supports were removed by the repair facility to complete a repair estimate; therefore the direct contact damage was obtained from the hood. The direct contact damage measured 19.1 cm (7.5") and began 5.1 cm (2.0") right of the centerline and extended to the right. Due to the removed frontal components, the crush was documented at the frame rails and the bumper mounts, which were deformed

**Figure 6. Frontal damage from the second utility pole impact.**

longitudinally and laterally as a result of the impact to the center of the frontal plane. The crush at the left frame rail measured 2.5 cm (1.0”) and the right frame rail was 5.1 cm (2.0”). The left bumper mount was deformed longitudinally to a depth of 4.6 cm (1.8”) and the right was 16.0 cm (6.3”). The CDC for this impact was 12-FCEN-1.

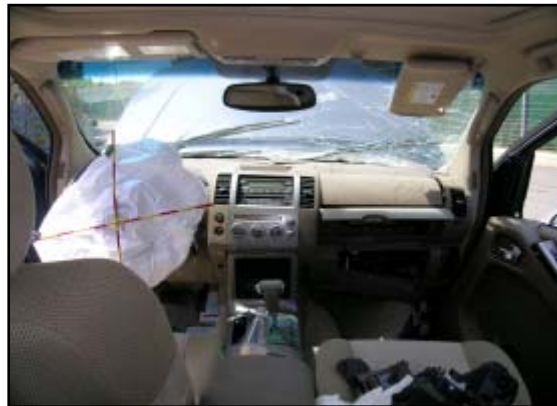
The 2005 Nissan Pathfinder sustained moderate damage as a result of passenger compartment intrusion. There were no occupant contacts present in the passenger compartment. **Figure 7** is an overall view of the forward aspect of the passenger compartment. The documented intrusions were as follows:

**Figure 7. Overall of the first of the passenger compartment.**

<b>Seat Position</b>	<b>Intruded Component</b>	<b>Magnitude</b>	<b>Direction</b>
Front Right	Instrument Panel	1.3 cm (0.5”)	Longitudinal
Front Right	Lower Instrument Panel	7.6 cm (3.0”)	Longitudinal
Front Right	Toe Pan	22.8 cm (9.0”)	Longitudinal
Front Right	Floor	2.5 cm (1.0”)	Vertical

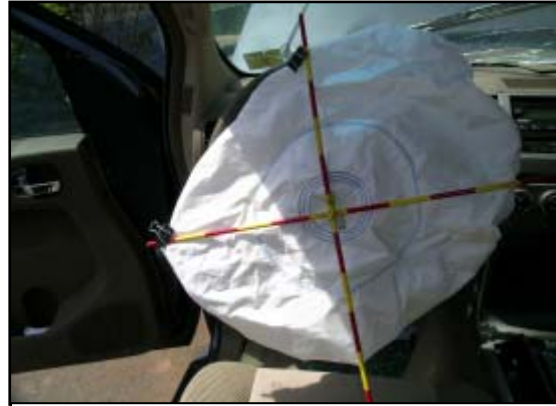
In the subject crash, the driver's frontal air bag deployed. The driver's air bag was conventionally located in the center of the steering wheel hub (**Figure 8**). Three cover flaps concealed the air bag. The top cover flap was semi-circle in shape and measured 6.8 cm (2.7") in height and 12.7 (5.0") in width. The lower cover flaps were symmetrical and measured 4.8 cm (1.9") in height and 6.4 cm (2.5") in width. The air bag membrane was 53.3 cm (21.0") in diameter in its deflated state and was vented by two 3.8 cm (1.5") diameter vent ports that were located on the rear aspect of the air bag at the 11 and 1 o'clock positions. The driver's air bag was vented by two vent ports and tethered by four 10.2 cm (4.0") wide band tethers at the 12 and 6 o'clock positions and the 9 and 3 o'clock positions. The maximum excursion of the driver's air bag was 22.9 cm (9.0") at the tether locations. There were no occupant contact points present on the air bag membrane. The following identifiers were stamped at the 12 o'clock position on the rear panel:

**Figure 8. Deployed driver's frontal air bag.**

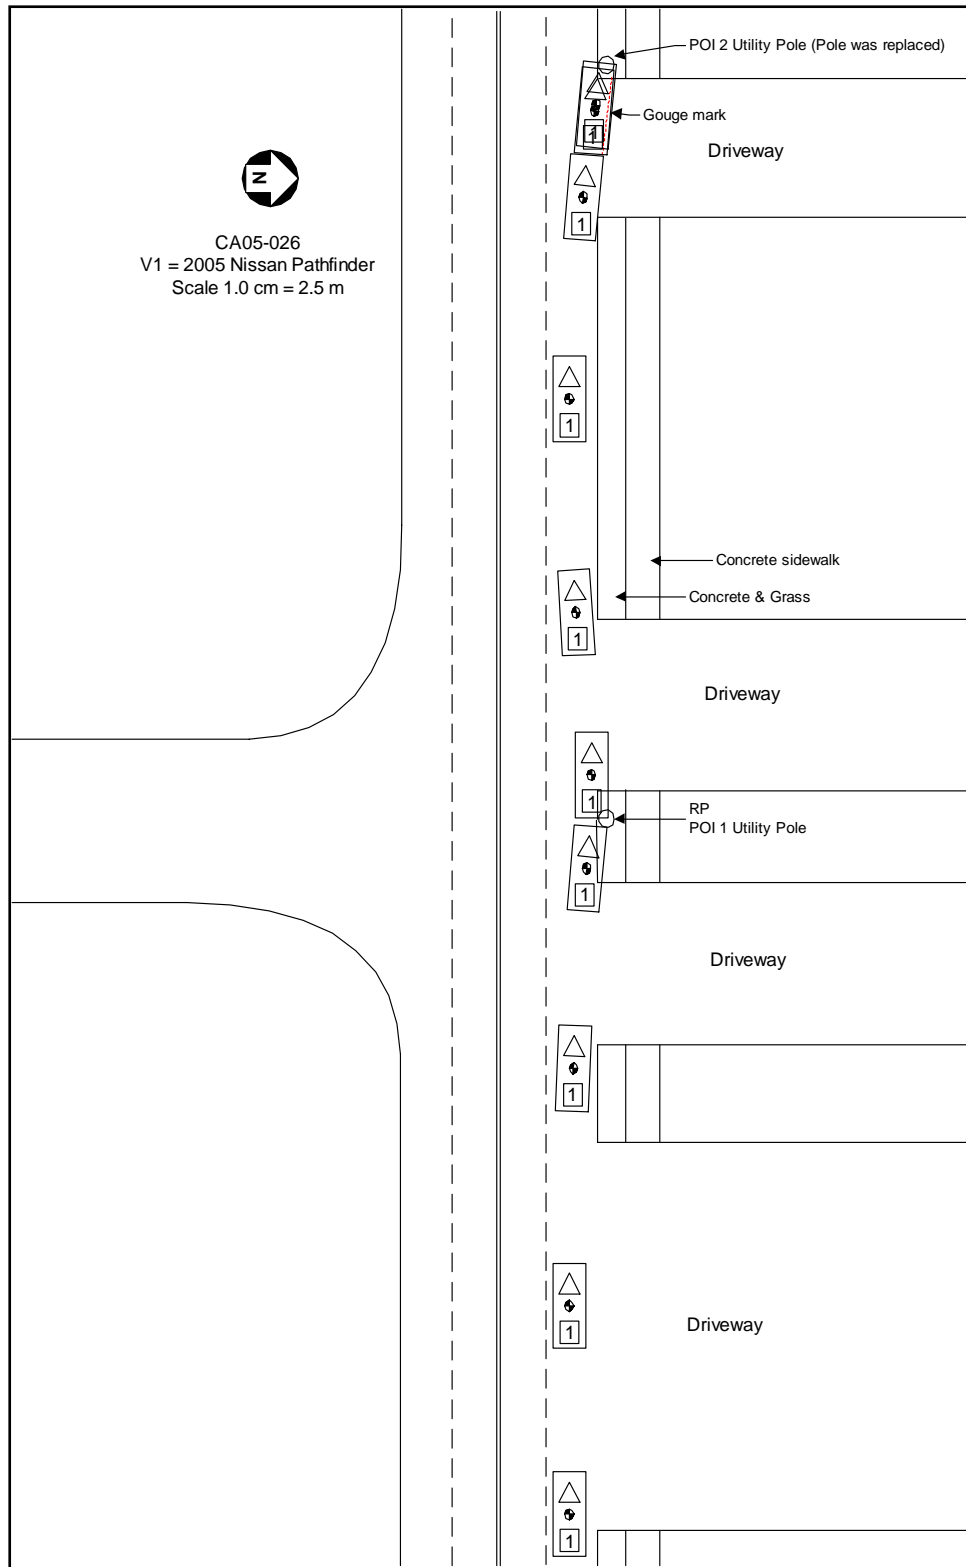
**Figure 9. Scene schematic**

road edges. The posted speed limit for the east/west roadway was 56 km/h (35 mph). The south roadside consisted of multiple driveways for commercial properties that intersected the roadway, and a 1.6-meter (5.2 feet) concrete/grass area located between the curb and the 1.9-meter (6.2 feet) sidewalk. The scene schematic is included as **Figure 9** of this report.
