ON-SITE OTHER INFLATABLE OCCUPANT PROTECTION INVESTIGATION

CASE NUMBER - IN-05-026

VEHICLE - 2005 HONDA ACCORD EX

CRASH DATE - July 2005

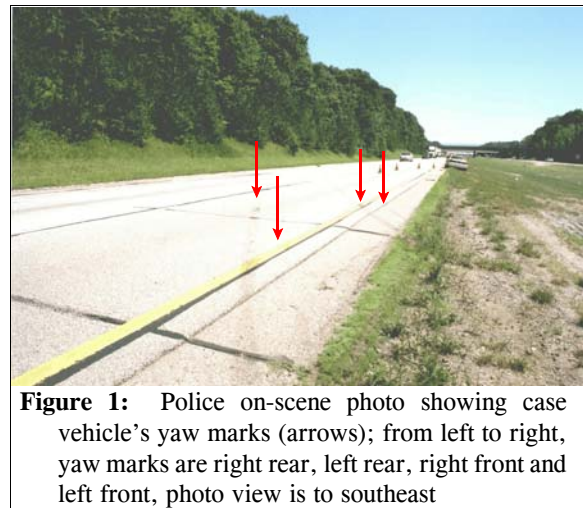
Pre-Crash: The case vehicle was traveling north in the outside northbound lane (**Figure 1**). The driver began to change lanes to the left and was startled by a non-contact car in the inside lane. The case vehicle's driver steered right to avoid the non-contact vehicle, and the case vehicle traveled onto the right shoulder. The case vehicle's driver then steered left in an attempt to return to the roadway. As a result, she lost control of the vehicle and it began to rotate counterclockwise. The case vehicle rotated counterclockwise across both northbound lanes, departed the left side of the roadway and entered the median in an increasing counterclockwise yaw. The crash occurred in the median of the two roadways.

Figure 1: Police on-scene photo showing case vehicle's yaw marks (arrows); from left to right, yaw marks are right rear, left rear, right front and left front, photo view is to southeast

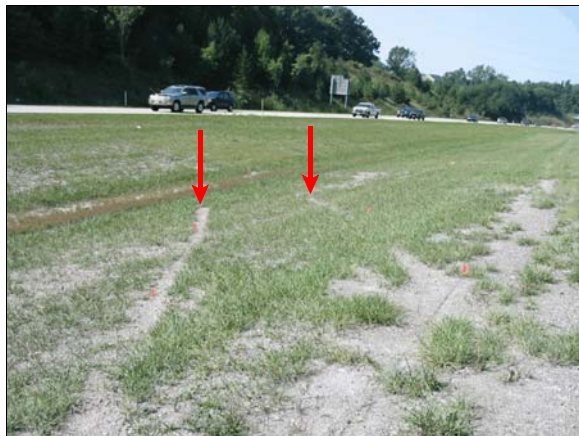
Crash: As the case vehicle's counterclockwise yaw increased and it traveled down into the median, the right side tires furrowed into the ground (**Figure 2** below), tripped the vehicle and it rolled over, passenger side leading, four quarter turns. The case vehicle's left side curtain air bag and driver's seat back-mounted side impact air bag deployed when the case vehicle landed hard on its left roof side rail and "C"-pillar (**Figure 3** below) at the beginning of the third quarter roll.

Figure 2: View northwest along approach of case vehicle to trip point (arrows), from left to right tire marks are right front and right rear

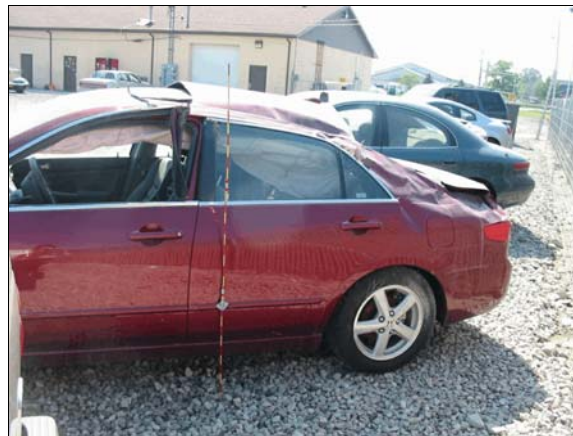
Figure 3: Damage to case vehicle's left roof side rail and left "C"-pillar from ground impact, each increment on rods is 5 cm (2 in)

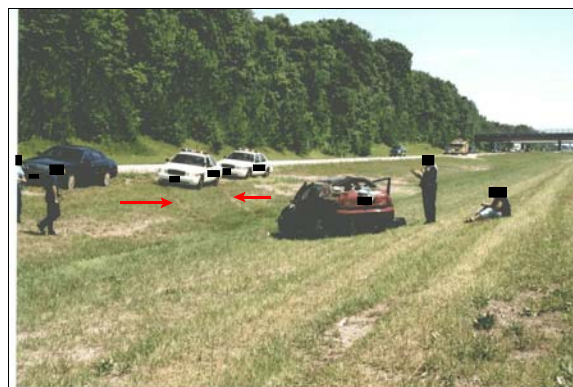
Post-Crash: The case vehicle came to rest on its wheels in the median heading southeast (**Figure 4**).

Figure 4: View southeast to case vehicle's rest position, arrows show case vehicle's tire furrows in grass

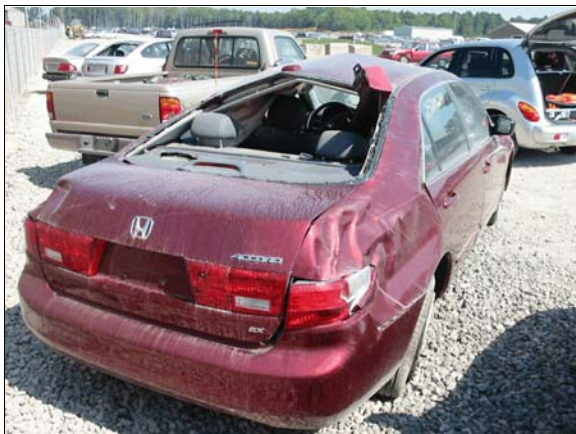
Exterior Damage: The case vehicle's rollover involved direct ground contact to the right quarter panel, right "C"-pillar, roof, trunk lid, left roof side rail, left "C"-pillar, left side door window frames, left fender and left front door (**Figures 6-9**). In addition, the beads on the right side tires were broken, and there was grass jammed in the beads of the left side tires. The maximum residual roof crush was approximately 16 centimeters (6.3 inches) occurring at the back of the left rear door.

Figure 6: Overview of back and right side showing rollover damage to right quarter panel and left "C"-pillar, roof and left roof side rail

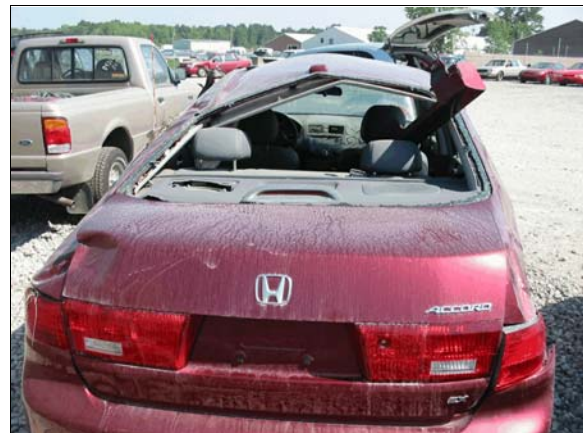
Figure 7: Back view of crush to left "C"-pillar and roof side rail

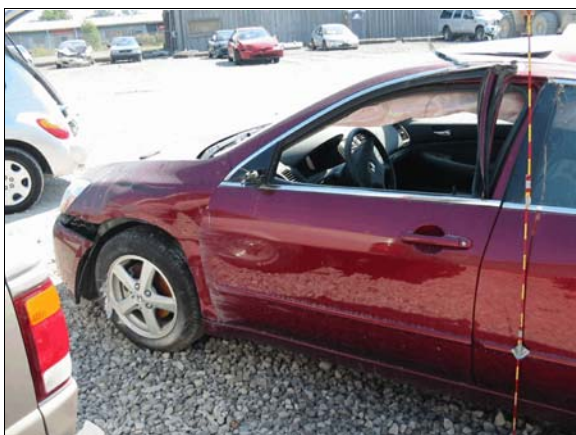
Figure 8: Rollover damage to left fender and left front door

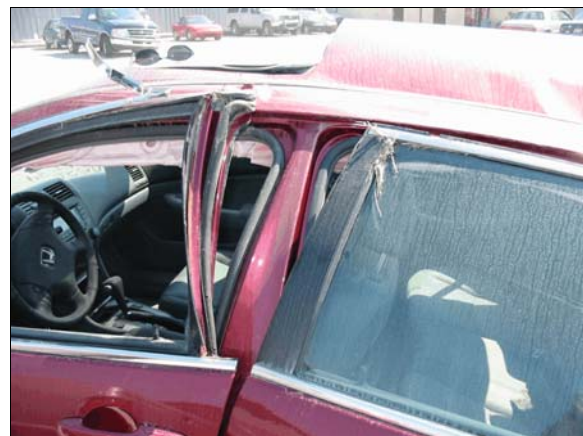
Figure 9: Rollover damage to left front and left rear doors

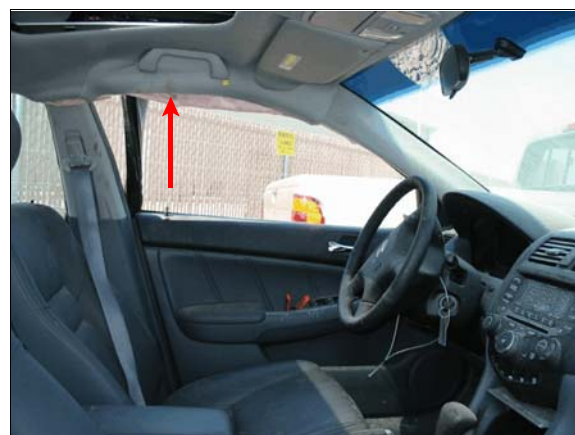
Vehicle Interior: Inspection of the case vehicle’s interior (**Figure 10**) revealed some reddish brown scuff marks on the roof nap along the left roof side rail just below the grab handle. These marks appeared to be possible makeup transfers from the driver. In addition, there were several scuff marks on the left side curtain air bag oriented in a line with the scuff mark on the roof side rail. The driver also loaded her lap-and-shoulder safety belt. The safety belt webbing would not retract at the time of inspection indicating actuation of the pretensioner. There was intrusion of the left roof side rail, roof and left C-pillar. The most severe intrusion involved the roof. It intruded vertically 16 centimeters (6.3 inches) into the back left seating position. Lastly, there was no evidence of deformation of the steering wheel or energy absorbing steering column (**Figure 11** below).

Figure 10: Overview of driver’s door, steering wheel , left instrument panel and left portion of windshield, arrow shows reddish brown scuff mark on roof side rail.

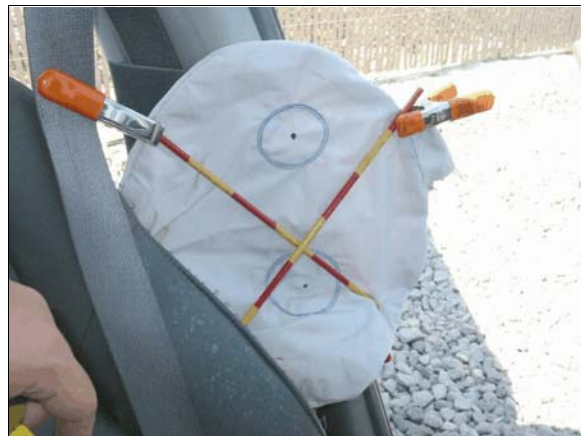
The driver's seat back-mounted side impact air bag (**Figure 12**) was located in the left side of the driver's seat back (**Figure 13**). The deployed side impact air bag was approximately oval in shape and was constructed with a fabric loop on its leading edge that was separated from the body of the air bag by stitching. The dimensions of the air bag were approximately 30 centimeters (11.8 inches) in height and 26 centimeters (10.2 inches) in width. The air bag was designed without tethers and had two small holes in the upper and lower portions of the air bag. These holes were not vent ports. They were sections of the air bag where both sides were stitched together. It appeared they were designed to control the width of the air bag during inflation. Each hole was 5 millimeters (0.2 inch) in diameter, and the diameter of the circular stitching was 6

Figure 12: Driver's seat back mounted side impact air bag

centimeters (2.4 inches). There was no module flap on the side of the seat back. The air bag deployed through a tear-seam in the side of the seat back. There was no evidence of damage to the air bag, but there were some yellowish discolorations on both the inboard and outboard sides of the air bag, which appeared to be moisture stains.

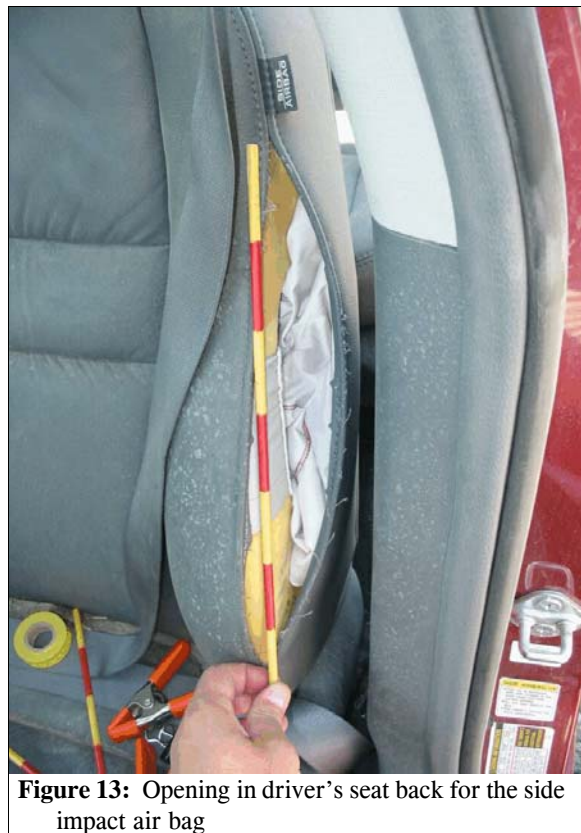
Figure 13: Opening in driver's seat back for the side impact air bag

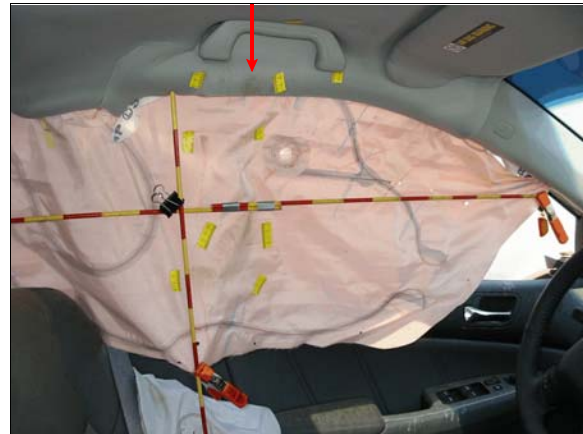
The left side curtain air bag was located along the left roof side rail, inside the head liner. The air bag extended along the roof side rail from the middle of the left A-pillar, across the front left and back left seat positions to the top of the left C-pillar (**Figures 14** and **15**). The left side curtain air bag was approximately 170 centimeters (67 inches) in length and 40 centimeters (15.7 inches) in height. It was constructed with three main inflation chambers, two at the driver's head area and one at the left rear passenger's head area. Each of these chambers had a 2 centimeter (0.80 inches) circular opening through the center surrounded by double circular stitching 6 centimeters (2.4 inches) in diameter that extended through both inboard and outboard sides of the air bag. Based on crash test videos, this appears to aid in shaping the air bag during inflation and to control the width of the air bag during deployment. While there were no obvious vent ports, the perimeter stitching of the front and rear inflation chambers did not meet. There was an opening approximately 4 centimeters (1.8 inches) wide, presumably to allow the inflation gases to escape the inflation chambers. Several scuff marks were observed on the side curtain air bag adjacent to the driver's seated position (**Figure 14**). They were oriented in a line below the probable driver's head contact mark on the roof side rail.

Figure 14: Driver's side curtain air bag, yellow tape shows areas of probable driver contact, arrow shows probable driver head contact on roof rail

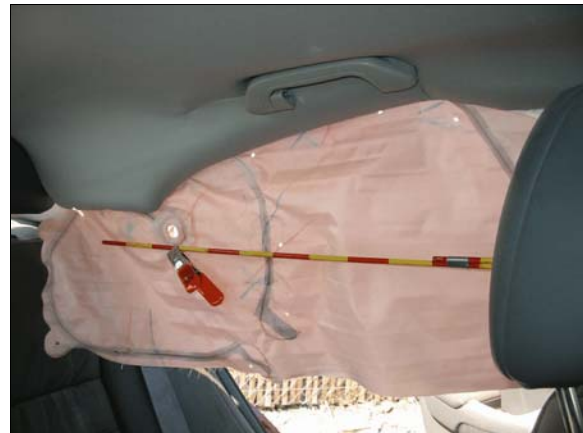
Figure 15: Back left passenger, side curtain air bag
