Electronic Stability Control/Vehicle Rollover
Dynamic Science, Inc./Case Number: DS05026
2005 Acura TSX
California
September 2005

1. Report No. DS05026	2. Government Accession No.		3. Recipient Catalog No.	
4. Title and Subtitle Electronic Stability Control System Investigation		5. Report Date June 27, 2006

14. Sponsoring Agency Code		
15. Supplemental Notes				
16. Abstract This on-site investigation focused on the Electronic Stability Control feature in a 2005 Acura TSX. This single vehicle crash occurred in September 2005 at 0103 hours in an urban area of California. The crash occurred at a three-leg intersection controlled by a large traffic circle located in the center of the two intersecting roadways. The case vehicle is a 2005 Acura TSX being driven by a 23-year-old restrained male. There was one additional occupant in the Acura. The Acura was traveling east in the right lane of a two lane, two way, undivided asphalt roadway and was approaching the intersection controlled by the traffic circle. The driver of the Acura reported that he did not see the traffic circle until it was too late to maneuver around it. The case vehicle continued straight ahead and the left side trav

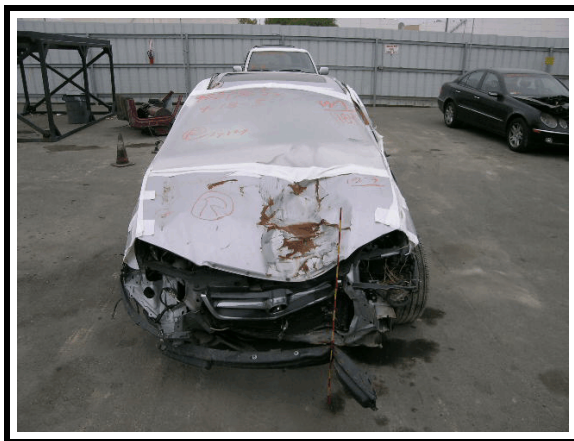
Figure 1. Front end damage - 2005 Acura TSX

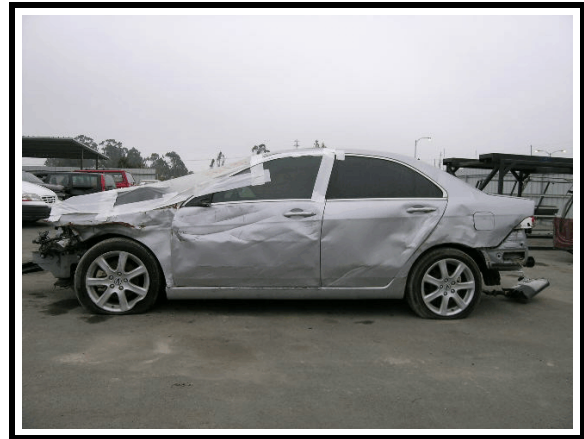
Figure 2. Left side rollover damage - 2005 Acura TSX

The case vehicle sustained moderate left side damage as a result of the rollover event. There was 15.0 cm (5.9 in) of lateral crush at the max crush location, 291.0 cm (114.6 in) forward of the left rear axle. There was no vertical crush as a result of the rollover.

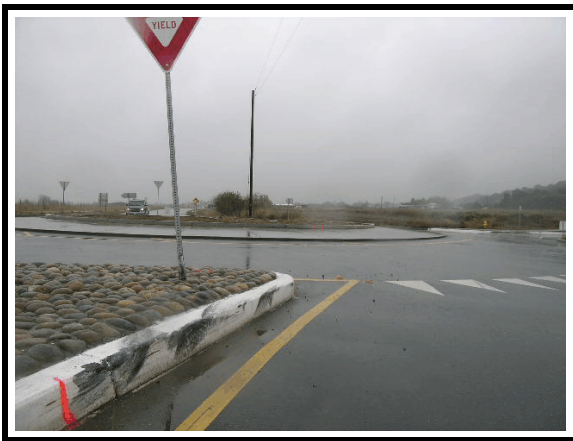
Figure 4. Initial roadway departure point and damaged yield sign (east)

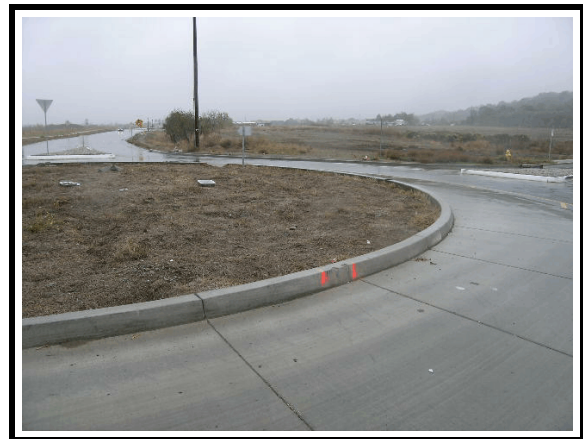
Figure 5. Damage to the traffic circle's inner curb (east)

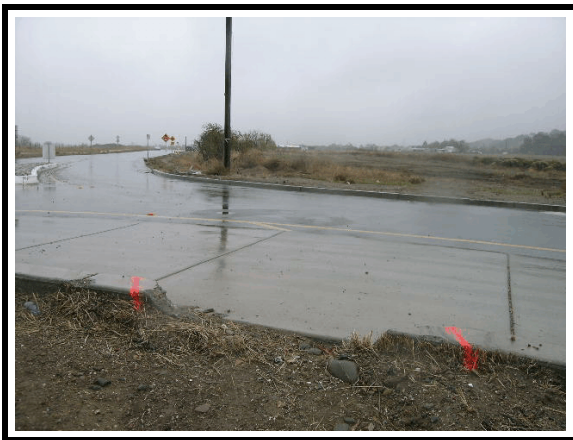
Figure 6. Damage from second curb impact (east)

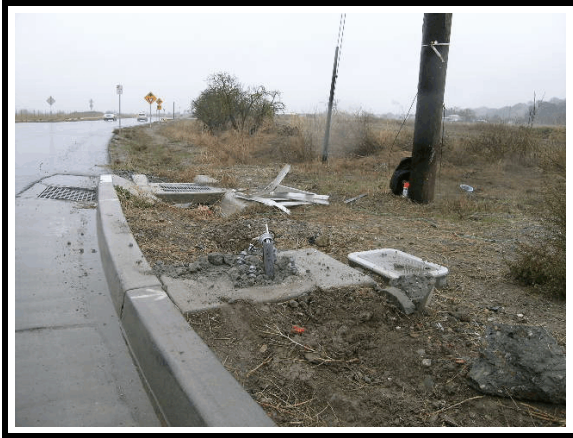
Figure 7. Pole sheared from its base

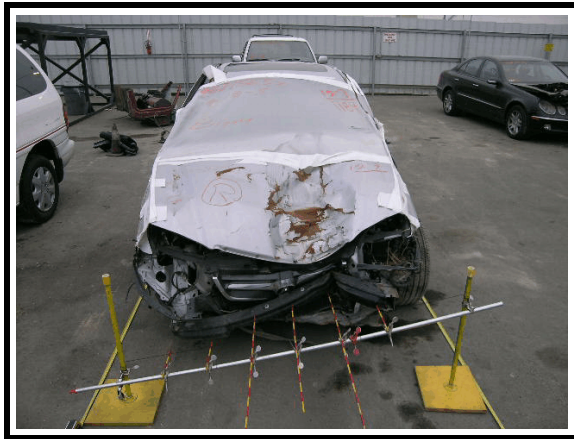
Figure 10. Front crush profile

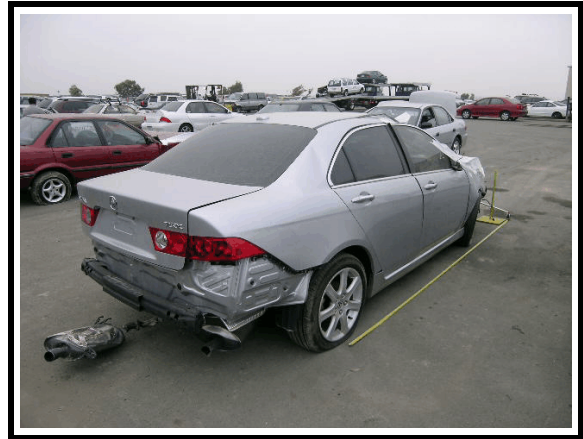
Damage Description: The 2005 Acura TSX sustained light undercarriage damage as a result of the first impact with the west side of the traffic circle's inner curb. There was very little damage other than sporadic undercarriage scrapes and damage to the left muffler, which appears to have snagged on the curb. The case vehicle sustained moderate front end damage as a result of the impact with the east side of the traffic circle's inner curb and the lamppost. The location and width of the direct damage could not be determined because the front bumper cover was not with the vehicle and there was overlapping front end damage from other crash events. The direct damage from the curb impact was low on the vehicle, mainly to the lower portion of the front bumper and below. The direct damage from the impact with the lamppost began near the centerpoint of the vehicle, and extended to the left. Six crush measurements were documented along the damaged front bumper as follows: C1=0.0 cm (0.0 in), C2=23.0 cm (9.1 in), C3=18.0 cm (7.1 in), C4=15.0 cm (5.9 in), C5=14.0 cm (5.5 in), C6=8.0 cm (3.1 in). An additional max crush measurement was taken 26.0 cm (10.2 in) left of the post-crash centerpoint. There was 27.0 cm (10.6 in) of longitudinal crush in this location. In order to calculate the correct amount of crush to the front bumper, freespace measurements were obtained from an exemplar vehicle. When the lamppost sheared from its base, it fell on top of the Acura and impacted both the left and right A pillars. The windshield header near the right A pillar was also damaged.

Figure 11. Back/right and muffler damage from undercarriage impact

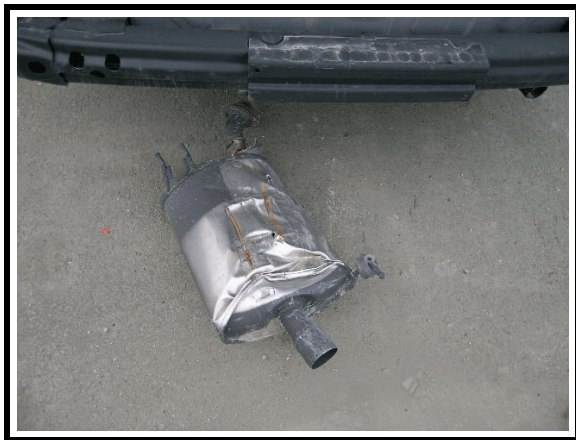
Figure 12. Damaged left muffler

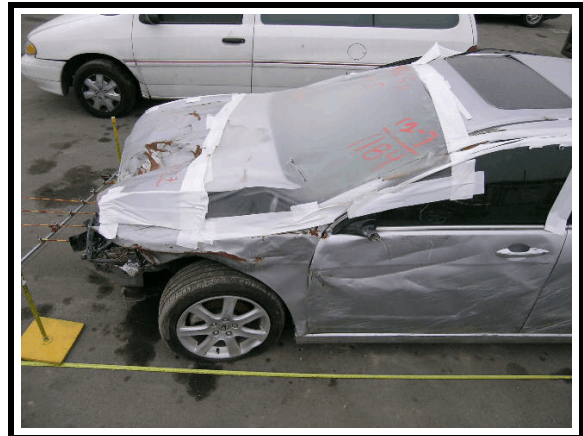
Figure 13. Left front rollover damage and left A pillar damage

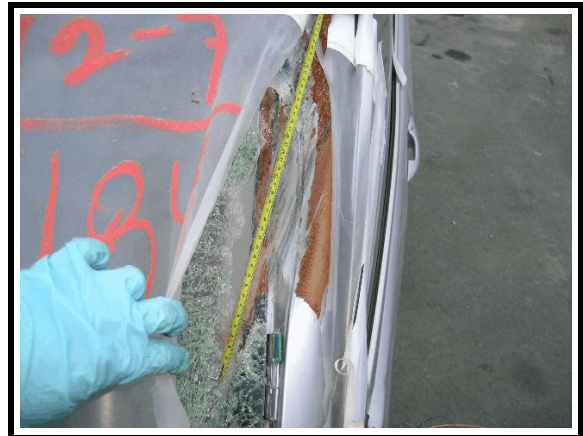
Figure 14. Closer view - Left A pillar damage

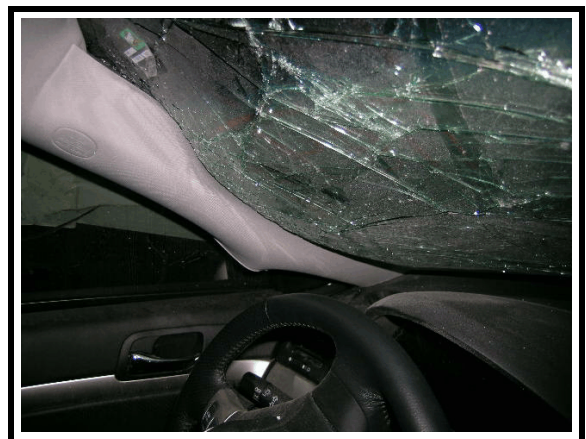
There was vertical windshield, windshield header and A pillar intrusion. The cover of the left A pillar intruded laterally and there was very slight lateral intrusion of the right front roof side rail. An exemplar vehicle was located in order to obtain comparative, undamaged measurements and the specific passenger compartment intrusions were documented as follows:

Figure 15. Windshield and left A pillar intrusion

Row/Position	Intruded Component	Magnitude of Intrusion	Direction
1L	A pillar	9.0 cm (3.5 in)	Vertical
1L	Windshield	9.0 cm (3.5 in)	Vertical
1C	Windshield	8.0 cm (3.1 in)	Vertical
1L	A pillar cover	7.0 cm (2.8 in)	Lateral
1R	A pillar	5.0 cm (2.0 in)	Vertical
1R	Windshield header	4.0 cm (1.6 in)	Vertical
1R	Windshield	4.0 cm (1.6 in)	Vertical
1R	Roof side rail	3.0 cm (1.2 in)	Lateral

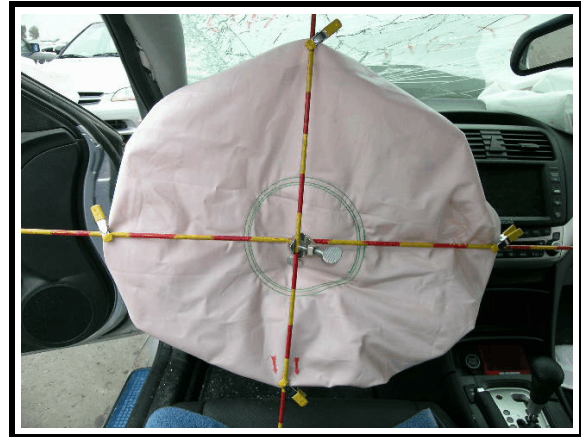
The driver's air bag was mounted in the center of the steering wheel hub. The air bag module cover flaps had a general H configuration with a few additional cutouts. The top cover flap measurements were as follows: the upper and lower flap edges were 13.5 cm (5.3 in) wide and both side flap edges were 5.0 cm (2.0 in) high. The bottom cover flap measurements were as follows: the upper flap edge was 13.5 cm (5.3 in) wide and the lower flap edge was 7.5 cm (3.0 in) wide. The sides of the bottom cover flap were faceted with the upper facet measuring 3.0 cm (1.2 in) and the lower facet measuring 6.0 cm (2.4 in). The air bag was circular in shape and measured 60.0 cm (23.6 in) high/wide in its deflated state with an excursion of 28.0 cm (11.0 in)

Figure 16. Driver's front air bag; arrows point to top of bag (upside down in photo)

from the module face. The longitudinal distance between the module face and the front left seat back was 72.0 cm (28.3 in). The air bag had two internal tethers and two circular vent ports on the back of the bag at the 10 and 2 o'clock positions. There were no visible signs of occupant contact or damage to the front or back of the driver air bag.

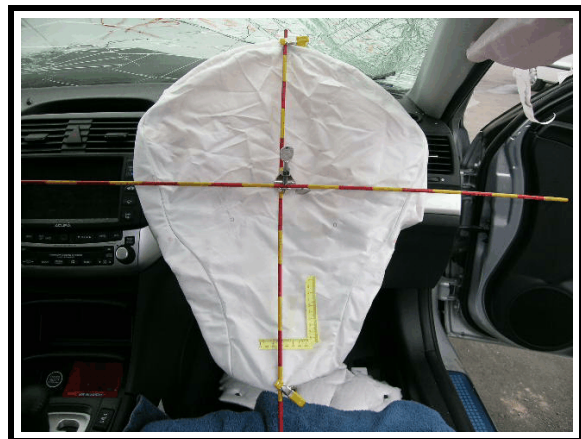
Figure 17. Front right passenger air bag

The front right passenger air bag was a top instrument panel mount. The air bag module cover flaps had an H configuration. The top and bottom cover flaps measured 24.0 cm (9.4 in) wide, with the height of the top flap measuring 5.0 cm (2.0 in) and the height of the bottom flap measuring 6.0 cm (2.4 in). The air bag had a diamond shape, with the top section measuring 48.0 cm (18.9 in) seam to seam laterally and the bottom section measuring 15.0 cm (5.9 in) laterally in its deflated state. The bag was 55.0 cm (21.7 in) high. In its deflated state, the maximum excursion was 73.0 cm (28.7 in) from the module face. The longitudinal distance between the module face and the front right seat back was 105.0 cm (41.3 in). There were two circular vent ports on the sides of the air bag at the 3 and 9 o'clock positions. There was no damage to the cover flaps or air bag. There was a light yellow discoloration found in the lower center section of the bag that matched yellow discolorations found near the cover flaps. It is likely these were from the deployment and not from occupant contact.

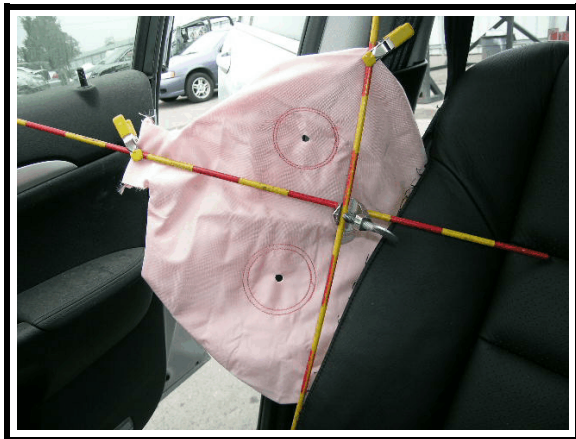
Figure 18. Front right passenger side air bag

The front right seat back mounted side air bag deployed during the collision, but it is not known which crash event triggered the deployment. The driver's side air bag did not deploy. The air bag module cover flap was rectangular in shape and measured 8.0 cm (3.1 in) wide and 22.0 cm (8.7 in) high. The deployed side air bag was semi-circular in shape with a height of 28.0 cm (11.0 in) and an excursion of 30.0 cm (11.8 in) in its deflated state. It had no tethers. There was one vent opening located at the 9 o'clock position as viewed from the left side of the bag. There were no visible signs of occupant contact or damage to the side air bag. There were black deployment transfers found in the inner upper right quadrant and faint yellowish streaks found on the outside lower right quadrant.

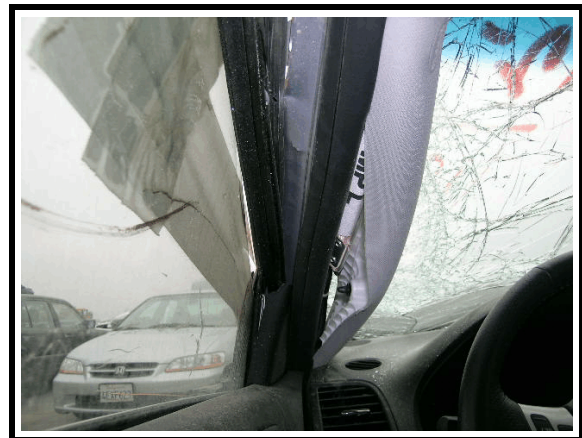
Figure 19. Deformed/Intruded left A pillar

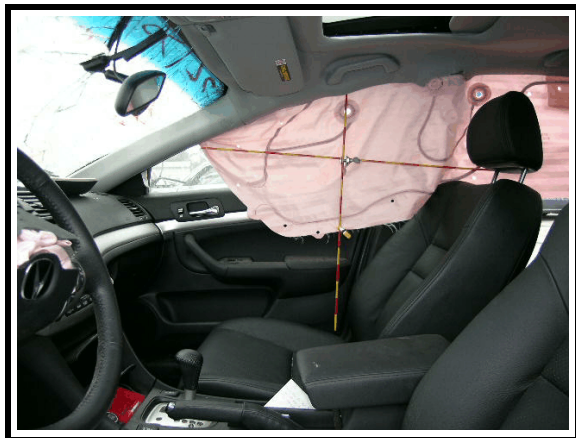
Figure 20. Right side curtain air bag

The right side curtain deployed during the collision, but it is not known which crash event triggered the deployment. The left side curtain did not deploy. Both A pillars were damaged during the non-horizontal pole impact. It appears that when the case vehicle struck the lamppost with its front end, the post sheared from its base and fell on top of the Acura as the vehicle continued traveling east. Part of the post impacted the middle of the left A pillar, deforming and intruding the pillar, and possibly damaging a portion of the left side curtain air bag module. The lamppost also impacted the top of the right A pillar, but this non-horizontal impact resulted in less passenger compartment intrusion and A pillar damage. The deployed right side curtain air bag extended from the A to the C pillar. There was a small coverage gap present at the A pillar. The gap consisted of a triangular shaped area measuring 15.0 cm (5.9 in) in height at the forward aspect of the bag, 35.0 cm (13.8 in) in width along the belt line and 25.0 cm (9.8 in) in length along the A-pillar. The side curtain was rectangular in shape and in its deflated state, measured 158.0 cm (62.2 in) in length. The height of the front section of the curtain measured 45.0 cm (17.7 in) and the back section measured 40.0 cm (15.7 in). The air bag had one external tether, located at the front of the bag at the A pillar. At the inspection, the tethered section was found still tucked under the right A pillar cover. When the side curtain was pulled out to expose the tether, the coverage gap at the A pillar decreased in size. There were no vent ports. The side curtain deployed from the A pillar and right roof side rail cladding. In the front right passenger's seating area, there were two small blood stains found on the lower portion of the outer curtain that were likely due to post-crash movement of this occupant inside the vehicle. There were no visible signs of damage to the side curtain.

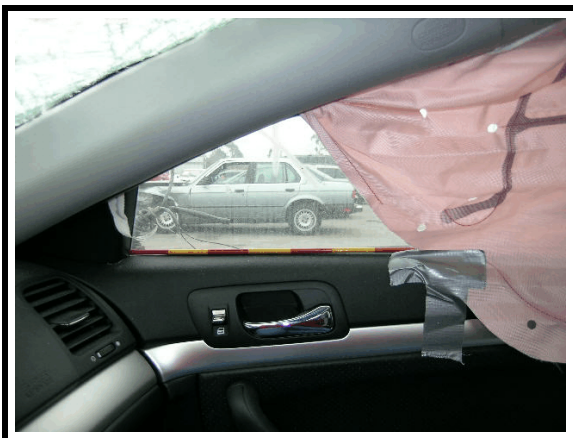
Figure 21. Gap distance at Right A pillar as found at the inspection

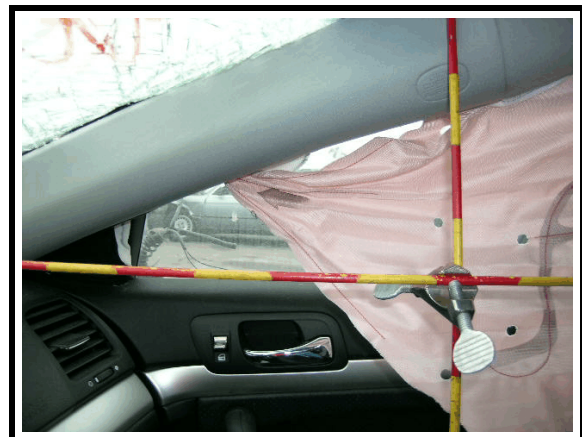
Figure 22. Gap distance after tether pulled out of the A pillar cover

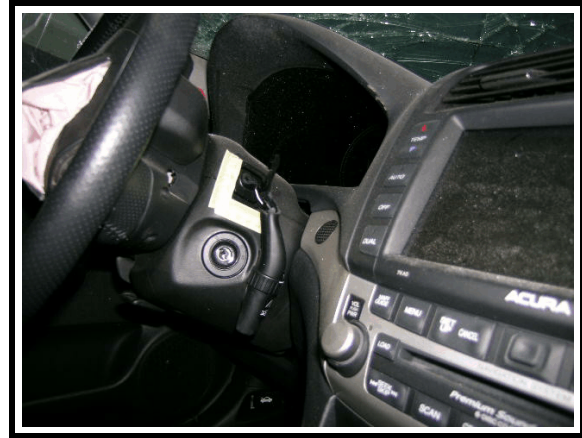
One of the right side steering column control levers was broken off, likely due to driver contact. There were signs of occupant contact to the glove compartment door, possibly from the passenger's lower left leg.

Figure 23. Broken steering column control lever

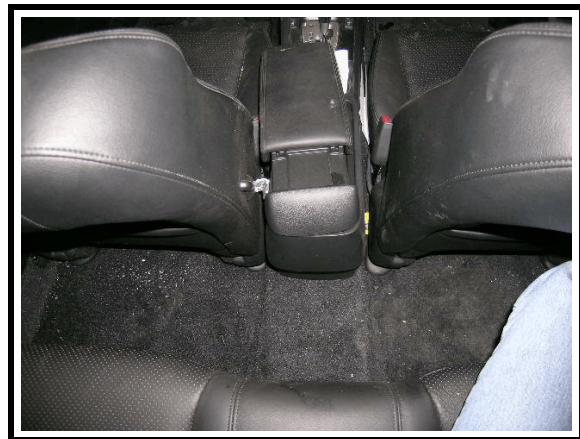
Figure 24. Deformed center console

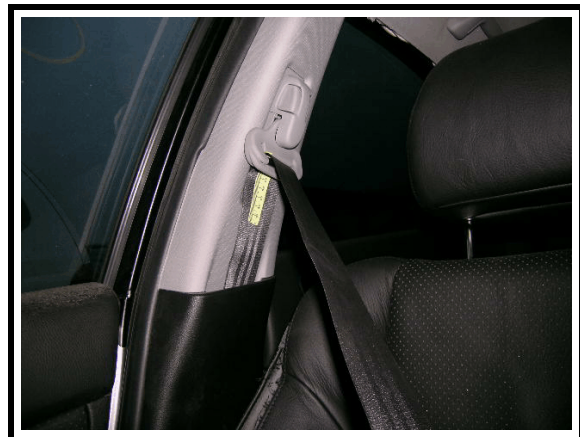
Figure 25. Evidence of loading to the right front passenger's seat belt

before it departed the roadway to the right. As the front of the Acura impacted the lamppost, this passenger initiated a slight forward trajectory towards the 12 o'clock direction of force, but was likely held in position by her seat belt. The lamppost sheared from its base and impacted both A pillars. The Acura continued east and the right side sideswiped a traffic barricade. This was also a low delta V event and the passenger likely remained in position. The Acura continued a short distance further and traveled into a ditch, causing the vehicle to rollover. As the Acura rolled one quarter turn to the left, this passenger initiated a lateral trajectory to her left and contacted the center console, deforming it (Figure 24). The case vehicle came to final rest laying on its left side in the ditch, facing east. This occupant's neck injury and tongue laceration appears to have occurred as a result of the impacts throughout this long crash sequence. The chest contusion was a result of loading to the torso portion of the lap and shoulder belt (Figure 25).
