ON-SITE CERTIFIED ADVANCED 208-COMPLIANT VEHICLE INVESTIGATION

CASE NUMBER - IN-05-036

VEHICLE - 2005 HONDA ACCORD

CRASH DATE - September 2005

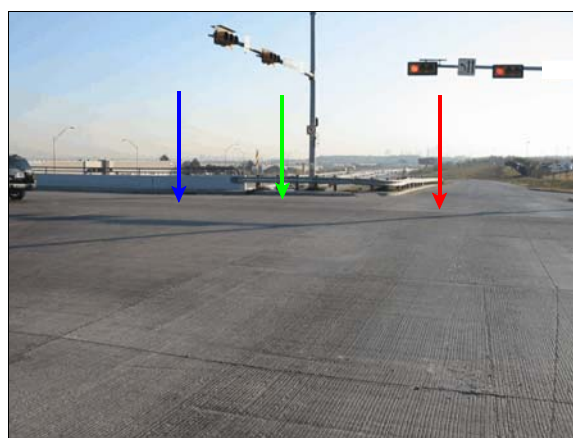
Figure 3: View northwest to area of impact (red arrow) and area of final rest of both vehicles, blue arrow shows estimated area of final rest of case vehicle, green arrow shows estimated area of final rest of other vehicle

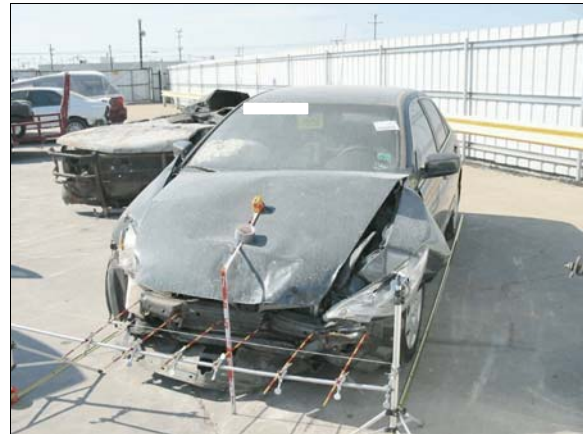
Crash: The front of the case vehicle (**Figure 4** below) impacted the left side of the other vehicle causing the case vehicle's driver and front right passenger air bags to deploy.

Figure 4: Front left overview of damage to case vehicle, each number on tape measure is tenths of meter, each stripe on rods is 5 cm (2 in)

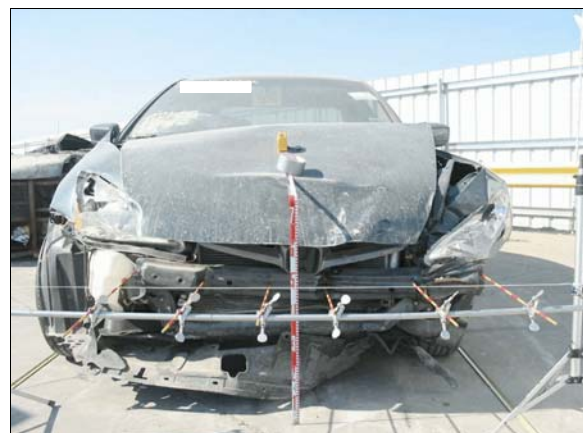
Exterior Damage: The case vehicle's contact with other vehicle involved nearly the entire frontal plane (**Figure 5**). The case vehicle's front bumper, bumper fascia, grille, radiator, headlamp/turn signal assemblies, and hood were directly damaged and crushed rearward. Direct damage began at the front right bumper corner

Figure 5: Damage to front of case vehicle from impact with the other vehicle

and extended 140 centimeters (55.1 inches) across the bumper. Residual maximum crush was measured as 39 centimeters (15.4 inches) occurring at C₃. The table below shows the case vehicle’s crush profile.

The case vehicle’s left side wheelbase was shortened 3 centimeters (1.2 inches) while the right side wheelbase was extended 1 centimeter (0.39 inch). Induced damage involved both fenders as well as the hood, and the windshield glazing. No obvious induced damage or remote buckling was noted to the remainder of the case vehicle’s exterior.

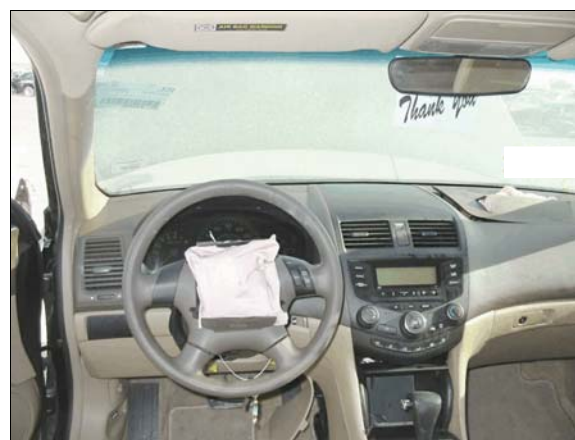
Vehicle Interior: Inspection of the case vehicle’s interior (**Figure 6** and **Figure 7** below) revealed occupant contact to the knee bolster and turn signal lever. The turn signal lever was broken off the steering column, and the knee bolster was broken. There was also a possible lip print on the center portion of the driver’s air bag. No passenger compartment intrusion was observed, and there was no deformation of the steering wheel or obvious compression of the energy absorbing steering column (**Figure 8** below).

Figure 6: Overview of steering wheel, instrument panel and windshield

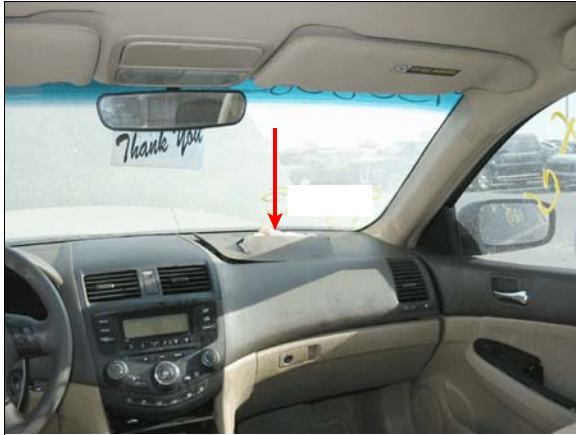
Figure 7: Overview of case vehicle's instrument panel and windshield, arrow shows location of front right passenger air bag

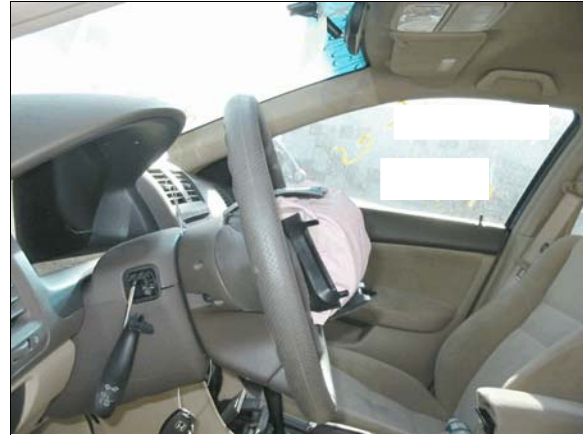
Figure 8: Left side view of case vehicle's steering wheel and steering column

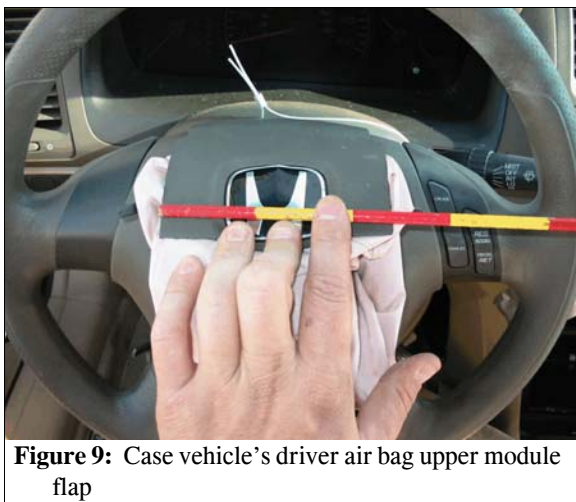
Figure 9: Case vehicle's driver air bag upper module flap

The case vehicle's driver air bag was located in the steering wheel hub. An inspection of the air bag module cover flaps and the air bag fabric revealed that the cover flaps opened at the designated tear points. There was no evidence of damage during the deployment to the air bag or the air bag module cover flaps (**Figure 9**). The module cover consisted of two rectangular cover flaps constructed of pliable vinyl approximately 3 millimeters (0.12 inch) thick. Both the upper and lower cover flaps were 12 centimeters (4.7 inch) in width and 6 centimeters (2.4 inches) in height. The driver's air bag was designed with two tethers, each approximately 6 centimeters (2.4 inches) in width, and had two vent ports (**Figure 10**), approximately 5 centimeters (2 inches)

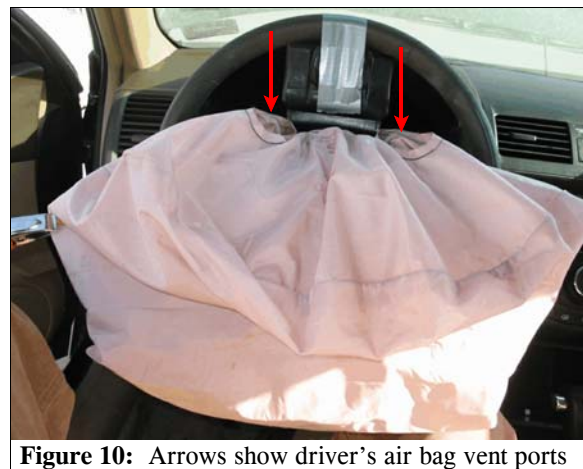
Figure 10: Arrows show driver's air bag vent ports

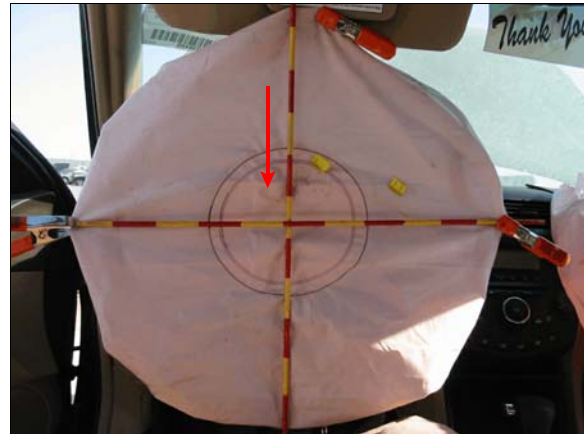
in diameter, located at the 11 and 1 o'clock positions near the center of the back of the air bag. The deployed driver's air bag (**Figure 11** below) was round with a diameter of approximately 55 centimeters (21.7 inches). The distance between the mid-center of the driver's seat back, as positioned at the time of the vehicle inspection (i.e., seat between middle and rearmost track position, seat back slightly reclined), and the front surface of the air bag's fabric at approximate full excursion was 47 centimeters (18.5 inches). An inspection of the driver's air bag fabric revealed a possible lip print on the center of the air bag as well as some kind of fluid stain, also near the center of the air bag.

Figure 11: Case vehicle driver's air bag, arrow shows location of possible lip imprint, yellow tape shows locations of stain, they did not appear to be related to occupant contact

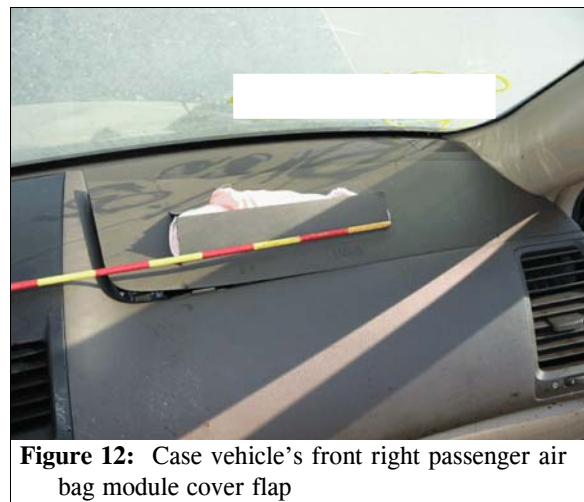
The front right passenger's air bag was located in the top of the instrument panel (**Figure 12**). An inspection of the front right air bag module cover flaps (**Figure 12**) and the air bag fabric revealed that the cover flaps opened at the designated tear points. There was no evidence of damage during the deployment to the air bag or the cover flaps. The module cover consisted of two rectangular cover flaps constructed of pliable vinyl approximately 4 millimeters (0.16 inch) thick. The upper and lower cover flaps were 22.5 centimeters (8.9 inch) in width and 5 centimeters (2 inches) in height. The distance between the front of the instrument panel and the leading edge of the module cover flaps was approximately 15 centimeters (5.9 inches). The front right passenger's air bag was designed without any tethers. The front right air bag had two vent ports, each approximately 6 centimeters (2.4 inches) in diameter, located at the 2:30 and 9:30 o'clock positions. The deployed front right air bag (**Figure 14** below) was rectangular with a height of approximately 55 centimeters (21.7 inches) and a width of approximately 40 centimeters (15.7 inches). The distance between the mid-center of the front right passenger's seat back, as positioned at the time of the vehicle inspection (i.e., seat at middle track position, seat back slightly reclined), and the front surface of the air bag's fabric at approximate full excursion was 32 centimeters (12.6 inches). An inspection of the front right passenger's air bag fabric revealed no evidence of occupant contact; however, there was a large splatter of what appeared to be dried coffee on the air bag.

Figure 12: Case vehicle's front right passenger air bag module cover flap

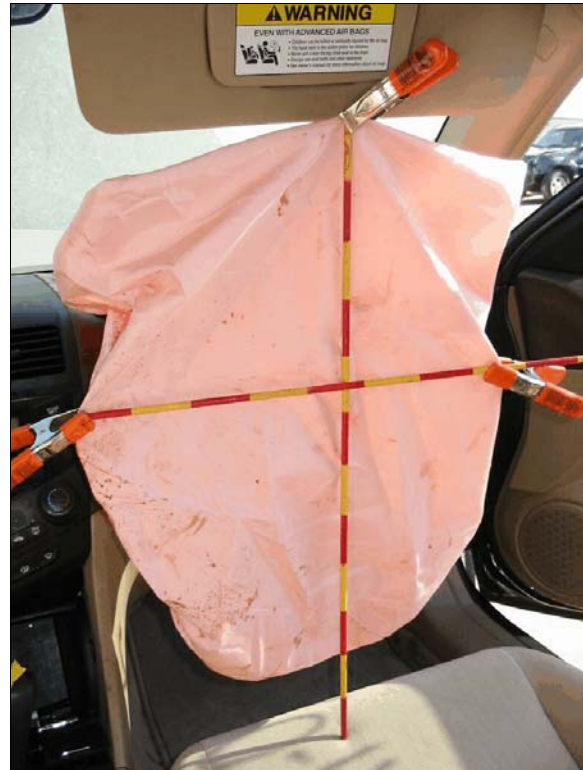
Figure 13: Case vehicle's front right passenger air bag, air bag has numerous stains on it, they appeared to be coffee stains

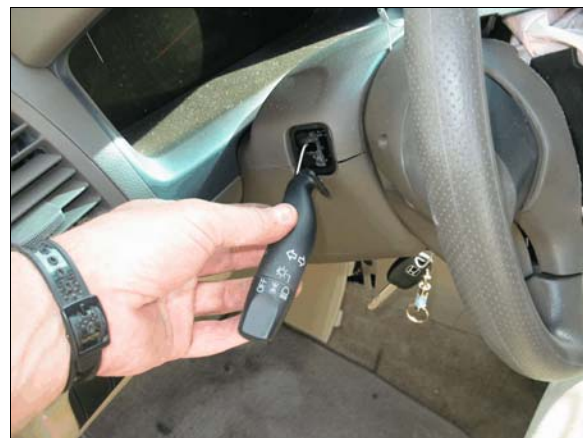
Figure 14: Case vehicle driver's left hand impacted and broke the turn signal lever off the steering column

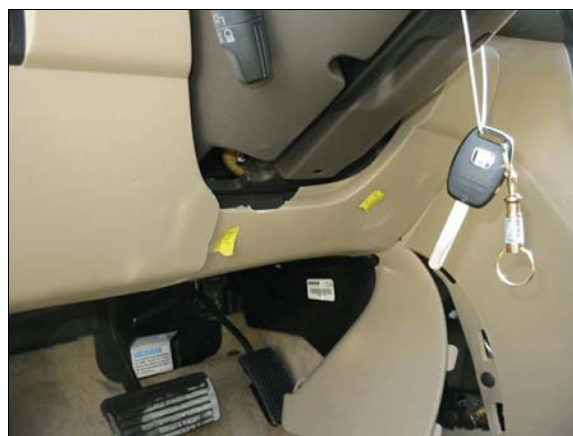
Figure 15: Case vehicle driver's knees impacted and broke the drivers knee bolster
