**CALSPAN ON-SITE ADAPTIVE CONTROL
VEHICLE CRASH INVESTIGATION**

CASE NO: CA05-037

VEHICLE: 2005 CHEVROLET VENTURE MINIVAN

CRASH DATE: MARCH 2005

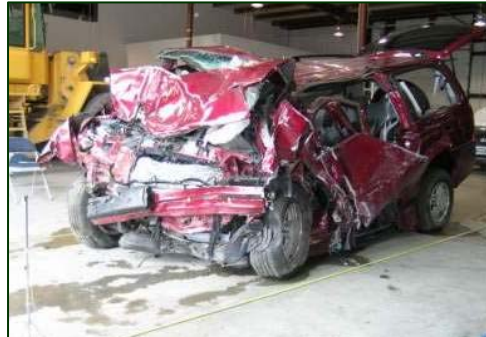
Figure 1. Severe frontal damage to the 2005 Chevrolet Venture adaptive control minivan.

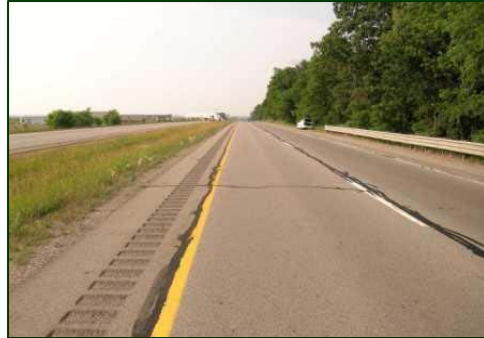
The crash occurred on a divided highway in a rural area during nighttime hours. The roadway consisted of two travel lanes in each direction that was separated by an 8 m (26.2') wide depressed grass median (**Figure 2**). The outboard travel lanes were 3.8 m

Figure 2. Northbound view of the crash site and the Venture's point of departure.

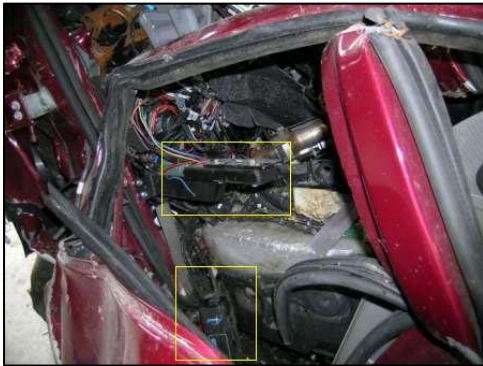
The interior adaptive driving equipment was installed by Clock Conversions of Grand Rapids, Michigan. This equipment was manufactured by Electronic Mobility Controls. The AEVIT line of electronically controlled adaptive equipment was installed and included a left side rigid stalk mounted throttle and brake controller. This unit was identified as the AEVIT DL-001. A T-handle extended from the controller which provided the driver with zero effort braking and throttle input. Additionally, this unit could be programmed to perform additional driving functions such as turn signals by clicking the T-handle laterally. It was unknown if any of these functions were programmed into this unit. This T-handle was fractured during the crash and the unit was separated from the mounting platform (**Figure 3**).

Figure 3. Adaptive throttle and brake hand control, separated from mount.

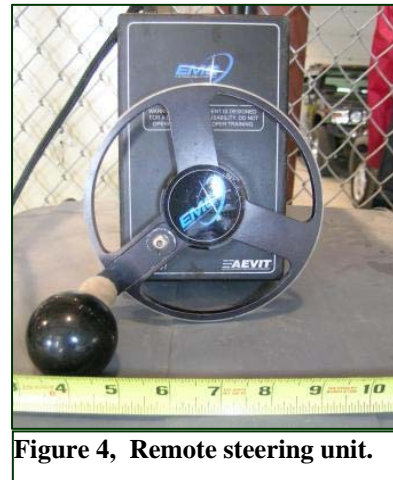
A remote zero-effort steering system (**Figure 4**) was stalk mounted at the center of the vehicle. This unit was removed during the police inspection of the vehicle. This unit consisted of a 15 cm (6") diameter steering wheel mounted to the control box which measured 12x19 cm (4.8x7.4") by 7 cm (2.75") in depth. A 5 cm (1.9") diameter steering knob was mounted to the perimeter of the remote steering wheel. This steering unit was identified by AEVIT DW-001, Serial No. DW-001.

Figure 4, Remote steering unit.

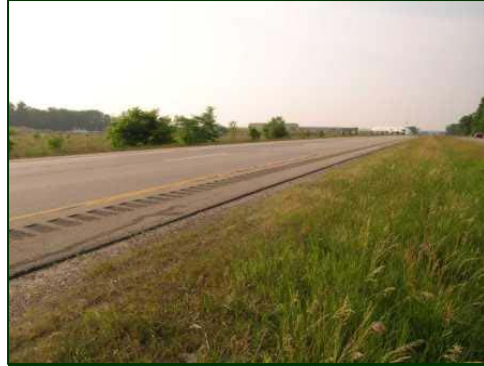
Figure 5. Chevrolet Venture's trajectory into the southbound travel lanes.

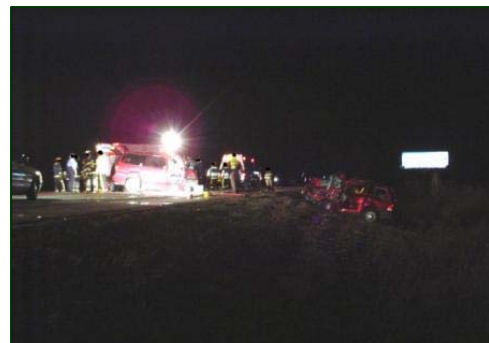
Figure 6. On-scene image of the vehicles at final rest.

perpendicular across the outboard southbound travel lane. The Windstar was deflected off the west road edge and came to rest beyond the shoulder, facing in an easterly direction. Based on its final rest position, the Ford rotated approximately 90 degrees counterclockwise. Both vehicles came to rest near the initial point of impact (**Figure 6**).

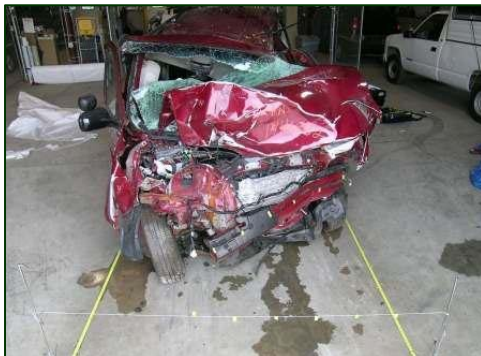
The adaptive control 2005 Chevrolet Venture minivan sustained severe frontal damage as a result of the head-on crash with the Ford Windstar. The direct contact damage extended full width across the vehicle and measured 171 cm (67.5”) along the level of the upper radiator support. The bumper fascia was fractured and separated from the vehicle. Maximum crush was located at the left corner of the front bumper beam and measured 145 cm (57.1”). The bumper beam was crushed rearward and displaced right resulting in a combined direct and induced damage width (Field L) of 104 cm (41”). The crush profile at the level of the bumper beam was as follows: C1 = 145 cm (57.1”), C2 = 139 cm (54.6”), C3 = 126 cm (49.5”), C4 = 100 cm (39.5”), C5 = 84 cm ((33”0, C6 = 67 cm (26.25”). **Figure 7** is an overhead view of the frontal crush profile. The Collision Deformation Classification (CDC) for this impact event was 12-FDEW-6.

Figure 7. Overhead view depicting the extend of frontal crush.

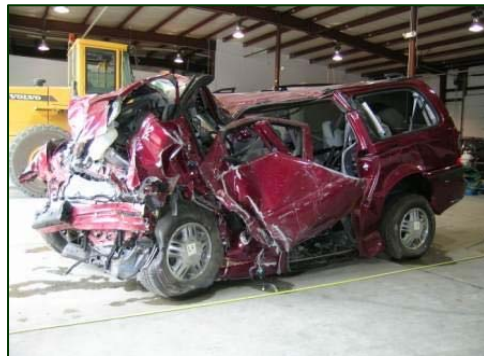
The impact resulted in severe frontal intrusion (**Figure 8**) of the interior and induced deformation of both side surfaces of the vehicle. The left front door opened due to rearward displacement of the left A-pillar and stress overload of the door latch. The latch released and the door opened during the crash. The lower door hinge was separated by damage. The left rear sliding door opened during the crash due to pillar displacement. The longitudinal distance between the left B- and C-pillars was 77 cm (30.5”). The sliding door, although damaged, was 112 cm (44”) in length post-crash. The rear lift gate remained closed and operational post-crash. The right front door remained closed during the crash. It appeared to have been forced open by rescue personnel. Due to body displacement, the door would not re-latch. The right rear sliding door was jammed closed.

Figure 8. Compression of the frontal structure and of the driver's compartment.

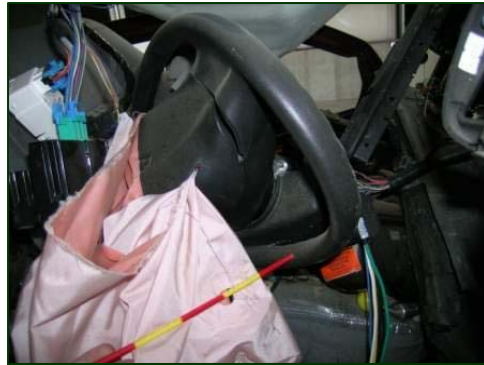
The interior of the Chevrolet Venture adaptive control minivan sustained severe damage as a result of the frontal deformation and resulting intrusion. Additionally, the safety belted driver loaded through the deployed driver's air bag and engaged the intruding steering assembly. Her loading of the steering assembly deformed the upper wheel rim (**Figure 9**) 13 cm (5") and compressed the energy absorbing column. This was verified by complete separation of the shear brackets. The sub instrument panel structure that the shear capsule blocks were mounted to was rotated vertically to a measured angle of 82 degrees. The front right seat and several components of the adaptive driving equipment were removed during the police inspection of the vehicle in search of the air bag control module. The interior intrusions are detailed in the following table.

Figure 9. Deformed upper steering wheel rim.

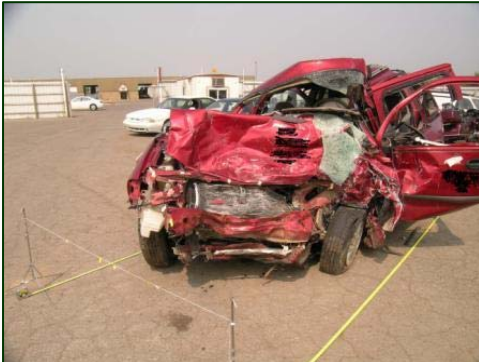
The Ford Windstar sustained severe frontal damage (**Figure 10**) as a result of the head-on crash with the Chevrolet Venture minivan. Maximum crush was measured at 148 cm (58.4") at the left corner of the upper radiator support and 139 cm (54.6") at the left corner of the bumper beam. The direct contact damage began at the right corner of the hood and extended 147 cm (58") to the left corner. The Ford's bumper fascia was separated by the impact and was not with the vehicle. (A Pontiac bumper fascia of another color was placed in the passenger compartment of this vehicle.) This fascia was not related to this crash. The impact severely crushed the frontal structure of the van. The left corner area was displaced rearward which deflected the right corner area of the Windstar laterally left. Two levels of measurements were documented for the frontal crush profile (**Figure 11**); one at the level of the bumper beam and the second at the level of the upper radiator support. The bumper beam was crushed and displaced left which

Figure 10. Frontal view of the damage to the Ford Windstar.

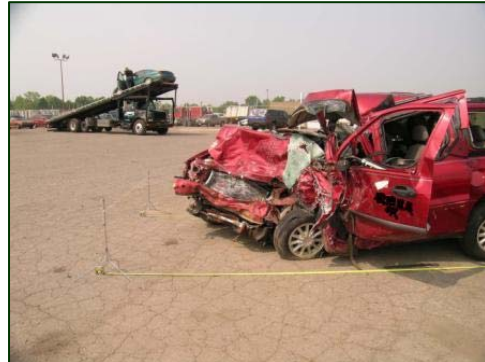
Figure 11. Lateral view of the Windstar's frontal crush profile.

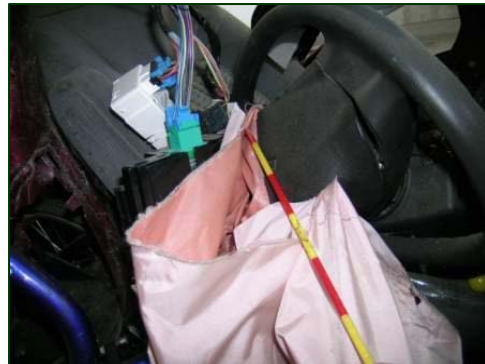
The driver air bag was conventionally mounted within the steering wheel and concealed by two I-configuration module cover flaps. The symmetrical cover flaps were 10 cm (3.75") in width and 11 cm (4.4") in height at the vertical tear seam. The air bag membrane was approximately 61 cm (24") in diameter in its deflated state and was tethered by two internal straps at the 3 and 9 o'clock positions. The air bag was vented by two 2 cm (0.75") diameter vents at the top forward panel of the bag. The driver air bag was torn on the left side adjacent to the module assembly (**Figure 12**). The air bag did not yield driver loading/contact evidence at the time of the SCI inspection.

Figure 12. Tear of the driver's air bag.

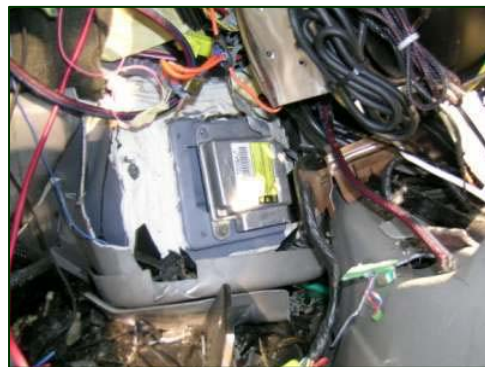
During the SCI inspection process of the vehicle, the total damage was evaluated, both exterior and interior. The SDM was observed by the SCI investigator who noted that the toe pan and forward floor pan of the lowered floor was crushed and displaced rearward. As a result of this floor deformation, the SDM’s mounting platform rotated from a horizontal position to a measured angle of 60 degrees rearward (**Figure 13**). NHTSA personnel inspected exemplar vehicles with the lowered floor that were not involved in crashes. All SDMs in these vehicles were properly oriented in a horizontal position.

Figure 13. Repositioned and rotated SDM by intrusion.

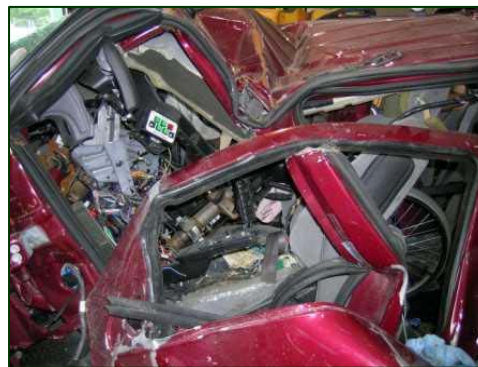
Figure 14. Intrusion of the driver’s compartment.

At impact, the frontal air bag system deployed. The exterior crush was translated into the passenger compartment as intrusion. The left A-pillar, instrument panel, toe and floor pans and the steering assembly grossly intruded into the driver's compartment (**Figure 14**). She initiated a forward trajectory in response to the frontal crash forces. She loaded the belt system and loaded through the deployed air bag as the steering assembly intruded rearward. Her loading of the steering assembly compressed the energy absorbing column and separated the shear brackets. The steering wheel rim was deformed approximately 13 cm (5") forward. As a result of her involvement with the intruding steering assembly, the driver sustained multiple lacerations of the liver, transaction of the pancreas, laceration of the descending aorta, multiple bilateral rib fractures, a sternum fracture, and pulmonary contusion hemorrhages.
