INDIANA UNIVERSITY

TRANSPORTATION RESEARCH CENTER

ON-SITE CERTIFIED ADVANCED 208- COMPLIANT VEHICLE INVESTIGATION

CASE NUMBER - IN-05-037
LOCATION - TEXAS
VEHICLE - 2005 GMC ENVOY XUV
CRASH DATE - August 2005

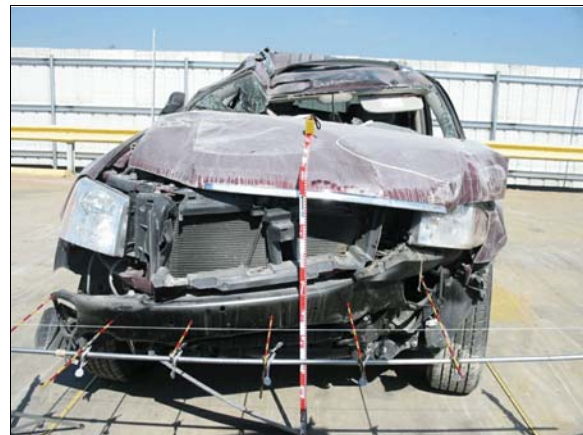
Crash: The case vehicle departed the roadway and crossed the median shoulder. The case vehicle's front left (Figure 2) impacted the concrete median barrier causing a stage one deployment of the case vehicle's driver air bag. The front right passenger's air bag did not deploy because there was no front right passenger in the vehicle at the time of the crash. Following the front impact with the median barrier, the case vehicle deflected to the right off the barrier and began to rotate clockwise. The vehicle continued to rotate clockwise until it was approaching broadside and tripped and rolled over, driver side leading. The vehicle landed hard on the right roof side rail (Figures 2 and 3) and continued over onto it wheels completing one full roll (i.e., four quarter rolls). The case vehicle then rolled onto its left side and onto its top and slid to final rest. The case vehicle rolled over a total of one-and-one-half rolls (i.e., six quarter rolls).

Figure 2: Damage to front of case vehicle from impact with concrete median barrier and to the roof from the rollover, numbers on tape measure on hood are tenths of meter

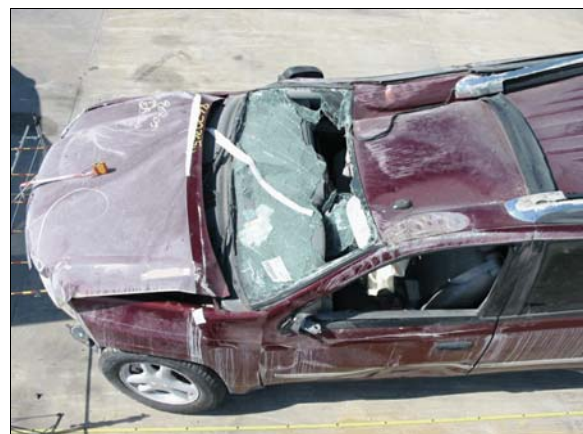
Figure 3: Top view of rollover damage to the case vehicle's roof, black marks on tape measure on ground are 0.31 meter (1 foot)

Damage Classification: Based on the vehicle inspection, the CDCs for the case vehicle were determined to be: **11-FLEW-1 (320 degrees)** for the impact with the concrete median barrier and **00-TDDO-4** for the rollover. The WinSMASH reconstruction program, barrier algorithm, was used to reconstruct the case vehicle’s Delta V for the impact with the concrete median barrier. The Total, Longitudinal and Lateral Delta Vs are, respectively: 14.0 km.p.h. (8.7 m.p.h.), -10.7 km.p.h. (-6.6 m.p.h.), and 9.9 km.p.h. (5.6 m.p.h.). The collision fits the reconstruction model, but based on the crush to the front of the case vehicle, the results appear low. The EDR recorded Delta V data for the case vehicle’s impact with the median barrier. The Total, Longitudinal and Lateral Delta Vs based on these data are, respectively: 25.30 km.p.h. (15.7 m.p.h.) -23.56 km.p.h. (-14.64 m.p.h.) 9.22 km.p.h. (5.73 m.p.h.). The EDR recorded Delta Vs appears consistent with the extent of crush to the front of the case vehicle. Based on the crush to the roof,

the severity of the rollover was determined to be severe. The case vehicle was towed due to damage.

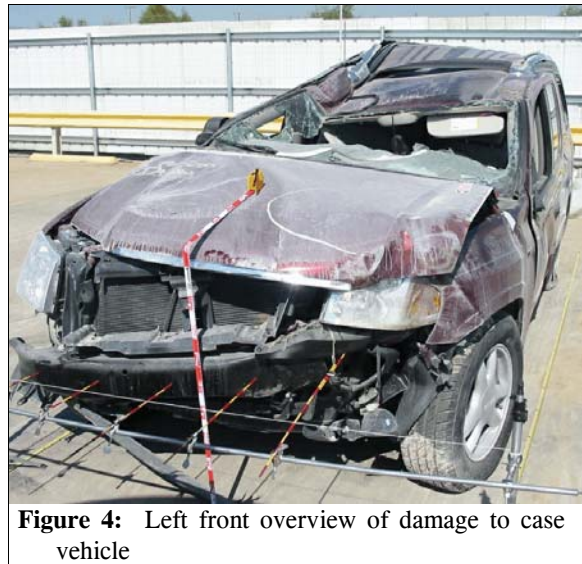
Exterior Damage: The case vehicle's impact with the median barrier involved the front left of the vehicle. The front bumper, left headlamp/turn lamp assembly, front of the left fender and the hood were directly contacted and crushed rearward and to the right (**Figures 4 and 5**). The direct damage began at the front left bumper corner and extended 54 centimeters (21.3 inches) across the bumper. The front crush measurements were taken at the bumper level, and the maximum residual crush was measured as 22 centimeters (13.7 inches) occurring at C₁. The direct damage from the rollover involved the left side (**Figures 6 and 7** below), left front and left rear wheel rims and the roof. The right side view mirror was turned in and there were a few scratches on the right front door and right fender. This appeared

Figure 4: Left front overview of damage to case vehicle

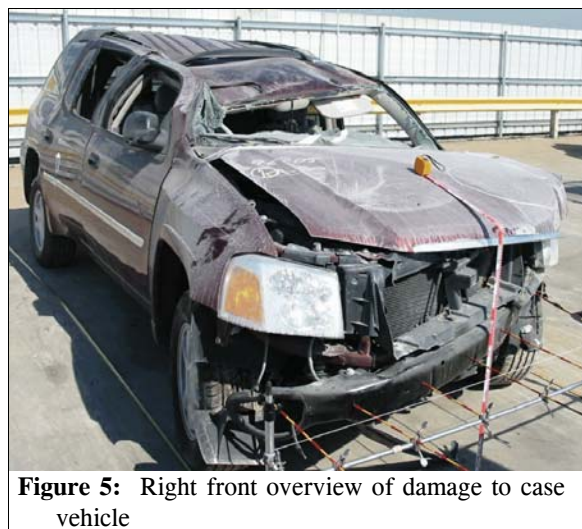
Figure 5: Right front overview of damage to case vehicle

to be related to towing activities when the vehicle was rolled back onto its wheels. The evidence indicated that the right side of the vehicle cleared the ground during the passenger side leading rollover. The table below shows the case vehicle's front crush profile.

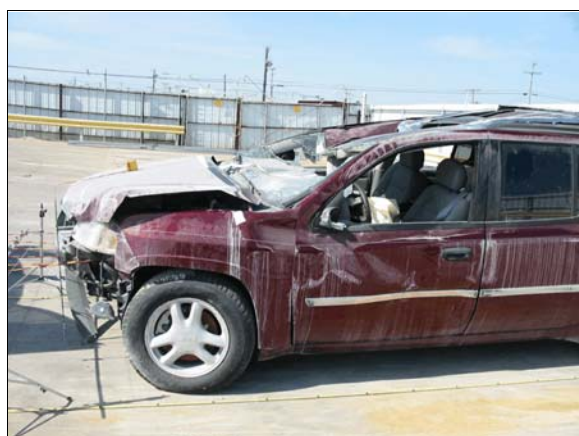
Figure 6: Rollover damage to left side of case vehicle

The case vehicle's left side wheelbase was reduced 8 centimeters (3.1 inches). The right side wheelbase was unchanged. Induced damage involved the entirety of the case vehicle with the exception of the tailgate, back bumper and right quarter panel.

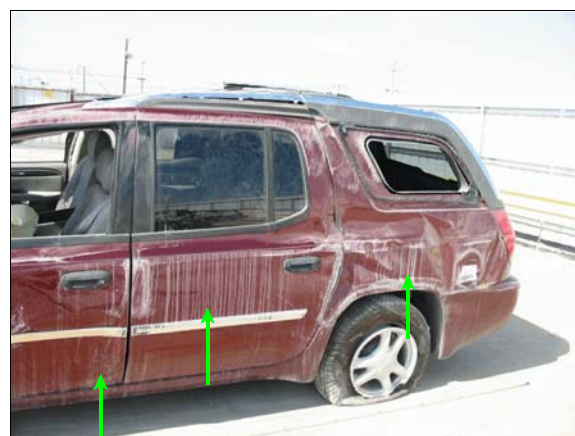
Figure 7: Rollover damage to left side of case vehicle, vertical streaks indicated by arrows are not rollover damage, they are streaks in dust from rain runoff

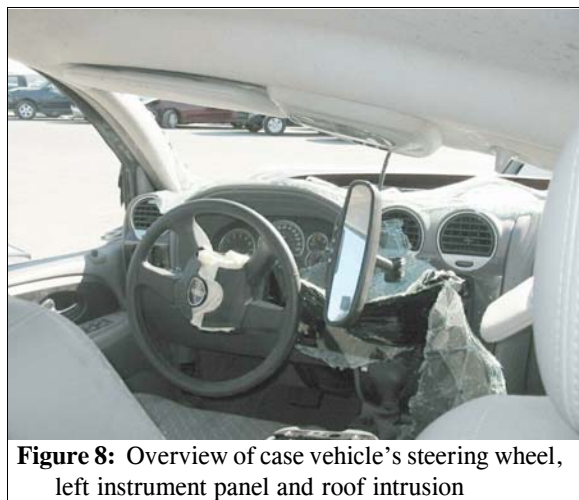
Vehicle Interior: Inspection of the case vehicle’s interior (**Figures 8 and 9**) revealed a few hairs adhering to the roof above the driver’s seat (**Figure 10** below) and a scuff on the left front corner of the driver’s seat cushion. No other evidence of occupant contact to any interior surfaces or components was observed. Numerous passenger compartment intrusions were observed and documented. The most severe intrusions involved the roof, windshield header and right A-pillar. There was approximately 34 centimeters (13.4 inches) of roof and windshield header intrusion into the front right occupant space and approximately 18 centimeters (7.1 inches) of roof and windshield header intrusion into the driver’s occupant space. In addition, the right “A”-pillar intruded approximately 10 centimeters (3.9 inches) vertically and 20 centimeters (7.9 inches) laterally into the front right occupant space. Lastly, there was no evidence of compression to the energy absorbing steering column or deformation of the steering wheel rim (**Figure 11** below).

Figure 8: Overview of case vehicle’s steering wheel, left instrument panel and roof intrusion

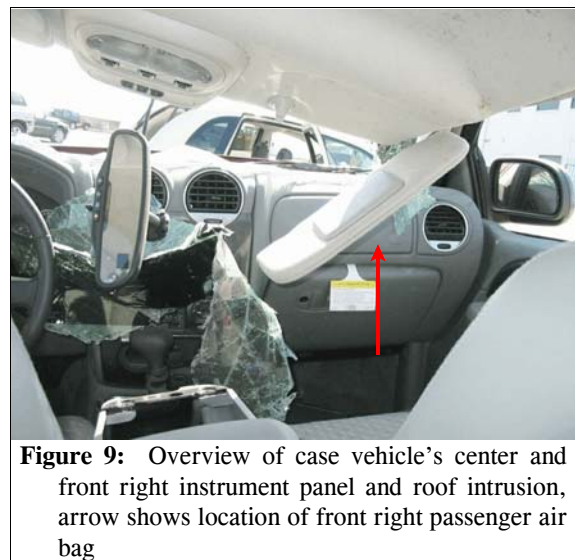
Figure 9: Overview of case vehicle’s center and front right instrument panel and roof intrusion, arrow shows location of front right passenger air bag

The case vehicle was equipped with manufacturer certified advanced 208-compliant air bags at the driver and front right passenger positions. The case vehicle’s SDM commanded a first stage deployment of the driver’s air bag due to the impact with the concrete median barrier. The front right passenger’s air bag did not deploy (Figure 9 above) because there was no front right passenger seated in the vehicle at the time of the crash. The case vehicle’s front right passenger sensor correctly determined the absence of a passenger and suppressed deployment of the front right passenger air bag.

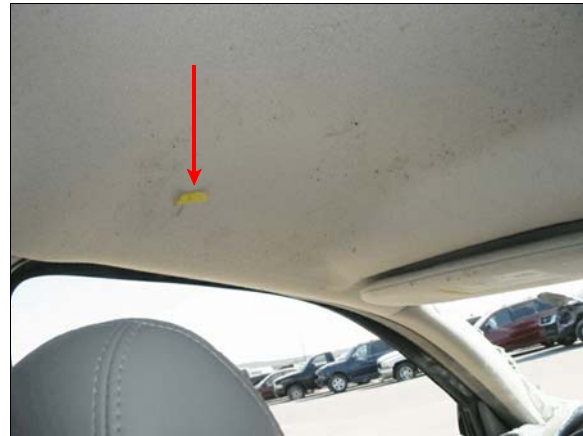
Figure 10: Arrow shows area of hair deposit on roof above driver’s seat

up against the left front door as the case vehicle began to rollover driver side leading. The driver moved toward the roof and she continued to load her safety belt. Her head impacted the intruding roof as the vehicle landed on its top during the second quarter roll. The driver most likely moved to the right and back down into her seat as the case vehicle completed its third and fourth quarter rolls and landed on its wheels. The driver then moved to the left and against the left front door and toward the roof a second time as the case vehicle completed its fifth and sixth quarter rolls and landed on its top. The driver most likely contacted her head on the roof a second time when the case vehicle landed on its top. The driver remained restrained in her seat as the case vehicle slid on the pavement on its roof and came to final rest. The driver most likely remained restrained in her seat, upside down, as the case vehicle came to rest. It is not known if the driver was able to exit the case vehicle under her own power following the crash. The driver's use of her integral, three-point, lap-and-shoulder safety belt, and the deployment of her safety belt pretensioner and air bag mitigated her interaction with the case vehicle's frontal components and reduced her injury potential during the barrier impact. The driver's use of her safety belt retained her in her seat and mitigated her interaction with the roof and interior vehicle components during the rollover.

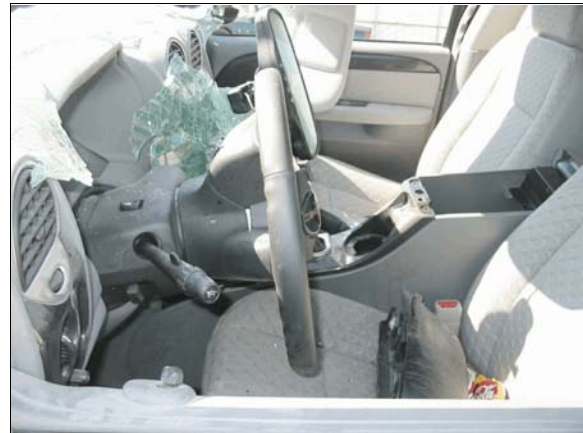
Figure 11: Left side view of case vehicle’s steering wheel and steering column showing lack of deformation

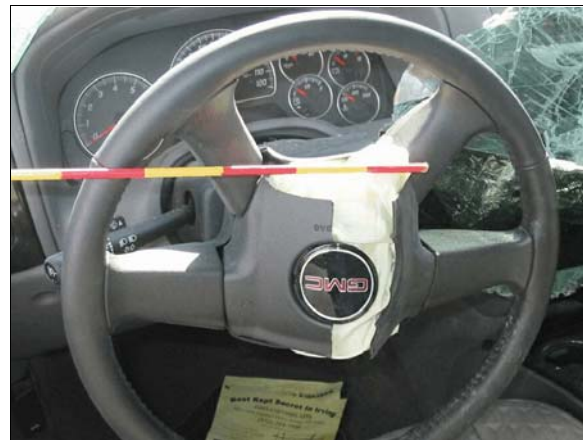
The case vehicle’s driver air bag was located in the steering wheel hub. An inspection of the air bag module cover flaps and the air bag fabric revealed that the cover flaps opened at the designated tear points (Figure 12). There was no evidence of damage during the deployment to the air bag or the cover flaps. The module cover consisted of “I” configuration cover flaps made of pliable vinyl. Each cover flap was 7.3 centimeters (2.9 inches) in width at the top, 5 centimeters (2 inches) in width at the bottom and 12 centimeters in height along the vertical tear seam. The center section of the right cover flap was designed with a circular GMC emblem. Half of the emblem fit into a semi-circular contour on the left cover flap. The driver’s air bag was designed with two tethers, each approximately 11 centimeters (4.3 inches) in width. The deployed driver’s air bag (Figure 13 below) was round with a diameter of approximately 62 centimeters (24.4 inches) and had two vent ports (Figure 14 below), each approximately 3 centimeters (1.2 inches) in diameter, located at approximately the 10:30 and 1:30 o’clock positions. The distance between the mid-center of the driver’s seat back, as positioned at the time of the vehicle inspection (i.e., seat between middle and forward most track

Figure 12: Case vehicle driver’s air bag module cover flaps, each stripe on rod is 5 cm (2 in)

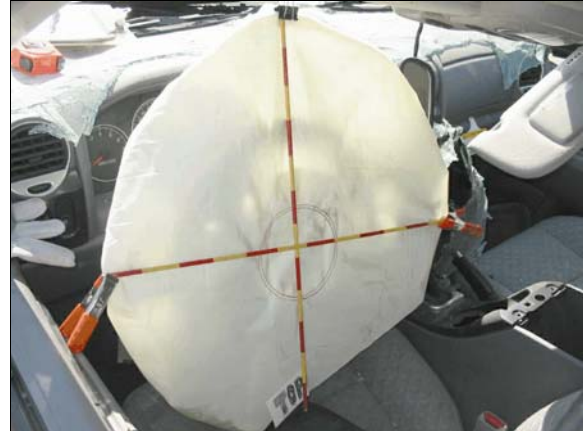
position, seat back slightly reclined), and the front surface of the air bag fabric at approximate full excursion was 30 centimeters (11.8 inches). An inspection of the driver's air bag fabric revealed no evidence of occupant contact to the air bag. However, there were several dirt or grease scuffs on the front on the air bag that may have been related to the driver exiting the vehicle following the crash.

Figure 13: Case vehicle's driver air bag, steering wheel is rotated 180 degrees, top of air bag is at bottom of photo

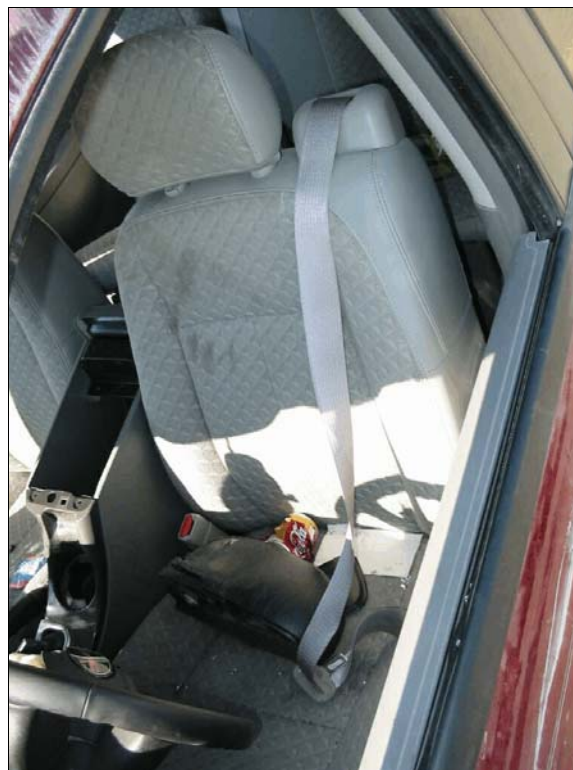
Based on this contractor's vehicle inspection, and supported by the EDR data, the case vehicle's driver was restrained by her integral, three-point, lap-and-shoulder safety belt system. The safety belt pretensioner had deployed and the belt was partially out of the retractor and the retractor was jammed (**Figure 15**).

Figure 15: Overview of driver's seat and safety belt, the safety belt was partially out of the retractor and the retractor was jammed

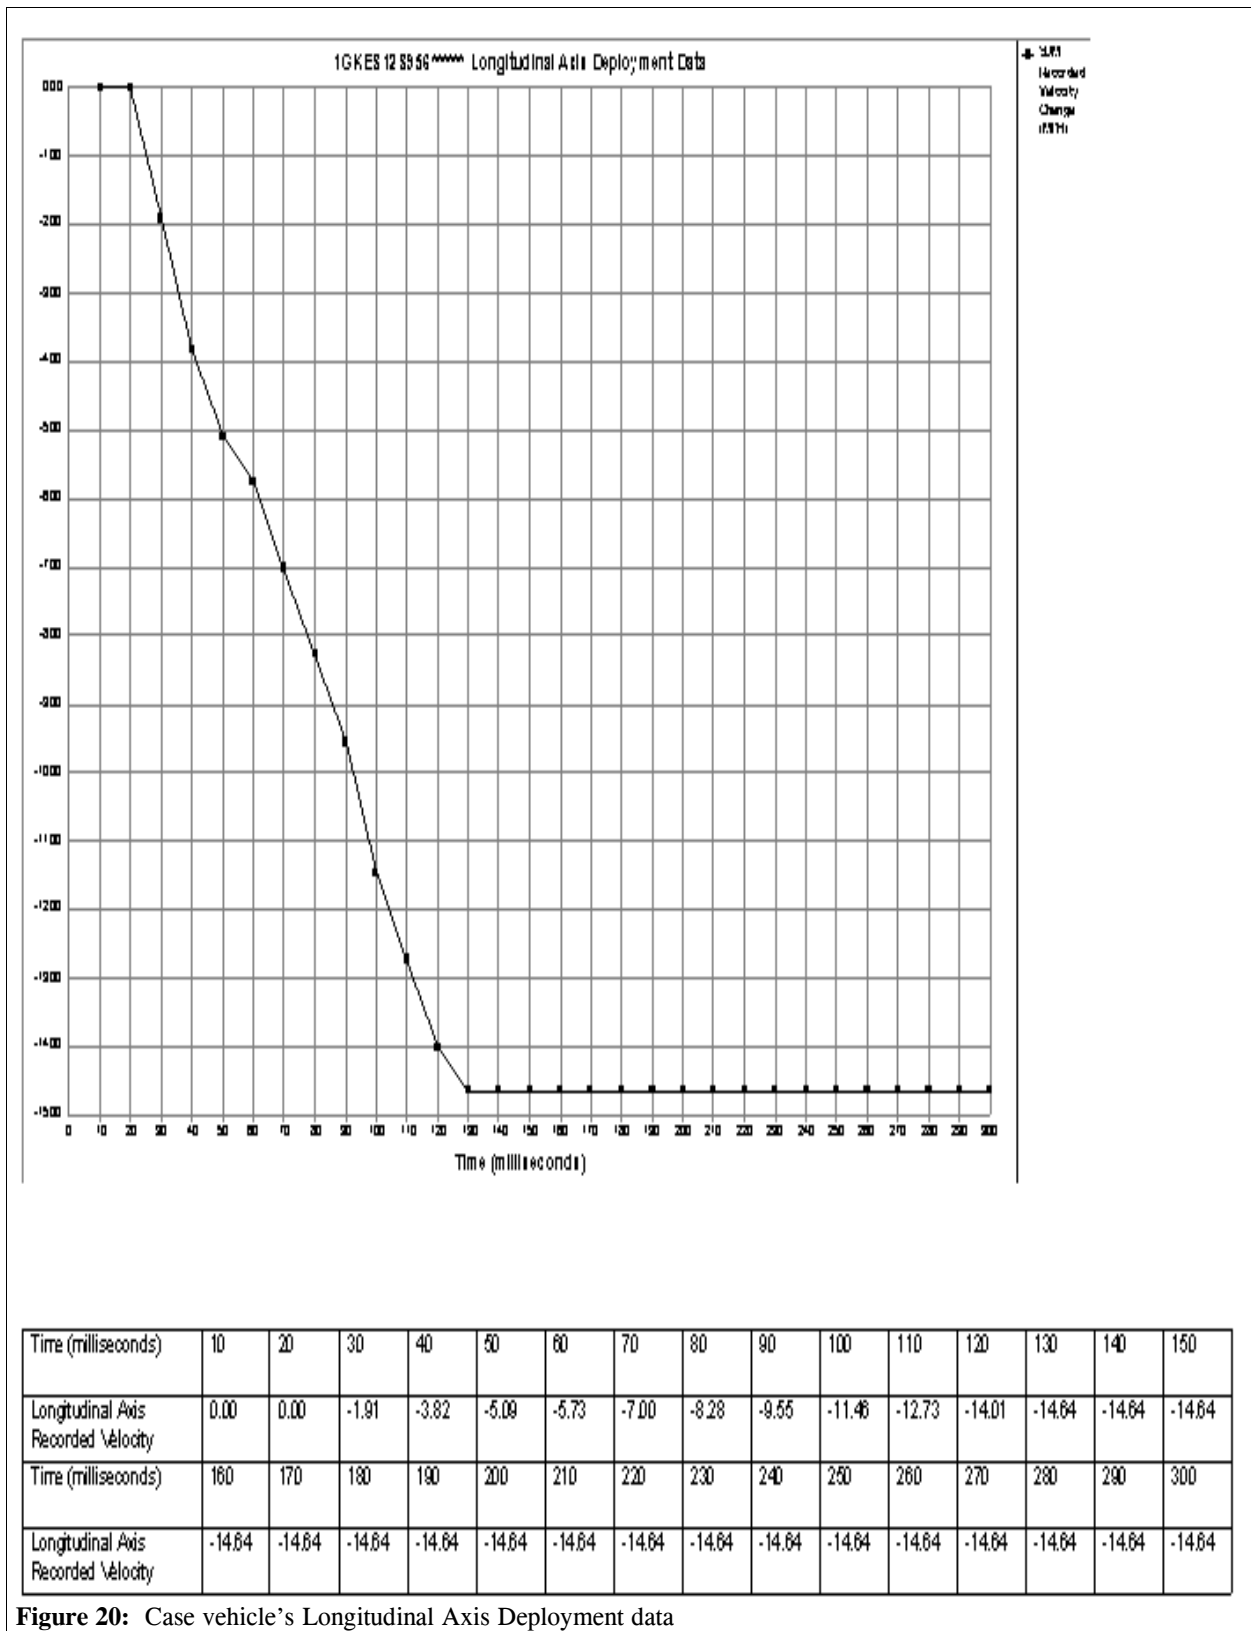
The deployment system status report shows that the driver's air bag, first stage deployment criteria was met 46.25 milliseconds after AE. The second stage deployment criteria was not met and a disposal of the second stage inflator was recorded. The deployment system status report also shows that the SIR warning lamp was recorded as "off", the driver's safety belt switch circuit was recorded as "buckled", her seat position switch circuit was recorded as "rearward" and her safety belt pretensioner was commanded to deploy. The EDR recorded a maximum longitudinal velocity change of -23.56 km.p.h. (-14.64 m.p.h.) occurring approximately 130 milliseconds after AE and a maximum lateral velocity change of 9.22 km.p.h. (5.73 m.p.h.) occurring approximately 110 milliseconds after AE. The pre-crash data indicated that the case vehicle was traveling 118 km.p.h. (73 m.p.h.) five seconds prior to AE slowing to 100 km.p.h. (62 m.p.h.) one second prior to AE. In addition, the brake switch circuit indicated that the brakes were not applied during the five seconds prior to AE.

Figure 20: Case vehicle's Longitudinal Axis Deployment data

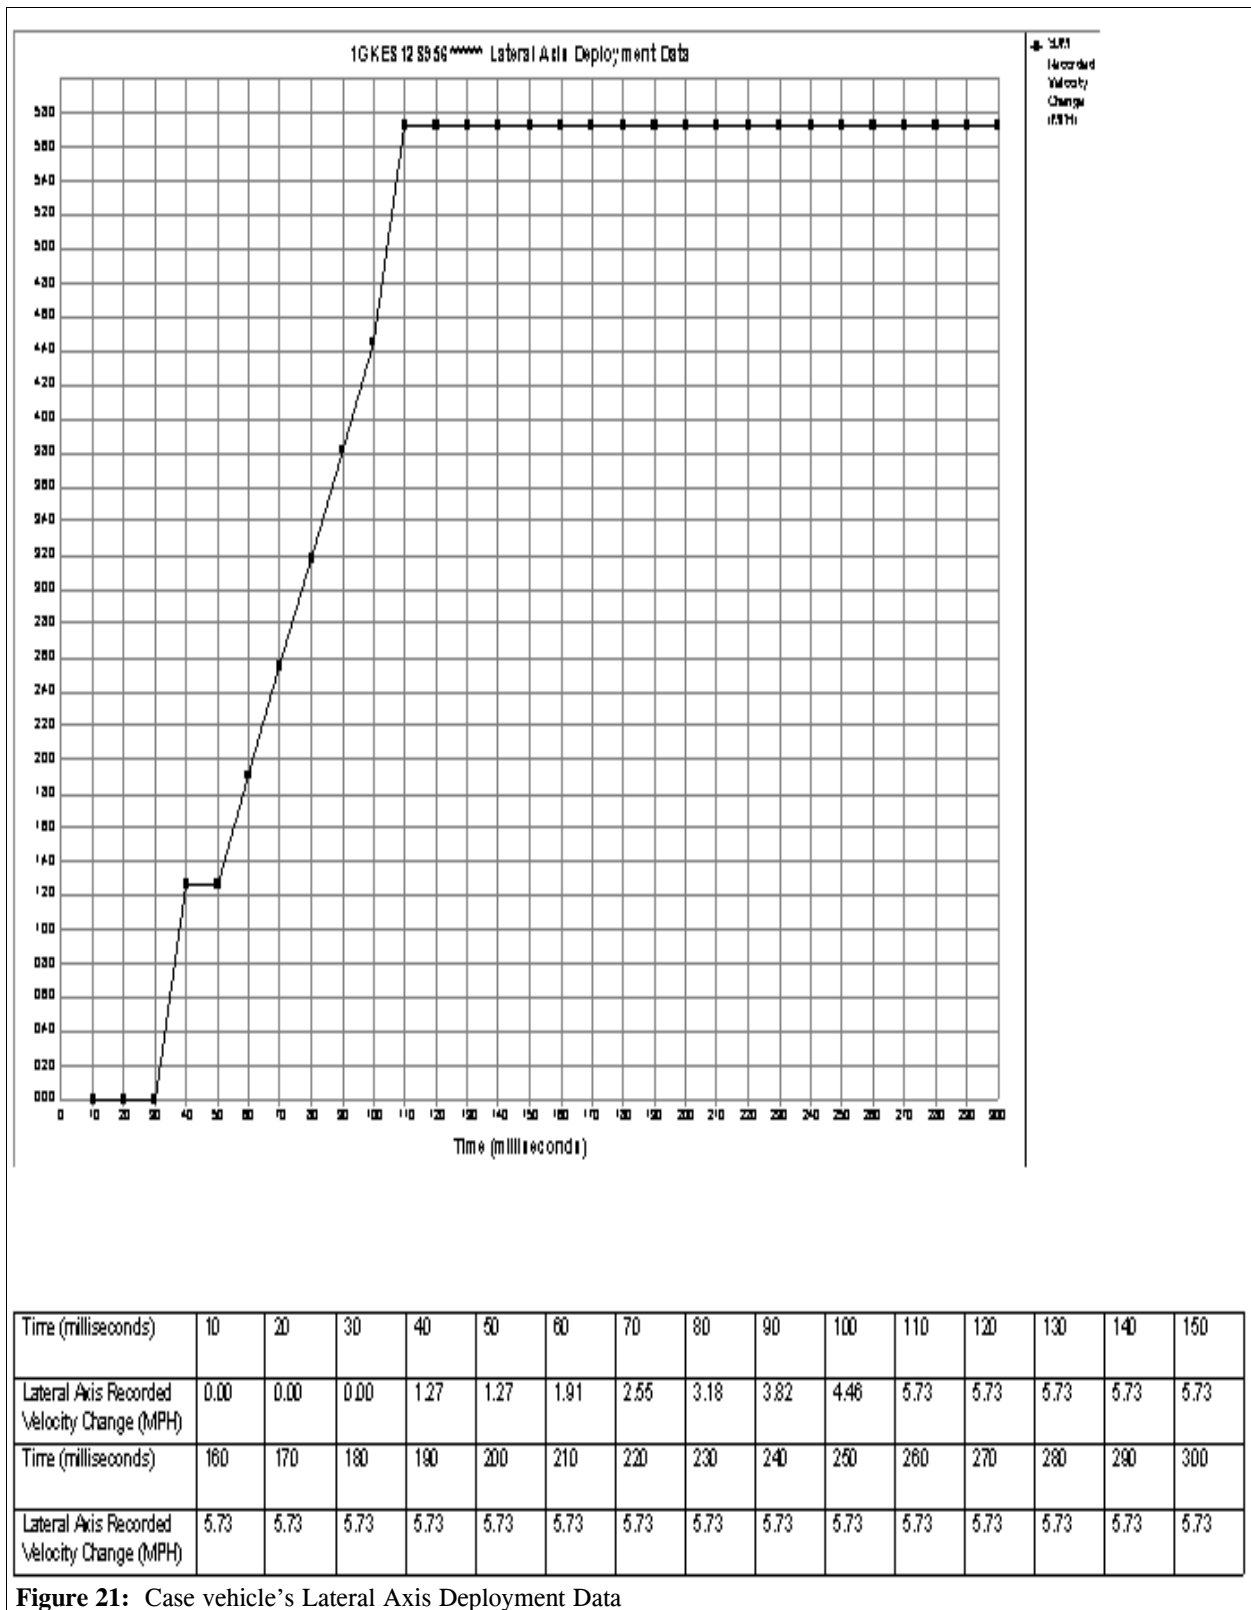
Figure 21: Case vehicle's Lateral Axis Deployment Data
