**CALSPAN ON-SITE CHILD SAFETY SEAT CRASH INVESTIGATION
SCI CASE NO: CA05-038**

**VEHICLE: 1998 CHEVROLET CAVALIER
LOCATION: FLORDIA
CRASH DATE: JUNE, 2005**

<p><i>14. Sponsoring Agency Code</i></p>	
<p><i>15. Supplementary Note</i> An investigation of a side impact crash involving a 1998 Chevrolet Cavalier.</p>			
<p><i>16. Abstract</i></p> <p>This investigation focused on the crash dynamics and fatal injury mechanisms of a 20 month old female seated in a Cosco Touriva convertible Child Safety Seat (CSS) restrained in the rear left position of a 1998 Chevrolet Cavalier. The Chevrolet was involved in a left side impact crash with a 2005 Suzuki GSX 1300 R Hayabusa motorcycle. The 26 year old female driver of the Chevrolet pulled out from a parking lot directly into the path of the motorcycle precipitating the crash. The impact of the motorcycle into the left rear door area of the Chevrolet resulted in a 47 cm (18.5 in) of door panel intrusion. The child was seated at the point of impact and sustained fatal head injuries. She was life-flighted to a trauma center and pronounced deceased. The driver of the Chevrolet was not injured. The motorcyclist sustained unidentified minor injur

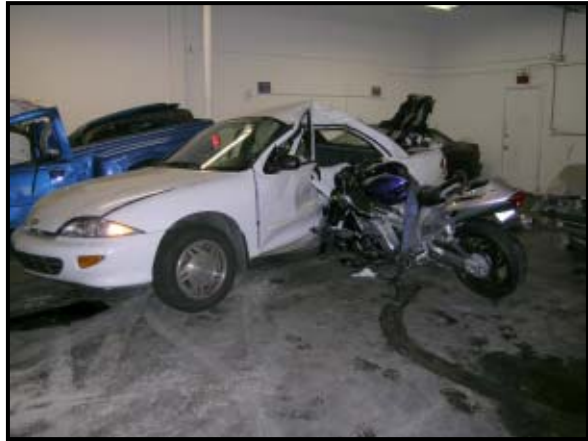
Figure 1: Left side view of the Chevrolet Cavalier and the impacting Suzuki motorcycle.

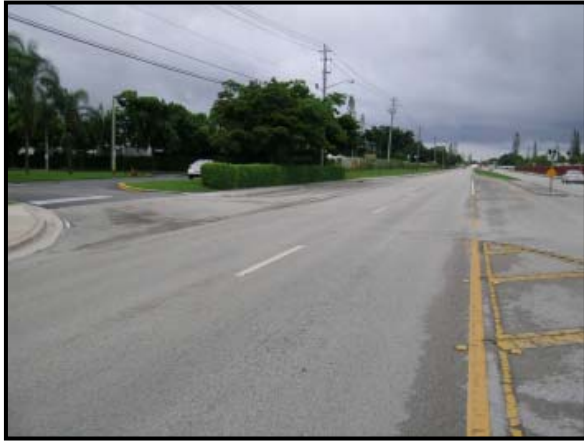
Figure 2: Northeasterly view of the crash site.

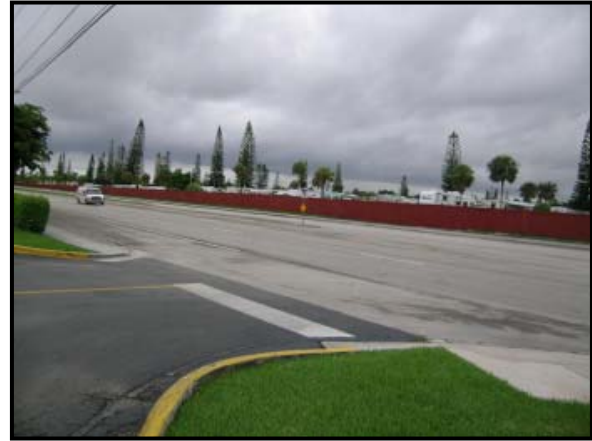
Figure 3: Southeasterly trajectory view from the parking lot exit.

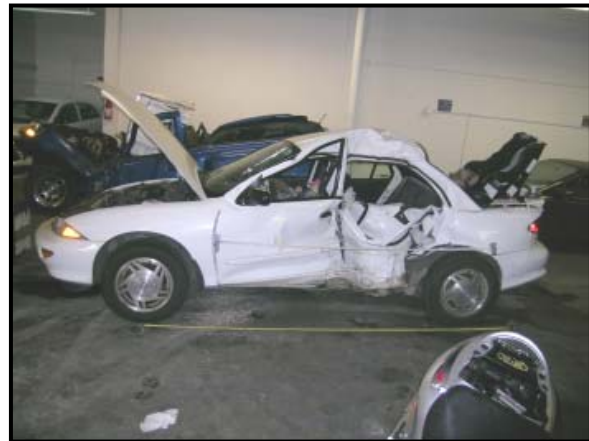
Figure 4: Left side view of the Cavalier.

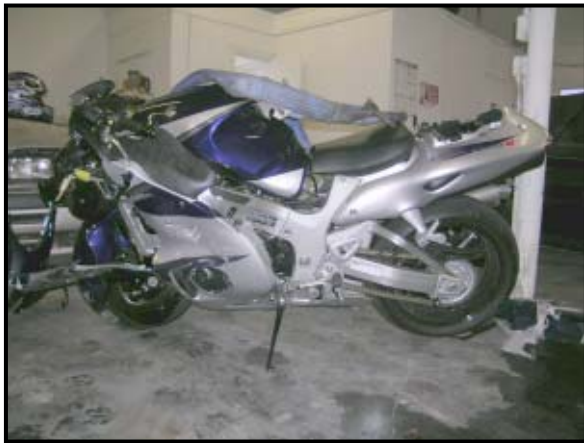
Figure 5 is a left side view of the motorcycle. The motorcycle sustained moderate damage to its front wheel assembly, front suspension/fork and the front fairings. The deformed wheelbase measured 132 cm (52 in). The 32 year old male driver of the motorcycle was wearing a full-face Shoei helmet, **Figure 6**, at the time of the crash. The left aspect of the helmet's chin guard fractured due to contact with the left roof rail during the impact. The helmet's face shield remained intact.

Figure 5: Left side view of the Suzuki.

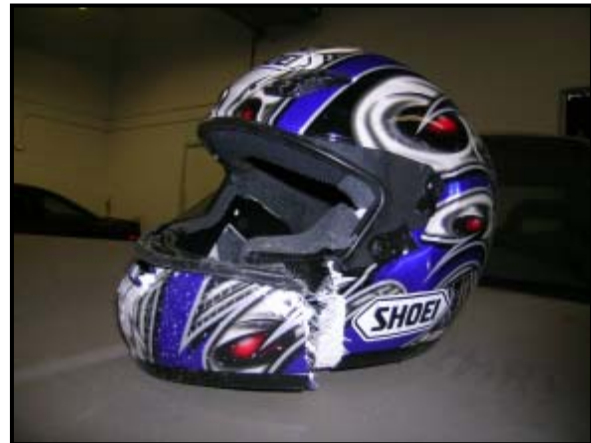
Figure 6: View of the fractured helmet...

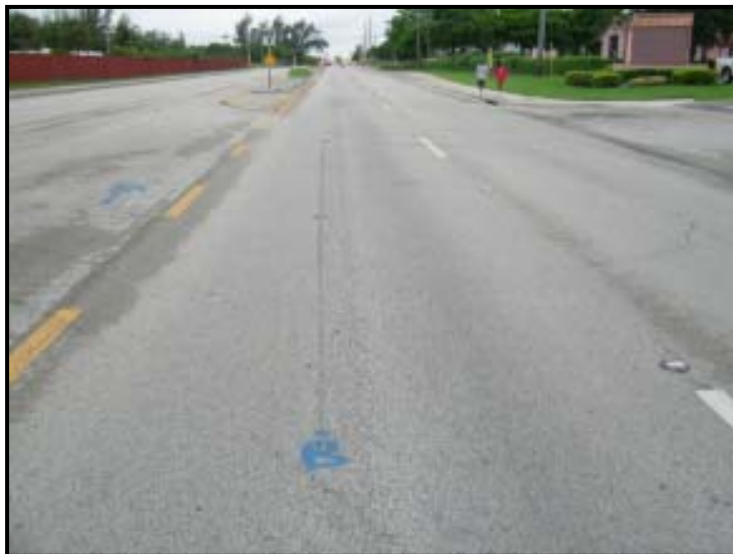
measured 18.3 m (60 ft) and 11.9m (39 ft), respectively, and were separated by a 4.9 m (16 ft) gap. The gap in the skid marks indicated the motorcyclist released and then reapplied the brakes. The end of the west skid identified the point of impact. **Figure 7** is a motorcycle trajectory view of the west skid mark and the point of impact. A schematic of the crash is attached to the end of this report as **Figure 17**.

Figure 7: Trajectory view of the motorcycle and the west skid leading to the point of impact.

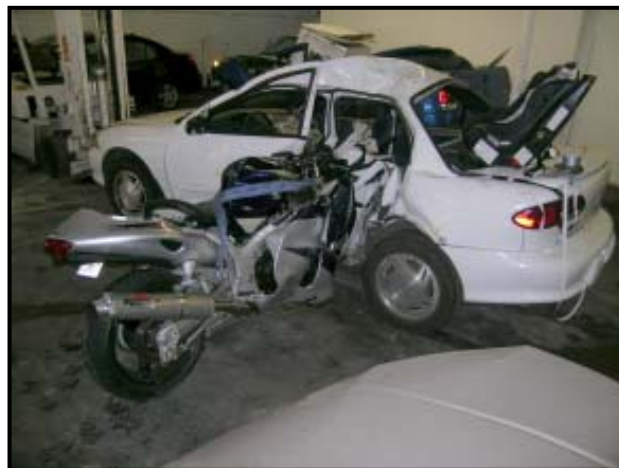
The Suzuki motorcycle impacted the left rear door of the Chevrolet in a T-configuration impact. **Figure 8** is a depiction of the vehicles at impact. The direction of force were in the 9/12 o'clock sectors for the Chevrolet and Suzuki respectively. The force of the impact rearward of the Chevrolet's center of gravity resulted in a counterclockwise (CCW) rotation of the vehicles during their engagement. The Chevrolet rotated approximately 330 degrees CCW and was displaced approximately 5.5 m (18 ft) to the southwest. The Suzuki and the motorcyclist separated from the Chevrolet as it neared the completion of its rotation. The Suzuki and motorcyclist came to rest approximately 9.1 m (30 ft) west of the impact. The Chevrolet came to momentary rest in the center of the road at the completion of its rotation and then rolled to its documented final rest location in the outboard westbound lane facing northward. The total delta V of the Chevrolet calculated by the Barrier Algorithm of the WINSMASH model was 37 km/h (23.0 mph). The longitudinal and lateral components of the delta V were -7 km/h (-4.3 mph) and 37 km/h (23.0 mph), respectively.

Figure 8: View of the impact configuration.

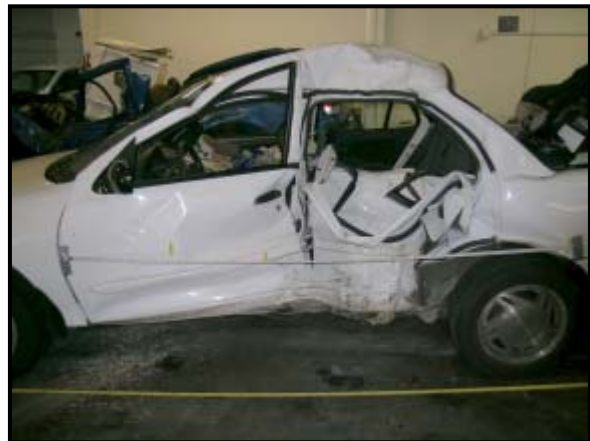
The left side plane of the Chevrolet sustained 68 cm (26.8 in) of direct contact damage as a result of the impact. The direct contact began 116 cm (45.5 in) forward of the left rear axle on the aft aspect of the left front door. The direct contact ended 47 cm (18.7 in) forward of the left rear axle on the aft aspect of the left rear door. Blue paint transfers from the motorcycle were noted within the region of direct contact. The combined width of the direct and induced damage measured 213 cm (84 in). The induced damage began 202 cm (79.7 in) forward of the left rear axle and ended 11 cm (4.3 in) rearward of the left rear axle. The residual crush profile at the mid-door elevation was as follows: C1 = 0, C2 = 19 cm (7.5 in), C3 = 58 cm (22.8 in), C4 = 34 cm (13.4 in), C5 = 9 cm (3.5 in), C6 = 0. The maximum crush was located 74 cm (29.3 in) forward of the left rear axle at the C3 crush measurement. The lateral deformation of the left roof rail measured 33 cm (13 in) at the left B-pillar location. The left wheelbase dimension was reduced 12 cm (4.8 in). The right wheelbase was unchanged. The Collision Deformation Classification (CDC) of the damaged vehicle was 09-LPAW4. **Figure 9** is a view of the left side damage.

Figure 9: View of the left side damage.

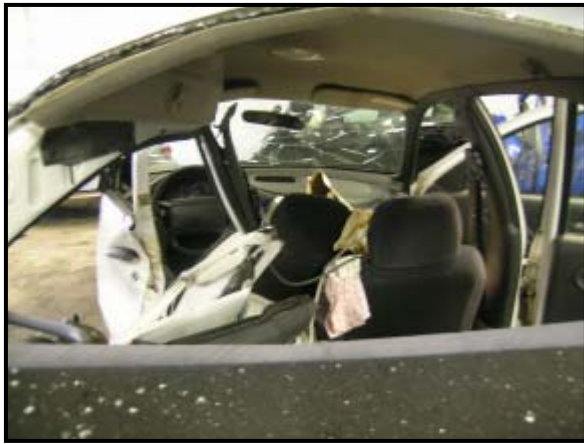
Figures 10 and 11 are views looking forward through the backlight depicting the front row and second intrusion, respectively. The residual left B-pillar intrusion measured 47 cm (18.5 in). The post-crash lateral distance from the left D-ring to the right D-ring measured 69 cm (27 in). The driver seat was displaced and rotated to the right by the intruding left side. The inboard aspect of the driver seat was in contact with the front right seat. The intrusion of the forward aspect of the left rear door panel measured 46 cm (18 in). This intrusion was measured 18 cm (7 in) forward of the leading edge of the rear seat cushion. The intrusion of the aft aspect of the left rear door (along the rear seat back) measured 19 cm (7.5 in). The painted C-rod in **Figure 11** was representative of the approximate center line of the vehicle.

Figure 10: View through the backlight of the extent of the intrusion.

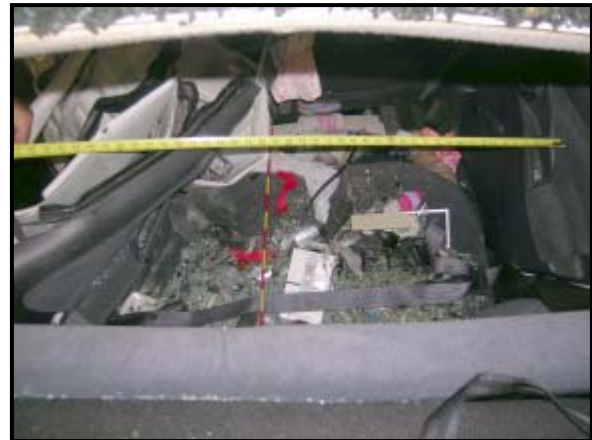
Figure 11: View through the backlight into the rear seat.

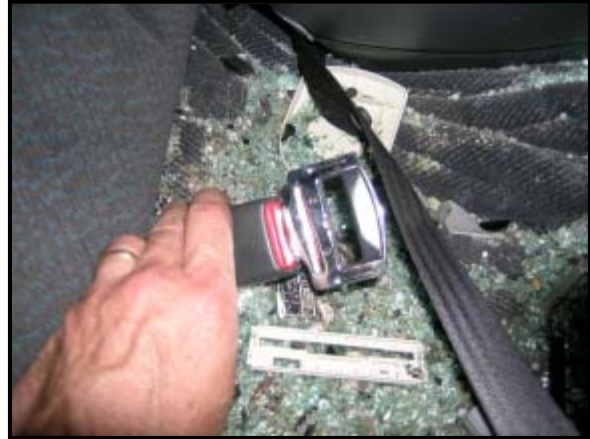
the latch plates light weight locking mechanism was fractured and missing, **Figure 12**. The light weight locking hardware likely fractured due to loading from the child safety seat as it was displaced laterally by the intruding door.

Figure 12: View of the left rear latch plate and receiver.

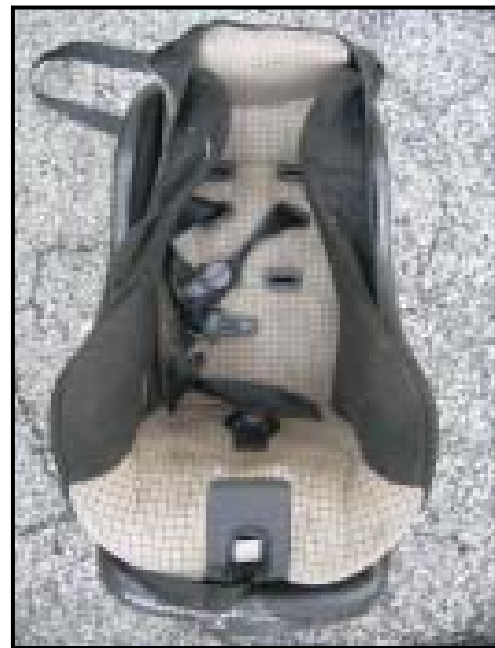
Figure 13: Front view of the CSS.

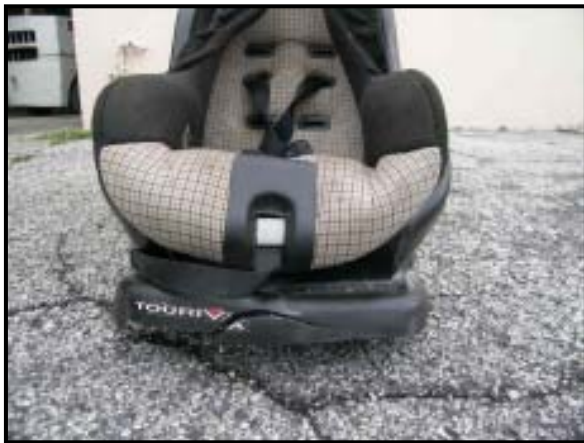
present and was located 30 cm (12 in) below the slots. The CSS was equipped with the Lower Anchors and Tethers for CHildren (LATCH) system. This system was not in use during the crash. Inspection of the CSS with the padding removed revealed fractures of the left forward and center aspects of the plastic shell. The black plastic shell was highly stressed evidenced by the “whited” plastic regions. The fractures and related stresses were directly related to contact from the intruding left rear door at impact. Refer to **Figures 14 and 15**. Minor abrasions were noted to the outboard edges of the forward-facing belt path. The CSS could not be repositioned into the vehicle’s left rear seat due to the magnitude of the intrusion. The label indicated the rear foot was to be extended while the CSS was used in the forward-facing mode. The foot was in the retracted position at the time of the inspection, **Figure 16**. It was not known if the position of the foot was altered by post-crash handling of the CSS.

Figure 14: Front view of the fractured CSS.

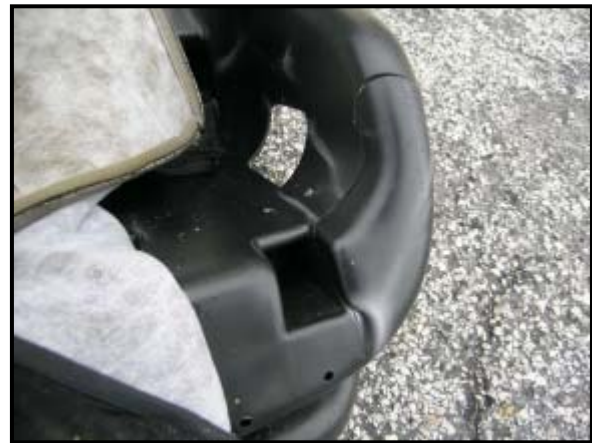
Figure 15: View of the fractured shell.

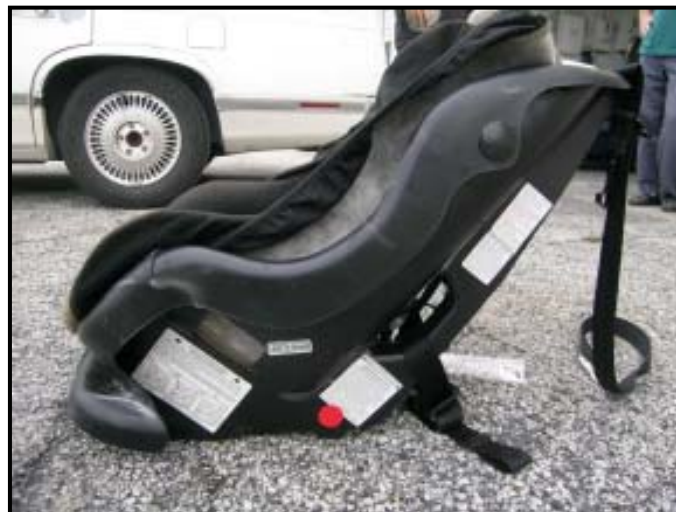
Figure 16: Left side view of the CSS.
