**CALSPAN ON-SITE ALTERNATIVE FUEL VEHICLE CRASH  
INVESTIGATION**

**CALSPAN CASE NO: CA05-041**

**VEHICLE: 2004 TOYOTA PRIUS**

**CRASH DATE: MAY 2005**

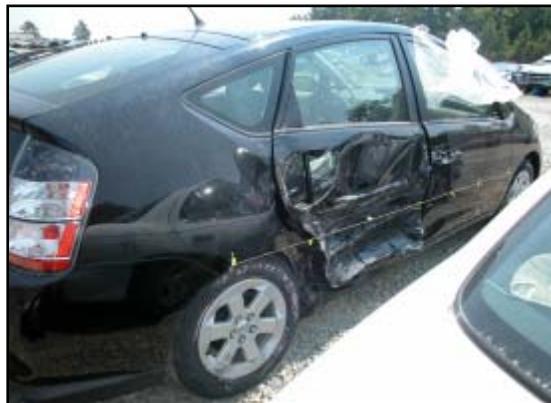
The 2004 Toyota Prius sustained minor right side damage as a result of the intersection collision with the Nissan (**Figure 4**). The damage consisted of lateral deformation to the right side doors and forward aspect of the right quarter panel. At the time of the SCI inspection, the rear right door was removed and placed in the rear seat of the vehicle. The SCI investigator repositioned the door and secured it in position for documentation of the damage. The direct contact damage began 10 cm forward of right rear axle and extended forward 137 cm (54.0") terminating 23 cm (9.0") forward of the rear edge of the right front door. The maximum crush measured 11 cm (4.3") and was located on the right rear door. The crush profile was documented utilizing six equidistant points along the mid-door level and were as follows: C1 = 0 cm, C2 = 5 cm (1.9"), C3 = 11 cm (4.3"), C4 = 9 cm (3.5"), C5 = 1 cm (0.4"), C6 = 0 cm. The Collision Deformation Classification (CDC) for this impact was 02-RZEW-2.

**Figure 4. Resultant right damage to the Prius.**

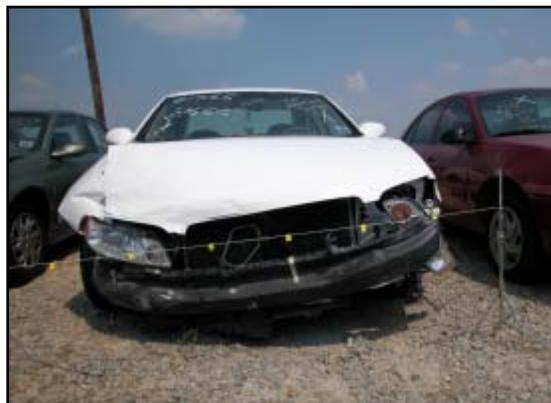
The 2000 Nissan Altima sustained minor damage as result of the impact with the Toyota (**Figure 5**). The damage consisted of longitudinal crush to the front bumper beam, hood, and to the right fender. The direct contact damage began 8 cm (3.0") right of the centerline and extended 65 cm (25.5") to the front right bumper corner. The maximum crush was located the right end of the bumper beam and measured 22 cm (8.7"). Six crush measurements were

**Figure 5. Nissan's minor frontal damage.**

documented along the full width of the front beam of 140 cm (55.0”), and were as follows: C1 = 0 cm, C2 = 0 cm, C3 = 3 cm (1.2”), C4 = 9 cm (3.5”), C5 = 15 cm (5.9”), C6 = 22 cm (8.7”). The CDC for the impact was 11-FZEW-1.

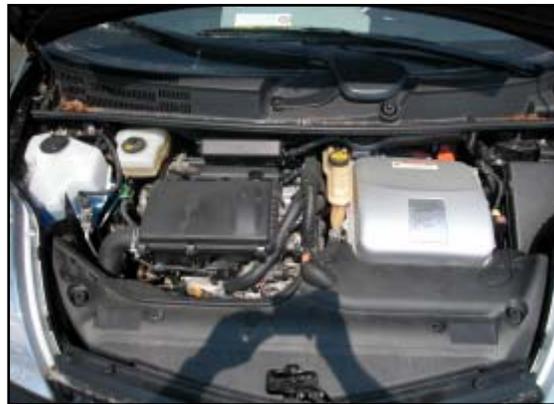
**Figure 6. Electric motor located in the left of the engine bay.**

This minor severity crash was isolated to the right C-pillar area. There was no intrusion of the battery pack area or damage to the area of the left side harness. The engine compartment was not damaged. This crash did not expose a risk to the driver. There was no evidence of damage or procedures initiated by the first responders to the crash site.

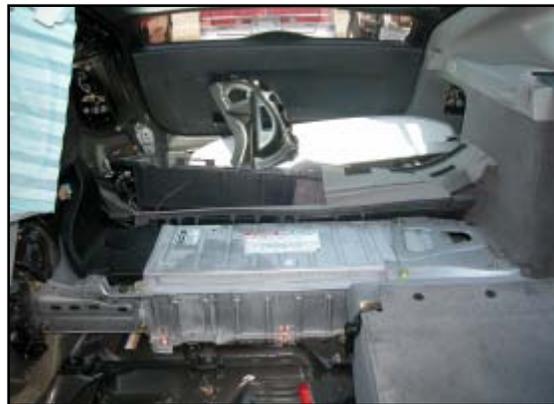
**Figure 7. Nickel metal-hydride battery pack.**

The battery system was a Nickel Metal-Hydride battery that was mounted in the rear cargo floor, aft of the second row seat (**Figure 7**). This high-voltage battery system was mounted lateral to the vehicle and was concealed and protected by an aluminum cover

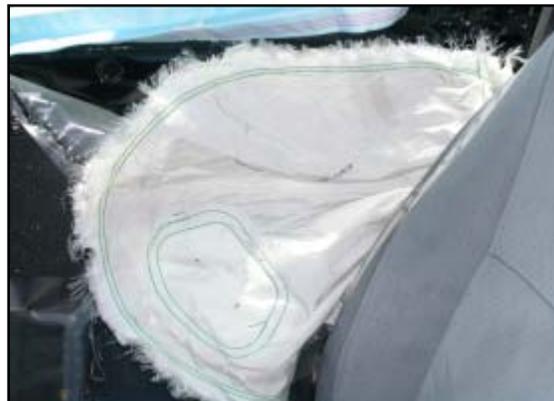
The 2004 Toyota Prius was equipped with seatback mounted side impact air bags for the front seating positions. In the subject crash, the right side impact air bag deployed (**Figure 8**). The air bag membrane was semi-circular in shape and measured 33.0 cm (13.0”) in height and 33 cm (13.0”) in width from the seatback. An additional 3 cm (1.0”) of air bag fabric extended beyond the outer edge peripheral seam of the expandable portion of the air bag. The entire perimeter of the side impact air bag was frayed. The air bag membrane contained two circular stitch patterns that created tethers between the front and rear panels. The outer stitching measured 15 cm (6.0”) in diameter and the inner stitching measured 13 cm (5.”). Two 1 cm (0.4”) diameter holes were located within the stitching. No occupant contacts or damage were noted to the air bag. The following nomenclature was printed on the inboard aspect of the air bag membrane:

**Figure 8. Deployed right seatback mounted side impact air bag.**

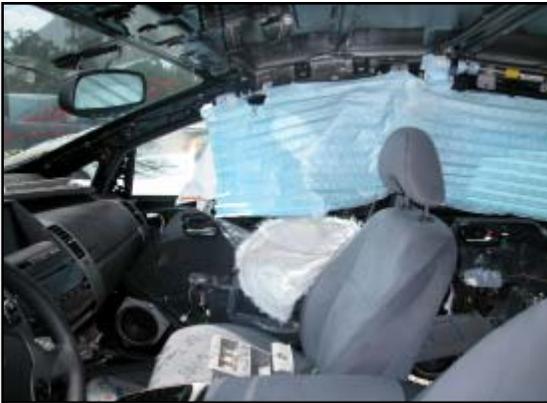
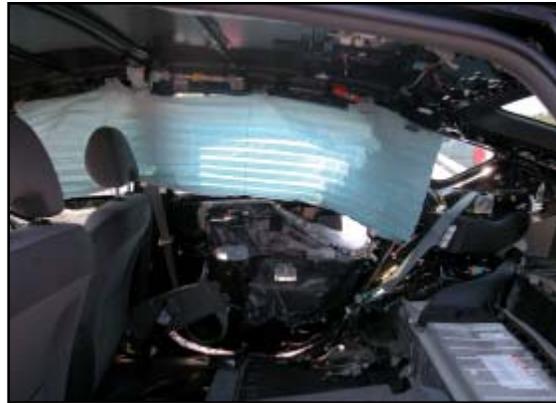
The 2004 Toyota Prius was equipped Inflatable Curtain (IC) air bags for the four outboard seating positions. As a result of the right side impact the right side IC deployed (**Figure 9 and 10**). The IC deployed downward from the right roof side rail and extended from the right A-pillar to the right C-pillar. Five clips attached the IC membrane to the roof side rail. The IC inflator canister was mounted on the side rail between the B- and C-pillars. The inflator canister measured 36 cm (14.3”) in length and 3 cm (1.0”) in diameter. The deployed IC was removed from the side rail during the estimate process and was temporarily reinstalled during the SCI inspection. The IC was free of occupant contact points or damage. A bar code noted with the following information was noted on the right IC:

**Figure 9. Front seat portion of the IC.**

**Figure 10. Rear seat portion of the right IC.**
