CALSPAN ON-SITE CHILD SAFETY SEAT CRASH INVESTIGATION

CALSPAN CASE NO: CA05-044

VEHICLE: 1998 DODGE CARAVAN

CRASH DATE: MARCH 2005

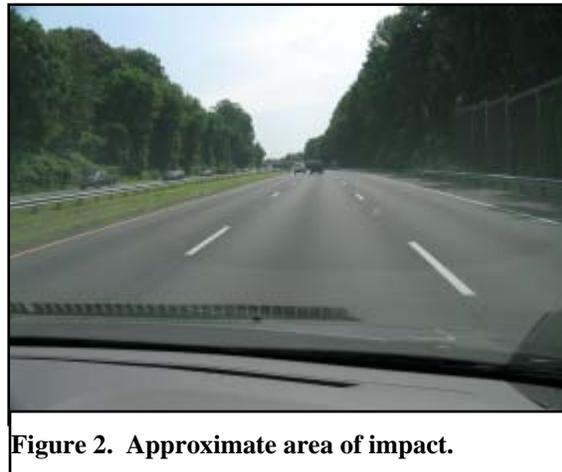
The front of the 2005 Ford E350 ambulance impacted the rear of the 1998 Dodge Caravan in slight off-set configuration. The front of the Ford impacted and overrode the rear bumper system of the Dodge resulting in contact and deformation to the tailgate and left quarter panel area. **Figure 2** is the approximate area of impact on the interstate.

Figure 2. Approximate area of impact.

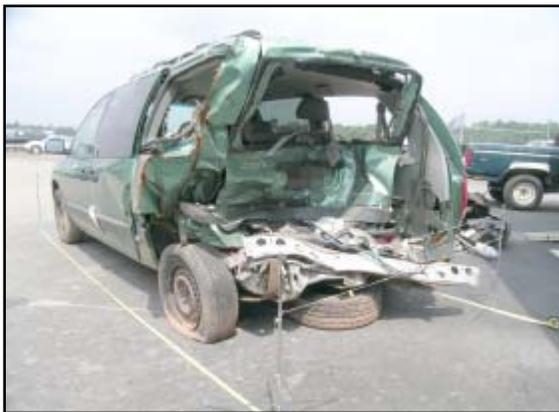
The 1998 Dodge Caravan sustained severe damage to the rear plane as a result of the impact with the 2005 Ford E350 ambulance. **Figures 3 and 4** are views of the damage to the Dodge. The front of the Ford contacted and overrode the rear bumper system of the Dodge resulting in deformation to both levels. Due to the override damage pattern, crush was documented at the bumper beam and the lower aspect of the tailgate. The direct contact damage at the bumper beam was 141 cm (55.5”) and began 63 cm (24.8”) right of the centerline and extended to the left corner. The maximum crush was 65 cm (25.6”) located at the left corner of the bumper beam. The residual crush was documented along the full width of the deformed bumper beam (Field L) of 133 cm (55.5”). Six equidistant crush measurements were documented at this level and were as follows: C1 = 65 cm (25.6”), C2 = 58 cm (22.8”), C3 = 48 cm (18.9”), C4 = 28 cm (11.0”), C5 = 12 cm (4.7”), C6 = 0 cm.

The above bumper crush was captured by measuring a crush profile 11 cm (4.5”) above the lower the edge of the tailgate. The six crush measurements were as follows: C1 = 79 cm (31.2”), C2 = 85 cm (33.5”), C3 = 87 cm (34.2”), C4 = 81 cm (31.9”), C5 = 39 cm (15.3”), C6 = 36 cm (14.2”). The Collision Deformation Classification (CDC) for this impact was 06-BDEW-6. Additional damage included a 3 cm (1.0”) reduction of the left wheelbase, deformation of the left quarter panel and roof. The backlight and both quarter windows were disintegrated. The front and side doors remained closed and operational. The latch released from the striker of the tailgate; however, it was jammed in a closed position.

Figure 3. Overall view of the rear damage.

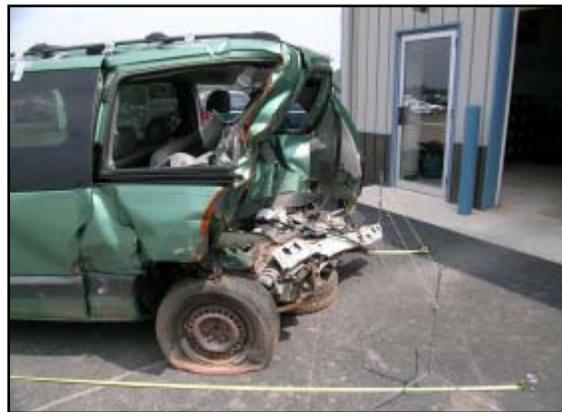
Figure 4. Lateral view of the crush.

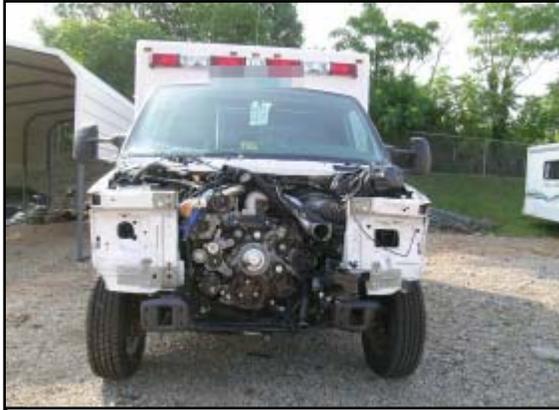
The 2005 Ford E350 ambulance sustained unknown severity frontal damage. The repairs to the frontal structure of the vehicle were started prior to the SCI inspection; therefore, there was not measurable crush. The estimated CDC was 12-FDEW-1. **Figures 5 and 6** are of the dismantled Ford.

Figure 5. Dismantled frontal structure

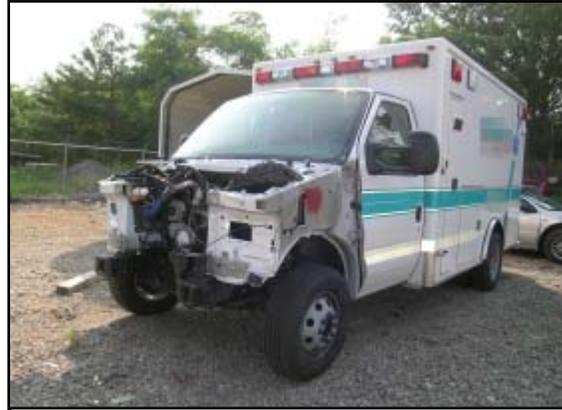
Figure 6. 2005 Ford E350 ambulance.

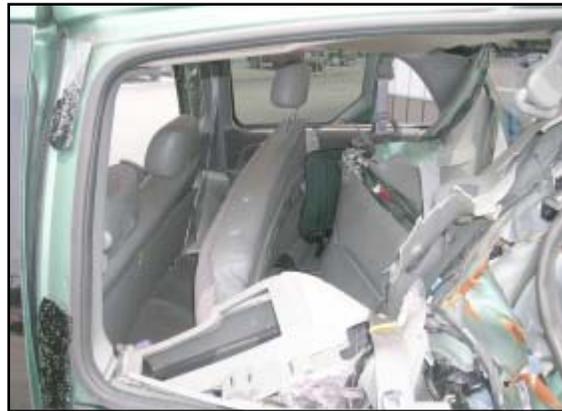
The interior of the Dodge sustained moderate damage from occupant contact. The occupant contact points consisted of deformed front seatbacks from loading by the driver and front right passenger. The inboard aspects of the seatbacks were deformed rearward and rotated inboard. The second row passengers loaded the seatback which was evidence by slight deformation to the outboard aspects. The second row bench seat was disengaged from the floor anchors which resulted from loading by the third row seat cushion. The Dodge sustained severe damage from passenger compartment intrusion (**Figure 7**). The intrusions are identified in the following table:

Figure 7. Third row intrusion and displaced third row bench seat.

Seat Position	Intruded Component	Magnitude	Direction
Third row	Left seatback	46 cm (18")	Longitudinal
Third row	Center seatback	43 cm (17")	Longitudinal
Third row	Right seatback	33 cm (13")	Longitudinal
Third row	Left seat cushion	19 (7.5")	Longitudinal
Third row	Center seat cushion	14 cm (5.7")	Longitudinal

Seat Position	Intruded Component	Magnitude	Direction
Third row	Right seat cushion	8 cm (3.2")	Longitudinal
Third row	Left tailgate (at beltline)	84 cm (33")	Longitudinal
Third row	Center tailgate (at beltline)	84 cm (33")	Longitudinal
Third row	Right tailgate (at beltline)	78 cm (30.7")	Longitudinal

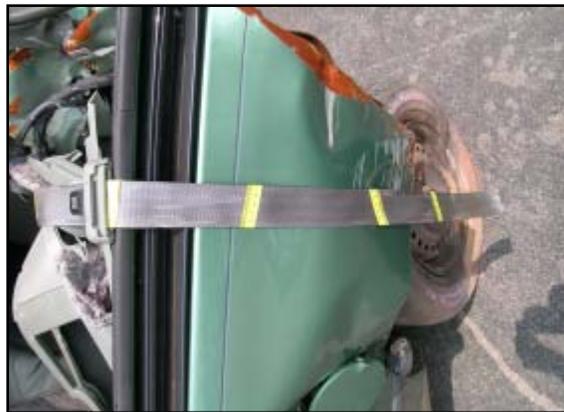
Figure 8. Third row left safety belt transfers and loading evidence.

abrasion was noted full width 6 cm (2.3”) on the D-ring. **Figure 8** is an overall view of the transfers and loading evidence on the third row left safety belt.

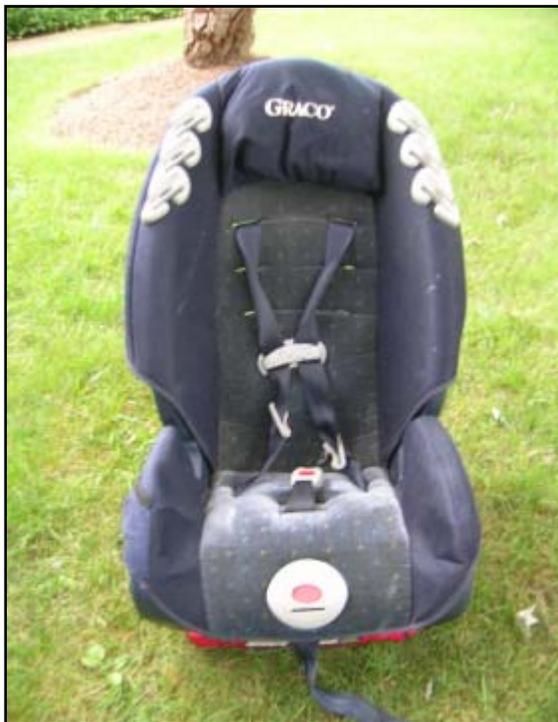
The 4-year-old female was restrained by the integrated five-point harness system of a forward facing child safety seat in the third row right position of the Dodge. The child safety seat was a Graco Ultra Cargo with a model number of 8487BLU. The manufacture date was 10/14/02 (**Figure 9**). The safety seat was designed to be used with the integrated harness system or as belt positioning booster seat. The safety seat was installed in the Dodge with the lap and shoulder belt routed through the forward facing belt slots. Due to the passenger compartment intrusion, the safety seat was compressed against the seatback of the second row seat. This compression resulted in numerous stress/loading marks to the plastic shell. The stress marks were located full width on the top and bottom aspects across the seat cushion area and the lower belt positioning booster seat belt path (**Figure 10**). Stress/loading marks were also noted on the outboard aspects of the safety seat. The forward facing belt path exhibited loading marks that resulted from interaction with vehicle’s lap and shoulder belt system. No fractures were present on the safety seat.

Figure 9. Graco child safety seat.

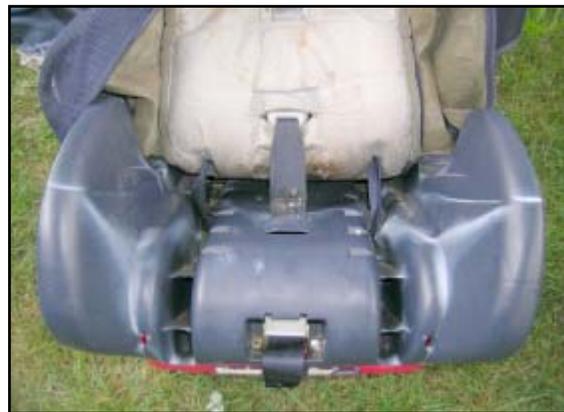
Figure 10. Stress marks on the seat cushion aspect.

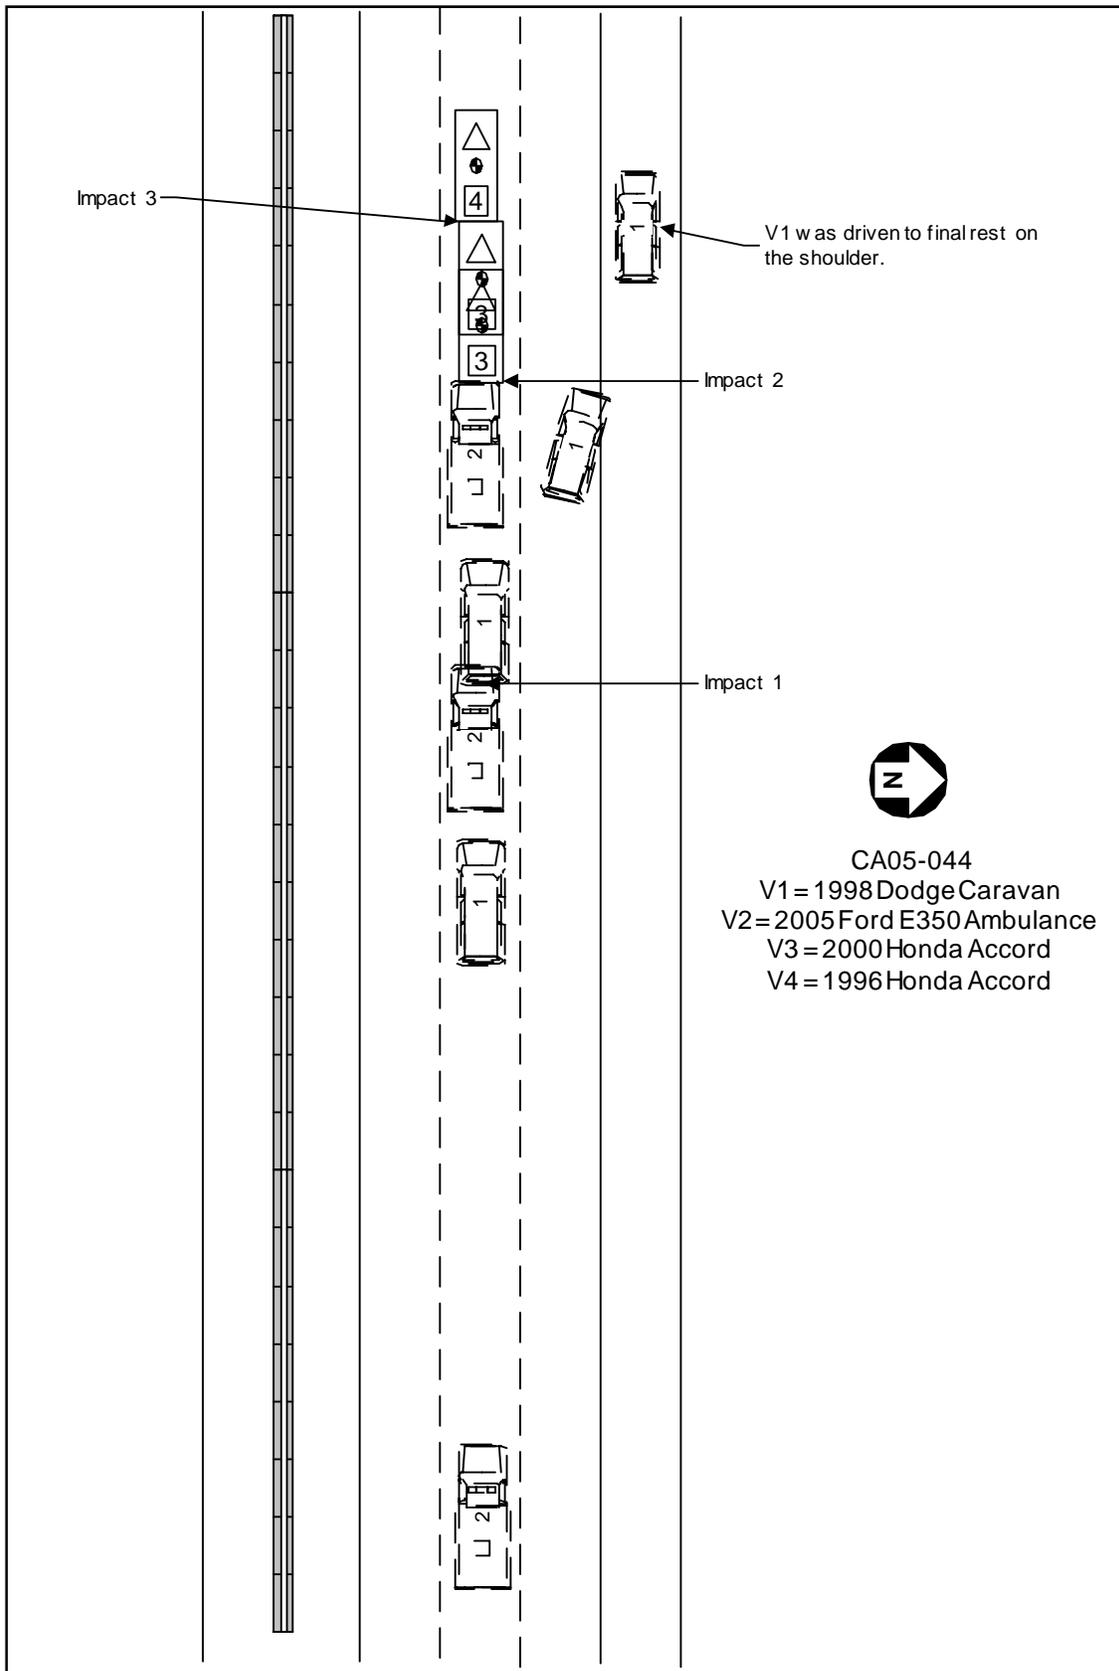
Figure 11: Scene Schematic

This rear-end crash occurred during the daylight hours on an east/west interstate roadway. The weather conditions at the time of the crash were reported as clear and the travel lanes were dry. The roadway consisted of three asphalt surfaced eastbound lanes with an asphalt shoulder. The east/westbound lanes were separated by a depressed grass median with a W-beam median barrier. A yellow fog line bordered the north road edge and a yellow fog line bordered the south road edge. The posted speed limit within the vicinity of the crash site was 89 km/h (55 mph). Due to the heavy traffic and the passage of time between the crash date and the case assignment, there was no physical evidence remaining at the scene. The scene schematic is included as **Figure 11** of this report.
