**CALSPAN ON-SITE CERTIFIED ADVANCED-208 COMPLIANT VEHICLE
CRASH INVESTIGATION**

SCI CASE NO. – CA05-053

SUBJECT VEHICLE – 2005 FORD ESCAPE

CRASH DATE – AUGUST 2005

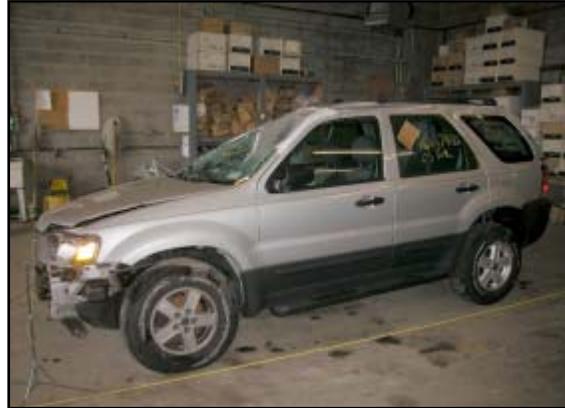
Figure 1. Subject vehicle 2005 Ford Escape.

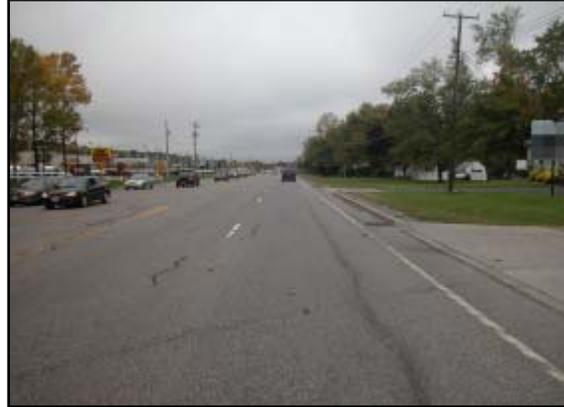
The restrained 45-year-old female driver of the 2005 Ford Escape was operating the vehicle westbound on the four-lane roadway in the right lane (**Figure 2**). The 26-year-old female driver of a 2002 Chevrolet Cavalier initiated a right turn from a business driveway and began to travel westbound in the right lane at a police reported speed of approximately 32 km/h (20 mph). A non-contact vehicle was traveling ahead of the Ford and changed lanes to the left to avoid contact with the Chevrolet. The driver of the Ford also attempted to change lanes and applied and left steering input.

Figure 2. Ford's westbound travel.

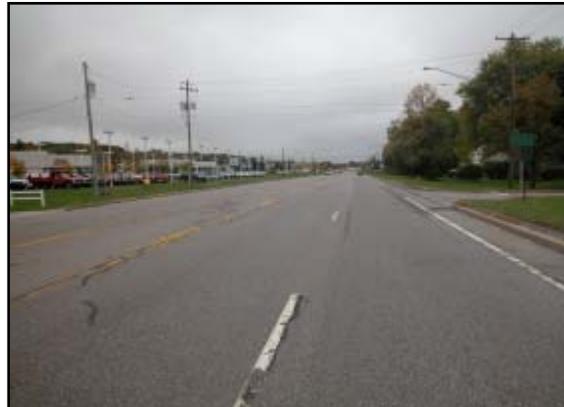
Although the driver of the Ford applied a left steering input, she was unable to avoid contact the Chevrolet. Consequently, the front right of the Ford impacted the rear left of the Chevrolet in an off-set corner type impact configuration (**Figure 3**). The resulting directions of force were 12 o'clock for the Ford and 6 o'clock for the Chevrolet. The RCM calculated delta-V was approximately 22.5 km/h (14 mph) at 112 ms. The RCM did not capture the entire crash due to memory limitation. At 112 ms the delta-V was increasing; therefore, only a portion of the delta-V was recorded. The WINSMASH program was used to calculate a delta-V for this impact. The total delta-V for the Ford was 12 km/h (7.5 mph) with longitudinal and lateral components of -12 (-7.5 mph) and 0 km/h, respectively. The total delta-V for the Chevrolet was 15.0 km/h (9.3 mph). The longitudinal and lateral components were 15 km/h (9.2) and -3 km/h (1.9 mph), respectively. Due to the off-set corner impact the WINSMASH program under estimated the delta-V. The driver's frontal air bag deployed in the Ford due to the deceleration sustained during the front-to-rear impact.

Figure 3. Area of impact between the Ford and Chevrolet.

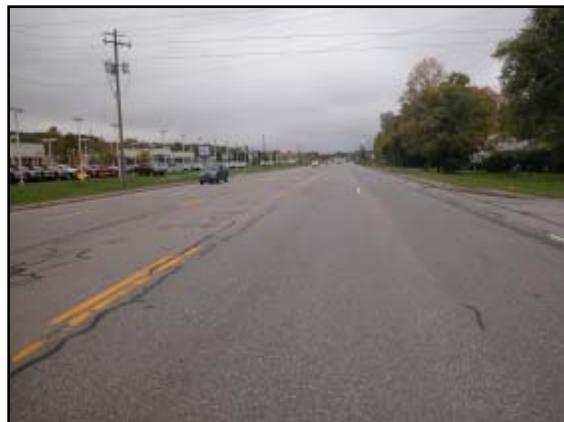
Figure 4. Approximate area of rollover event.

The impact location to both vehicles was outboard of the frame rails. The Ford continued forward remaining engaged with the Chevrolet. The Ford's right front wheel contacted the rear left wheel of the Chevrolet. As a result, the Ford rotated clockwise allowing the left tires to roll under the alloy wheels and contact the asphalt road surface. This contact tripped the vehicle and it rolled two quarter turns left side leading onto its roof (**Figure 4**). There was no physical evidence at the crash site to indicate the point of trip and rollover.

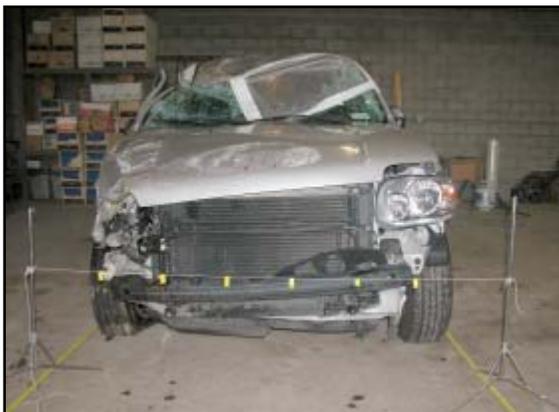
The 2005 Ford Escape sustained minor severity frontal damage as a result of the impact with the Chevrolet (**Figure 5 and 6**). The direct contact damage began 45 cm (17.7") right of the vehicle's centerline and extended 21 cm (8.3") to the front right bumper corner. Due to the corner impact, the direct contact damage extended down the right front fender 77 cm (30.3"), terminating rear of the right front wheel. The maximum crush measured 4 cm (1.6") and was located at the front right corner of the bumper beam. The crush was documented utilizing six equidistant points along the 112 cm (44.0") width of the front bumper beam and were as follows: C1 = 0 cm, C2 = 0, C3 = 0, C4 = 0, C5 = 2 cm (0.8"), C6 = 4 cm (1.6"). Crush was noted to the front right frame rail which was deformed 4 cm (1.6") rearward. The Collision Deformation Classification (CDC) for this impact was 12-FREE-4.

Figure 5. Frontal damage from the impact with Chevrolet.

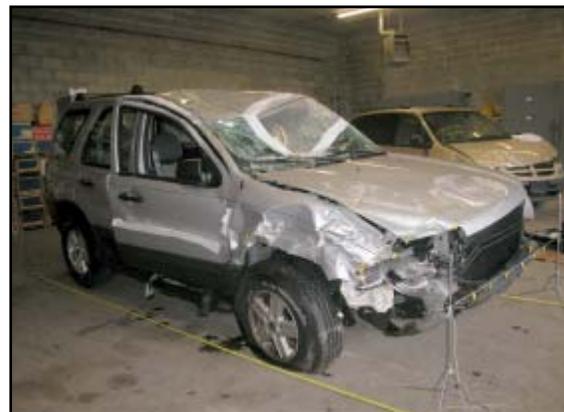
Figure 6. Direct contact damage on right front.

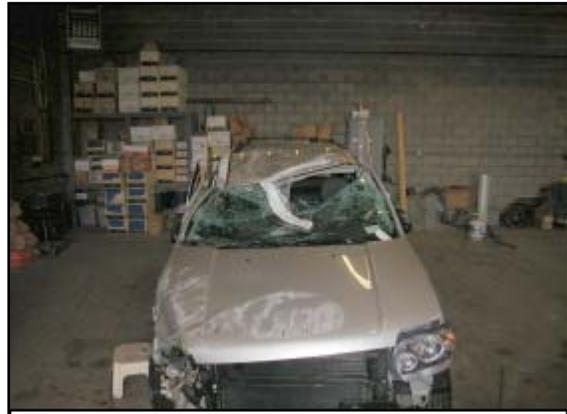
The Ford sustained moderate roof damage with the maximum area of deformation occurring along the windshield header (**Figure 7**). The direct contact damage measured 114 cm (44.8") and extended across the full width of the windshield header. The direct contact damage also extended rearward 62 cm (24.4") terminating at the B-pillar. The maximum crush measured 20 cm (7.9") and was located at the right A-pillar. Abrasions and scattered dents were noted along the full length of the left side rail of 235 cm (92.5"). A crush profile was documented across the windshield header which was as follows: C1 = 10 cm (3.9"), C2 = 7 cm (2.8"), C3 = 10 cm (3.9"), C4 = 13 cm (5.1"), C5 = 19 cm (7.5"), C6 = 20 cm (7.9"). The CDC for this impact was 00-TYDO-3.

Figure 7. Roof crush profile.

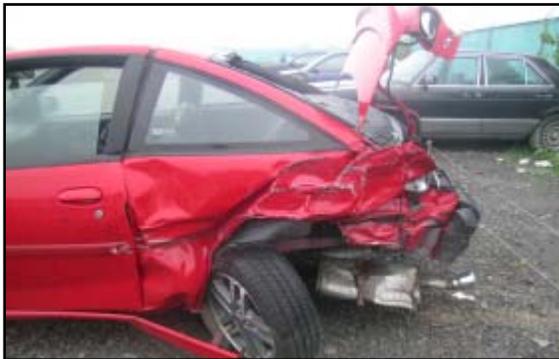
The 2002 Chevrolet Cavalier sustained moderate severity damage to the rear as a result of the impact with the Ford. The direct contact damage began 41 cm (16.2") left of the centerline and extended 17 cm (6.8") to the rear left corner of the bumper beam. The maximum crush measured 18 cm (7.1") and was located at the left corner of the bumper beam. Due to the corner impact, the direct contact damage also extended onto the left side 178 cm (70.0") terminating at the B-pillar (**Figure 8**). A crush profile (**Figure 9**) was documented across the full width of the rear bumper beam of 116 cm (45.5"). The crush profile was as follows: C1 = 18 cm (7.1"), C2 = 15 cm (5.9"), C3 = 8 cm (3.1"), C4 = 4 cm (1.6"), C5 = 4 cm (1.6"), C6 = 0 cm. The CDC for this impact was 06-BLEE-4.

Figure 8. Direct contact damage on the left side.

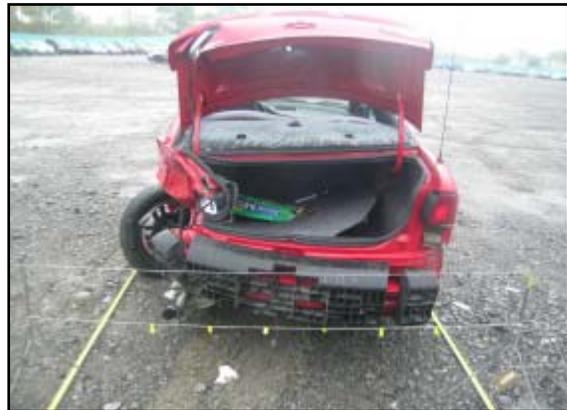
Figure 9. Crush profile of the rear bumper beam.

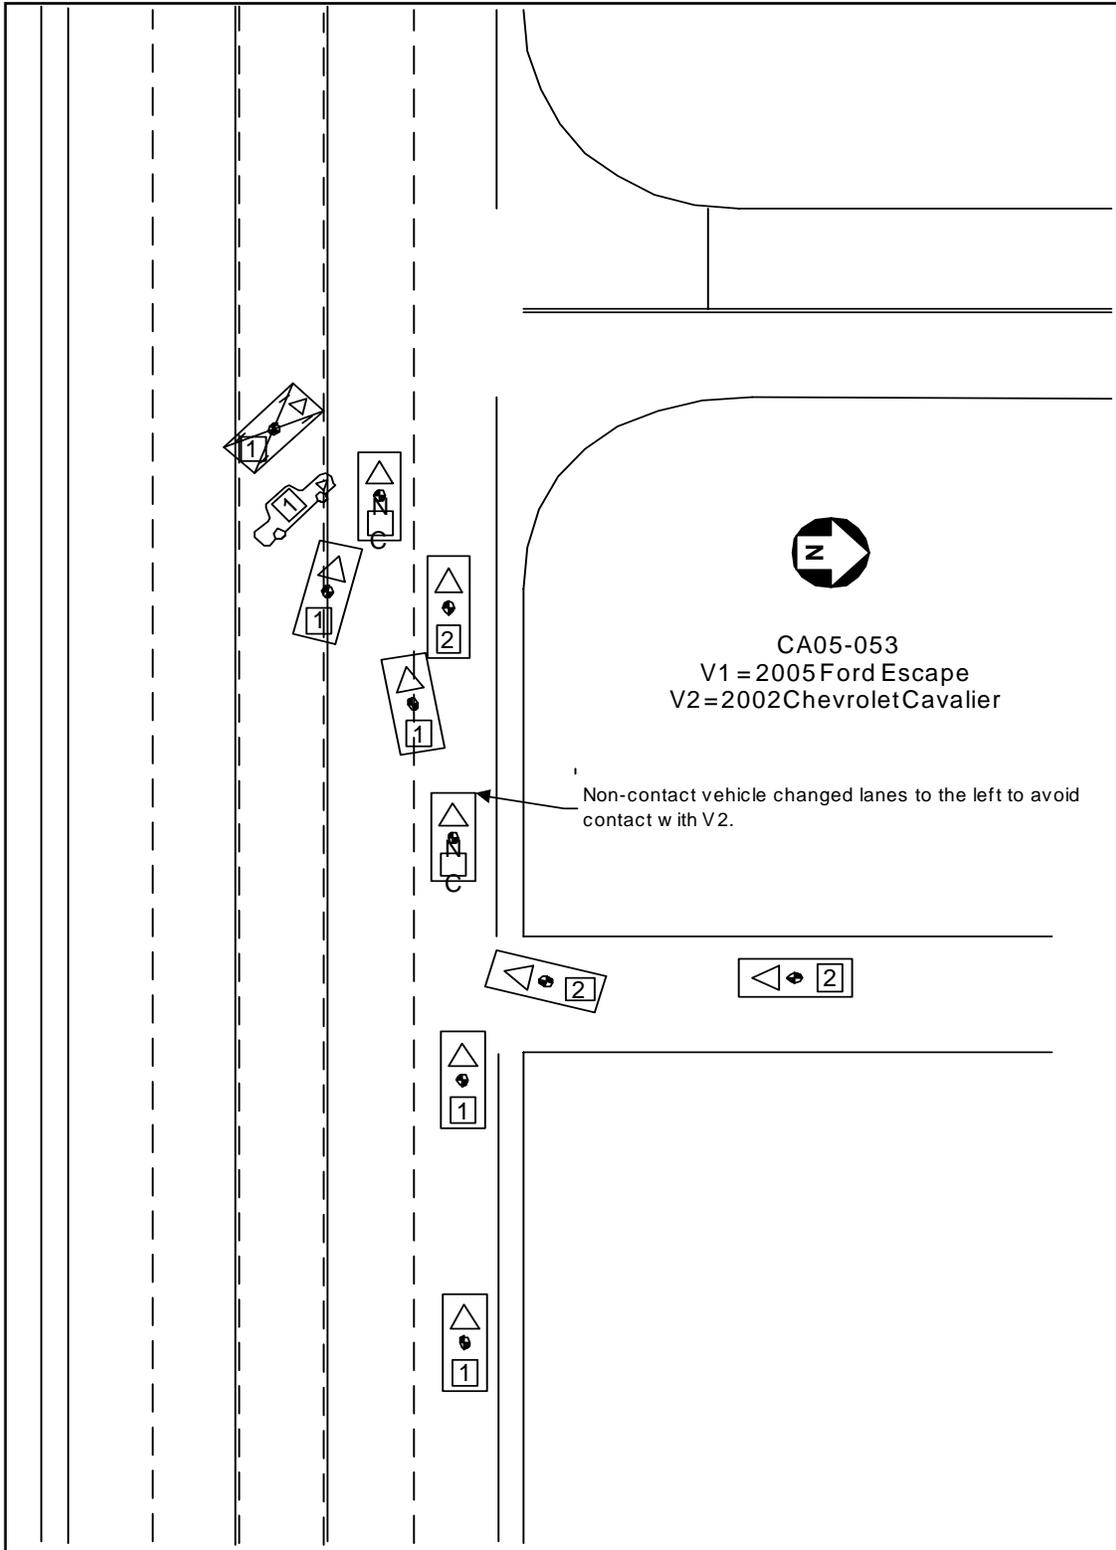
Figure 10. Scene schematic

asphalt shoulders extended 1.1 meters (3.6 feet) beyond the fog lines. Concrete barrier curbs were located adjacent to the shoulders. A T-intersection was located immediately west of the crash location. The posted speed limit for roadway was 80 km/h (50 mph). The scene schematic is included as **Figure 10** of this report.
