**CALSPAN ON-SITE SIDE IMPACT INFLATABLE OCCUPANT PROTECTION
INVESTIGATION**

SCI CASE NO. – CA05-056

SUBJECT VEHICLE – 2005 FORD EXPLORER

LOCATION - STATE OF NEW YORK

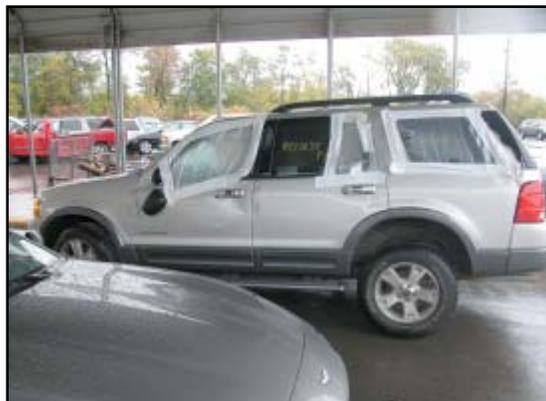
Figure 1. Subject vehicle 2005 Ford Explorer.

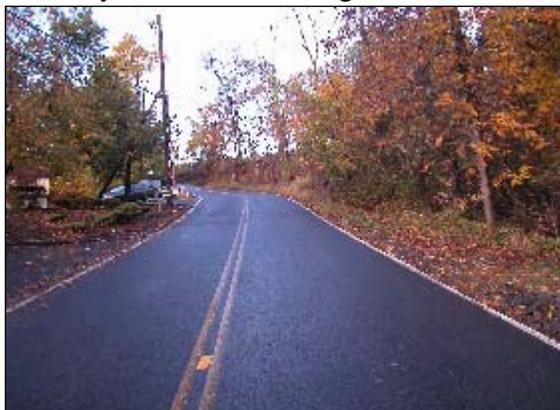
The restrained 24-year-old female driver of the Ford was operating the vehicle northbound on the roadway (**Figure 2**). The driver of the Ford was entering the left curve section of the S-curve roadway. She failed to negotiate the curve and departed the right roadside (**Figure 3**).

Figure 2. Ford's northbound travel direction.

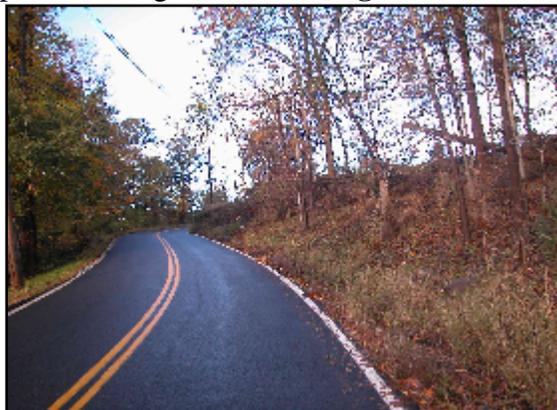
Figure 3. Right side road departure.

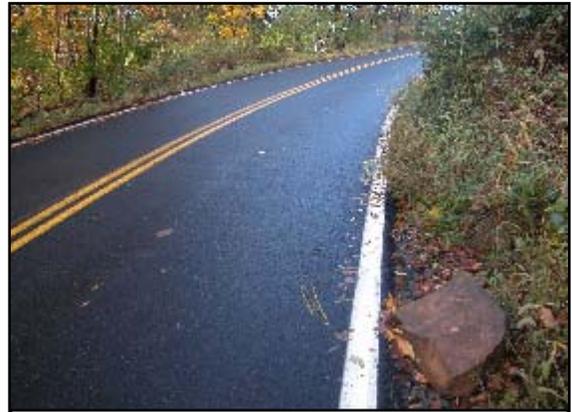
The impact with the boulder induced a counterclockwise (CCW) rotation. The left side of the Explorer entered the roadway while rotating which resulted in lateral forces to the left vehicle. As a result of the lateral forces, the left side tires rolled under the alloy wheels, which allowed the alloy rims to contact the asphalt road surface. This contact was evidenced by a 0.5 meter (1.6 feet) gouge on the road surface. The wheel contact tripped the Ford and the vehicle rolled one-quarter turn onto its left side (**Figure 4**). The rollover event triggered the deployment of the left and right canopy air bags. The RCM output indicated that the curtain air bags were commanded to deploy at 588 ms after rollover algorithm wake-up. The safing criteria was met 8 ms after rollover algorithm wake-up. Additionally, the accumulated angle at the time of deployment was -48 degrees (to the left) with an angular rate at the time of the rotational energy criteria was met was -53 degrees per second.

Figure 4. Area of rollover initiation.

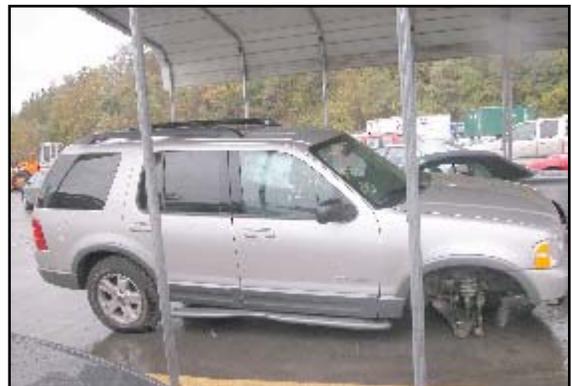
Figure 5. Right step rail damage.

tubular step rail (**Figure 5**). The direct contact damage measured 50 cm (19.7”) length and began 100 cm (39.3”) rear of the right front axle. The step rail was deformed vertically upward approximately 5 cm (2.0”). A crush profile was not documented for this component. The Collision Deformation Classification (CDC) for this impact was 00-UPRW-1.

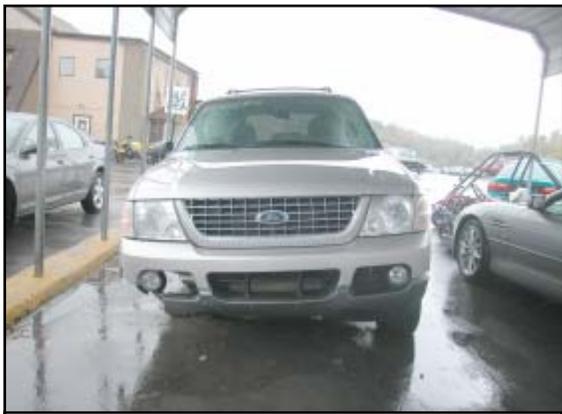
The Ford sustained moderate severity damage from the impact with the boulder (**Figures 6 and 7**). The direct contact damage from this impact began 29 cm (11.4”) right of the vehicle’s centerline and extended 53 cm (20.8”) to the right. There was no structural contact to the front of the vehicle and the direct damage consisted of a fractured section of the front right bumper fascia. Therefore, a crush profile was not documented for this impact. Additionally, the impact damage extended to the right front axle, which resulted in separation of the right front wheel from the drive axle, tie rod, and upper and lower control arms. The CDC for this impact was 12-FRLE-4.

Figure 6. Frontal damage from the boulder impact.

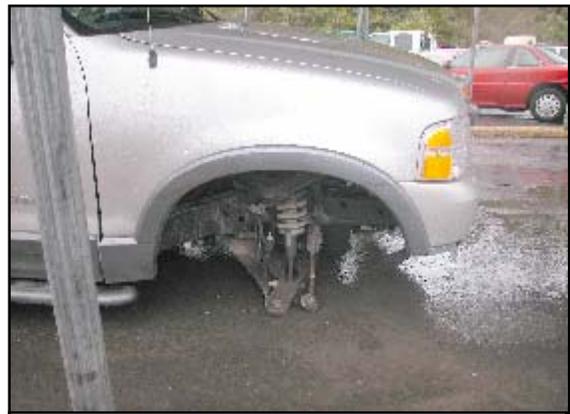
Figure 7. Right front axle damage.

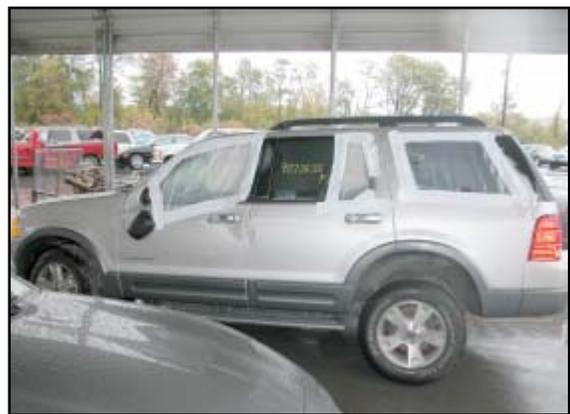
The Ford sustained minor damage as a result of the rollover event. The direct contact damage consisted of abrasions to the left side plane. The direct contact damage began 79 cm (31.1”) rear of the left rear axle and extended 396 cm (155.9”) forward. Additionally, four separate dents were noted on the left side plane of the Explorer. These dents were located at the base of the A-pillar on the left front door, below the left front door handle, upper aspect of the C-pillar, and lower aspect of the D-pillar. The maximum crush for these dents was 2 cm (0.8”), 1 cm (0.3”), 3 cm (1.2”), and 2 cm (0.3”), respectively. Further damage consisted of abrasions to the left side alloy rims from contact with the asphalt road surface. The CDC for this impact was 00-LDAO-2.

Figure 8. Left side rollover damage.

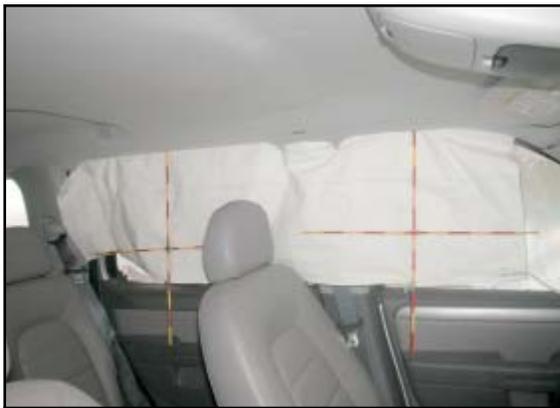
Figure 9. Left side canopy air bag.

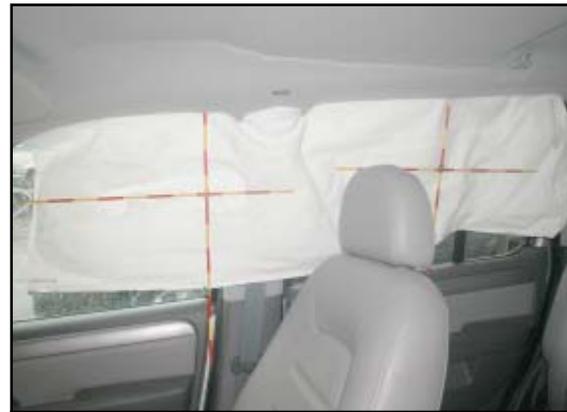
Figure 10. Right side canopy air bag.

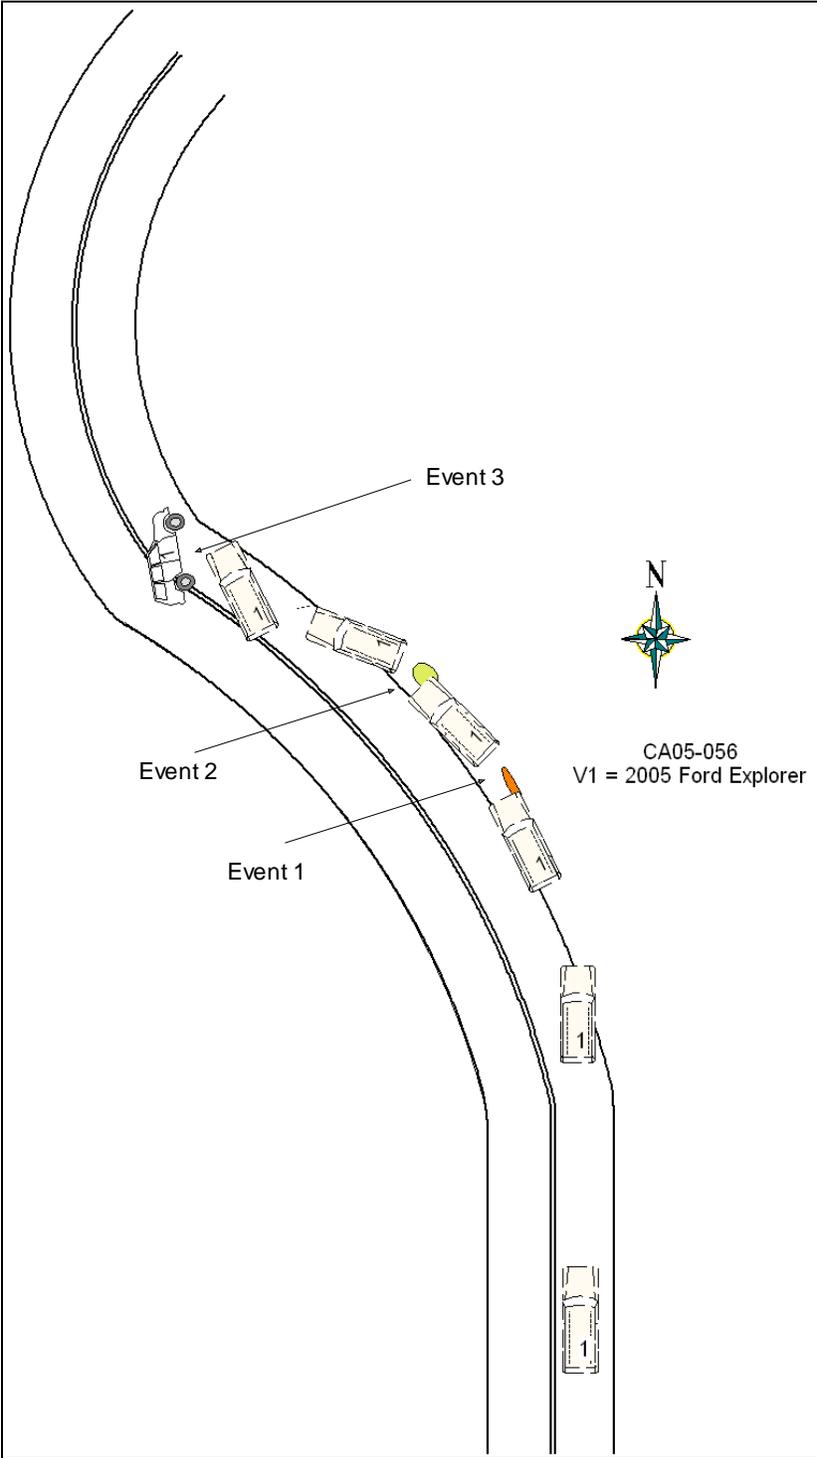
Figure 11. Scene Schematic

This run-off-road crash occurred during the early morning hours of September 2005. At the time of the crash, the weather was clear with no adverse conditions. The crash occurred on the east roadside of a north/south roadway. The north/southbound roadway was configured with one travel lane in each direction with an S-curve. The north/south roadway was delineated by double-yellow centerlines and had a slight uphill grade for northbound travel. The east roadside consisted of an embankment, logs, boulders, and a tree line. There was no posted speed limit within the vicinity of the crash site; therefore, the speed limit defaults to the state limit of 89 km/h (55 mph). The scene schematic is included as (**Figure 11**) of this report.
