**CALSPAN ON-SITE CHILD SAFETY SEAT CRASH INVESTIGATION**

**CASE NO.: CA05-059**

**VEHICLE: 2002 DODGE GRAND CARAVAN**

**DATE OF CRASH: NOVEMBER 2005**

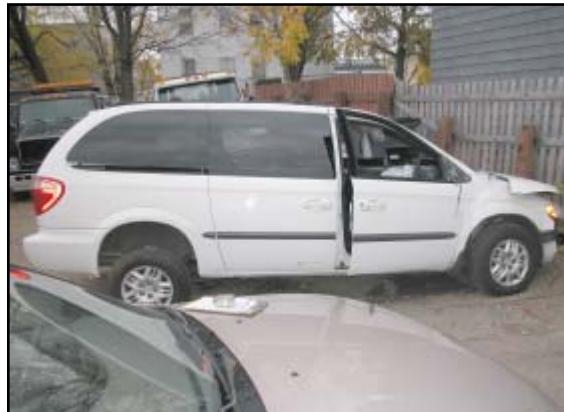
This on-site investigative effort focused on the performance of a child safety seat and the resulting injuries of a 3-year-old male passenger of a 2002 Dodge Grand Caravan (**Figure 1**). The child safety seat was removed from the vehicle on the day of the SCI inspection prior to the arrival of the SCI investigator. Numerous attempts were made to obtain the child safety seat for inspection without success. Therefore, the child safety seat was not inspected for this on-site investigative effort. The Dodge was involved in a run-off-road collision with a wood utility pole. The vehicle was equipped with dual-stage frontal air bags for the driver and front right positions and buckle mounted safety belt pretensioners for the front positions. The Dodge was occupied by a restrained 34-year-old female driver, a restrained 7-year-old male second row left passenger, and a 3-year-old male second row right passenger who was restrained in a backless booster seat. The 34-year-old female driver of the Dodge relinquished control of the vehicle and departed the left roadside. Consequently, the front of the vehicle struck a wood utility pole. As a result of the collision, the frontal air bag system deployed and the front left safety belt buckle pretensioner fired. The driver sustained severe injuries and was transported to a local hospital where she was hospitalized for twenty days. The 7-year-old male rear left passenger sustained minor severity injuries and was transported to a local hospital where he was treated and released. The 3-year-old male sustained moderate severity injuries and was transported to a local hospital where he was hospitalized for two days.

**Figure 1. 2002 Dodge Grand Caravan subject vehicle.**

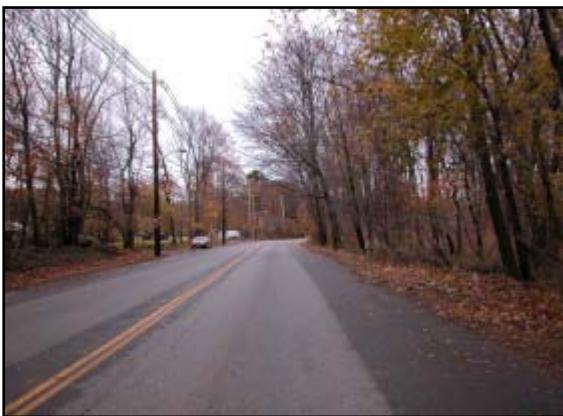
The 34-year-old female driver was operating the Caravan westbound on the two-lane roadway at a police reported high rate of speed (**Figure 2**). The driver had successfully negotiated the left curve and began traveling on the straight segment of the roadway. As she continued to travel in a westerly direction, the driver applied a left steering input resulting in a lane departure to the left. The Dodge traversed the eastbound lane traveling in a southwesterly direction approaching the south road side. As the vehicle neared the curb, the driver applied a right steering input and a possible brake application resulting in a clockwise rotation of the vehicle of approximately ten degrees. This steering maneuver resulted in a 9 meter (29.5 feet) left front tire scuff and a 3.7 meter (12.1 feet) left rear tire scuff, which began on the eastbound lane and extended onto the south curb (**Figure 3**). The Dodge overrode the curb and began a northwesterly trajectory exposing the left front corner of the vehicle.

**Figure 2. Westbound pre-crash travel for the Dodge.**

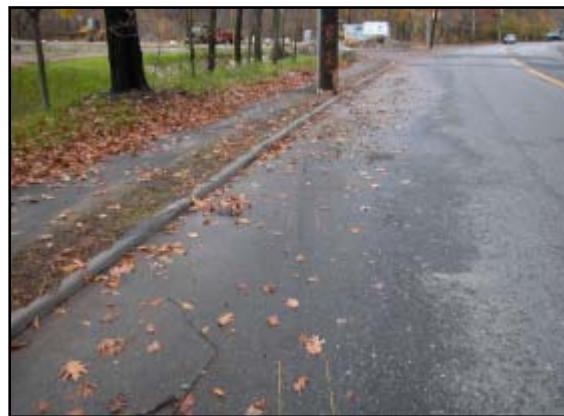
**Figure 3. Pre-impact tire scuff marks.**

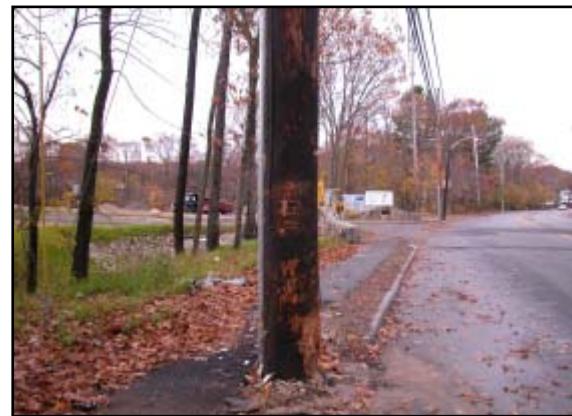
The front left corner of the Dodge impacted a 43 cm (17") diameter wood utility pole (**Figure 4**) that was located 0.7 meters (2.3 feet) south of the curb. The resultant direction of force for this impact was 12 o'clock. The impact occurred outside the left frame rail of the Caravan. As the corner of the bumper beam crushed rearward, the left front fender, tire, wheel axle and suspension components, cowl, A-pillar, and windshield header engaged the pole. The WINSMASH damage algorithm was used to calculate a delta-V for this impact. The total delta-V was 32 km/h (19.9 mph) with longitudinal and lateral components of -32 km/h (-19.6 mph) and 6 km/h (3.5 mph), respectively. The delta-V

**Figure 4. Struck 43 cm (17.0") diameter utility pole.**

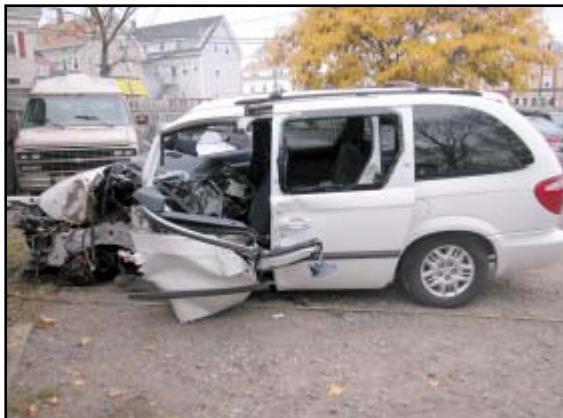
The 2002 Dodge Grand Caravan sustained severe frontal damage as a result of the impact with the wood utility pole. The impact location was outboard of the left frame which allowed the vehicle to continue forward engaging the left front fender, tire/wheel and suspension components, cowl and windshield header locations. The resultant crush was documented at the front bumper beam, cowl, and windshield header to capture the extent of damage to the Dodge. **Figures 5 and 6** are an overall view of the residual damage and maximum crush.

**Figure 5. Overall view of the residual damage.**

The maximum crush at the left corner of the bumper beam was 49 cm (19.3”), and 100 cm (39.3”) and 26 cm (10.2”) at the cowl and windshield header, respectively.

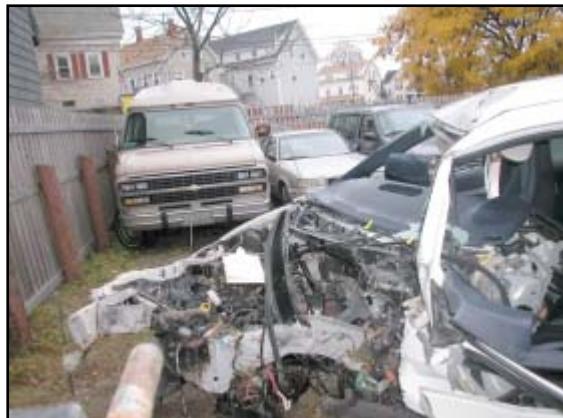
**Figure 6. Lateral view of the maximum crush.**

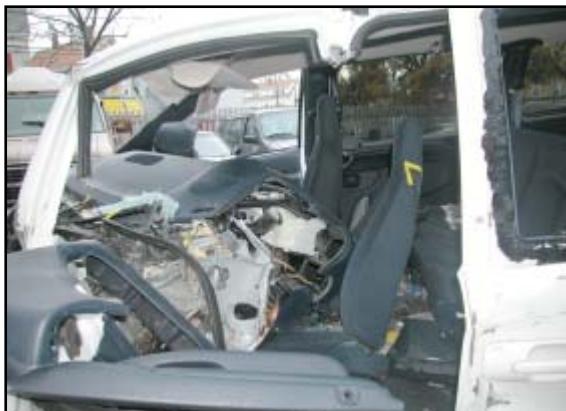
The interior of the Dodge sustained severe damage that was attributed to passenger compartment intrusion and occupant contact points (**Figure 7**). The driver's occupant contact points consisted of tears to the top of the left instrument panel from contact with her head/face. A make-up transfer was noted to the deployed front right air bag from possible contact from the driver's face. Occupant contact points could not be identified to the lower left instrument due to the severe deformation and intrusion. The occupant contact points from the rear left passenger consisted of yellow powder residue on the rear of the left front seat back. Although not considered an occupant contact point, body fluid was present on the leading edge of the rear left seat cushion. The second row right passenger contacted the rear of the right front seat back, which was evidenced by a yellow powder transfer and white colored fluid. The frame of the right front seat back could not be accessed; however, based on the 3-year-old's leg fractures it was probable that he contacted this component. Additionally, body fluid was also noted on the leading edge of the rear right seat cushion. **Figure 8** illustrates the occupant contact points to the rear of the front seat backs. The passenger compartment intrusions are identified in the following table:

**Figure 7.** Lateral view of the driver's area.

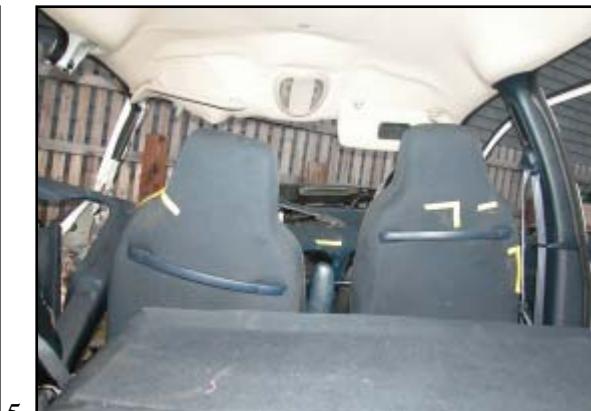
**Figure 8.** Occupant contact points to the rear of the front seat backs.

The 3-year-old male child passenger was seated in a backless booster seat and was restrained by the vehicle's lap and shoulder belt system. At impact, the child responded to the frontal crash forces by initiating a forward trajectory. His legs contacted and loaded the rear of the seatback which resulted in the right lower leg abrasion, right tibia mid shaft fracture transverse non-displaced, and the right fibula mid shaft fracture transverse non-displaced. Additionally, he loaded the lap and shoulder belt system with his torso and hips. The anterior neck abrasion 8 cm x 2 cm (3.1" x 0.8") with a mild laryngeal edema, right shoulder abrasion, right chest contusion, and right waist abrasion resulted from this loading.

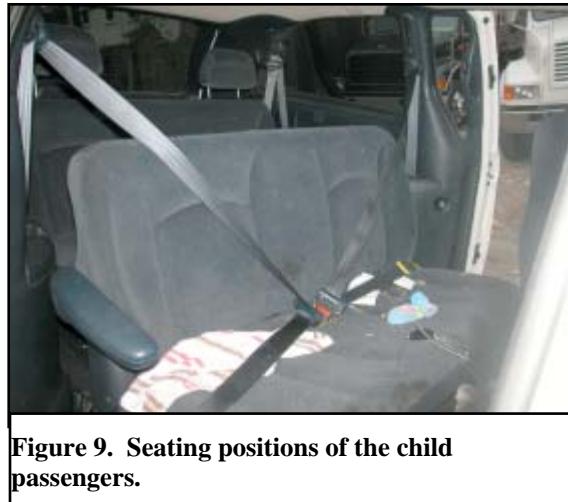
The 3-year-old male passenger was restrained by the lap and shoulder belt system in the second row right position of the Dodge. He was seated in an unknown backless booster seat. The manufacturer of the safety seat was unknown. The child safety seat was removed from the vehicle on the day of the SCI inspection, prior to the arrival of the SCI investigator. Numerous attempts were made to obtain the child safety seat for inspection; however, these were unsuccessful. The tow yard operator observed the safety seat during its removal and described it to the SCI investigator as not having a backrest and resembling a telephone book. Due to this description, it was determined that this safety seat was a backless booster. **Figure 9** is of the seating locations for the child passengers.

**Figure 9. Seating positions of the child passengers.**

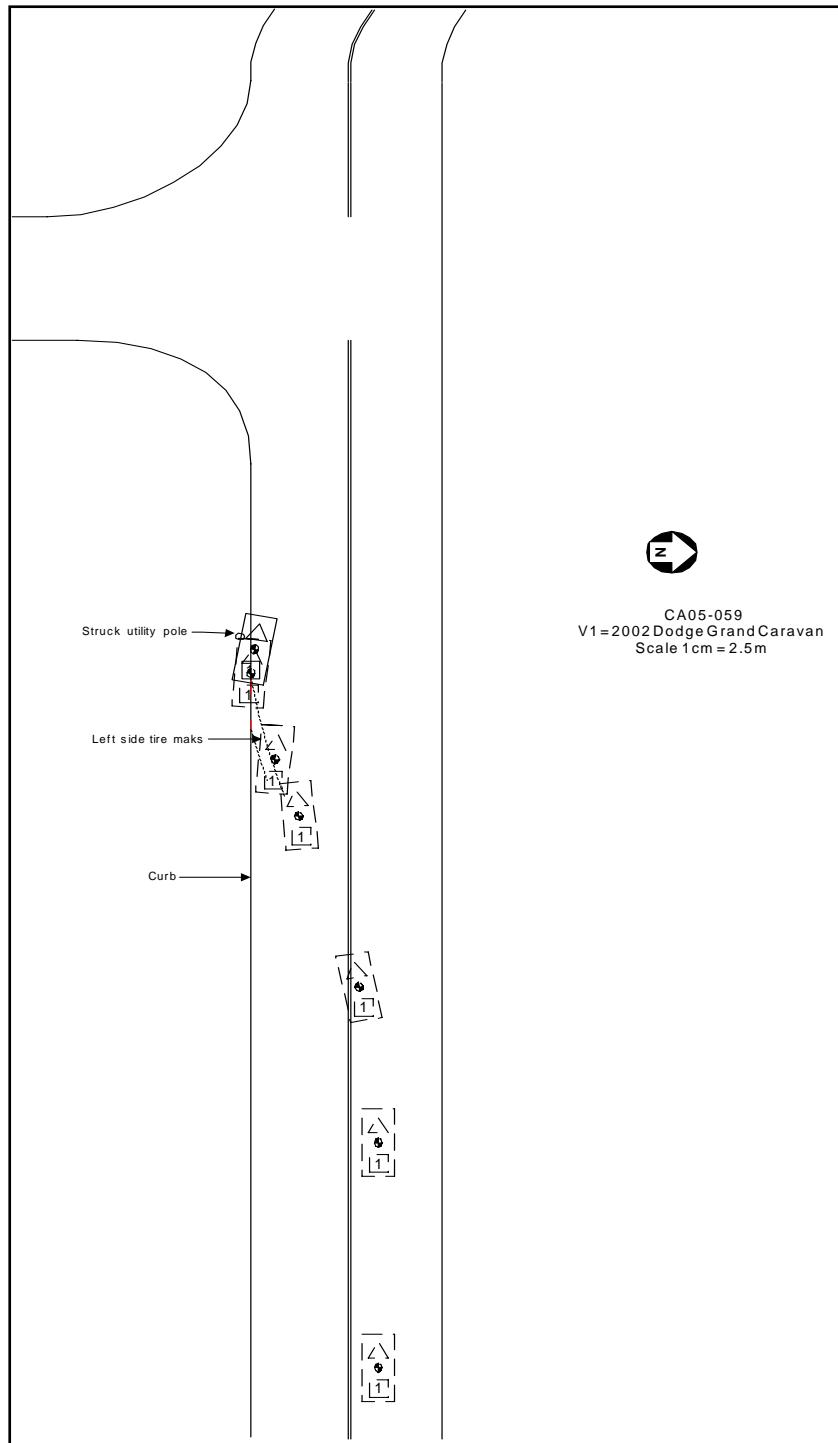
*Figure 10: Scene Schematic*

This run-off road crash occurred on the south roadside of a two-lane east/west road in a residential area. The travel lanes were 6 meters (19.7 feet) in width and delineated by double yellow centerlines. A positive grade of 2 percent terminated 114.7 meters (373.3 feet) east of the crash site. A right curve began 20.2 meters (66.3 feet) west of the crash site. Dirt and grass bordered the north road edge and a low concrete curb bordered the south road edge. Adjacent to the curb was a sidewalk that contained several wooden utility poles placed between the curb and the sidewalk. There was no posted speed limit within the vicinity of the crash site; therefore, it defaults to the state speed limit of 89 km/h (55 mph). The scene schematic is included as **Figure 10** of this report.
