**CALSPAN ON-SITE CHILD SAFETY SEAT CRASH INVESTIGATION
EVENFLO CONVERTIBLE CHILD SAFETY SEAT
SCI CASE NO: CA05-062**

**VEHICLE: 1998 FORD CONTOUR
LOCATION: NEW YORK
CRASH DATE: NOVEMBER, 2005**

Contract No. DTNH22-01-C-17002

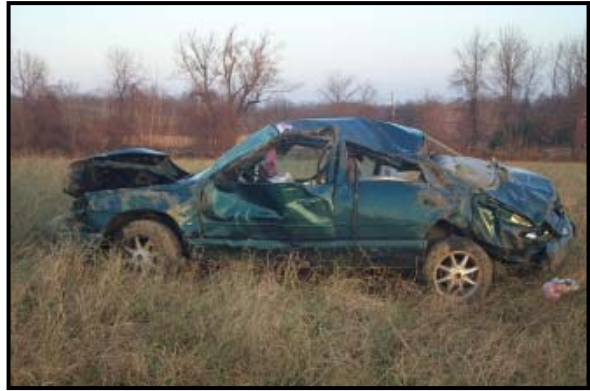
Figure 1: Final rest position of the Ford.

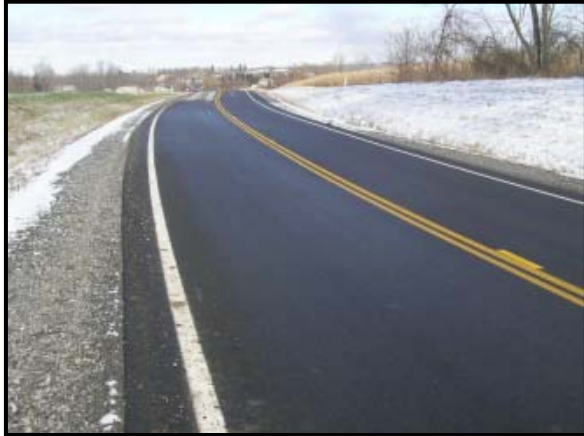
in) above the road. The speed limit in the area of the crash was 89 km/h (55 mph), with a posted 72 km/h (45 mph) advisory speed for the curve. **Figure 2** is a northbound trajectory view at the exit of the curve. **Figure 3** a trajectory view at the point of roadside departure taken during the police investigation.

Figure 2: Trajectory view exiting the right curve.

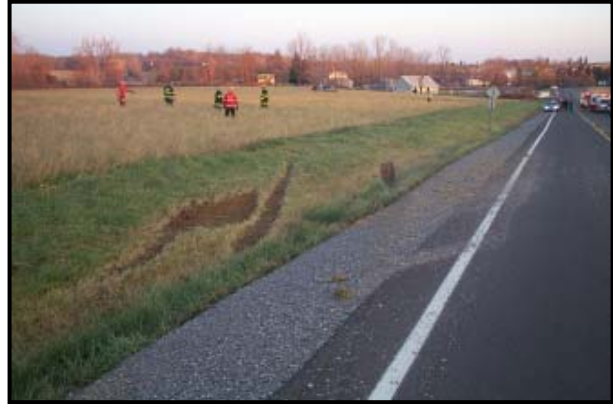
Figure 3: On-scene trajectory view at the roadside departure.

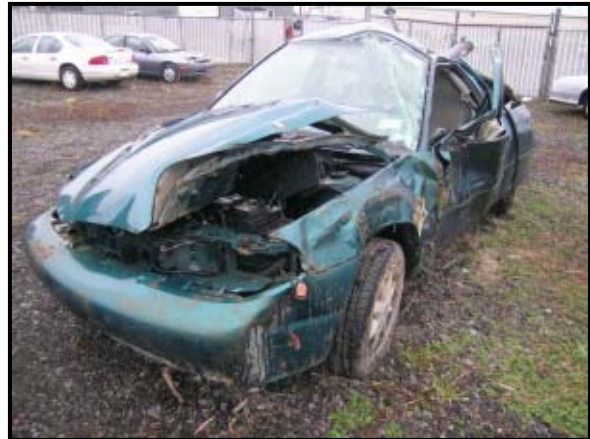
The 1998 Ford Contour SE, **Figure 4**, was identified by the Vehicle Identification Number (VIN): 1FAFP6635WK (production sequence deleted). The four-door sedan was equipped with a power train that consisted of a 2.0 liter I4 engine linked to a four-speed automatic transmission. The service brakes were equipped with four wheel ABS. The manual restraint system consisted of 3-point lap and shoulder belts for the five seat positions. The vehicle was equipped with redesigned frontal air bags that deployed as a result of the crash. The odometer read 195,508 km (121,483 miles) at the time of the inspection. The date of manufacture was unknown. The vehicle was equipped with BF Goodrich Touring T/A P205/60R15 tires on OEM steel wheels. The recommended tire pressure was 233 kPa (34 PSI). It should be noted that the rear tires were worn smooth, the tread depth measured zero. The specific measured tire data at the time of the SCI inspection is identified in the following table:

Figure 4: Left front view of the Ford.

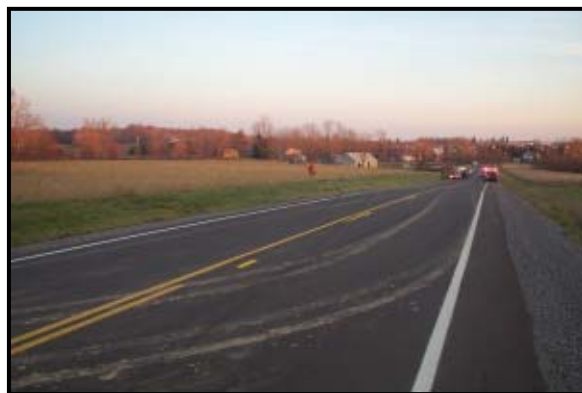
The 1998 Ford Contour was traveling northbound driven by a 20 year old unrestrained male. The Ford's rear left position was occupied by a 3 year old female restrained within an Evenflo Convertible Child Safety Seat (Unknown Model) in a forward facing mode. The driver's trip plan was to run an errand to a local video store and return to his residence. Reconstruction analysis indicated the driver of the Ford was operating the vehicle in excess of the speed limit [estimated 120 km/h (75 mph)] on the approach to the right curve. The driver steered late, and drove wide through the curve crossing the centerline. The driver overcorrected the vehicle's errant trajectory back to the right, reentered the northbound lane and then over-steered back to the left. The vehicle's rear tires lost traction and the Ford began to rotate counterclockwise. The police investigation documented that the right side tire scuffs began 11 m (37 ft) north of the exit of the curve. The vehicle yawed approximately 66 m (216 ft), across the centerline, through the southbound lane and departed the west side of the road, **Figure 5**. The Ford had rotated 115 degrees counterclockwise at the point of departure. The vehicle's front fascia and right tires furrowed into the ditch and back slope (refer to **Figure 3** above). The vehicle's furrowing tripped the vehicle into a right side leading roll.

Figure 5: On-scene view of the yaw marks.

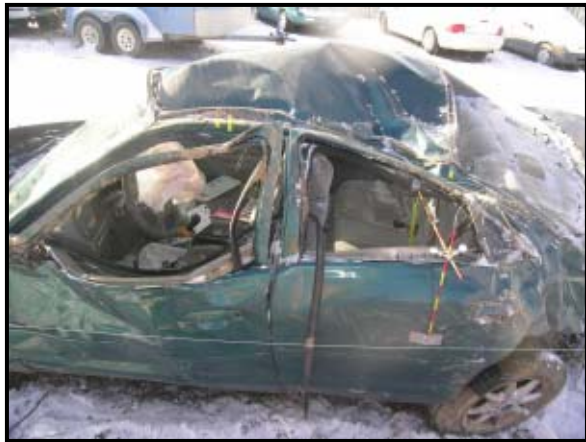
The exterior damage to the Ford Contour was consistent with a multiple turn rollover event. The vehicle's two side planes, top plane and the all wheels/tires exhibited damage from multiple ground impacts. The scratch pattern was primarily lateral and biased front to rear. The exposed body panel seams on the left side of the vehicle were packed with soil and debris consistent with the direction of the roll. The left window glazings and backlight had disintegrated. The left doors were jammed shut and deformed outboard. The right doors remained closed during the crash sequence and were operational post-crash. The windshield was fractured by the exterior forces of the crash. The most severe damage was vertical damage was located in the left C-pillar area of the roof. The greatest lateral damage was located across the left rear quarterpanel. Refer to **Figures 6 and 7**. The damage at these locations occurred during the first ground impact when the vehicle was rolling between quarter turns 2 and 3. At this time, the vehicle's momentum/energy was the greatest.

Figure 6: Left view of the roof deformation.

The deformation was measured vertically along the left roof rail with a damage length of 114 cm (45.0 in). C1 was located at the junction of the top aspect of the left C-pillar and the left roof rail. C6 was located at the junction of the windshield header and the top aspect of the left A-pillar. The residual vertical crush profile was follows: C1 = 30 cm (12.0 in), C2 = 34 cm (13.2 in), C3 = 29 cm (11.3 in), C4 = 21 cm (8.4 in), C5 = 18 cm (6.9 in), C6 = 14 cm (5.5 in). The maximum crush was located in the left C-pillar area, 10 cm (4 in) forward of C1. The maximum crush measured 38 cm (14.9 in). The maximum right lateral displacement of the left roof rail measured 23 cm (9 in) at left C-pillar.

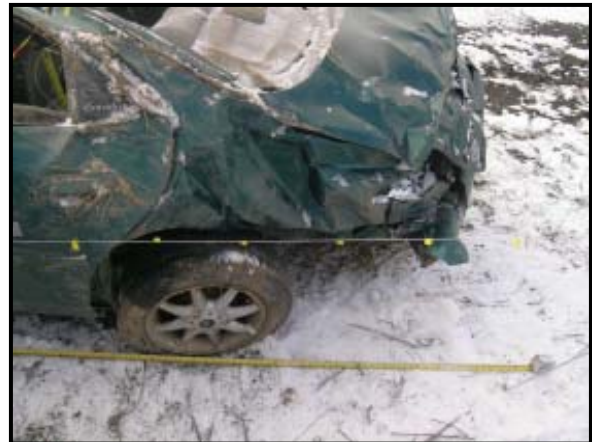
Figure 7: Left rear quarterpanel deformation.

The vehicle's orientation during the left rear quarterpanel's impact with the ground resulted in a non-horizontal impact force in the 9 o'clock sector. The entire rear clip of the vehicle was swayed to the right resulting in induced buckling of the right rear quarterpanel. The deformation of the left rear quarterpanel was documented at the trim level. The Field L measured 119 cm (47.0 in). C1 was located at the left end of the rear bumper. The residual crush profile (less assumed free space) was as follows: C1 = 21 cm (8.1 in), C2 = 29 cm (11.0 in), C3 = 25 cm (10.2 in), C4 = 34 cm (13.2 in), C5 = 14 cm (5.5 in), C6 = 4 cm (1.5 in). The Collision Deformation Classification of the rollover damage was 00-TDDO3.

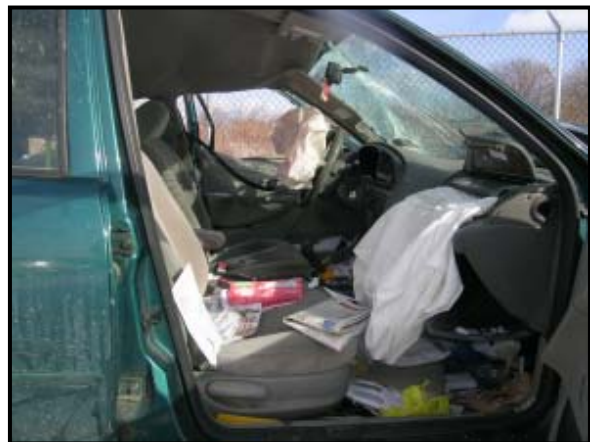
The interior of the Ford Contour was configured with bucket seats for the driver and front right passenger and a three passenger rear bench seat. **Figure 8** is a right view across the front interior. The occupant space in the front compartment was reduced due to the lateral and vertical intrusion of the left roof rail as a result of the rollover impact forces. The left roof rail was intruded laterally 13 cm (5.0 in) due to deformation of the upper aspect of the left B-pillar. The roof rail intruded vertically 13 cm (5.0 in) and was in contact with the head restraint of the driver's seat.

Figure 8: Intrusion of the left rear position.

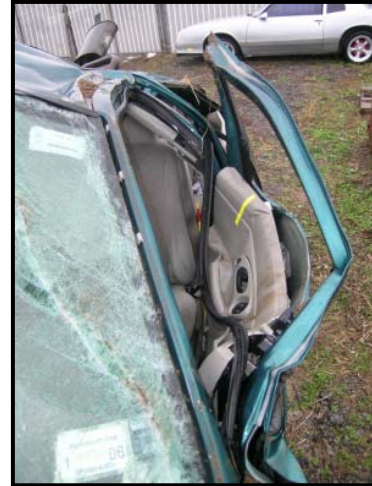
The left doors were jammed shut during the rollover. The driver's door panel exhibited direct occupant contact and loading, **Figure 9**. The door panel was deformed outboard 22 cm (8.5 in) at the beltline. The driver's contact to the door panel began 23 cm (9 in) forward of the B-pillar closure and extended forward 46 cm (18 in). The panel was fractured 58 cm (23 in) forward of the closure over a 10 cm (4.0 in) length and the panel was displaced upwards. The panel displacement measured 6 cm (2.5 in) at the rear aspect relative to the sill. The outboard deformation of the door panel created the driver's ejection path. A 5 cm x 8 cm (2.0 in x 3.0 in) scuff mark located at the outboard aspect of the instrument panel was identified. This mark resulted from probable contact with the driver's lower extremities during the ejection sequence.

Figure 9: View of the driver's ejection path.

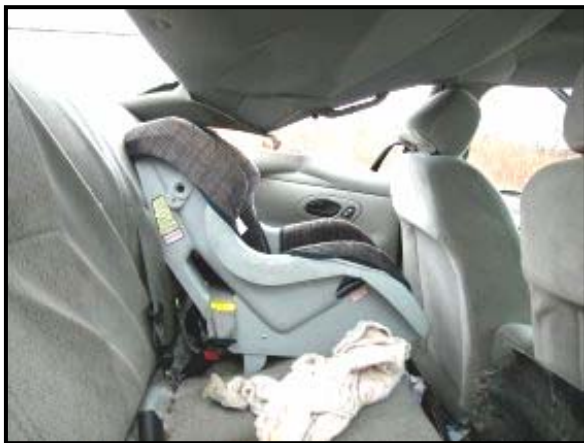
The occupant space at the left rear seat position was reduced as a result of the intruded left C-pillar and roof. The intrusion of the left C-pillar was measured at the top aspect of the trim. The magnitude of the intrusion measured 30 cm (12 in) vertical and 23 cm (9 in) lateral. The C-pillar was in contact with the package shelf and the top aspect of the rear seat back. The intrusion measured at the grab handle located on the left roof rail measured 23 cm (9 in) vertical and 23 cm (9 in) lateral. **Figures 10 through 12** depict the relationship between the installed CSS and the residual intrusion. After re-installation, the left C-pillar was in contact with the left wing safety seat shell. The intruded left C-pillar trim contacted and lacerated the left scalp of the child passenger. An 8 cm x 8 cm (3 in x 3 in) area of blood evidence was identified at the top aspect of the trim panel.

Figure 10: View of the relationship between the CSS and the intrusion.

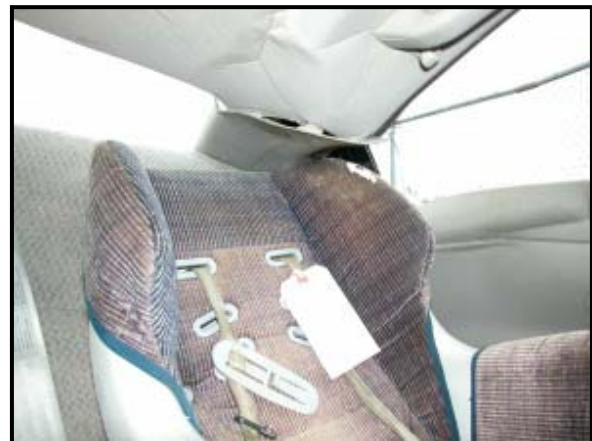
Figure 11: Top aspect of the CSS and intruded trim.

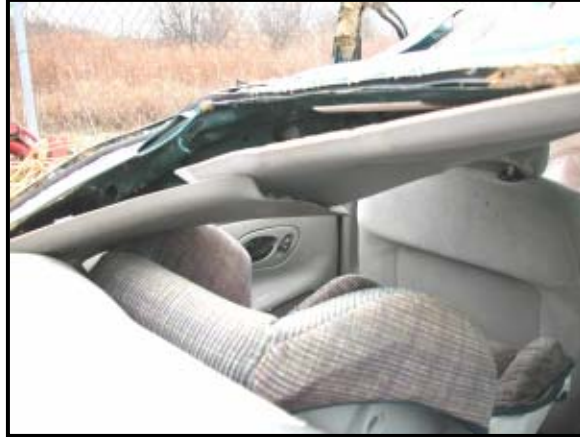
Figure 12: View of reinstalled CSS through the backlight.

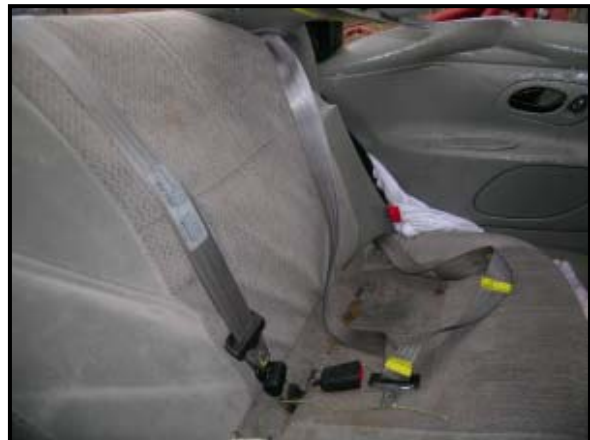
The rear seat positions in the Ford Contour were each equipped with 3-point lap and shoulder belts. The restraint in the rear left position, **Figure 13**, consisted of a continuous loop webbing, sliding latch plate and a switchable Automatic Locking/Emergency Locking (ALR/ELR) retractor. The webbing was extended from the retractor and was lying on the seat at the time of the SCI inspection. The length of the extended webbing measured 174 cm (68.5 in). The sliding latch plate was located 69 cm (27.0 in) from its exit from the seat bight above the outboard anchor point and the webbing was creased at that location. A 20 cm (8.0 in) section of the webbing exhibited evidence of loading. This webbing section began and ended 47 cm and 67 cm (18.5 in and 26.5 in) above the reference point, respectively, and was consistent with a routing through the forward-facing belt path of the CSS. During the inspection, it was possible to extend the belt webbing further from the switchable retractor. This indicated that the retractor had not been switched to the automatic locking mode during the installation of the CSS. Additionally, the return spring of this retractor was weak and/or was broken. The webbing would not respool onto the retractor. Based on the SCI inspection, the CSS was restrained by the vehicle's safety belt through the forward facing belt path with the retractor in the emergency locking mode. No locking clip was in use.

Figure 13: Rear left safety belt.

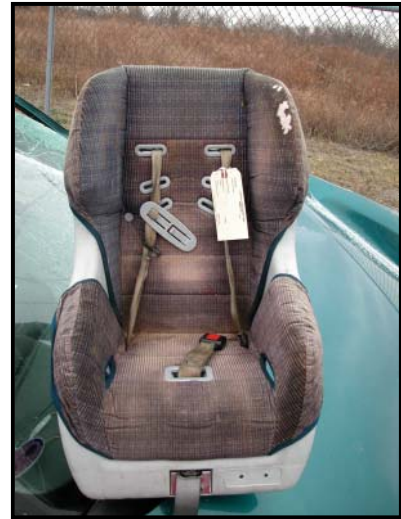
Figure 14 is a front view of the Child Safety Seat (CSS) in use at the time of the crash. The CSS was an Evenflo Secure Choice convertible seat Model No: 2471298P1, manufactured March 21, 2002. The CSS was restrained in the rear left position of the Ford Contour by the vehicle's 3-point lap and shoulder belt in a forward facing mode. The seat was labeled for rear facing use by infants 2 kg to 14 kg (5 lb to 30 lb) and for forward facing use by toddlers 9 kg to 18 kg (20 to 40 lb). The labeled height requirement was 48 cm to 102 cm (19 in to 40 in). Some of the manufacture's labels had been removed. The instruction manual was not present and there was no locking clip.

Figure 14: View of the Evenflo CSS.

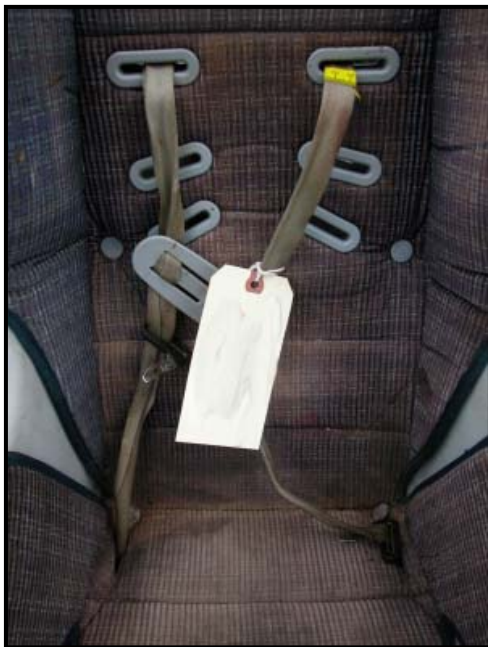
The CSS was configured with a 5-point harness system. The harness was routed through the top slots. Both harness straps were folded over, roped, and creased. At the time of the inspection, the straps had been fully extended offering the greatest slack. This adjustment was probably made during the removal of the child from the CSS by EMS. Blood evidence was identified on the left strap and was probably indicative of the adjusted location of the straps. The blood evidence was located 48 cm (19 in) above the seat's base, **Figure 15**. The harness retainer clip was located 30 cm (12 in) above the seat base. The shell of the seat was intact; there were no fractures. The left wing of the seat exhibited minor stress marks as a result of its contact with the intruded left C-pillar, **Figure 16**.

Figure 15: View of the blood evidence and probable strap adjustment.

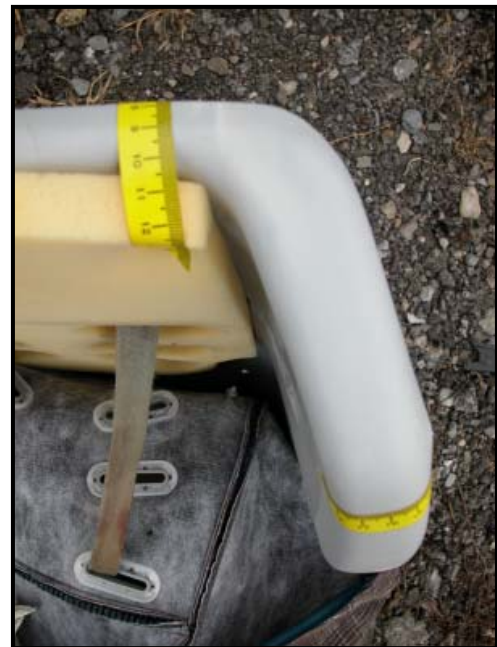
Figure 16: Minor stress marks on left wing of the CSS shell.

Upon the first impact with the ground, the left C-pillar area and the roof intruded downward into the left rear occupant space. The left C-pillar contacted the left wing of the CSS indicated by the stress marks in the CSS shell. The trim panel covering the C-pillar lacerated the child's left face and caused a facial contusion about her left eye. During roll sequence, the child's forearm probably flailed and was fractured by an unidentified interior contact as the vehicle impacted the ground.

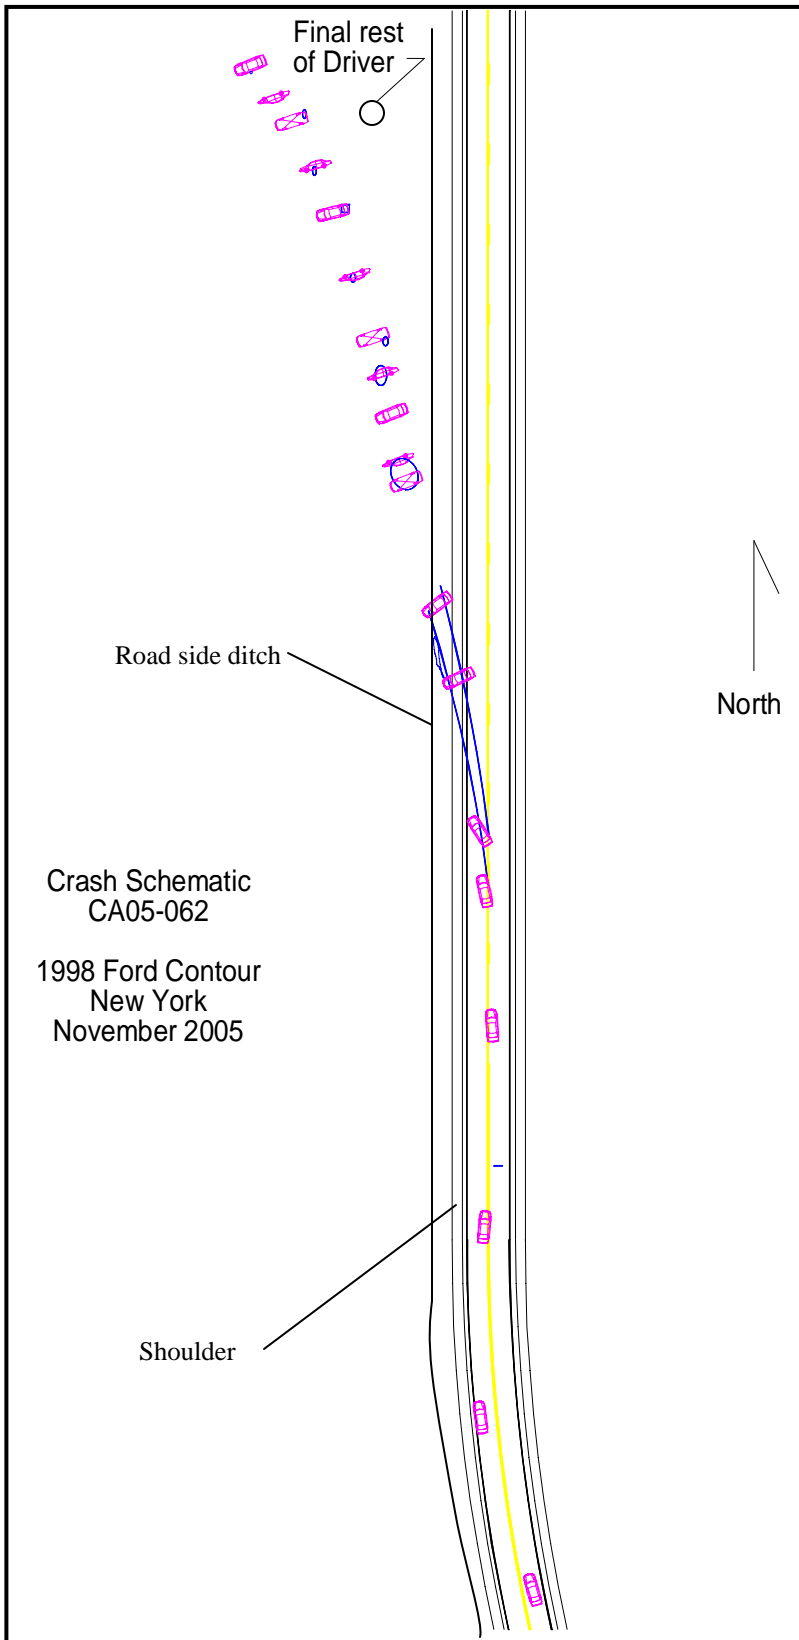
Figure 17: Crash Schematic

overload the door panel and it deformed outboard 20 cm (8 in). The outboard deformation created an ejection portal. The driver was ejected and came to rest approximately 40 m (130 ft) north of the second ground contact. The vehicle then rolled an additional 1-3/4 revolution (7 quarter turns) with a trajectory that arced to the northwest. The vehicle impacted the ground at least seven more times during this interval. The vehicle came to rest on its tires 34 m (110 ft) west of the road edge facing west-southwest. The final rest position measured 87 m (287 ft) from the trip point. A schematic of the crash is attached to the end of this narrative report as **Figure 17**.
