**CALSPAN REMOTE SIDE IMPACT INFLATABLE OCCUPANT PROTECTION
SYSTEM CRASH INVESTIGATION**

CASE NO: 2006-02-037B

VEHICLE: 2006 PORSCHE BOXSTER

CRASH DATE: JUNE 2006

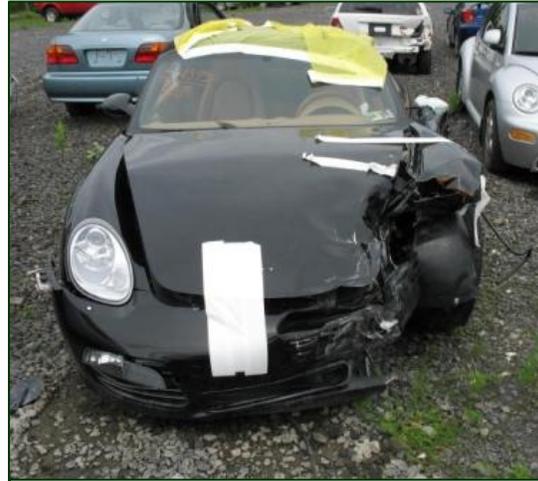
This remote investigation focused on the performance of the side impact air bag system that deployed in a 2006 Porsche Boxster (**Figure 1**) and the injury source of a laceration to a previously transplanted left kidney. The Porsche was equipped with a Certified Advanced 208-Complaint frontal air bag system, seat back mounted side impact air bags, and door mounted head protection air bags. The driver's frontal air bag and the left side impact air bags deployed as a result of an offset head-on crash with a 1990 Toyota Corolla, which was operated by a 21-year old male. The Toyota crossed the centerline into the Boxster's path of travel. Following the

Figure 1. Front left damage to the Porsche Boxster.

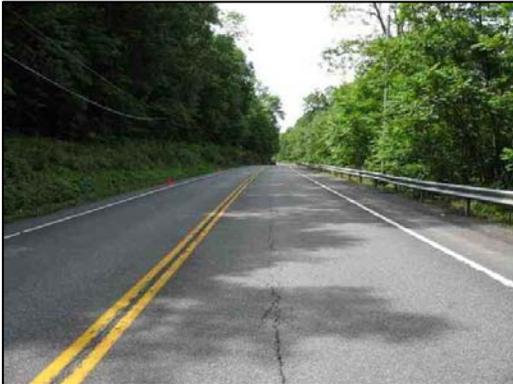
The 49-year old male driver of the Boxster was traveling in a southerly direction (**Figure 2**) at a driver estimated speed of 69 km/h (43 mph). The 21-year old male driver of the Toyota was traveling in a northerly direction on the same roadway (**Figure 3**). A 49-year old female was operating the Ford Explorer and was traveling behind the Boxster in the southbound lane. The driver of the Boxster observed the northbound Toyota cross the centerline and encroach into his travel lane. He took evasive action by steering to the right and applying the brakes in an attempt to avoid the crash. Roadway gouging at the point of impact was present near the southbound fog line.

Figure 2 - Southbound approach of the Porsche Boxster.

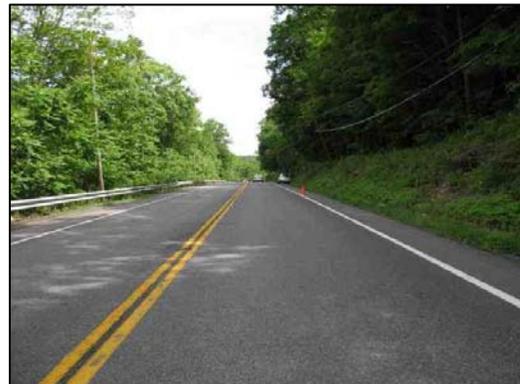
Figure 3 - Northbound approach of the Toyota.

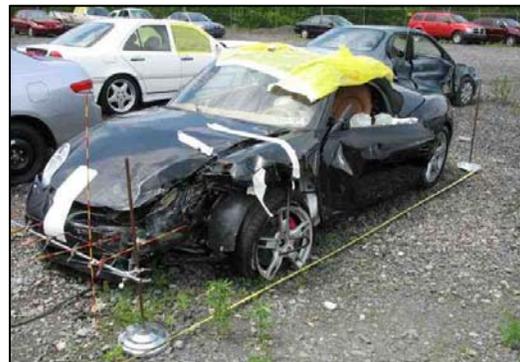
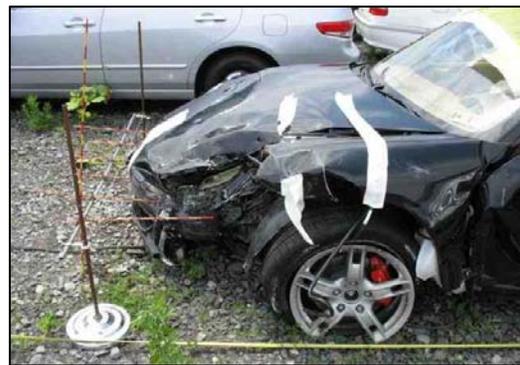
The 2006 Porsche Boxster sustained severe frontal and left side damage as a result of the impact with the Toyota Corolla (**Figures 4 and 5**). The field investigation followed NASS exterior documentation protocols with regard to measuring crush along the frontal plane, specifically the bumper beam. However, the severity of the damage is not reflected using this technique as the innermost crush was located outboard of the left frame rail and extended to the left front wheel. The left front wheel was fractured and the wheelbase was compressed 9 cm (3.5”). The left fender was deformed and induced damage was present down the entire left side. The induced damage buckled the driver’s door, which was later mechanically opened by rescue crews, and the sill. The actual crush exceeded the prescribed extent of 2 per NASS protocol and appeared to have extended into zone 4.

Figure 4 – Front left view of Porsche Boxster.

Figure 5 – Left side view of Porsche Boxster.

damage began 76 cm (30") inboard of the right front bumper corner and extended 67 cm (26.4") to the front left corner. The SCI revised combined direct and induced damage encompassed the entire front end and measured 143 cm (56.3") in width. The maximum crush was located at the left front bumper corner and measured 36 cm (14.2") in depth. The crush profile consisted of six equidistant crush measurements taken along the vehicle's bumper and was as follows: C1 = 36 cm (14.2"), C2 = 17 cm (6.7"), C3 = 7 cm (2.8"), C4 = 3 cm (1.2"), C5 = 1 cm (0.4") and C6 = 0 cm. Please note that C6 was revised by the SCI team based on the images provided by the NASS investigation. The Collision Deformation Classification (CDC) for the impact with the Toyota was 12-FYEW-2.

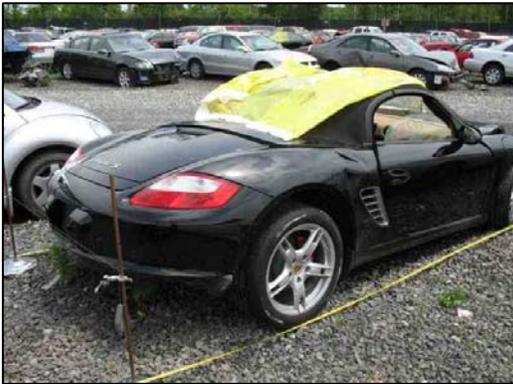
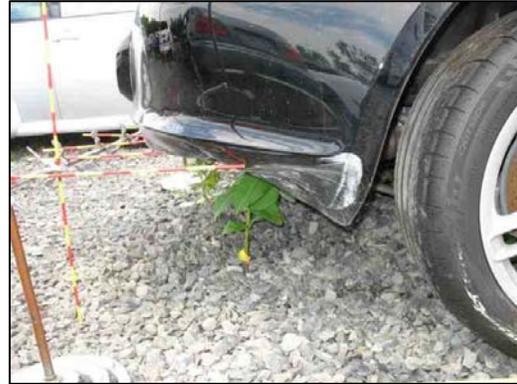
A minor secondary impact to the Boxster resulted from the impact to the guardrail. This damage was located at the back right corner of the vehicle (**Figures 6 and 7**). The Principal Direction of Force (PDOF) for this impact was 100 degrees. The damage consisted primarily of surface scratching of the composite plastic rear bumper cover with associative component deformation. A crush profile was not recorded by the NASS team; however, the width of direct contact damage was estimated to be approximately 35 cm (14"). The CDC for the secondary impact was 03-RBLE-3.

Figure 6 - Right rear corner damage to the Porsche Boxster.

Figure 7 - Close-up of damage on right rear corner.

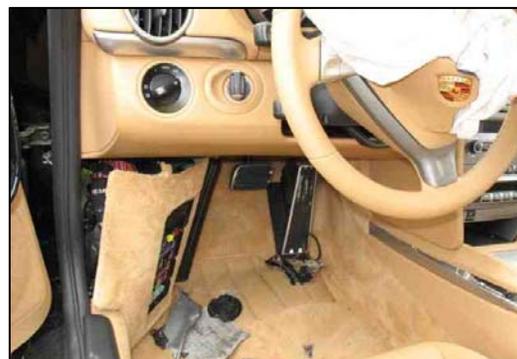
Figure 8 - Pedals and floor panel of Porsche Boxster.

slightly deformed to the right which likely occurred as a result of pre-crash braking maneuvers and loading at impact. The left floor panel was slightly buckled and the driver's seatback was minimally deformed. The following table outlines the SCI revised passenger compartment intrusion by their respective magnitude:

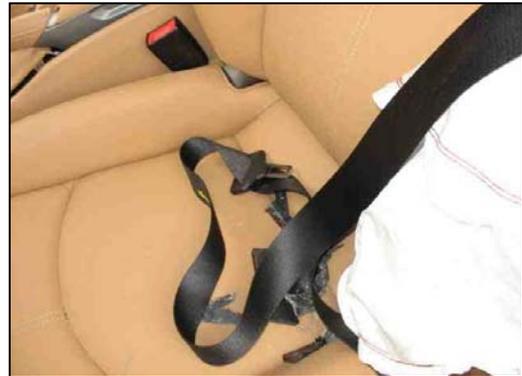
The 2006 Porsche Boxster was configured with manual 3-point lap and shoulder restraints for both frontal seating positions. The driver's safety belt was configured with a sliding latch plate and an Emergency Locking Retractor (ELR). The driver's safety belt sustained visible stretching due to occupant loading (**Figure 9**). The safety belt's retractor pretensioner fired as a result of the impact and the post-crash webbing was spooled out in a worn position. No discernable transfer evidence was identified during the NASS inspection and a review of the images yielded nothing further. The front right restraint was configured with a sliding latch plate and a switchable retractor that was in the ELR mode. This position was not occupied; therefore the retractor pretensioner did not fire.

Figure 9 - Post-crash manual lap and shoulder restraint.

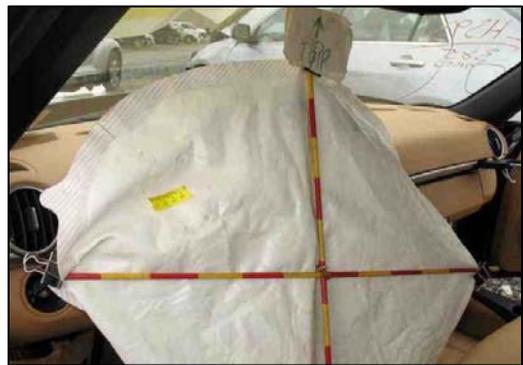
The 2006 Porsche Boxster was equipped with a Certified Advanced 208-Compliant (CAC) frontal air bag system that included dual stage air bags for the driver and front right passenger. The driver's air bag (**Figure 10**) deployed from the steering wheel hub through trapezoidal cover flaps. The deployed air bag membrane exhibited a grayish transfer on the upper left quadrant approximately 10 cm (4") above and 15 cm (6") to the left of the air bag's center point. The air bag was vented by two ports located at the 10 and 2 o'clock positions on the back aspect of the bag.

Figure 10 - Driver's air bag.

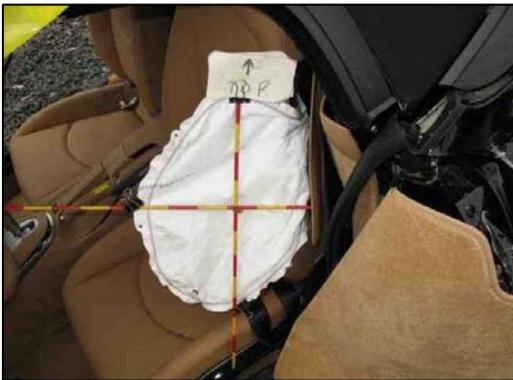
The 2006 Porsche Boxster was equipped with seat back mounted side impact air bags and door mounted head protection air bags. The seat back mounted torso air bag deployed from a single vertical cover flap on the outboard aspect of the driver’s seat back (**Figure 11**). The circular air bag was 40 x 40 cm (16 x 16”). Vinyl striations were present on the air bag’s membrane on its upper left quadrant inboard side due to contact with the tear flap during the deployment phase.

Figure 11 - Seat back mounted air bag.

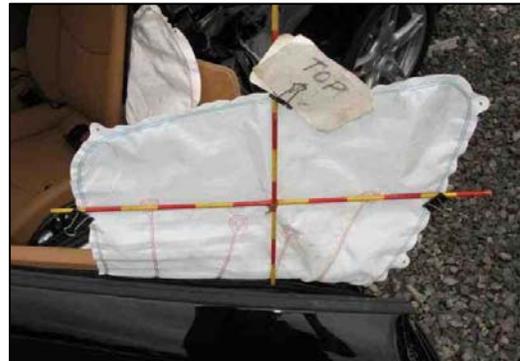
The head protection air bag deployed from the top aspect of the door panel between the door’s interior trim and the base of window (**Figure 12**). The air bag was 50 cm vertically and 35 cm horizontally and trapezoidal in form. The NASS investigation yielded no discernable evidence from the head protection air bag.

Figure 12 - Door mounted head protection air bag.

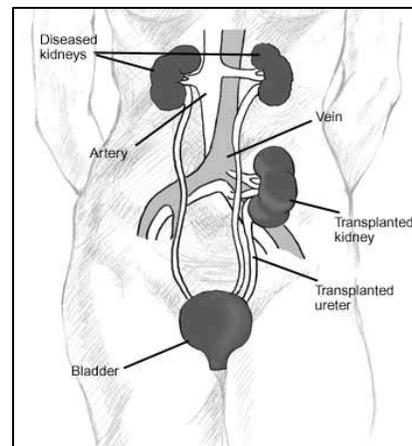
The 49-year old male driver of the Porsche was a recent left kidney transplant recipient. It should be noted that the kidney was repositioned to the lower left anterior aspect of the abdomen, a common practice for the transplant procedure. The transplanted kidney is placed in the lower abdomen of the recipient rather than its natural position in the back because it is easier to surgically attach it to the bladder from this location (Figure 13). In most cases, the native kidneys are left in

Figure 13 - Diagram of kidney transplant procedure.

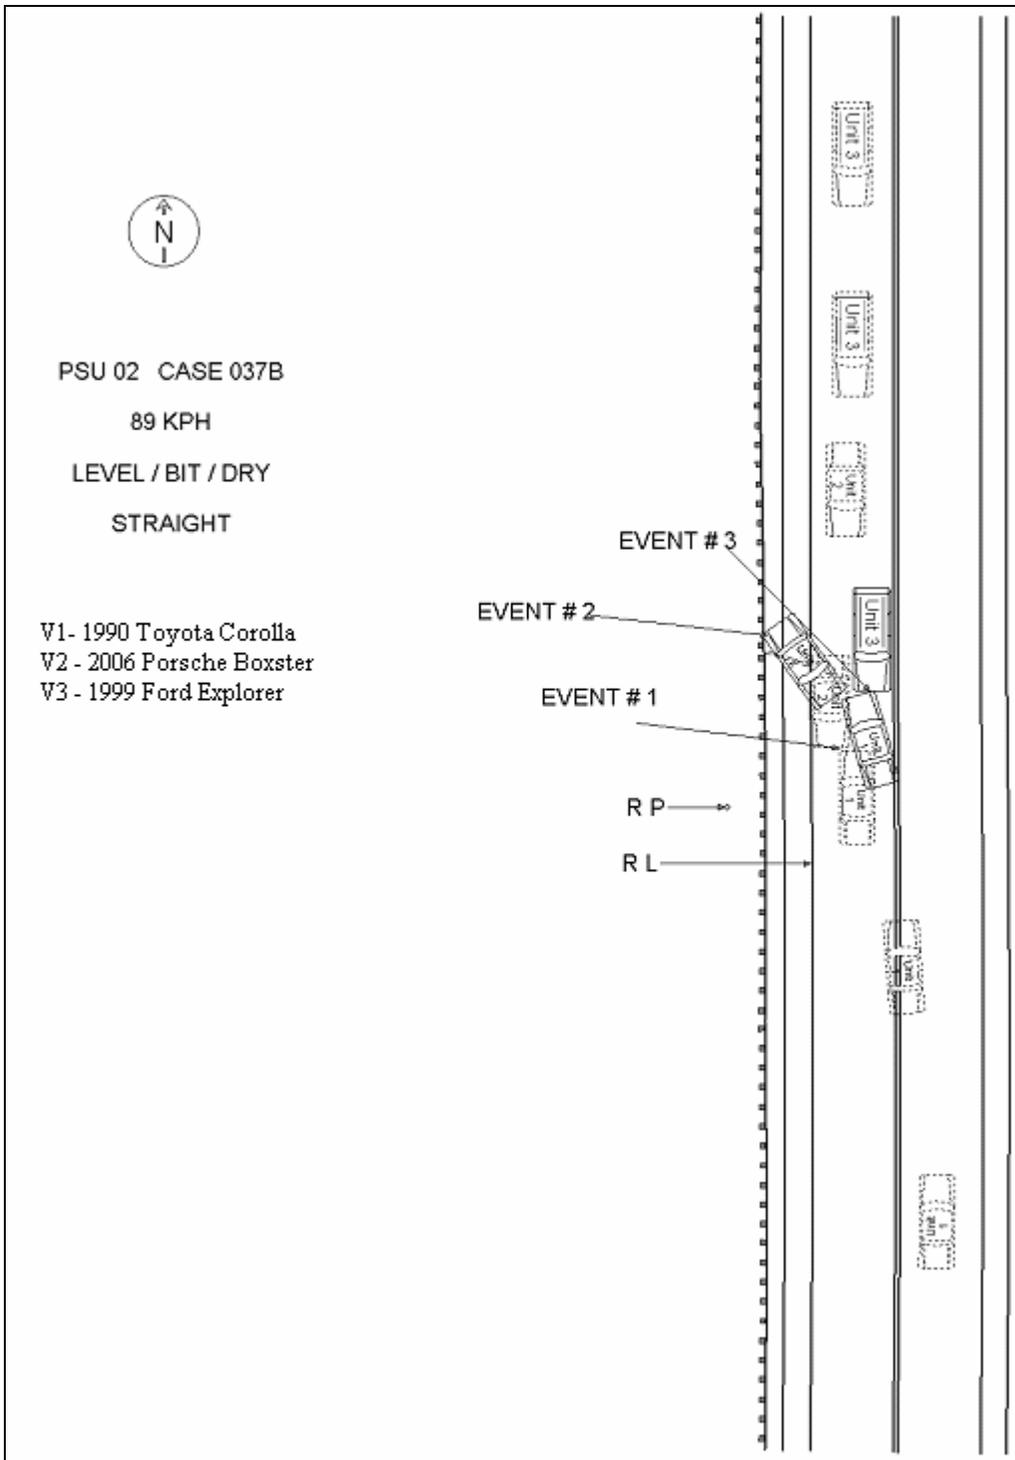
Figure 14 – NASS Scene Schematic

The crash occurred during daylight hours on a two-lane north/south roadway. The asphalt roadway was configured with one lane in each direction, both of which were 4 m (13') in width. Double-yellow painted centerlines delineated the travel lanes and the paved shoulders were delineated with white fog lines. A W-beam guardrail was positioned 1.5 m (4') outboard of the southbound shoulder. The roadside environment consisted of natural growth. The roadway had a slight positive grade for southbound traffic. At the time of the crash, there were no adverse weather conditions and the roadway was dry. The posted speed limit for this roadway was 89 km/h (55 mph). The NASS Crash Schematic is included as **Figure 14** at the end of this narrative report.
