SCI/NASS COMBINATION SEAT BELT-RELATED SERIOUS INJURY INVESTIGATION

CASE NUMBER - 2006-48-006K
LOCATION - Alabama
VEHICLE - 1999 HONDA ACCORD
CRASH DATE - January 2006

Submitted:
November 15, 2006
Revised:
April 11, 2008

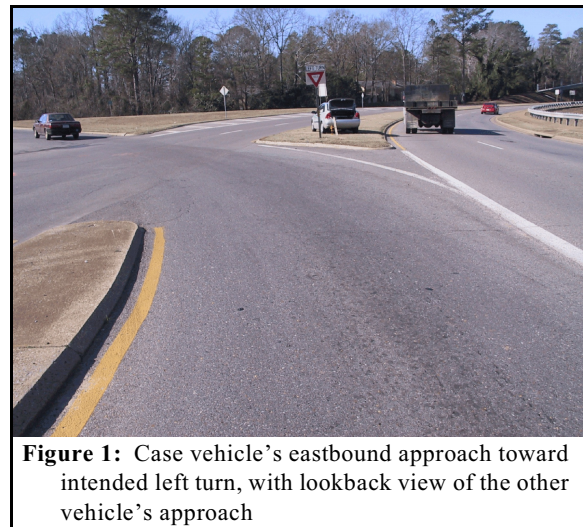
Figure 1: Case vehicle's eastbound approach toward intended left turn, with lookback view of the other vehicle's approach

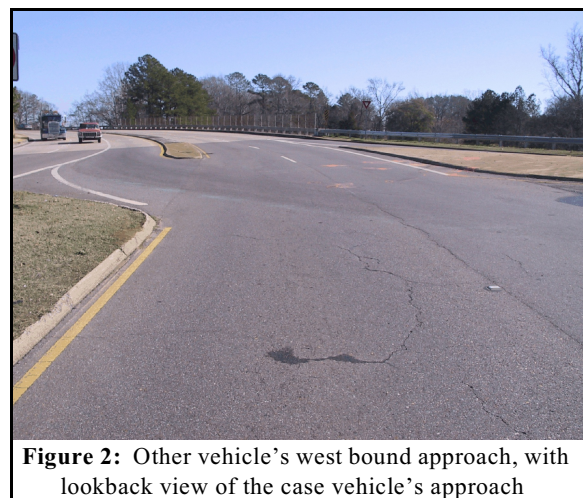
Figure 2: Other vehicle's west bound approach, with lookback view of the case vehicle's approach

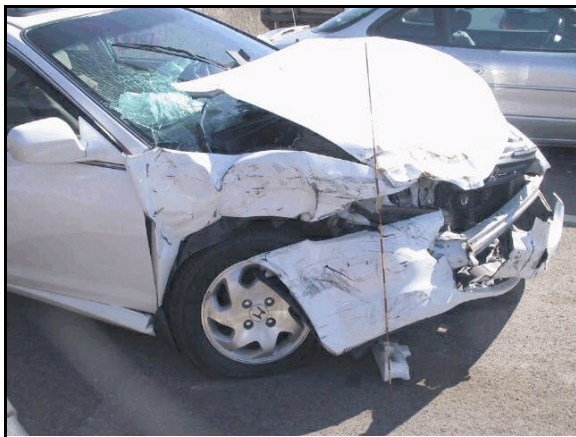
Figure 3: Case vehicle's front and right side

The case vehicle's single impact was at the front right corner, with direct contact damage extending across approximately the right half of the front plane, and on the right fender with direct contact rearward to the A-pillar. The other vehicle's front bumper overrode the case vehicle's bumper and the structures at the front right corner were crushed rearward and inward, with the right side of the radiator pressed against the engine block. The engine hood was buckled and displaced rearward, with its right rear corner impacting the windshield and causing extensive cracking across the entire width. There was no other glazing damage. The bumper cover was torn off and the steel bumper was crushed rearward on the right. The right door and rocker panel sustained induced damage but the door remained closed and operational. The right front wheel/tire assembly was displaced rearward and restricted due to being pressed against the right lower A-pillar with the tire deflated, and there was no other wheel/tire damage. The right wheelbase was shortened by 7 centimeters [2.8 inches]

and the left wheelbase shortened by 2 centimeters [0.8 inches]. The grille and the right headlamp/turn signal assembly were shattered and broken away, with the left headlamp/turn signal assembly intact but displaced due to damage to the adjacent components.¹

The CDC for the case vehicle's single impact was determined to be **01-FZEW-2 (40 degrees)**. The WinSMASH reconstruction program, CDC-only algorithm based on the case vehicle's CDC and the other vehicle's crush profile, was used. The total, longitudinal and lateral delta-Vs are, respectively: 36 km.p.h. [22.4 m.p.h.], -28 km.p.h. [-17.4 m.p.h.] and -23 km.p.h. [-14.3 m.p.h.]. This is a borderline reconstruction but the results seem reasonable and this was a crash of moderate severity (24-40 km.p.h. [15-25 m.p.h.]) for the case vehicle.

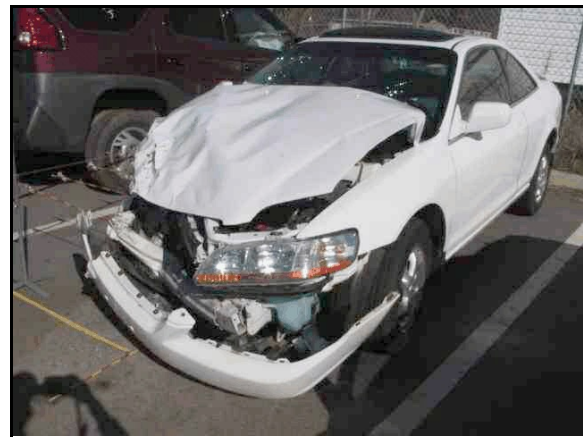
Figure 4: Case vehicle's front and left side

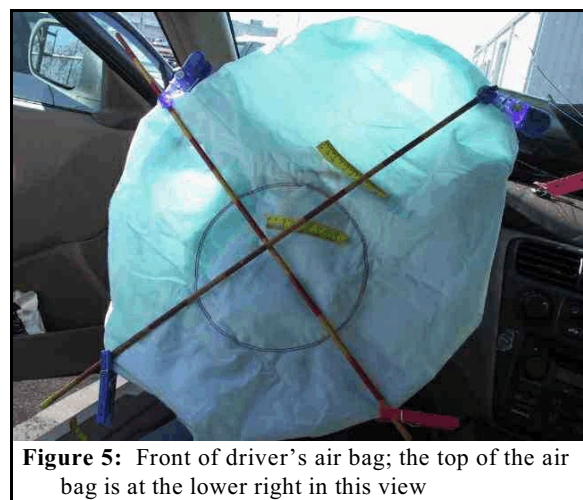
The driver's air bag was located in the steering wheel hub with the module cover flaps in the "H" configuration (**Figure 5**). The cover flaps opened at

Figure 5: Front of driver's air bag; the top of the air bag is at the lower right in this view

the designated tear points and there was no evidence of damage to the cover flaps or the adjacent structures. The deployed driver's air bag was round. There was no evidence of damage to the air bag. There was an area of cosmetics transfer on the front of the air bag fabric near the center.

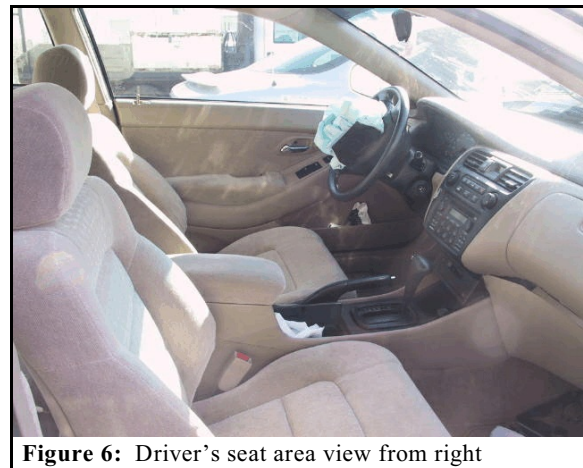
The case vehicle's driver (51-year-old female, white, non-Hispanic, 152 centimeters, 64 kilograms [60 inches, 141 pounds]) was restrained by her available, manual, three-point, lap-and-shoulder safety belt system and the steering wheel air bag deployed. The driver was not able to describe the position of either the lap or the shoulder portions of the safety belt webbing. The seat track was found at the full rear position at the time of the inspection, but the driver stated that the seat track was adjusted full forward at the time of the crash. The adjustable head restraint was flush against the top of the seat and the seat back was slightly reclined. The driver stated that her back was against the seat back, with her right foot operating the foot controls, her left foot on the floor and both hands on the steering wheel (**Figure 6**).

Figure 6: Driver's seat area view from right

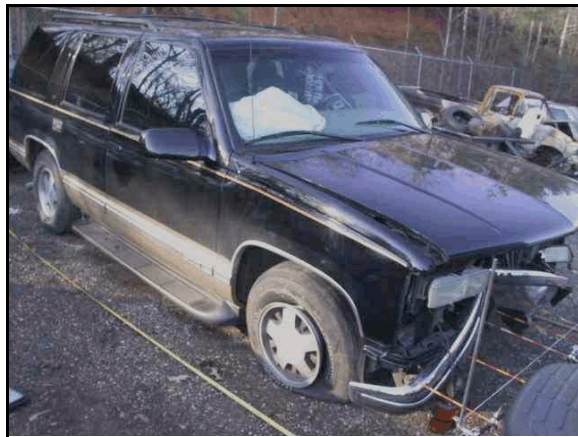
The Yukon's damage was concentrated at the center of the front, with a relatively deep V-shaped indentation resulting from the Yukon's initial contact with the apex of the case vehicle's front right corner (**Figures 7 and 8**). Direct contact was measured as beginning at the front left corner and extending inward 108 centimeters [42.5 inches], reflecting the Yukon's contact with the case vehicle's front surface (to the right of the V) and right fender (to the left of the V). The bumper was crushed inward and slightly upward at the center, with the right end of the bumper flexed forward. The wheelbase was unchanged. The bottom edge of the radiator was crushed rearward but the top

edge and the support bracket were not damaged, reflecting the Yukon's override engagement with the case vehicle's front. The grille and the left headlamp assembly were shattered and broken away, and the two turn signal assemblies were separated from their mountings and dangling from their wires. The right headlamp was undamaged and there was no direct contact on the leading edge of the hood. Maximum crush was measured as 52 centimeters [20.5 inches], between C3 and C4. The right front tire was deflated, with no other wheel/tire damage. All of the Yukon's glazing was intact.

Figure 7: Other vehicle's front and right side

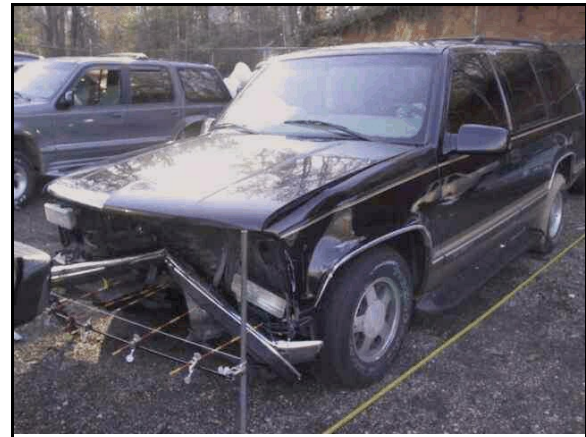
Figure 8: Other vehicle's front and left side

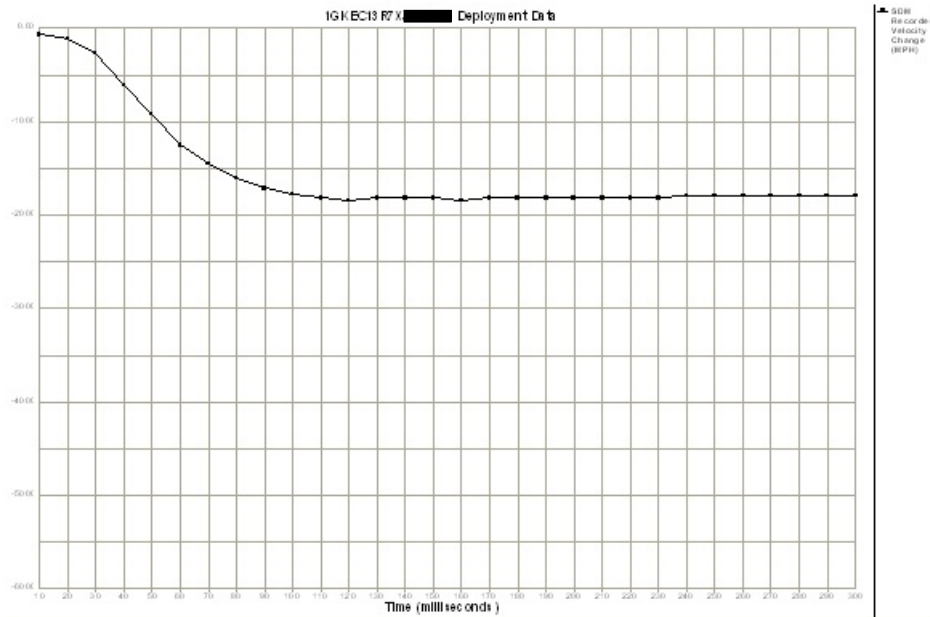
Diagnostic Module reports are presented as **Figures 9 and 10** at the end of this report. The report shows that the SIR warning lamp was off, indicating no faults in the air bag system, and the passenger's air bag was not suppressed. There is no pre-crash data in the report for this early (model year 1999) EDR. The command to deploy the air bags was issued 60 milliseconds (ms) after algorithm enable. The velocity change data show a moderately steep crash pulse, from -1.1 km.p.h. [-0.66 m.p.h.] at 10 ms to -20.1 km.p.h. [-12.51 m.p.h.] at 60 ms and -29.7 km.p.h. [-18.43 m.p.h.] at 120 ms. The velocity change oscillated between -29.9 km.p.h. [-18.43 m.p.h.] and -29.0 km.p.h. [-17.99 m.p.h.] for the duration of the recording, which ceased at 300 ms.

SIR Warning Lamp Status	OFF
Driver's Belt Switch Circuit Status	UNBUCKLED
Passenger Front Air Bag Suppression Switch Circuit Status	Air Bag Not Suppressed
Ignition Cycles At Deployment	17053
Ignition Cycles At Investigation	17056
Time From Algorithm Enable To Deployment Command (msec)	60
Time Between Non-Deployment And Deployment Events (sec)	N/A

Figure 10: Other Vehicle's SDM report, System Status at Deployment and Velocity Change graph and data
