Certified Advanced 208-Compliant Air Bag Investigation
Dynamic Science, Inc./Case Number: 2006-79-094J
2006 Volkswagen Passat
California
June 2006

1. Report No. 2006-79-094J		2. Government Accession No.		3. Recipient Catalog No.	
4. Title and Subtitle Certified Advanced 208-Compliant Air Bag Investigation				5. Report Date August 31, 2006

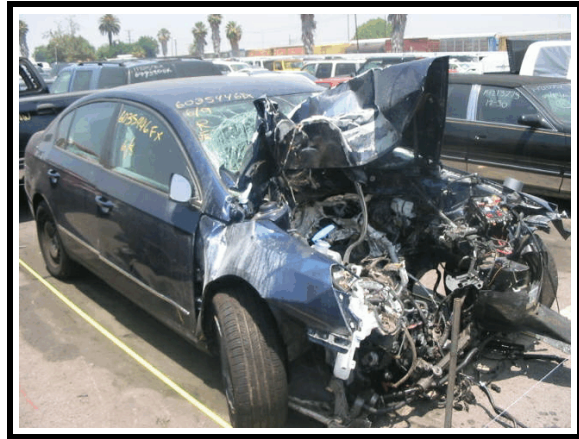
Figure 1. Front/Right - 2006 Volkswagen Passat

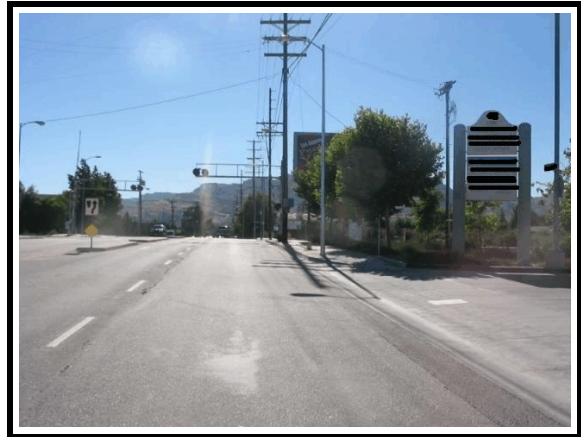
Figure 2. Approach of case vehicle (west)

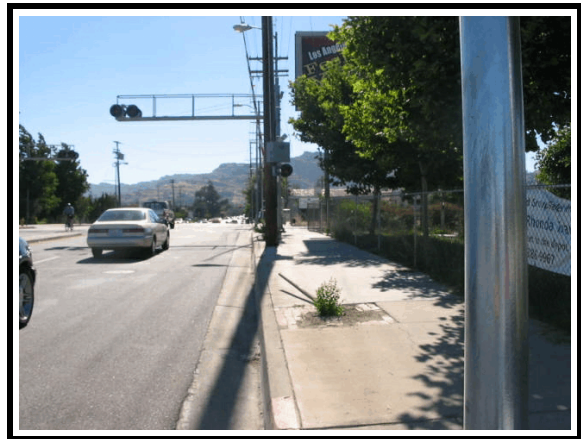
Figure 3. Impacted light post (foreground), pole and wooden utility pole (background)

The first steel pole was knocked down during the crash. According to the power company, it was replaced by an identical steel pole.

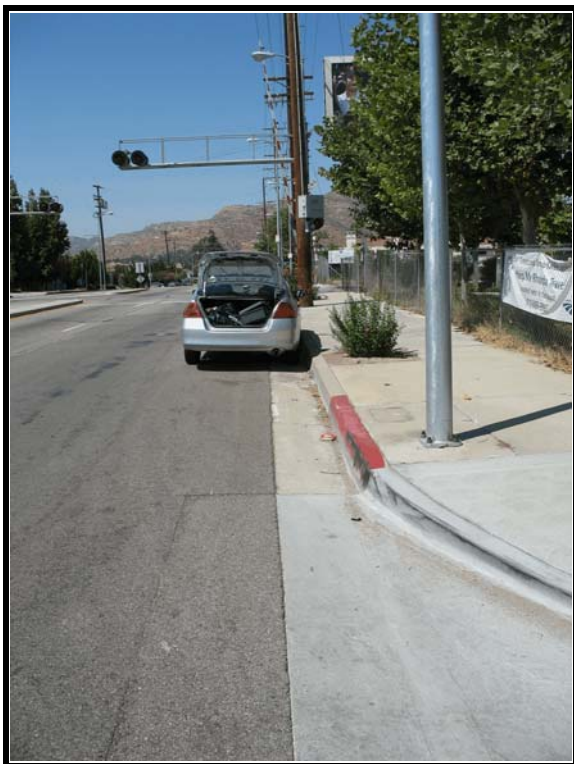
Figure 4. Impact with first pole

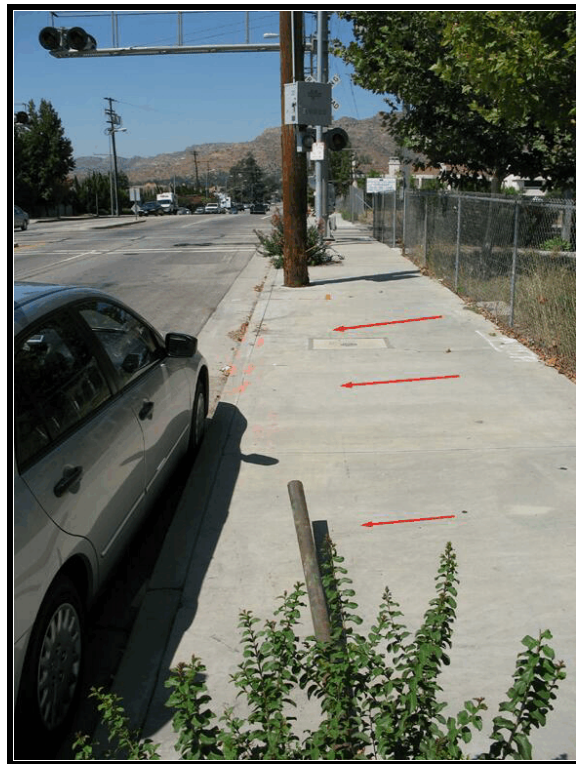
Figure 5. Struck second pole and path to impact with third pole

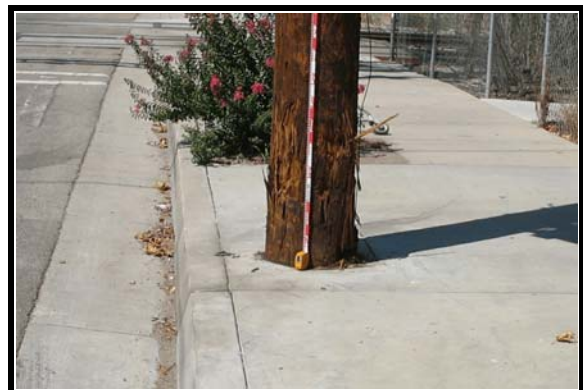
Figure 6. Impact with third pole

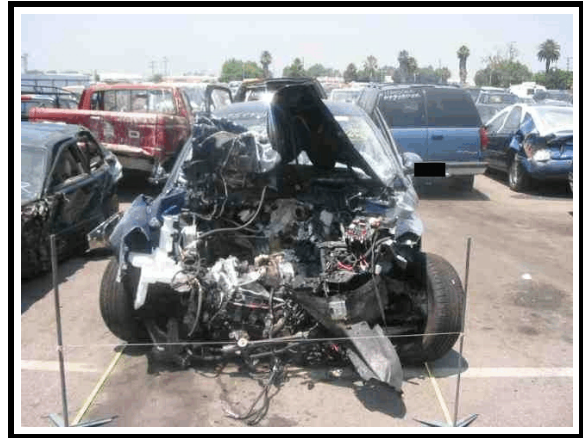
Damage Description: The 2006 Volkswagen Passat sustained severe front end damage as a result of the impacts with the three poles. There was extensive engine damage. The hood was crumpled rearward and appears to have partially impacted the case vehicle's windshield, holing the glazing in the lower center section.

The location of direct damage from the individual impacts was not documented due to overlapping damage. Crush profiles were not obtained. For the initial crash event between the Passat's front end and the first pole, the NASS researcher assigned a Collision Deformation Classification (CDC) of 12FDEW6. Given the diameter of the pole, it is unlikely the direct damage extended across the entire front end of the vehicle. It is also unlikely that the direct damage from this first crash event would have resulted in crush that extended into extent zone 6. It is more likely that the third impact to the large wooden pole caused the most damage and crush to the vehicle. This third event left the most distinctive crush pattern to the vehicle's front end, including a distinct outline of the shape of the pole near the center of the hood.

Figure 7. Front - 2006 Volkswagen Passat

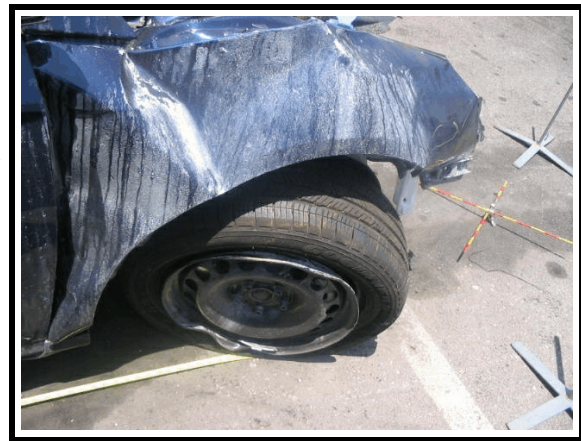
Position	Measured Pressure	Measured Tread Depth	Restricted	Damage
LF	310 kPa (45 psi)	8 mm (10/32 in)	Yes	None
LR	310 kPa (45 psi)	6 mm (8/32 in)	No	None
RR	310 kPa (45 psi)	6 mm (8/32 in)	No	None
RF	Flat	6 mm (8/32 in)	Yes	Tire debanded; rim damaged

Figure 8. Right front tire & rim damage

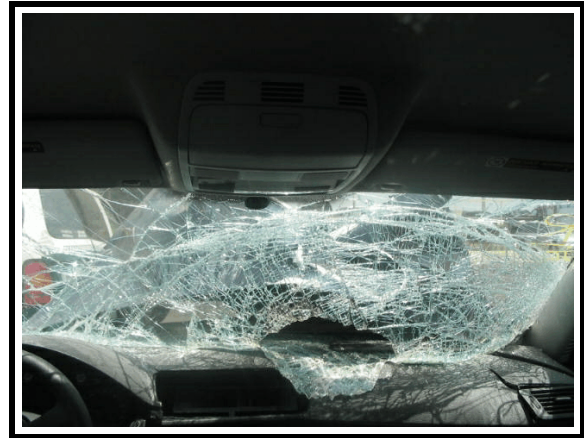
Figure 9. Windshield damage/intrusion

There was integrity loss to the windshield. The glazing was in place and holed near the bottom center. The entire windshield was cracked due to impact forces and the hole appears to have been caused by contact with the damaged hood. The rearview mirror broke off its base, either due to impact damage or occupant contact. The vehicle's side doors all remained closed and operational.

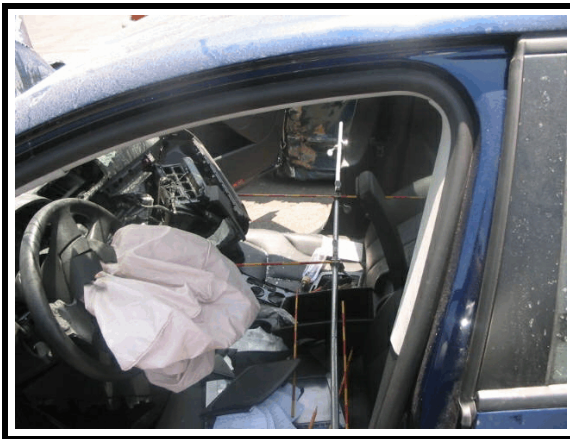
Figure 10. Front row intrusion

There was longitudinal intrusion of the windshield and instrument panel. It appears that there were additional components that had intruded but the photographic documentation of the front row passenger compartment was not sufficient to be able to use for coding. The specific passenger compartment intrusions were documented as follows:

Row/Position	Intruded Component	Magnitude of Intrusion	Direction
1M	Instrument panel	> = 8.0 to < 15.0 cm (3.1 - 5.9 in)	Longitudinal
1R	Instrument panel	> = 8.0 to < 15.0 cm (3.1 - 5.9 in)	Longitudinal
1M	Windshield	0 to < 8.0 cm (0 - 3.1 in)	Longitudinal
1R	Windshield	0 to < 8.0 cm (0 - 3.1 in)	Longitudinal

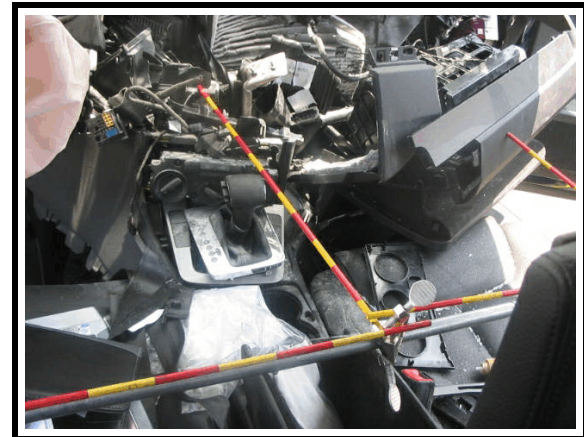
Figure 11. Center & Right instrument panel intrusion

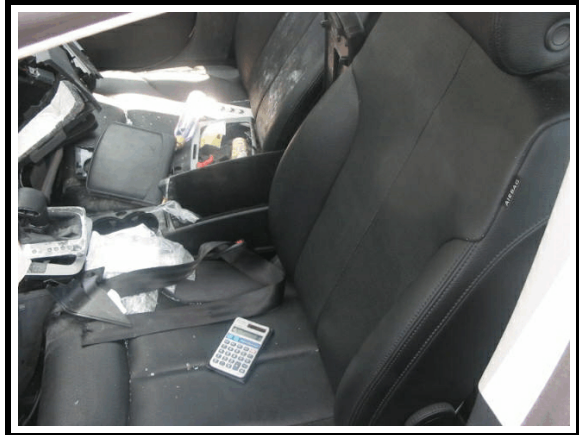
Figure 12. Driver's seat belt, cut by fire/rescue personnel

The driver's seat belt was cut by fire/rescue personnel post-crash.

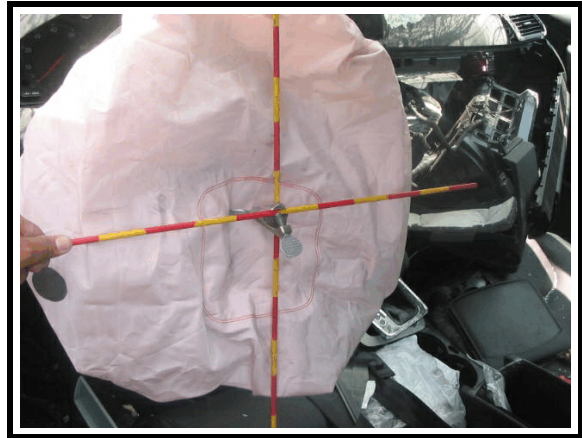
Figure 13. Deployed driver front air bag

The driver's front air bag was mounted in the center of the steering wheel hub. The NASS researcher did not document the air bag module cover flap configuration and flap measurements. The air bag was circular in shape. The diameter of the air bag is unknown. It is not known if the air bag had tethers. It appears from the photographs that there is at least one vent port, located near the 9 o'clock position. There was no damage to the air bag or air bag module cover flaps. There was a scuff to the lower left section of the air bag which may have been a cover flap transfer that occurred during the deployment.

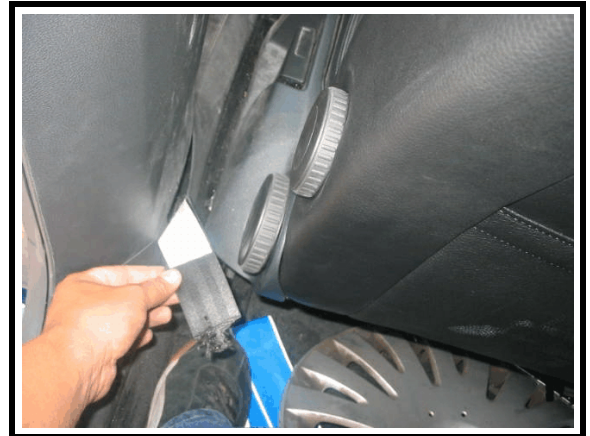
Figure 15. Driver's seat belt - cut by fire/rescue personnel

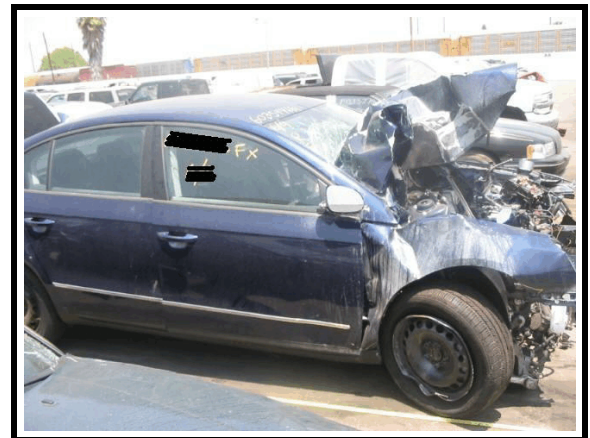
Figure 14. Angled hood damage

V event. The angled hood damage gives the appearance that the back of the case vehicle may have lifted up into the air during this crash event, possibly resulting in the driver's lumbar compression fracture. It is possible that the driver's face may have contacted the rearview mirror, resulting in the driver's orbital fracture and eyelid laceration. The vehicle came to final rest near the struck utility pole, facing west.
