Combination Child Safety Seat Investigation / Vehicle to Vehicle
Dynamic Science, Inc. / Case Number: 2006-81-042B
1989 Honda Civic
Washington
May 2006

1. Report No. 2006-81-042B		2. Government Accession No.		3. Recipient Catalog No.	
4. Title and Subtitle Combination Child Safety Seat Investigation				5. Report Date January 25, 2007

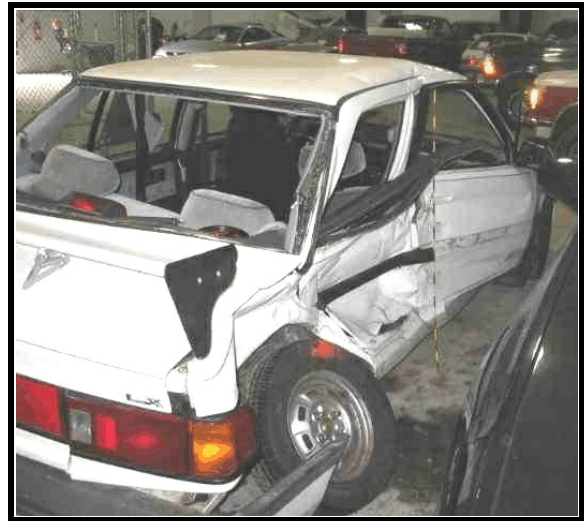
Figure 1. Right side damage, Honda Civic

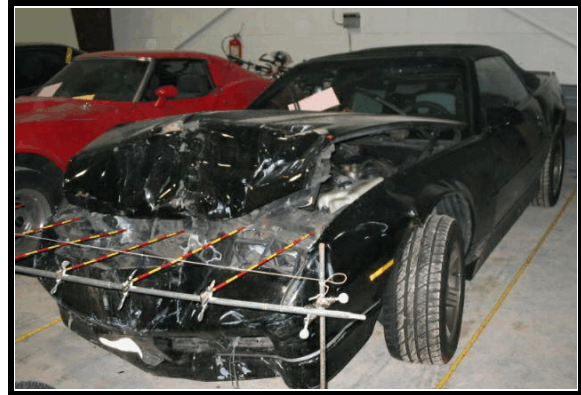
The driver of the Chevrolet Camaro failed to stop, entered the intersection, and struck the right side of the Civic with its front end (see Figure 4). The right side window and backlight of the Civic disintegrated during the impact. The Civic began a rapid clockwise rotation. There was a secondary impact between the front of the Honda and the right side of the Camaro as the Honda was spun around. During the rotation, the 9-month-old second row right side occupant was ejected and fatally injured. The Civic continued rotating before coming to rest off-road in the northeast quadrant facing northwest. The Chevrolet Camaro was redirected slightly to the right and continued traveling northbound. The Camaro entered the northern leg of the intersection and struck the rear of the Toyota pickup (see Figure 5).

Figure 4. Front, 1988 Chevrolet Camaro

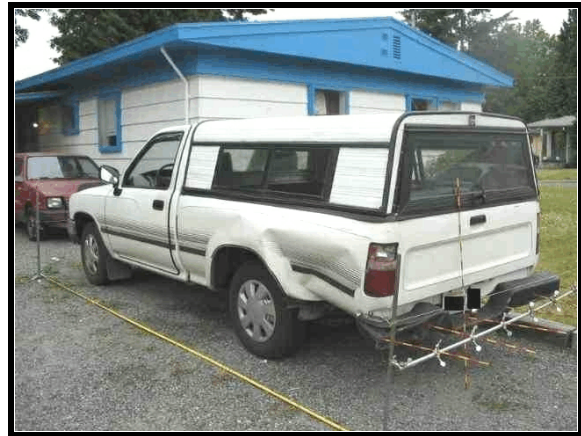
Figure 5. Rear damage, 1993 Toyota pickup

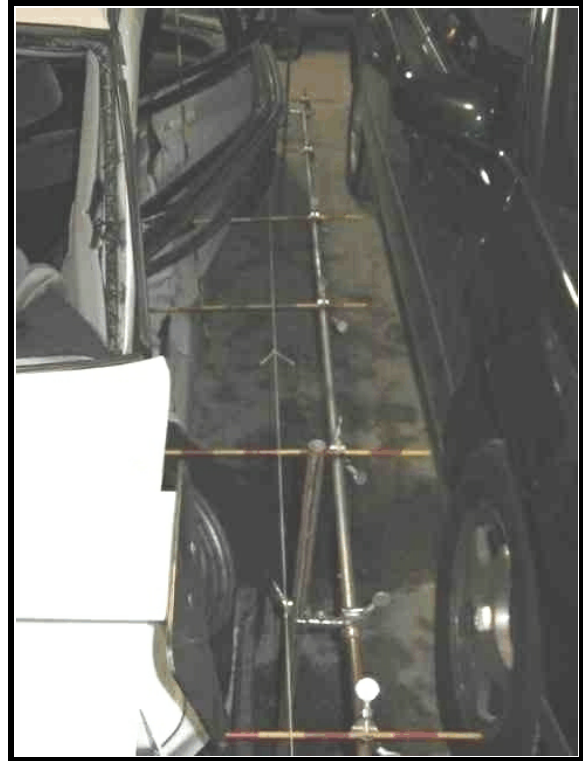
The 1989 Honda Civic sustained moderate right side damage as a result of the impact with the Chevrolet Camaro (see Figure 6). The direct damage began 51.0 cm (20.1 in) aft of the rear axle and extended 173.0 cm (68.1 in) forward along the right side plane. The front right, left rear and right rear doors were jammed shut. The windshield was cracked from impact forces. The right rear windows and the backlight were disintegrated. Six crush measurements were documented at the mid door level as follows: C1 = 1.0 cm (0.4 in), C2 = 33.0 cm (13.0 in), C3 = 37.0 cm (14.6 in), C4 = 33.0 cm (13.0 in), C5 = 16.0 cm (6.3 in), C6 = 0 cm (0 in).

Figure 6. Honda Civic, right side damage

CDC:	Impact 1: 03RZEW3 Impact 2: 12FRLE1	
Delta V (Impact 1):	Total	26 km/h (16.2 mph)
	Longitudinal	-45 km/h (-27.9 mph)
	Latitudinal	-26 km/h (-16.2 mph)
	Energy	49,952 joules (36,842 ft-lbs)

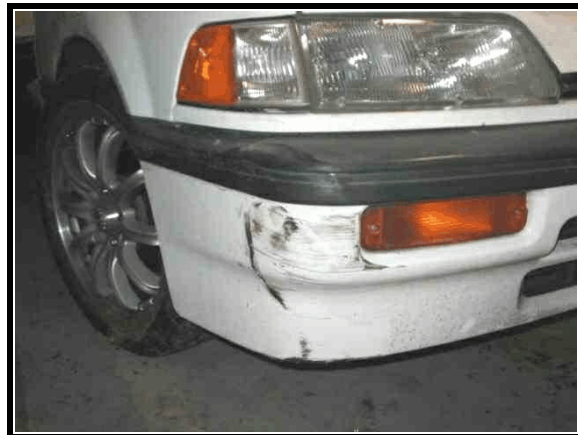
The Honda Civic also sustained minor damage to the front bumper as a result of contacting the Chevrolet Camaro during rotation (see Figure 7). The direct damage began at the front right bumper corner and extended 13.0 cm (5.1 in) laterally along the front bumper.

Figure 7. Honda Civic, front right bumper corner damage

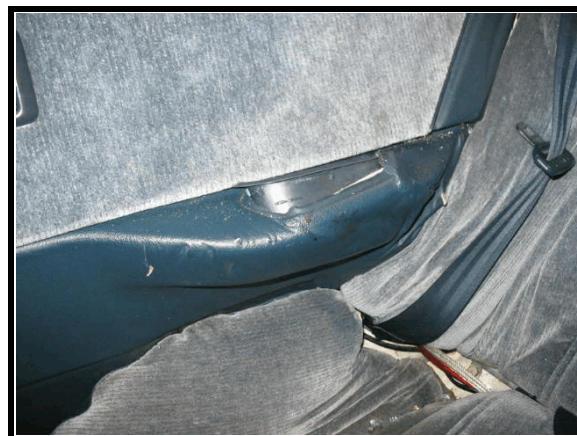
The 1989 Honda Civic sustained moderate interior damage as a result of passenger compartment intrusion (see Figure 8). The right side doors, B pillar, C pillar and roof side rail sustained lateral intrusion. As a result of the lateral intrusion, the second row right seat cushion and seat back were compressed laterally.

Position	Intruded Components	Magnitude of intrusion	Direction
FR	B pillar	25.0 cm (9.8 in)	Lateral
FR	Door side panel	26.0 cm (10.2 in)	Lateral
FR	Roof side rail	8.0 cm (3.1 in)	Lateral
FM	Front seat back	10.0 cm (3.9 in)	Lateral
RR	Door side panel	20.0 cm (7.9 in)	Lateral
RR	Roof side rail	5.0 cm (1.9 in)	Lateral
RR	Floor pan	25.0 cm (9.8 in)	Lateral
RR	C pillar	≥ 8.0 cm (3.1 in) < 15.0 cm (5.9 in)	Lateral

Figure 8. Intrusion at second row right door

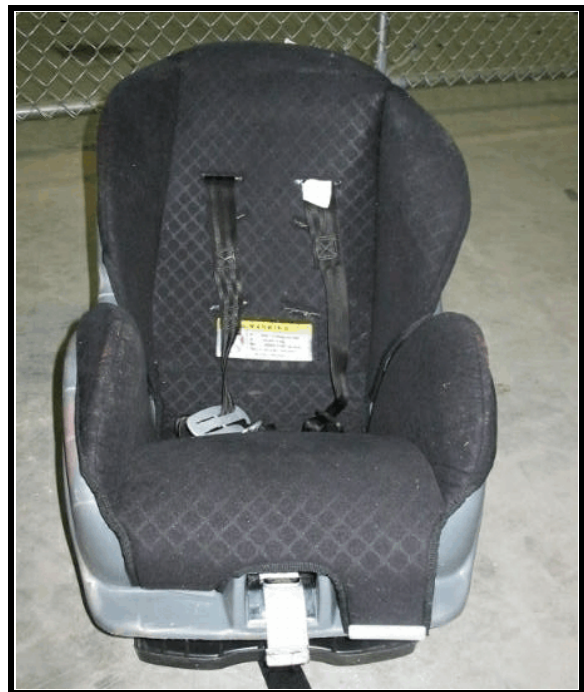
An Evenflo Tribute convertible child safety seat (CSS) was positioned in the second row middle seat of the Honda (see Figures 9 and 10). Based on the right side loading damage from the second row right seat occupant, it appears more likely that it was in the forward facing mode. The model number was 3792096 P1 and the date of manufacture was July 18, 2003. The CSS was configured with a five-point harness and a harness retainer clip. The harness was threaded through the top slots. The manufacturer recommends child seat usage as follows:

The child seat was damaged on the right side from occupant contact/loading.

Figure 9. Evenflo Tribute child safety seat

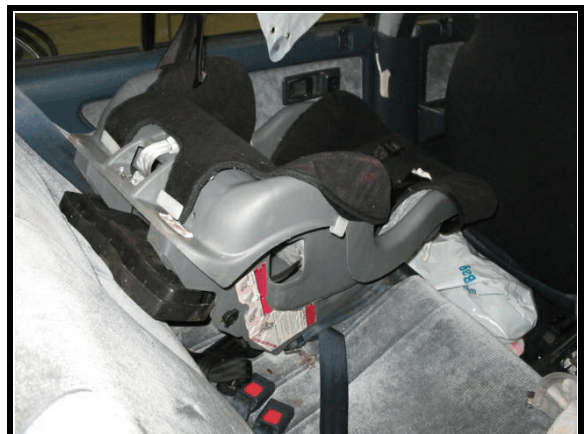
Figure 10. Child seat in vehicle at time of inspection (on its back and not anchored)

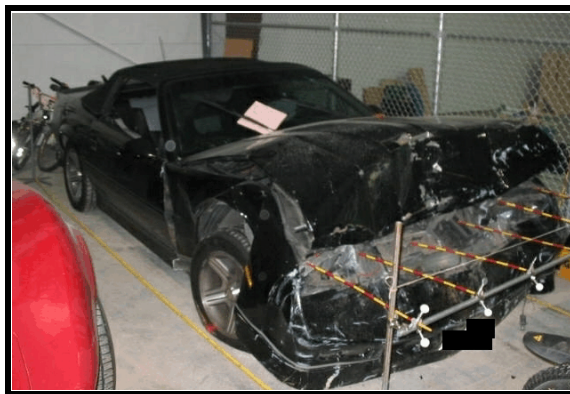
Description:	1988 Chevrolet Camaro two-door convertible	
VIN:	1G1FP31F3JLxxxxxx	
Engine:	5.0 liter, V8	
Reported Defects:	None noted	
Cargo:	None	
Damage Description:	Moderate front end damage.	
CDC:	Impact 1: 12FDEW2 Impact 2: 12RBWN1 Impact 3: 12FREW9	
Delta V:	Total	Unknown
	Longitudinal	Unknown
	Latitudinal	Unknown
	Energy	Unknown

Figure 12. Front right, Chevrolet Camaro

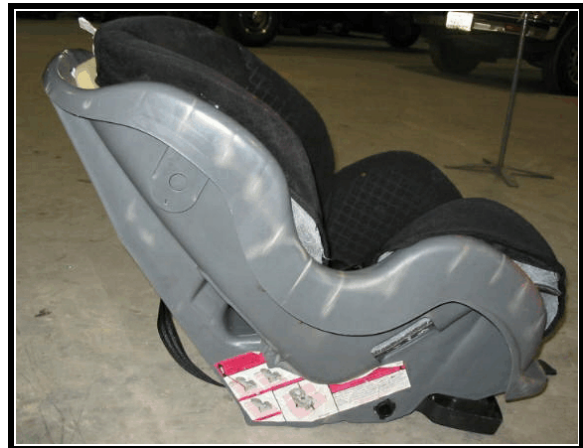
The 2-year-old male child was restrained in a forward facing child safety seat by the five-point harness. The CSS was installed in the second row middle seat position of the Honda Civic with the lap belt. It is not known if the child seat was properly anchored to the vehicle. At impact, the child and the CSS initiated a lateral trajectory to the right. Intrusion to the right door resulted in the movement of the second row right seat occupant in the direction of the child seat. There was loading evidence found on the right side of the CSS (see Figure 13). As the CSS became fixed in place while in contact with the right seat occupant, the child's head engaged the interior of the CSS shell causing a subdural hematoma, a brain stem compression, and a cerebral infarction. The case vehicle began a clockwise rotation after the initial impact. During rotation, this occupant likely shifted to the right but was restrained by the child seat. There was a secondary impact with the Camaro but this was a minor impact would have had little effect on this occupant. The 2-year-old was transported to a local trauma center and was hospitalized for 22 days for his injuries.

Figure 13. Right side loading damage

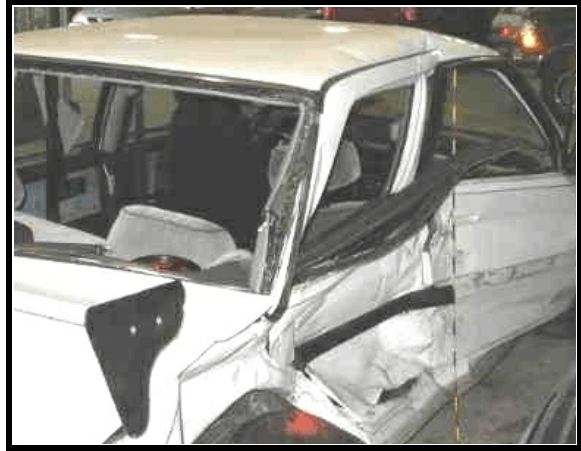
Figure 14. Ejection path, right rear window

The 9-month-old female second row right occupant was seated, forward facing, on the lap of the adult occupant of this seat position. There were no restraints in use. At impact, this occupant initiated a lateral trajectory to the right. She engaged the right side intruding door with the right side of her body. This likely caused the thoracic spinal injury and the right side rib fractures. As the collision continued, she pitched laterally and was fully ejected through the right rear window during rotation. She landed on the roadway causing multiple skull fractures and brain injuries. She was transported to a local trauma center where she died shortly after arrival.
