**CALSPAN ON-SITE CHILD AIR BAG RELATED FATALITY CRASH
INVESTIGATION**

CALSPAN CASE NO: CA06-001

VEHICLE: 1995 FORD MUSTANG

CRASH DATE: JANUARY 2006

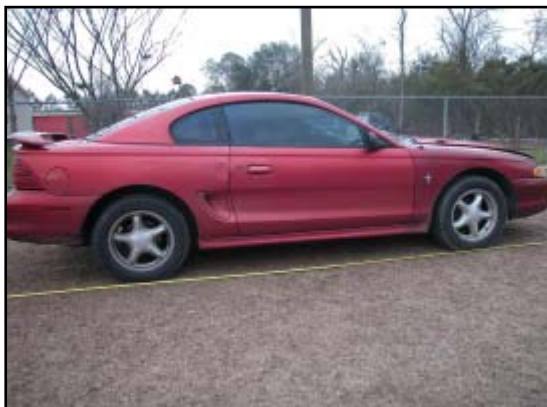
Figure 1. 1995 Ford Mustang subject vehicle.

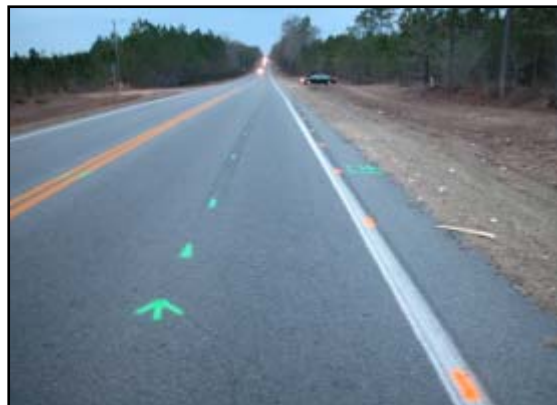
Figure 2. Ford's pre-crash skid marks.

The driver detected the stopped vehicles prior to impact. She steered right and applied full braking force to lock the front wheels of the vehicle. As the Mustang skidded in a tracking mode, the right side tires crossed the right side white edge line. Two locked front wheel skid marks were present and documented at the scene (**Figure 2**). The skid marks measured 34.2 m (112') and 42.5 m (139.4') for the left and right front tires respectively. The equivalent velocity loss due to braking was calculated at approximately 87 km/h (54 mph). At impact, the Mustang was straddling the right (east) edge line.

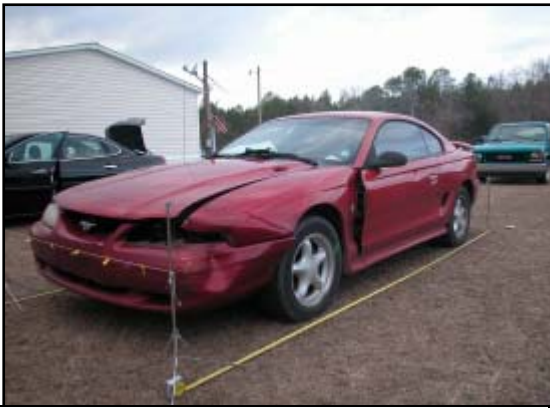
The Ford Mustang sustained minor severity frontal damage as a result of its impact sequence with the Toyota (**Figure 3**). Maximum crush was 13 cm (5.1”), located at the left corner of the front bumper beam. The direct contact damage consisted of abrasions and a fracture site to the bumper fascia. The direct damage began 31 cm (12.2”) left of the vehicle’s centerline and extended 46 cm (18.1”) to the left bumper corner. The damage also extended vertically, involving the headlamp assembly and the leading edge of the left front fender (**Figure 4**). The impact deformed the full width of the bumper beam resulting in a combined induced and direct damage length (Field L) of 140 cm (55.1”). Six equidistant crush measurements were documented at this level and were as follows: C1 = 13 cm (5.1”), C2 = 10 cm (3.9”), C3 = 0 cm, C4 = 0 cm, C5 = 0 cm, C6 = 0 cm. Damage components included the hood, front bumper fascia and reinforcement beam, left headlamp and turn signal assembly, and the left front fender. The Collision Deformation Classification (CDC) for this impact was 12-FLEW-1.

Figure 3. Overall view of the frontal damage.

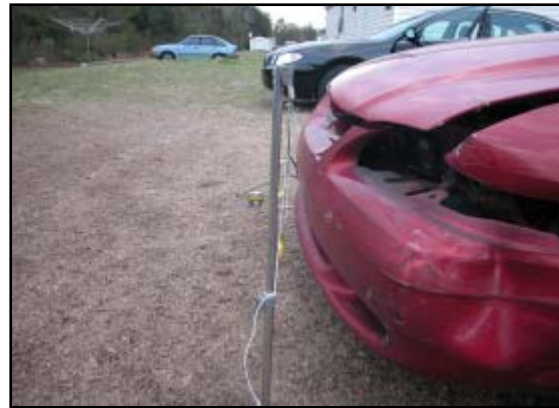
Figure 4. Lateral view of the crush profile

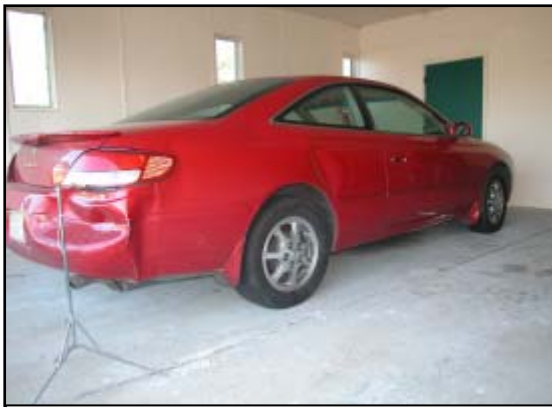
The Toyota was struck in the rear by the front left area of the Ford. This impact resulted in minor damage to the rear right area of the Toyota (**Figure 5**) with a maximum crush of 25 cm (9.8”) located at the right corner of the back bumper beam. The direct contact damage began 15 cm (5.9”) right of center and extended 60 cm (23.6”) to the right rear corner. The impact produced a large dent to the bumper fascia and displaced the entire width of the bumper beam forward, resulting in a combined induced and direct contact damage length of 135 cm (53.1”). A crush profile was documented at the level of the bumper beam and was as follows: C1 = 0 cm, C2 = 0 cm, C3 = 0 cm, C4 = 1 cm (0.4”), C5 = 7 cm (2.8”), C6 = 13 cm (5.2”). Induced damage extended onto the right rear quarter panel with two isolated dents noted forward of the tail lamp assembly and at the leading edge of the wheel opening (**Figure 6**). The CDC for this impact was 06-BZLW-1.

Figure 5. Resultant damage to the rear of the Toyota.

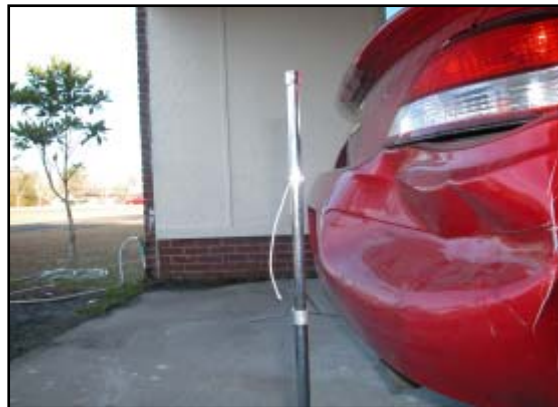
Figure 6. Lateral of the resultant crush.

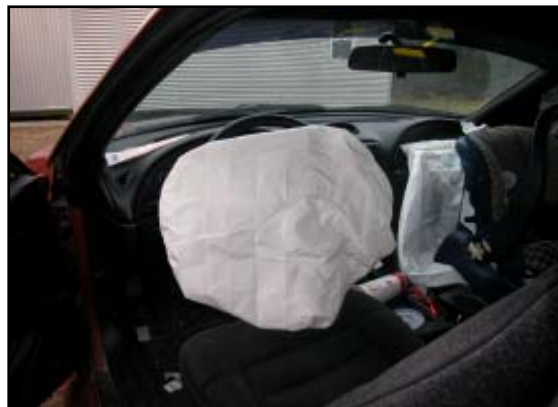
The driver’s air bag was contained within the four-spoke steering wheel rim and concealed by two H-configuration cover flaps. Both flaps were 15 cm (6”) wide at the horizontal tear seam. The upper and lower flaps were measured at 10 cm (4”) and 6 cm (2.5”) in height respectively. The air bag membrane (**Figure 7**) measured 62 cm (24.5”) in diameter in its deflated stated and was tethered by four internal tethers at the 12/6 and 3/9 o’clock sectors. Two vent ports located on the backside of the bag at the 11 and 1 o’clock

Figure 7. Driver's frontal air bag.

sectors vented the bag into the passenger compartment. The maximum rearward excursion of this bag at the tether locations was 32 cm (12.5"). There was no damage or evidence of driver contact on the face of the deployed air bag.

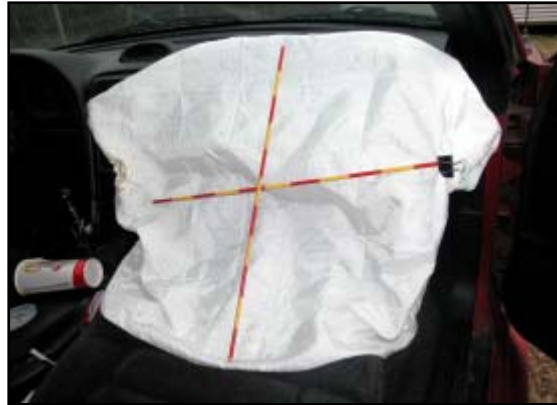
The front right passenger air bag was a mid-mount design, incorporated into the right instrument panel. Two symmetrical H-configuration cover flaps concealed the bag. Both flaps were 41 cm (16") wide at the horizontal tear seam and 8 cm (3") in height. There was no damage or contact evidence to the cover flaps. The air bag (**Figure 8**) measured 74 cm (29") in width and 64 cm (25") in height. The bag was not tethered; however, it was vented by a single port on the left side panel at the 9 o'clock position. The maximum rearward excursion of this bag at the midpoint measured 81 cm (32").

Figure 8. Overall view of the front right air bag membrane.

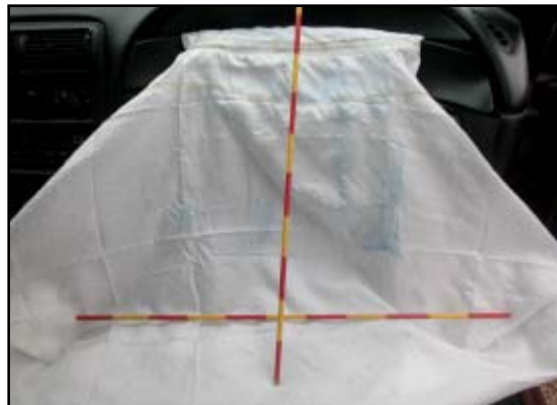
The front right passenger air bag deployed against the backside of the shell of the rear-facing child safety seat. This interaction fractured the shell of the CSS and was evidenced by blue plastic transfers to the face, top, and side surfaces of the bag membrane. The top panel of the air bag contained a blue transfer that extended 24 cm (9.25") aft of the forward seam and 18-53 cm (7-21") left of the right seam (**Figure 9**). A 5x17cm (2x6.5") transfer was noted to the extension panel that was affixed to the inflator housing and the top panel of the air bag. The face of the air bag was marked by a blue plastic transfer that extended 25-31 cm (10-12") below the top panel and 22-33 cm (8.75-13") inboard of the right seam.

Figure 9. Blue plastic transfer on the top panel of the air bag membrane.

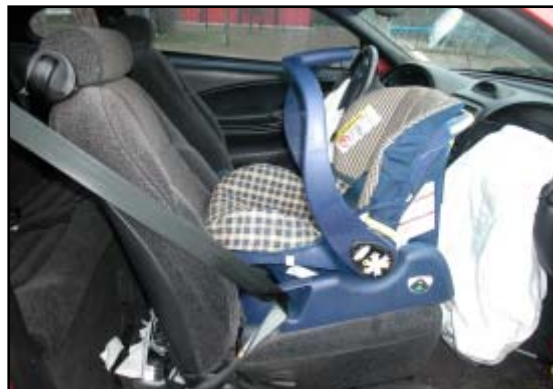
Figure 10. RFCSS installed in the front right position.

The RFCSS (safety seat and base) was installed in the front right position of the Mustang (**Figure 10**). The driver stated during the SCI interview that she was not aware of the risks associated by placing the RFCSS in the front right position of a vehicle that was equipped with a front right air bag system. Although the vehicle and the RFCSS were equipped with warning labels advising against this placement, she failed to observe these warnings.

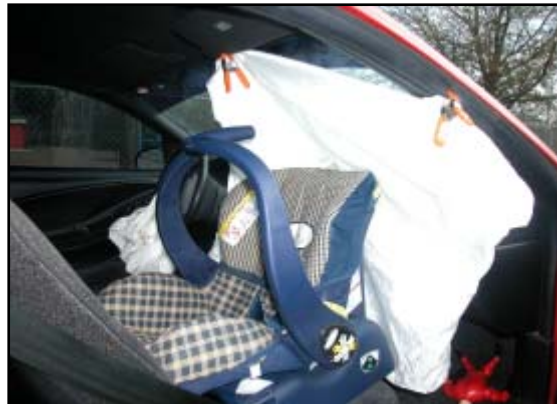
Figure 11. Expansion of the air bag membrane against the RFCSS.

At impact, the frontal air bag system deployed. The front right air bag membrane expanded against the leading edge and backside of the shell of the RFCSS (**Figure 11**). The top surface of the shell was stressed from bag contact.

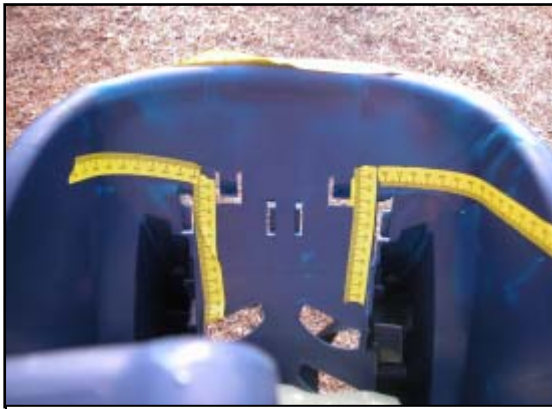
The shell of the CSS was extensively fractured. As a point of reference, when viewed from the backside of the RFCSS, a fracture line extended vertically 21 cm (8.25") from the forward edge of the shell to the left vertical reinforcement, terminating at the top harness strap slot. A near matching fracture line extended along the right side of the

shell, ending at the top slot. **Figure 12** is an overall view of the fractures at top aspect and harness strap slots.

Figure 12. Fractures at the top of the RFCSS.

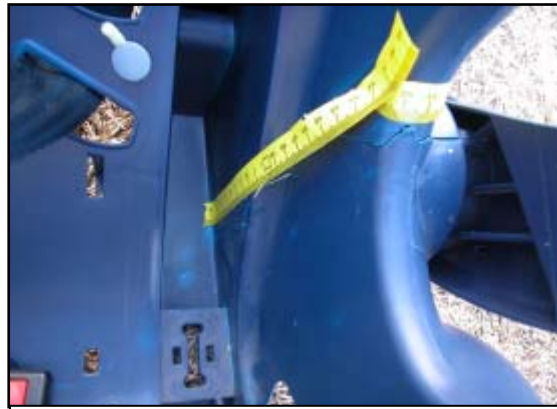
The continued expansion of the air bag accelerated the RFCSS rearward. The carrying handle loaded the front right seat back. This loading force fractured the outboard aspect of the shell, beginning at the outboard pivot point and extending 17 cm (6.75”) toward the back of the seat (**Figure 13**). The pivot point of the carrying handle separated; however, the handle remained intact.

Figure 13. Fracture at the carry handle.

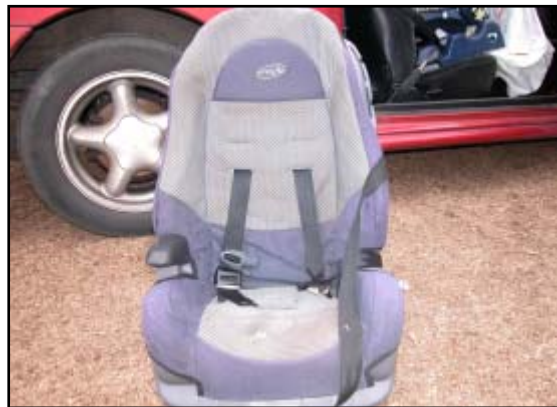
The 3-year old male was restrained in the rear right position of the Mustang. He was seated in an Evenflo Comfort Touch high-back belt positioning booster seat (**Figure 14**) and restrained by the manual three-point lap and shoulder belt system. The booster seat model number and date of manufacturer was unknown. The booster seat was placarded with a label that advised against usage after year 2010.

Figure 14. Evenflo high-back booster seat.

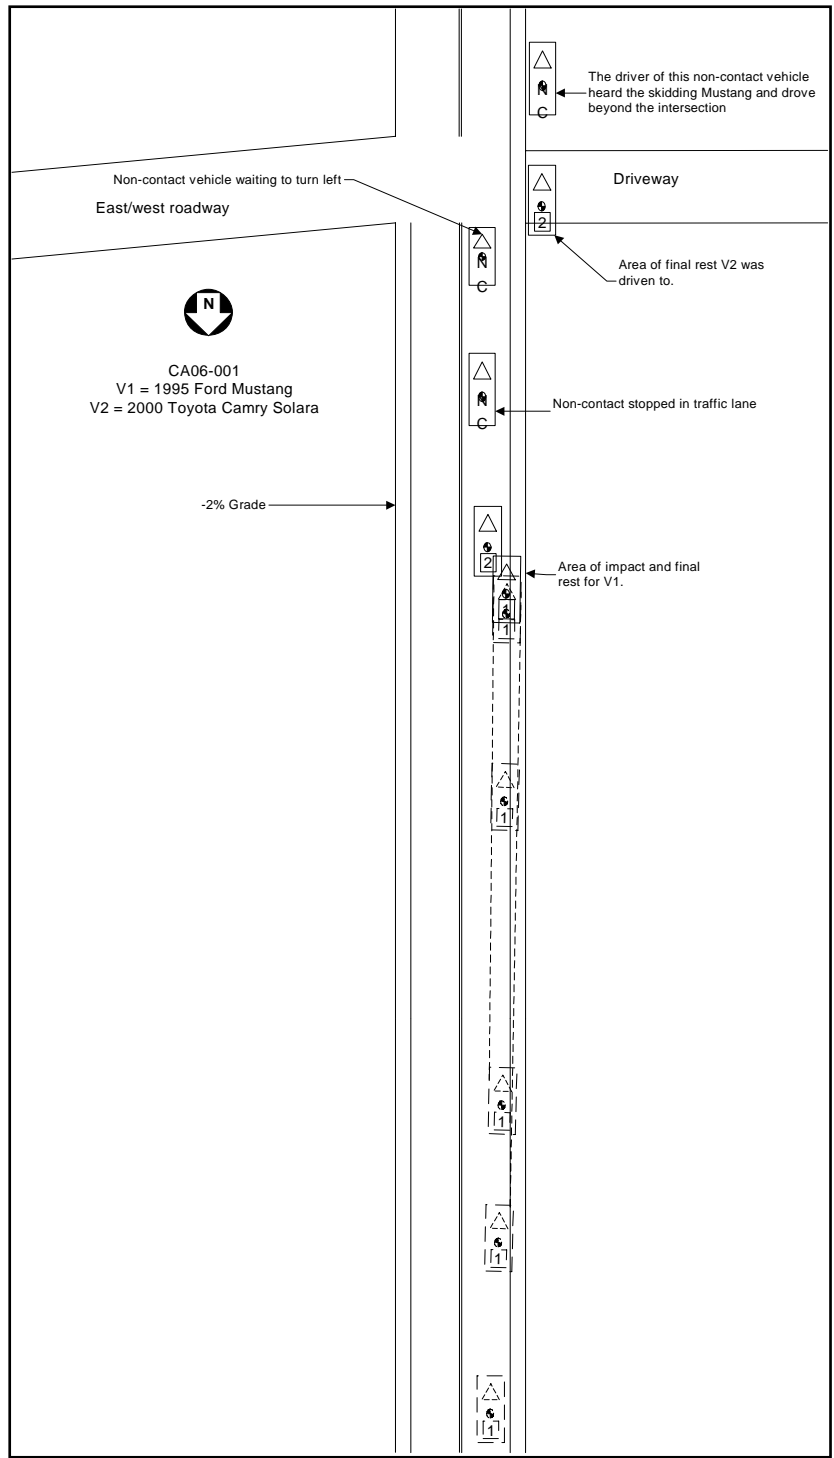
Figure 15: Scene Schematic

The crash occurred on a two-lane north/south road in a rural, undeveloped area. The travel lanes were 3.3 meters (11 feet) in width and delineated by solid white edge lines and a double yellow centerline. In the vicinity of the crash site, the roadway was straight with a negative grade of 2 percent in the southbound direction. Paved shoulders that measured 1m (3.3 feet) in width bordered the travel lanes. Cut grass that transitioned into drainage ditches paralleled both shoulders. A two-lane asphalt roadway intersected the north/south roadway at the left side (west). An incomplete driveway intersected the roadway opposite of the T-intersection. The posted speed limit was 89 km/h (55 mph). The scene schematic is included as **Figure 15** of this report.
