Side Curtain and Side Air Bag Investigation/Vehicle to Objects
Dynamic Science, Inc./Case Number: DS06006
2003 Volkswagen Golf
Washington
February 2006

1. Report No. DS06006	2. Government Accession No.	3. Recipient Catalog No.	
4. Title and Subtitle Side Curtain and Side Air Bag Investigation		5. Report Date August 18, 2006

This on-site investigation focused on the side curtain and side air bag systems in a 2003 Volkswagen Golf.

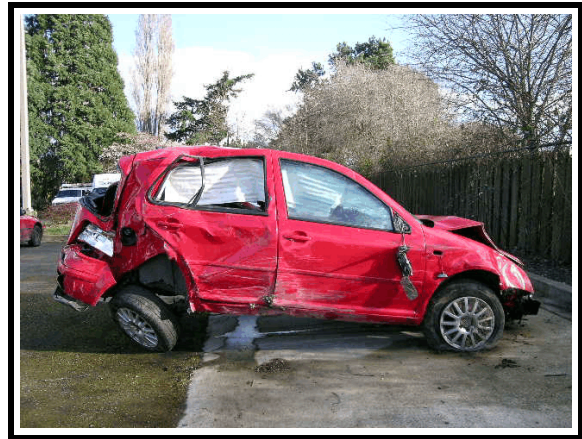
Figure 1. Right side damage - 2003 Volkswagen Golf

The case vehicle sustained right side damage from sliding through the blackberry vines, dirt and grassy ditch area. The investigating agency initially reported that this right side damage occurred when the Volkswagen was being towed out of the brush. While some of this damage may be attributed to tow-out activities, the scene inspection and other post-vehicle inspection reconstruction activities showed that this damage occurred prior to the rollover event. The CDC for this event was 03RYEW1. The damage from this event mainly consisted of dirt and scrapes to the lower passenger compartment sill and right front tire and hubcap.

The 2003 Volkswagen Golf sustained moderate right side damage as a result of the impact with the first set of three trees. Due to the amount of sporadic vehicle damage, the location of the direct damage from this specific event could not be determined. The CDC for this event was 03RZAW3. The area of maximum crush was to the right C pillar. The right rear tire and axle were severely damaged during this event. The fuel tank filler neck was deformed and out of position, but no evidence of fuel leakage was found.

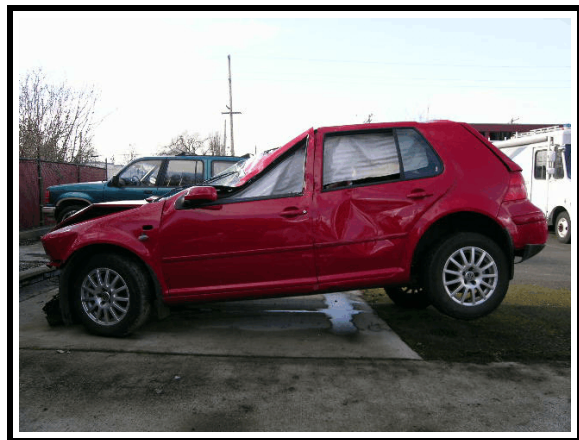
Figure 2. Left side damage - 2003 Volkswagen Golf

The left side of the Volkswagen sustained moderate damage as a result of the final impact between the case vehicle and the last grouping of trees. Just after the top of the Volkswagen impacted the trees, the vehicle began its third quarter turn of the rollover event. The left side of the vehicle impacted the trees, causing direct damage and crush to the left front and rear doors and left B pillar. The CDC for this event was 00LPAW3.

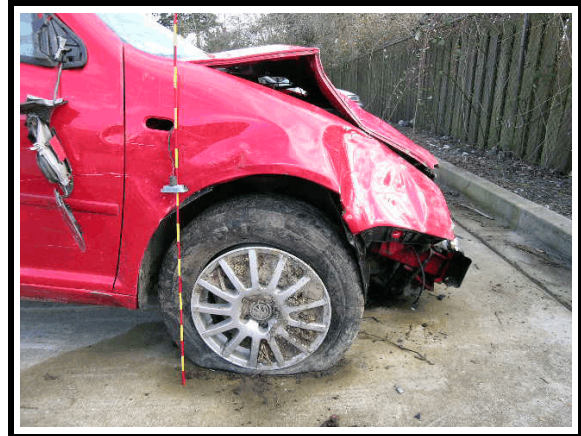
Figure 10. Right front damage

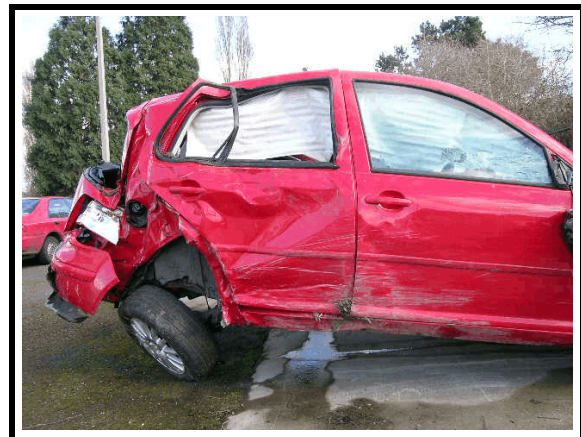
Figure 11. Right rear damage

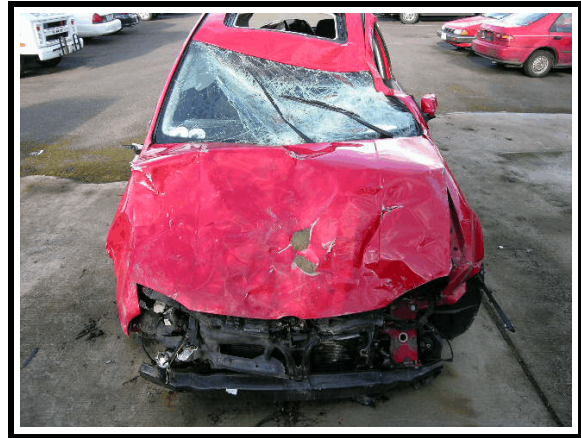
The case vehicle sustained moderate top damage due to the impact between the hood and the second cluster of trees. It is possible that the front right fender hit the cluster of trees first and the hood impacted them as the vehicle continued to rollover mid-air. There is right fender damage that is similar and somewhat consistent to the hood damage. Only one CDC was coded because the impact configuration could not be verified. The vehicle was airborne and rolling over at the time of the impact, resulting in sporadic damage to the vehicle's hood. The CDC for this event was 40TFDW6. Both frame rails sustained downward vertical frame rail shift that was greater than 10 cm (4.0 in).

Figure 12. Damage to front end/hood

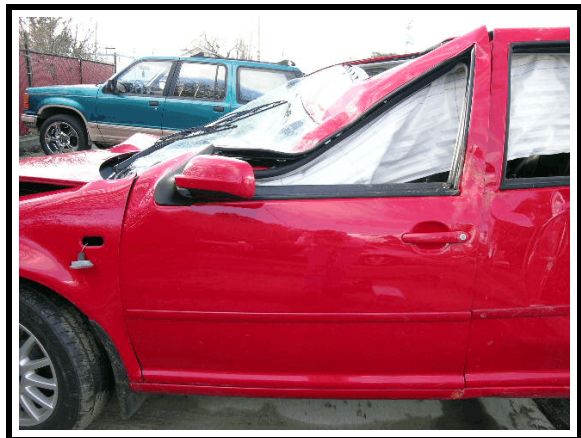
Figure 13. Left A, B pillar and LF door damage

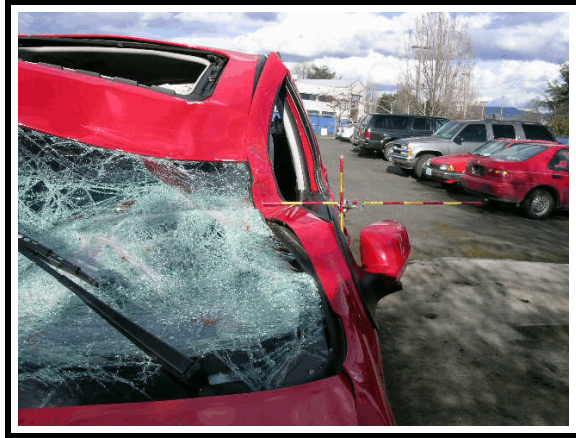
Figure 14. A pillar damage from tree impact - occurred during the rollover event

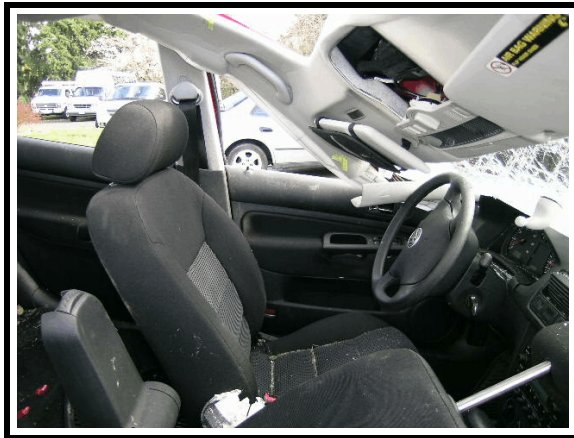
Figure 15. Intrusion and possible occupant contact points in driver area

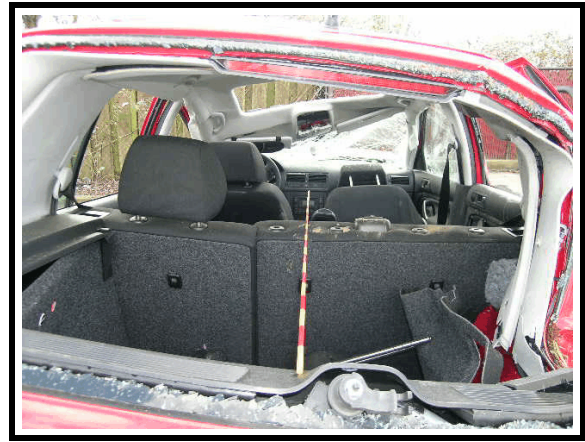
Figure 16. Passenger compartment damage/intrusion

There were multiple vertical and lateral intrusions into the passenger compartment seating areas. The specific passenger compartment intrusions were documented as follows:

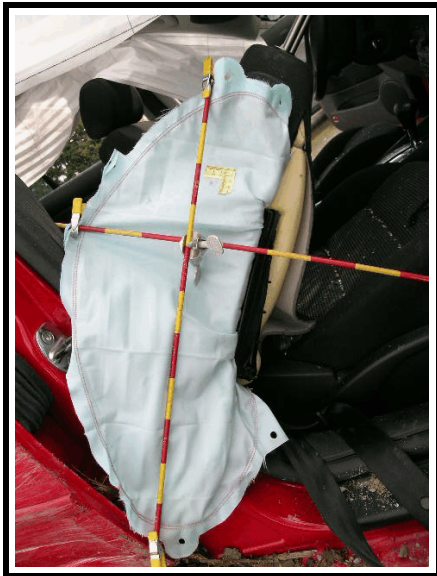
The inner portion of the passenger's side air bag had two small reddish stains but neither appear be due to occupant contact. The bag had been exposed to the elements post-crash and the discolorations may have occurred due to the exposure.

Figure 18. Front right passenger side air bag

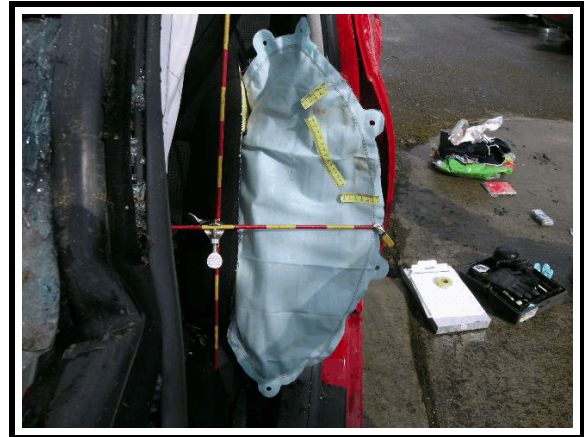
The inner portion of the driver's side air bag had visible blood stains extending from the 1 to the 3 o'clock locations. There were no visible signs of occupant contact or damage to the outside portion of the air bag.

Figure 19. Driver's side air bag

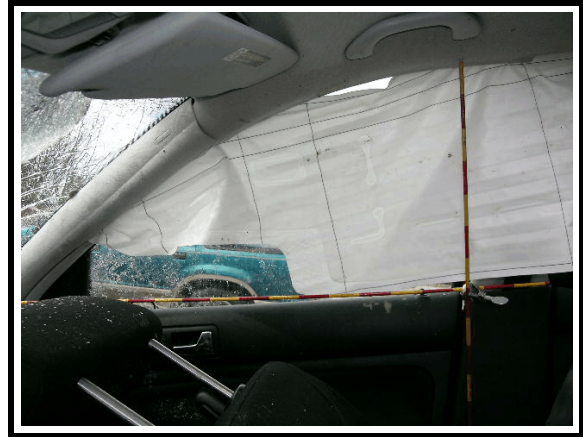
The deployed left and right side curtain air bags extended from the A pillars to the C pillars. There was a small coverage gap present at both A pillars, but the gap was eliminated on the left side due to the A pillar intrusion. The gap on the right side measured 46.0 cm (18.1 in) wide by 14.0 cm (5.5 in) high. The side curtains were rectangular in shape and in their deflated state, measured 186.0 cm (73.2 in) in length. The height of both side curtains was 28 cm (11.0 in). The curtains did not have tethers or vent ports. The side curtains deployed from the roof side rails.

Figure 23. Right side curtain gap distance at the right A pillar

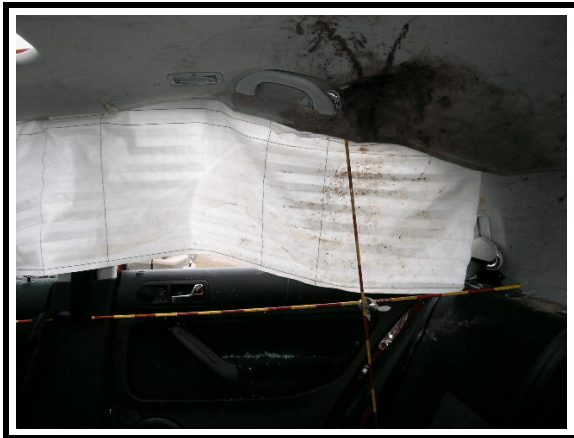
The left curtain showed no visible signs of occupant contact. The right curtain was dirty toward the front of the bag and the back section had multiple bloodstains from the second row right seat passenger. The material on the outer side of both curtains was dirty from the rollover event.

Figure 24. Back section of the right side curtain

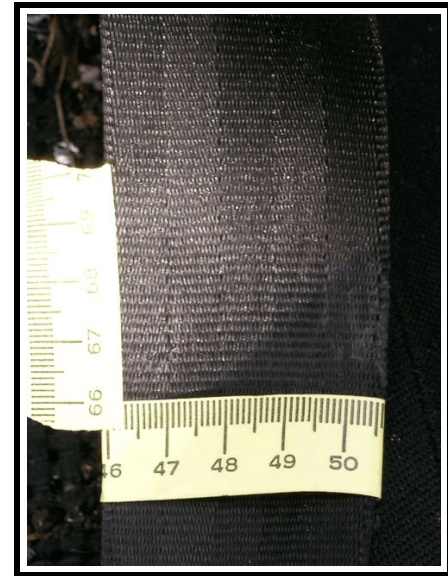
Figure 25. Evidence of loading - Driver's seat belt

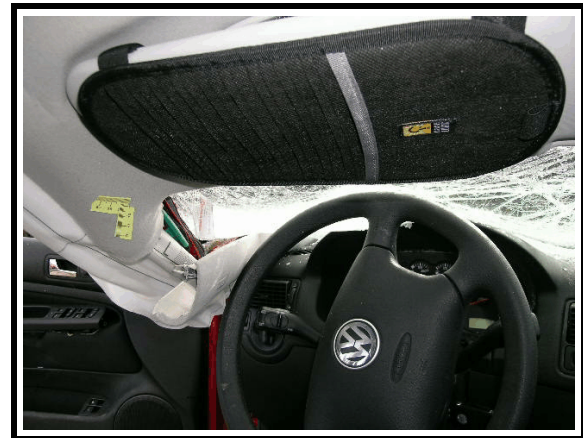
Figure 26. Possible occupant contact to top of left A pillar

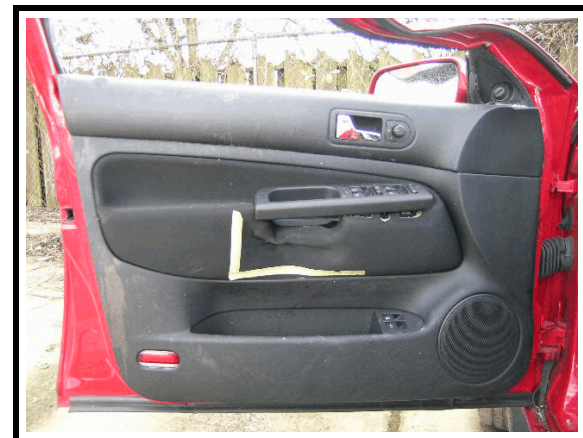
Figure 27. Deformation to LF door armrest

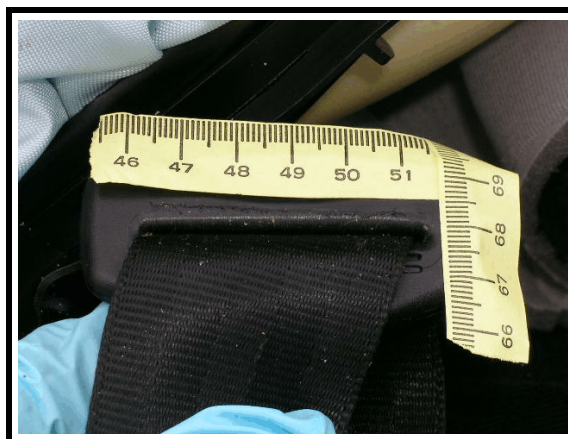
Figure 28. Evidence of loading to front right passenger's seat belt

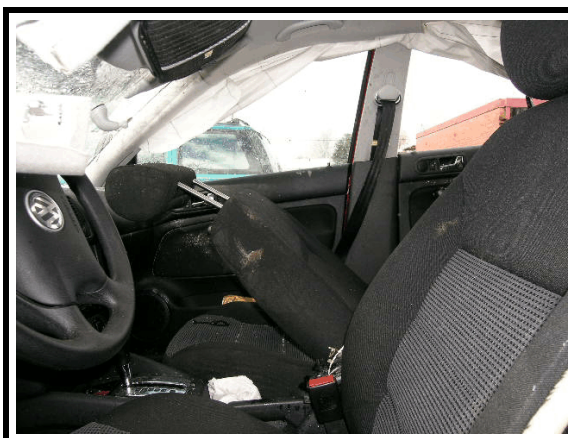
Figure 29. Damaged front right seat back - locked in this position

the front right seat back, causing it to move forward and lock at a 55 degree angle. When this occupant's seat back was struck by the back seat passengers, her upper body was forced forward with the seatback, causing her to load her seat belt and hit her head on the instrument panel. The Volkswagen completed its third quarter turn, and the left side impacted the same two trees. The case vehicle rebounded from the tree impact, rotated one quarter turn to the left and fell to the ground, landing on its right side, causing this occupant to initiate a lateral trajectory to her right.

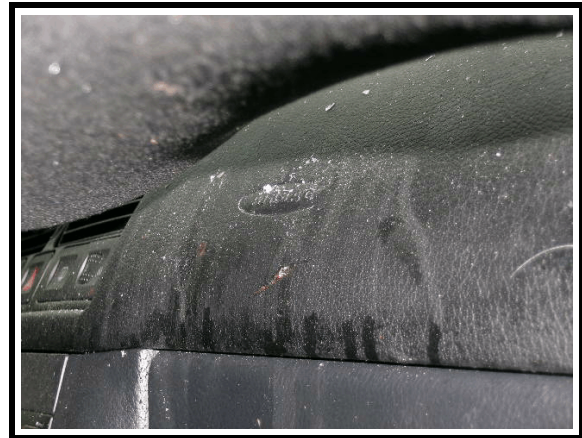
Figure 30. Close-up - blood on upper right instrument panel from occupant contact

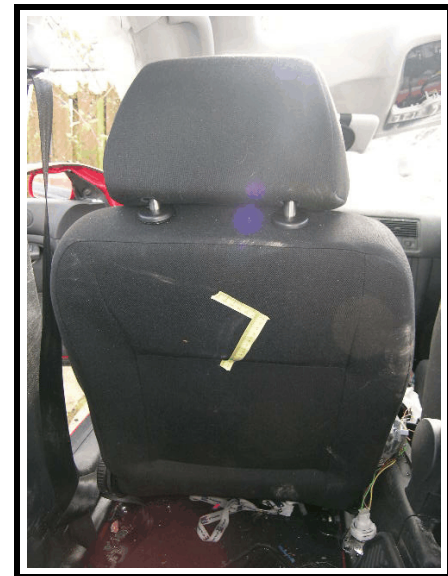
Figure 31. Possible occupant contact - back of the driver's seat back

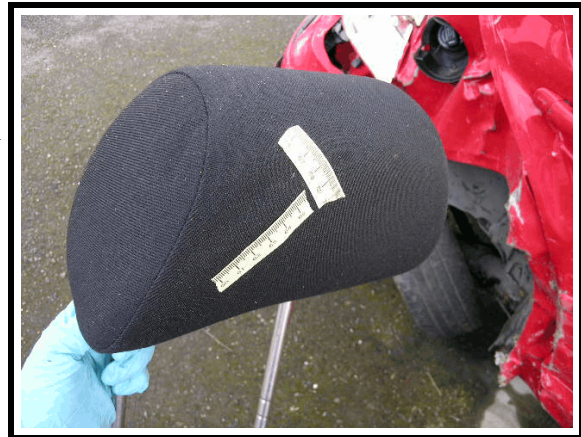
Figure 32. Possible occupant contact to head restraint (restraint found in rear cargo area)

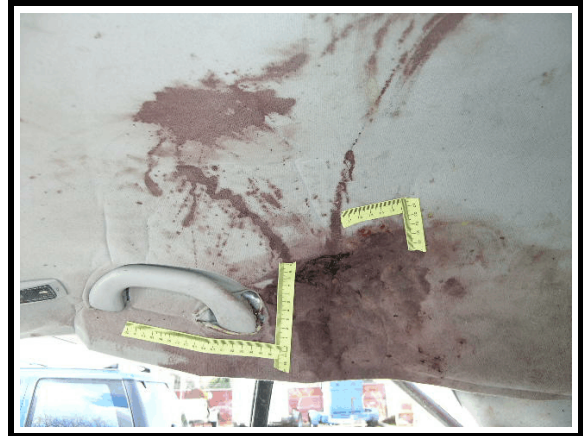
second row right seat passenger. On the roof side rail and roof area in the second row right seating position, there were black hairs, blood and brain matter found. The handle located on the roof side rail above the right rear glazing had blood and black hair on it as well. All of the contact evidence found in this area was due to occupant contact from the head of the fatally injured second row right seat passenger.

Figure 33. Occupant contacts - roof side rail, roof and handle

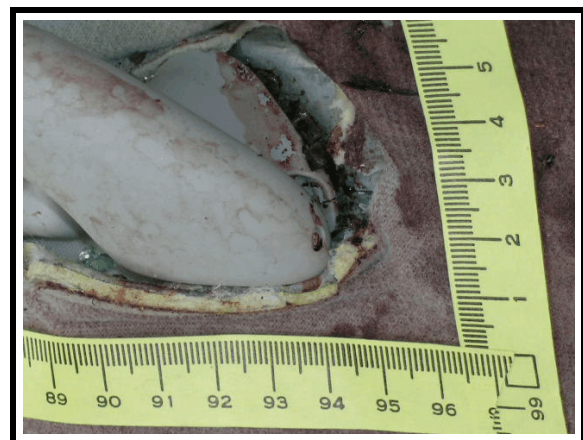
Figure 34. Close up - Handle located above the right rear window frame

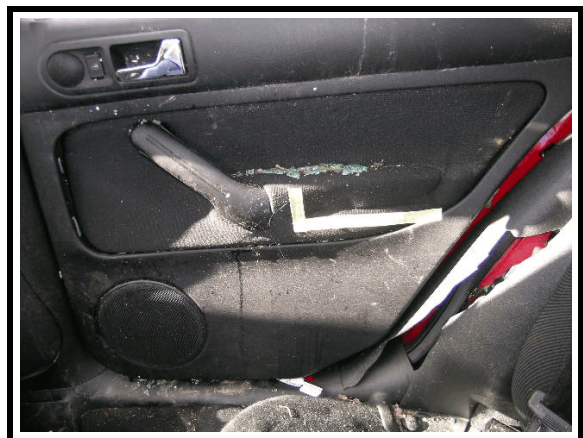
Figure 35. Occupant contact - right rear door armrest

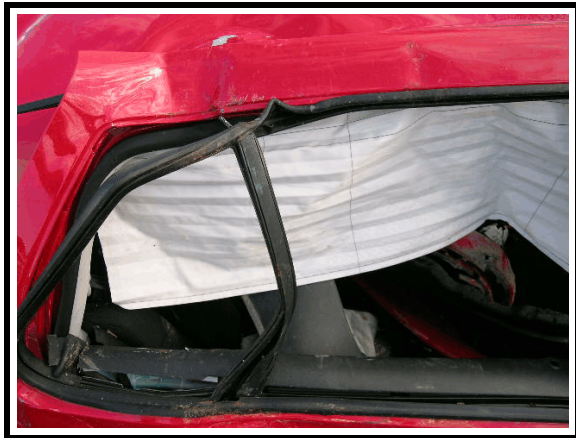
Figure 36. Deformed right rear window frame

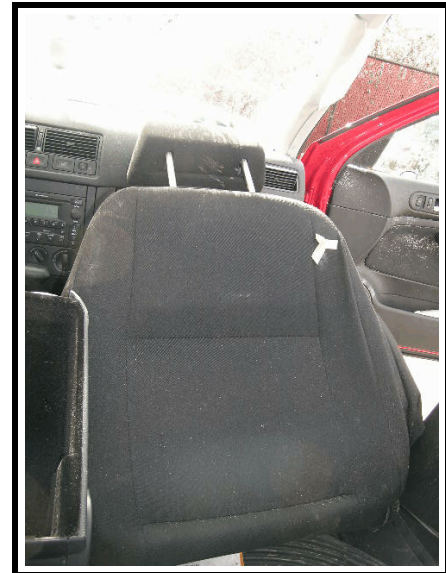
Figure 37. Possible occupant contact to the back of the right front seat back
