Advanced Occupant Protection System Investigation / Vehicle to Object
Dynamic Science, Inc. / Case Number: DS06007
2005 Chevrolet Malibu
California
February 2006

Figure 1. 2005 Chevrolet Malibu

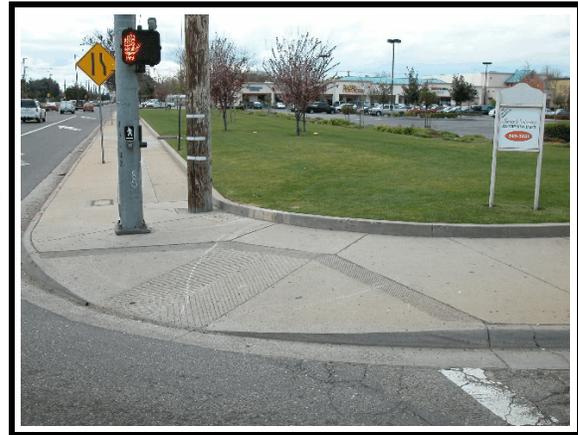
Figure 3. Area of pole and curb impacts

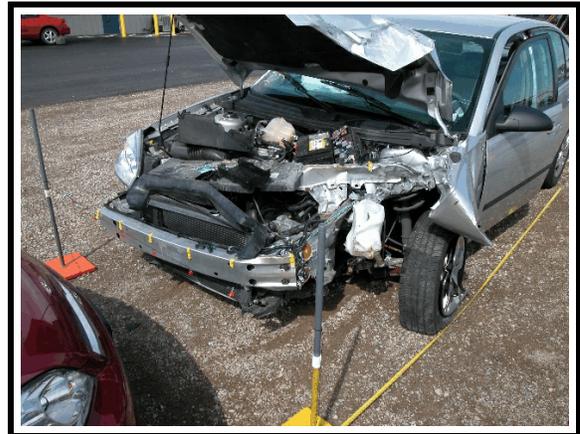
The direct damage for the pole impact began 22.0 cm (8.7 in) from the left front bumper corner (fascia) and extended 27.0 cm (10.6 in) laterally. Six crush measurements were documented along the backing bar as follows: C1 = 34.0 cm (13.4 in), C2 = 11.0 cm (4.3 in), C3 = 5.0 cm (2.0 in), C4 = 2.0 cm (0.8 in), C5=0.0 cm (0.0 in), C6=0.0 cm (0.0 in). The measurement for C1 was averaged with the crush at the radiator support level.

Figure 4. Impact with pole

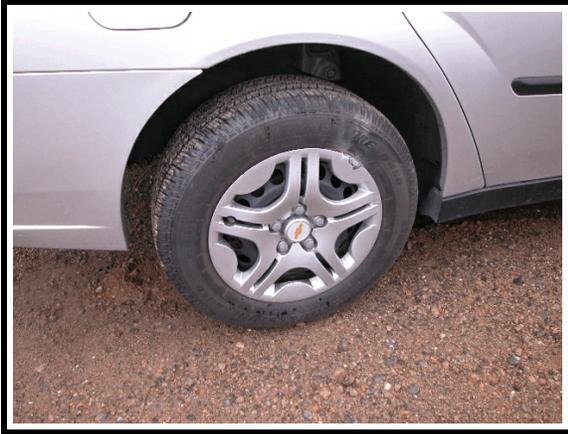
Figure 5. Right rear tire, impact with curb

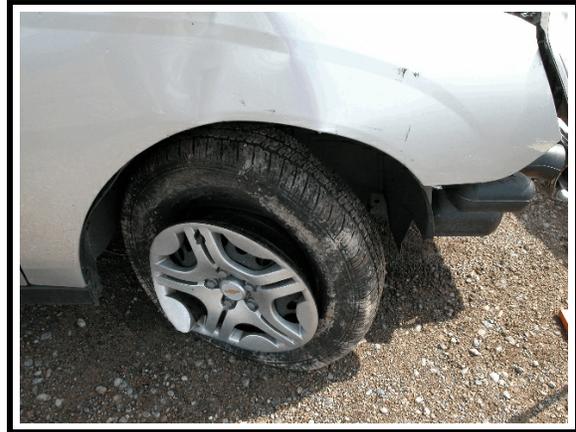
Figure 6. Front right tire, impact with curb

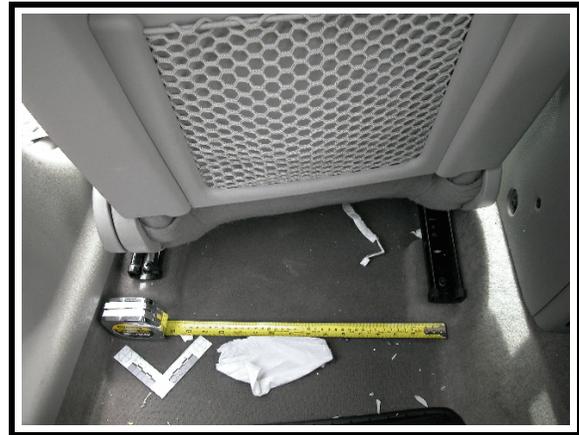
The right driver's seat track failed during the crash causing the driver's seat to rotate in a counterclockwise direction. The seat track on the left side as measured from the back of the track rail was 9.0 cm (3.5 in). The measurement on the right side was 23.0 cm (9.0 cm). The right side was 14.0 cm (5.5 in) forward of the left.

Figure 7. Seat movement from seat track failure

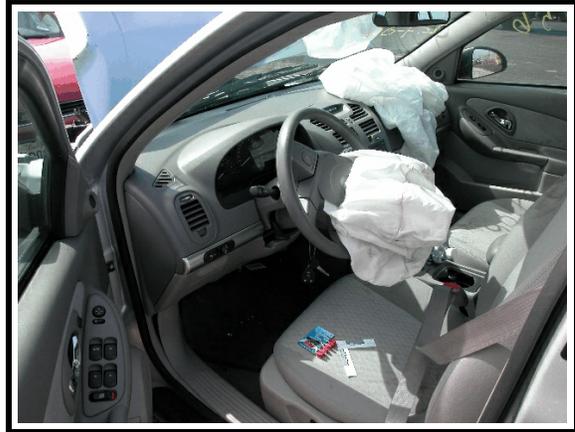
The driver's air bag deployed from the center of the steering wheel hub through symmetrical I-configuration module cover flaps. Each flap measured 7.5 cm (2.9 in) in height and 13.5 cm (5.3 in) in width. The deployed driver's air bag measured 62.0 cm (24.4 in) in its deflated state. The air bag was tethered by a single internal strap. A single circular vent port was located at the 12 o'clock aspect on the rear of the air bag. There were no indication of occupant contact or damage to either the air bag or the module covers.

Figure 8. Driver's air bag

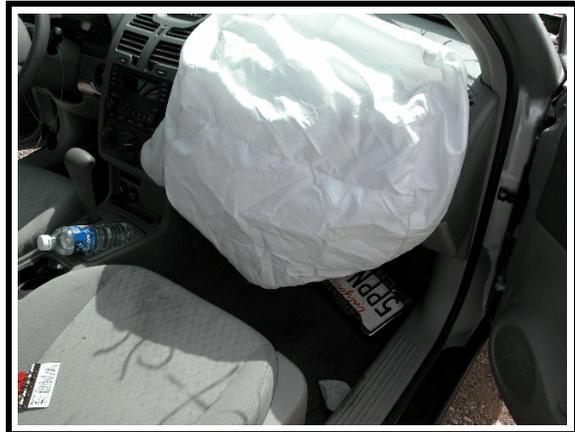
The front right passenger's air bag deployed from a front mount module with asymmetrical H-configuration module cover flaps. The top flap measured 30.0 cm (11.8 in) wide by 8.5 cm (3.3 in) high. The bottom flap measured 30.0 cm (11.8 in) wide by 5.0 cm (1.9 in) high. The deployed front right passenger's air bag measured 51.0 cm (20.0 in) wide seam to seam and was 56.0 cm (22.0 in) high. To the left of air bag itself was a separate panel made of the same material as the air bag. The panel measured 58.0 cm (22.8 in) high by 38.0 cm (14.9 in) wide. The air bag was tethered by a single internal strap. Two circular vent ports were located at the 9 and 3 o'clock aspects of each side panel of the air bag.

Figure 9. Front right passenger's air bag

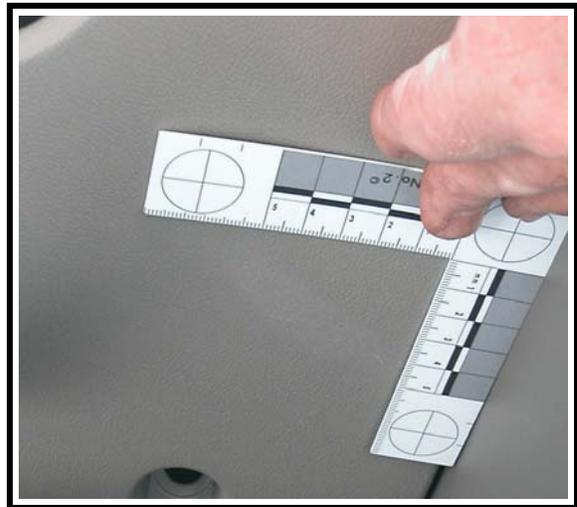
The driver's knee bolster exhibited a faint scuff on the right side that appeared to be a knee contact. There was 5.0 cm (2.0 in) of vertical intrusion below the left instrument panel from a dislodged portion of the lower instrument panel.

Figure 10. Right knee contact to lower instrument panel
