ON-SITE CHILD SAFETY SEAT INVESTIGATION

CASE NUMBER - IN-06-008

VEHICLE - 2001 PONTIAC GRAND AM GT

CRASH DATE - March 2006

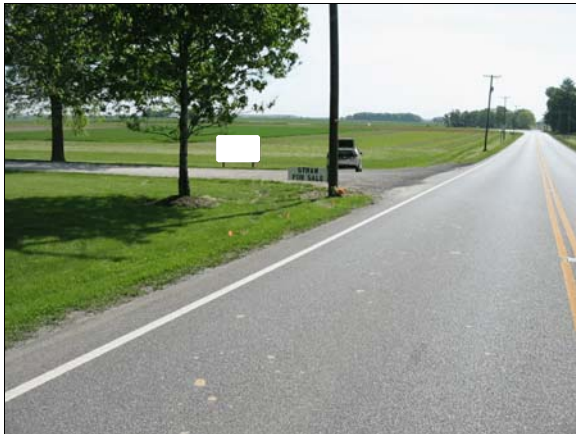
Figure 2: Approach of case vehicle to roadway departure and impact with utility pole, new utility pole has been installed

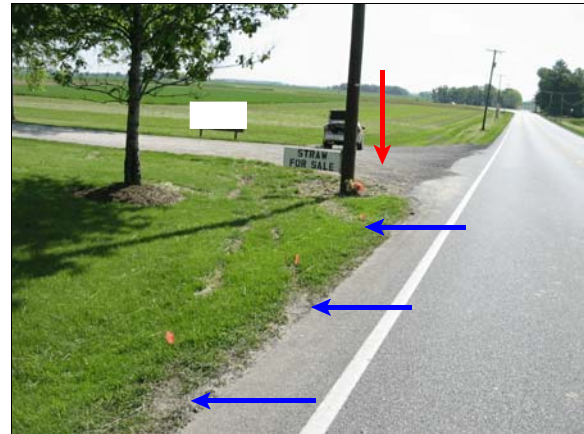
Crash: The case vehicle departed the roadway with the right side leading (**Figure 3** below). The right side of the case vehicle (**Figure 4** below) then impacted a utility pole causing the driver's and front right passenger air bags to deploy.

Figure 3: Overview of case vehicle's tire furrows (blue arrows) in grass and location of impacted utility pole, red arrow shows case vehicle's area of final rest

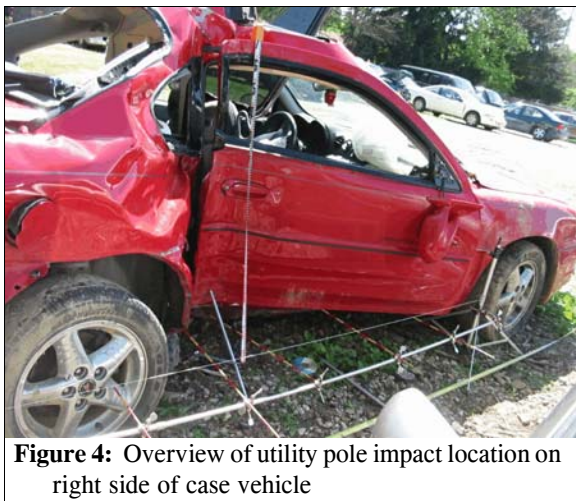
Figure 4: Overview of utility pole impact location on right side of case vehicle

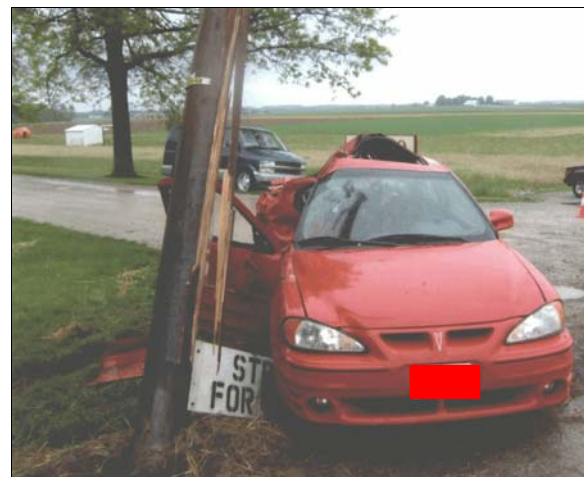
Post-Crash: The impact displaced the utility pole in the ground tilting it to the northeast and fracturing it at the base. The case vehicle rotated clockwise off the utility pole and came to rest in the driveway to the farm house heading southeast (**Figure 5** below).

Figure 5: Police on-scene photo showing case vehicle's final rest position and post-impact condition of utility pole

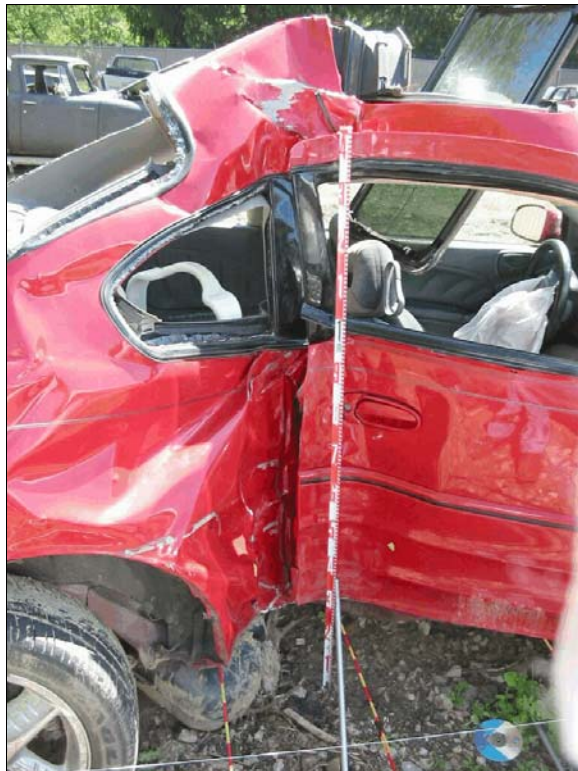
Exterior Damage: The case vehicle’s right side impact with the utility pole involved the right front door and right quarter panel (**Figure 6**). The rear portion of the right front door, the front portion of the quarter panel, right “B”-pillar, the sill and right roof side rail were directly contacted and crushed inward. The direct damage began 164 centimeters (64.6 inches) rear of the right front axle and extended 38 centimeters (15 inches) along the right side. Crush measurements were taken at the sill level because the door was open and could not be fully closed. The residual maximum crush was measured as 57 centimeters (22.4 inches) occurring at C₃ (**Figure 7**). The table below shows the case vehicle’s right side crush profile.

Figure 6: Direct damage to case vehicle’s right front door and quarter panel from utility pole impact, increments on tape measure are tenths of meter

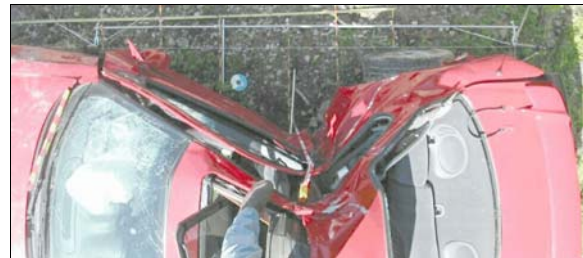
Figure 7: Top view of crush to right side of case vehicle due to utility pole impact

The right side wheelbase was reduced 21 centimeters (8.3 inches) while the left side wheelbase was extended 2 centimeters (0.8 inch). Induced damage involved the roof, trunk, right front door, left front door, right quarter panel, left quarter panel and back bumper fascia. In addition, the right front door window, right quarter window, left quarter window and backlite glazing were broken out and the windshield was fractured.

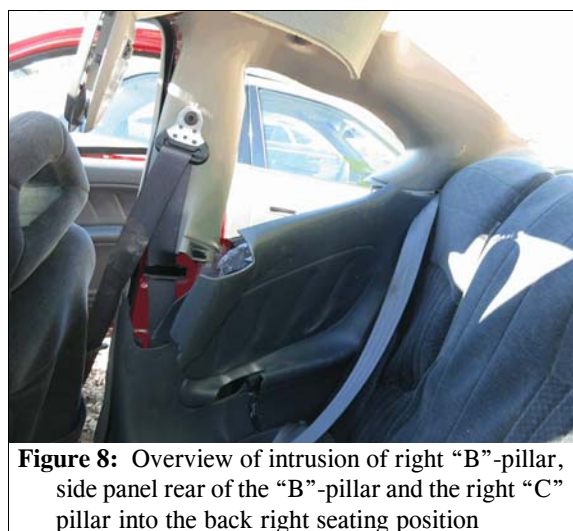
Vehicle Interior: Inspection of the case vehicle's interior revealed blood stains on the front right passenger's air bag and some of the driver's hair adhering to the right "A"-pillar, right upper windshield and right front door window frame. In addition, there was a blood stain on the front of the right front seat back. No other evidence of occupant contact to any interior surfaces or components was observed. There was extensive intrusion into the passenger compartment from the right side of the case vehicle. The most severe intrusions involved the back right seat position (**Figure 8**) as follows: the side panel rear of the right "B"-pillar intruded laterally 53 centimeters (20.9 inches), the right "B"-pillar intruded laterally 50 centimeters (19.7 inches), the sill intruded laterally 40 centimeters (15.7 inches) and the right "C"-pillar intruded laterally 31 centimeters (12.2 inches). Lastly, there was no evidence of compression of the energy absorbing steering column or deformation of the steering wheel rim.

Figure 8: Overview of intrusion of right "B"-pillar, side panel rear of the "B"-pillar and the right "C" pillar into the back right seating position

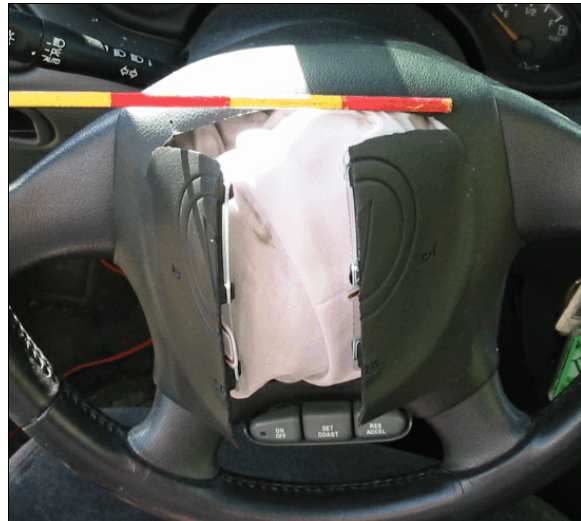
The case vehicle's driver air bag was located in the steering wheel hub. The air bag module consisted of symmetrical "I"-configuration cover flaps made of thick, pliable vinyl. Each module cover flap was 7 centimeters (2.8 inches) in width at the top and bottom and 14 centimeters (5.5 inches) in height at the vertical tear seam. An inspection of the air bag module cover flaps and the air bag fabric revealed that the cover flaps opened at the designated tear points (**Figure 9**). There was no evidence of damage during the deployment to the air bag or the cover flaps. The driver's air bag was designed without tether straps and had two vent ports, each approximately 3 centimeters (1.2 inches) in diameter, located at approximately the 11 and 1 o'clock positions. The deployed driver's air bag (**Figure 10**) was round with a diameter of approximately 62 centimeters (24.4 inches). The distance between the mid-center of the driver's seat back, as positioned at the time of the vehicle inspection (i.e. forward-most track position), and the front surface of the air bag's fabric at approximate full excursion was approximately 24 centimeters (9.4 inches). An inspection of the driver's air bag fabric revealed no evidence of occupant contact on the front of the air bag. However, a small stain of unknown origin was observed on the right central edge of the air bag and a few possible deployment scuffs were noted at the top of the air bag.

Figure 9: Overview of driver's air bag module cover flaps, each increment on rod is 5 cm (2 in)

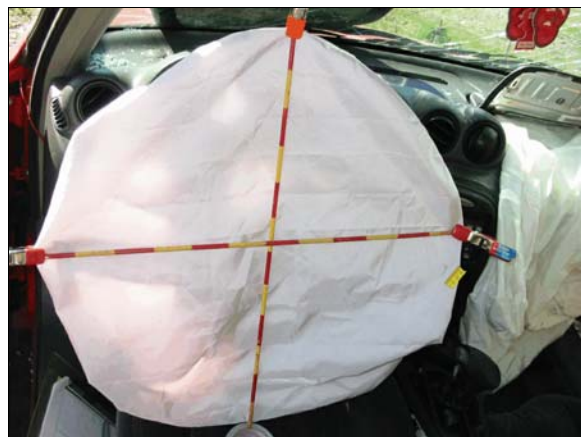
Figure 10: Overview of case vehicle driver's air bag

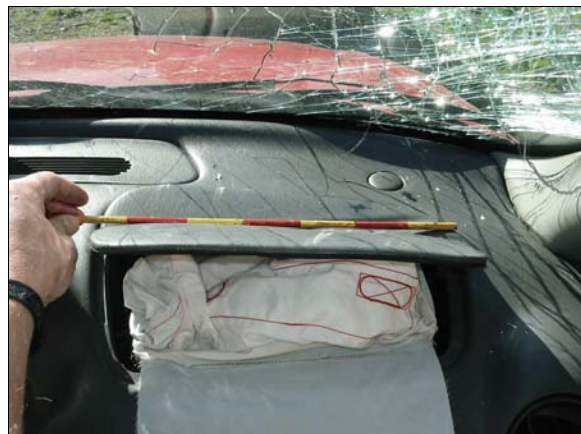
The front right passenger's air bag was located in the middle of the instrument panel (**Figure 11**). The air bag module cover consisted of a single metal cover flap covered with lightly padded vinyl. The cover flap hinged approximately 5 centimeters (2 inches) forward of the flap's back edge. The cover flap's overall

Figure 11: Front right passenger air bag module cover flap

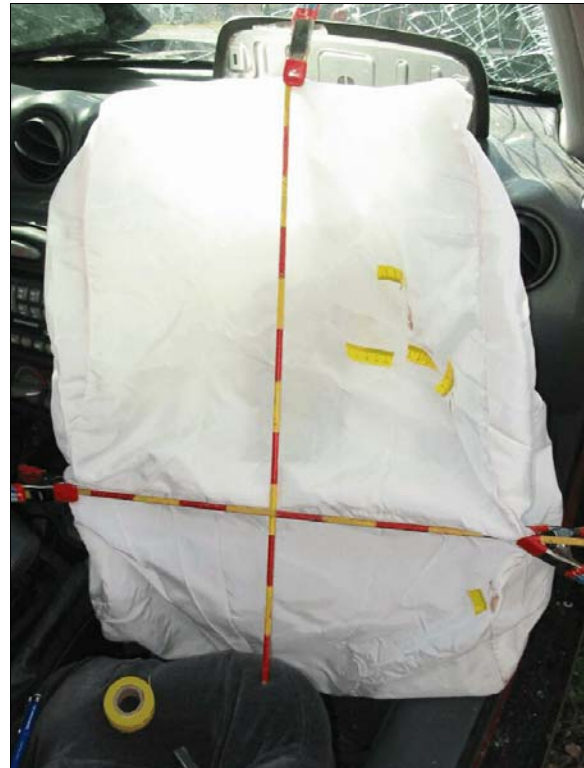
dimensions were 22 centimeters (8.7 inches) in height and 35 centimeters (13.8 inches) in length. An inspection of the air bag module cover flap and the air bag fabric revealed that the cover flap opened at the designated tear points (**Figure 11** above). There was no evidence of damage during the deployment to the cover flap. A few holes from flying glass were noted on the right lower side of the air bag. The front right passenger air bag was designed with two tether straps, each 8 centimeters (3.1 inches) in width. The air bag was not equipped with vent ports. The front right passenger air bag (**Figure 12**) was approximately 67 centimeters (26.4 inches) in height and 48 centimeters (18.9 inches) in width. Inspection of the air bag fabric revealed blood stains, which appeared to be splatter, on the right upper and lower quadrants of the air bag.

Figure 12: Overview of case vehicle's front right passenger's air bag

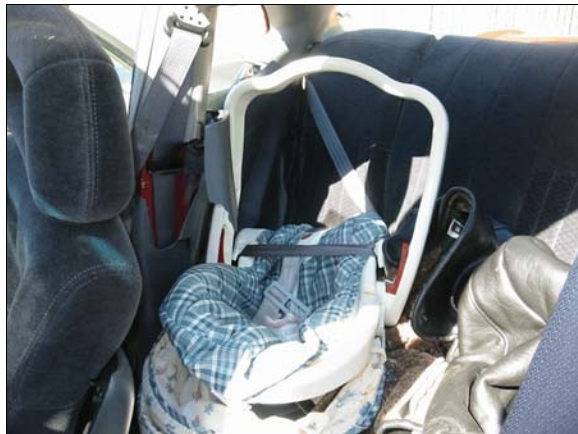
Figure 15: Overview of back right passenger's rear-facing infant seat as found in the case vehicle

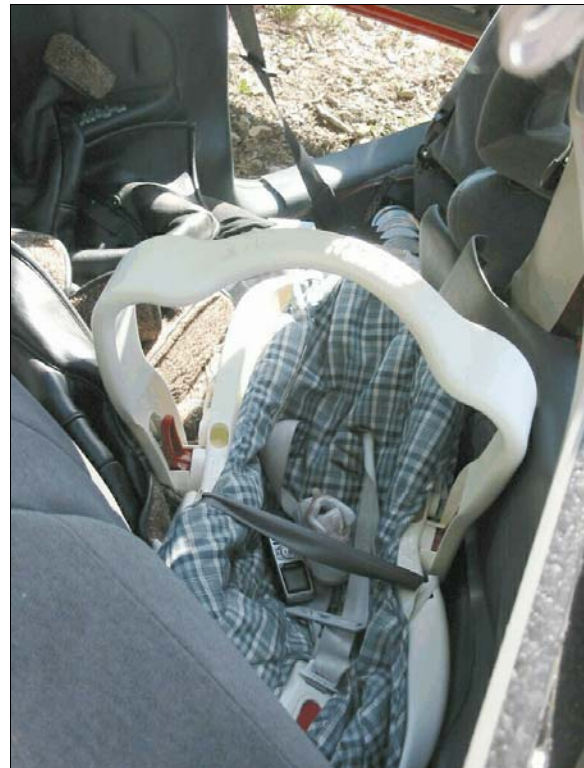
Figure 16: Top view of back right passenger's infant seat showing extent of intrusion of right "B" pillar and side panel rear of "B"-pillar.

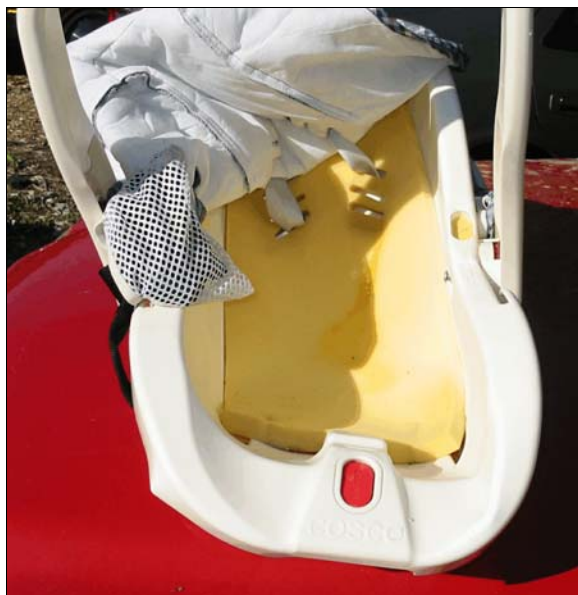
Inspection of the infant seat revealed that the top portion of the seat was bent to the right (**Figure 18** below) due to the intrusion of the case vehicle's right "B"-pillar and side panel rear of the "B"-pillar. The displacement of the infant seat due to the intrusion appeared to have caused the seat to load against the case vehicle's lap belt, which caused a mark in the plastic on each side of the infant seat below the belt path. The deformation of the infant seat also jammed the carry handle. No other damage or load marks were noted to the infant seat.

Figure 18: Front view of infant seat showing bending of the seat due to loading by the case vehicle's intruding right "B"-pillar and side surface rear of the "B"-pillar

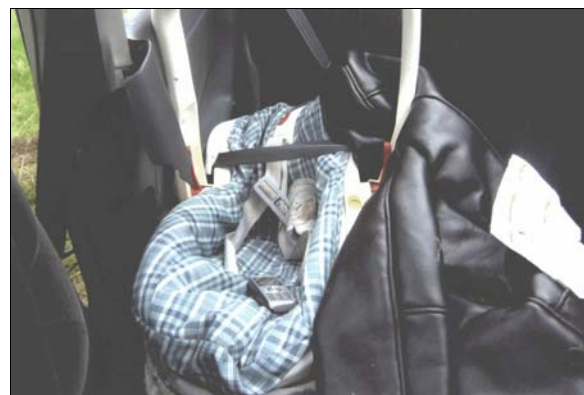
Figure 17: Police on-scene photo showing post-crash condition of back right passenger's infant seat

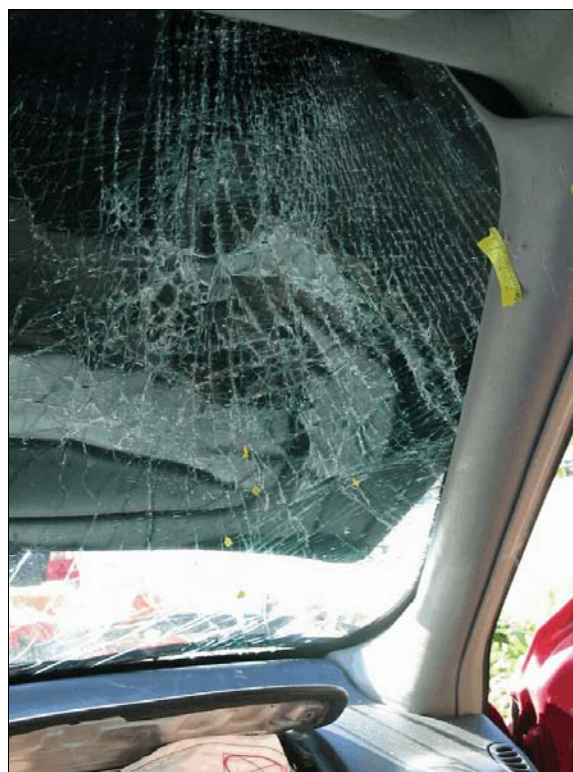
Figure 17: Overview of driver's head impact to windshield and right "A"-pillar, yellow tape shows hair adhering to windshield and contact mark to right "A"-pillar

over the air bag, and the back of her head impacted the windshield (**Figure 19** above) causing a large laceration to the back of her head and a nonanatomic brain injury. The right side of the driver's head also impacted the right "A"-pillar causing a large contusion to the right side of her head. The driver rebounded off these components and as the case vehicle rotated clockwise her head impacted the right front door window frame leaving a deposit of hair in the window frame and she was partially ejected out of the right front window, which had been broken out due to the impact. The driver came to rest with the upper part of her body hanging out of the right front window, where she was found by emergency medical personnel.

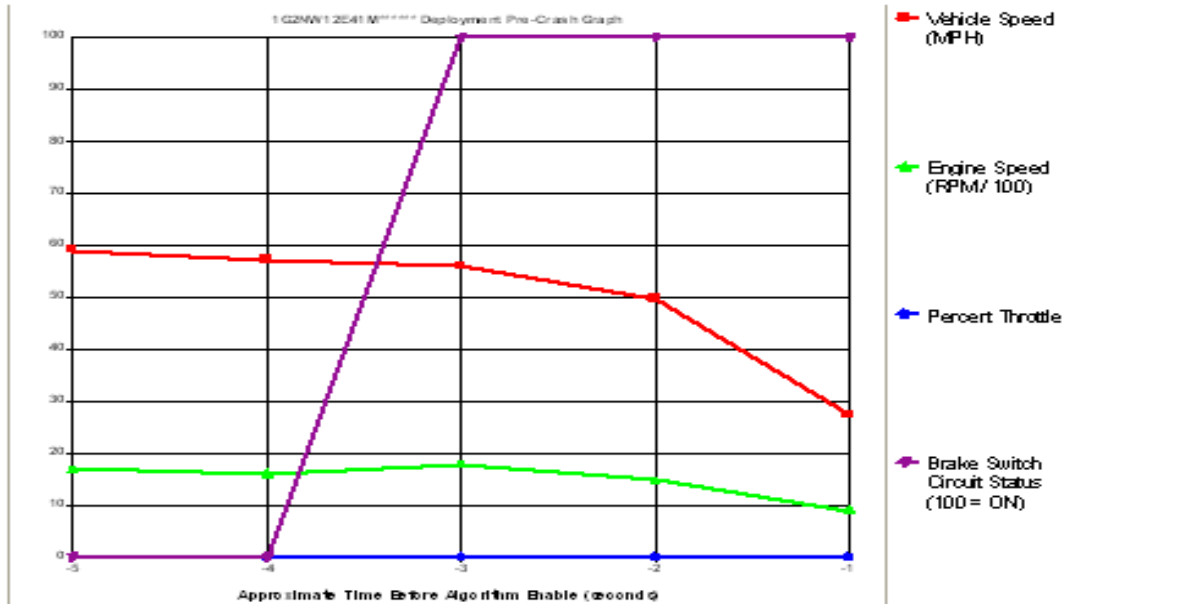
The EDR system status at deployment report shows that the SIR warning lamp was recorded as off, and the driver's safety belt switch circuit was recorded as unbuckled. In addition, the velocity change graph showed that the maximum recorded longitudinal velocity change was -16.82 km.p.h. (-10.45 m.p.h.) occurring 80 milliseconds after algorithm enable (AE). The data also indicated that the deployment command was issued at approximately 20 milliseconds after AE.

The pre-crash data indicated that five seconds prior to AE, the case vehicle was at 0% throttle traveling at 95 km.p.h. (59 m.p.h.), and the brake switch was recorded as off. At three seconds prior to AE, the brake switch was recorded as on, throttle remains at 0 % and speed was recorded as 90 km.p.h. (56 m.p.h.). The brake switch remains on and percent throttle remains at 0% for the remaining of the pre-crash recording.

Figure 22: Case vehicle's System Status at Deployment report and pre-crash data
