ON-SITE REAR OCCUPANT PROTECTION PROGRAM INVESTIGATION

CASE NUMBER - IN-06-009

VEHICLE - 2002 TOYOTA COROLLA LE

CRASH DATE - May 2006

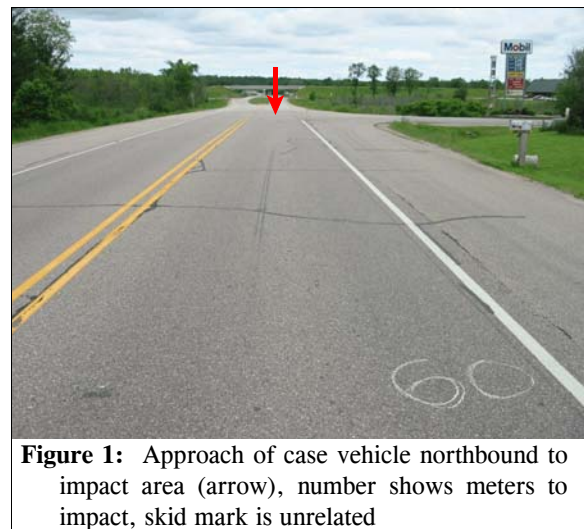
Figure 1: Approach of case vehicle northbound to impact area (arrow), number shows meters to impact, skid mark is unrelated

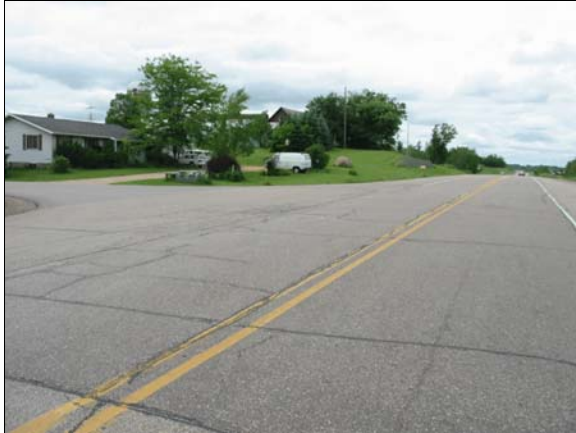
Figure 2: Approach of Kenworth southeastbound turning onto intersecting roadway

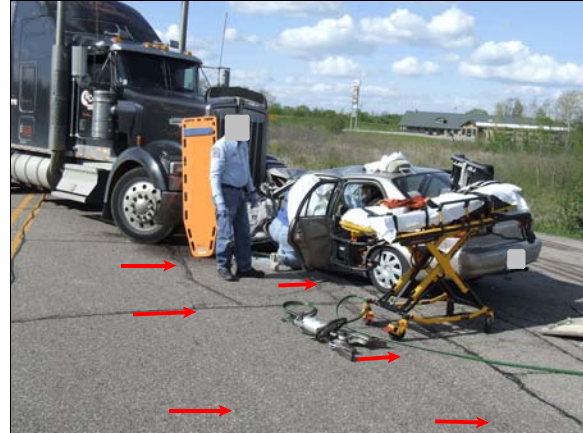
Figure 3: Police on-scene photo showing rest positions of case vehicle and Kenworth, arrows show case vehicle's pre-impact skid marks

Post-Crash: Based on the police on-scene photographs, the case vehicle rotated counterclockwise and came to rest in the northbound lane against the front of the Kenworth heading northwest (**Figures 3** and **6**). The Kenworth came to final rest with the front of the vehicle in the northbound lane heading southeast (**Figures 3** and **6**). The Kenworth's semi-trailer was blocking the southbound lane.

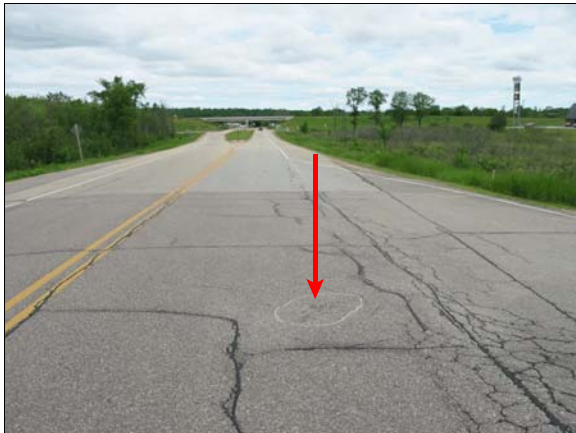
Figure 4: Approach of case vehicle northbound to impact, arrow shows impact gouges on pavement

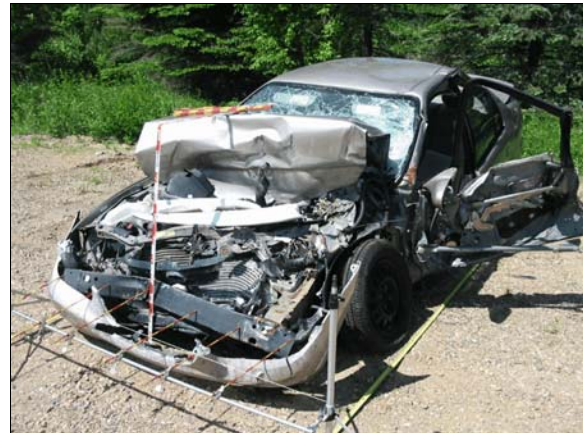
Figure 5: Damage to front of case vehicle from impact with the Kenworth, each increment on rods is 5 cm (2 in), vertical scale is graduated in tenths of meter

Crash: The front of the case vehicle (**Figure 5**) impacted the front of the Kenworth causing the case vehicle's driver air bag and front right passenger air bag to deploy. The front of the case vehicle underrode the front of the Kenworth (**Figure 6**).

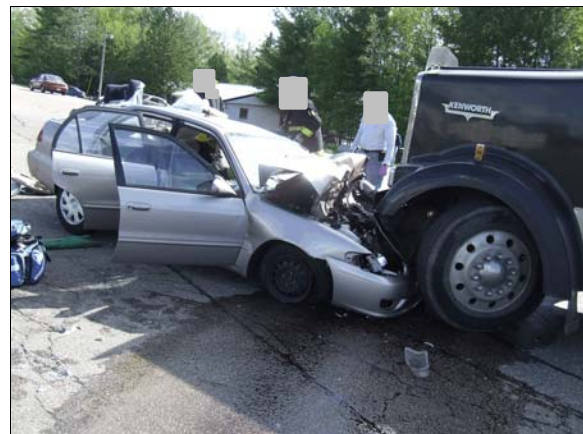
Figure 6: View southwest showing case vehicle's underride of front of Kenworth

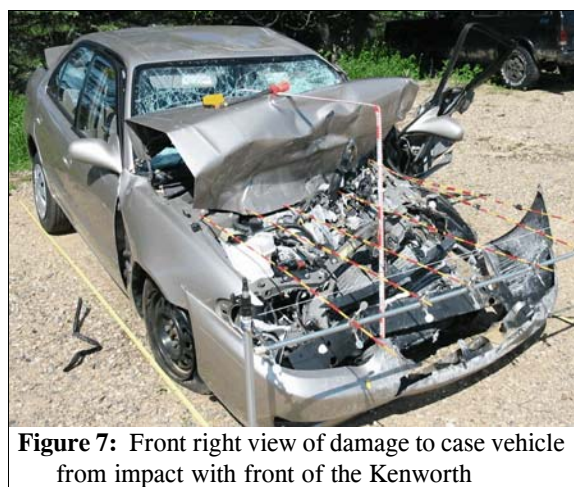
Exterior Damage: The case vehicle’s impact with the Kenworth involved the front plane. The front bumper, left front fender, grille, radiator and hood were directly damaged and crushed rearward (**Figure 7**). The hood was folded back and contacted the windshield during the crash. Rescue personnel cut the left “B”-pillar, partially cut the left “A”-pillar and pried the driver’s door open. The direct damage began at the front left bumper corner and extended 102 centimeters (52.8 inches) across the front bumper and hood. Crush measurements were taken at the bumper level, the radiator level and the hood level (**Figures 8 and 9** below). The residual maximum crush occurred at the hood level and was measured as 102 centimeters (40.1 inches) occurring at C₂. The residual maximum crush at the bumper level was 37 centimeters (14.6 inches) occurring at C₄. The residual maximum crush at the upper radiator support level was 64 centimeters (25.2 inches) occurring at C₂. The table below shows the case vehicle’s crush profile following the averaging of the crush values at the bumper level and upper radiator support level.

Figure 7: Front right view of damage to case vehicle from impact with front of the Kenworth

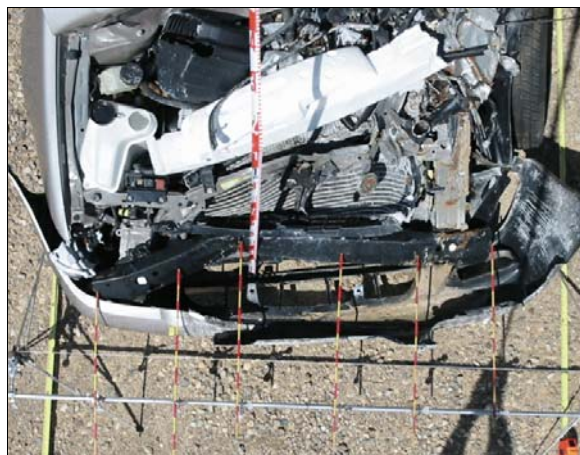
Figure 8: Top view of crush to case vehicle's front bumper

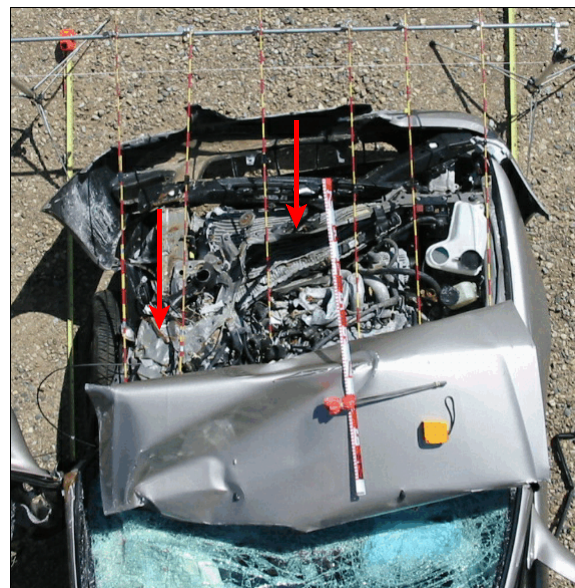
Figure 9: Top view of crush to case vehicle's hood and hood contact with the windshield, red arrows show crush to radiator frame

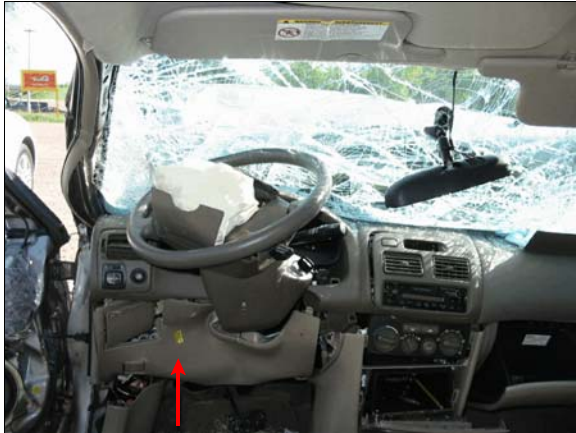
Vehicle Interior: Inspection of the case vehicle's interior revealed deformation to the driver's knee bolster (**Figure 10** below). In addition, the steering column was found displaced considerably upward, which was inconsistent with loading by the restrained driver. It was subsequently determined that the steering column deformation was the result of driver extrication activities. The back of the driver's seat had a small scuff at the bottom and a small localized impression at the top (**Figure 11** below), which appeared to be probable occupant contact by the back left passenger. No other occupant contact evidence was found. Intrusion involved the left

Figure 10: Overview of steering wheel, instrument panel and windshield, arrow shows deformation of driver's knee bolster

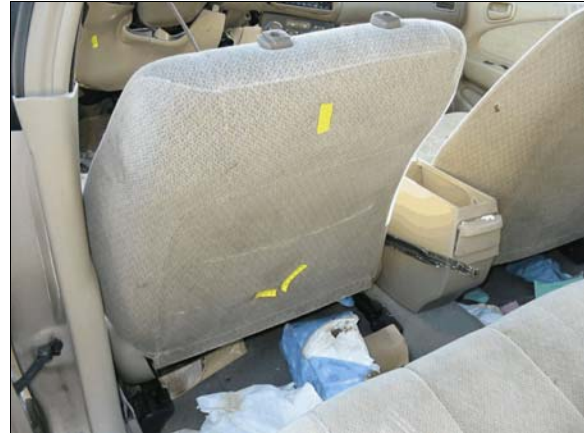
Figure 11: Yellow tape shows probable occupant contact marks from back left passenger on the back of the driver's seat

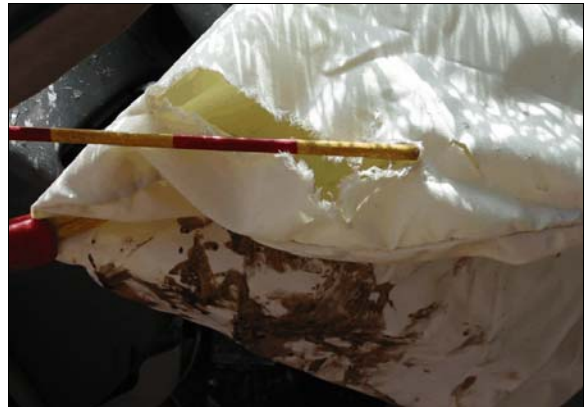
Figure 12: Close view of tear in driver's air bag

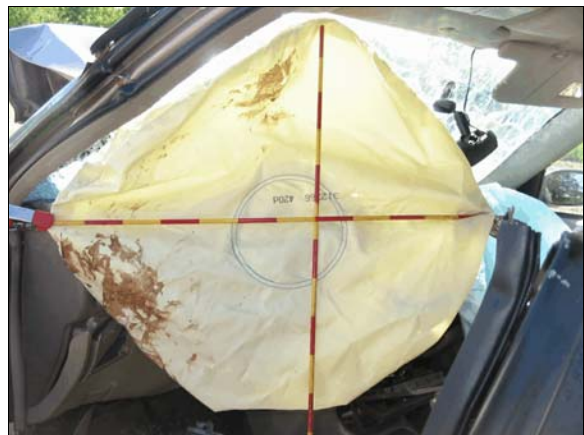
the crash. The deforming hood may have dynamically deformed the windshield to the extent that it interacted with the air bag during the crash. The deployed driver's air bag (**Figure 13**) was round with a diameter of approximately 60 centimeters (23.6 inches). The air bag was designed with two tethers, each approximately 14.5 centimeters (5.7 inches) in width. There were two vent ports on the back of the air bag, each approximately 2.5 centimeters (1 inch) in diameter, located at the 11 and 1 o'clock positions. There were two large blood stains located on the front surface of the air bag at the approximate 11 o'clock and 8 o'clock positions.

Figure 13: Overview of driver's air bag

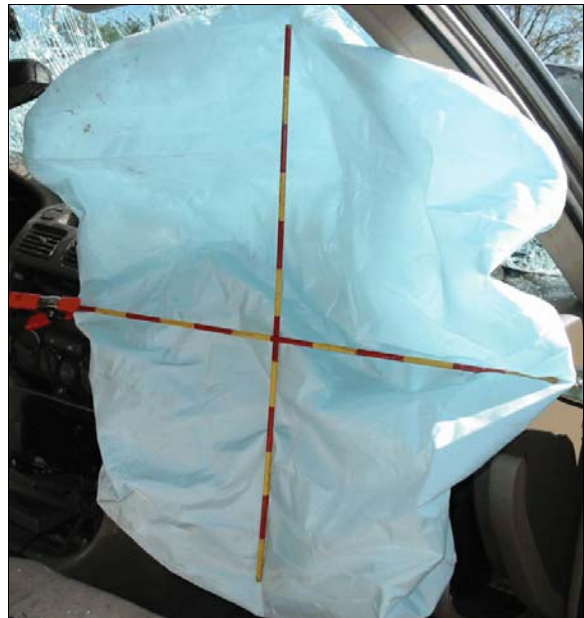
The front right passenger air bag was located at the top of the instrument panel. The air bag module cover consisted of a two rectangular cover flaps. The upper flap was 23 centimeters (9.1 inches) in width and 4 centimeters (1.6 inches) in height. The lower flap was 23 centimeters (9.1 inches) in width and 6 centimeters (2.4 inches) in height. An inspection of the air bag module cover flaps revealed that the cover flaps opened at the designated tear points. There was no evidence of damage to the cover flaps or the air bag fabric. The evidence showed that the front right air bag impacted and fractured the windshield during the deployment. The deployed front right passenger's air bag (**Figure 14**) was approximately rectangular in shape. The air bag was 75 centimeters (29.5 inches) in height and 65 centimeters in width (25.6 inches). The air bag was designed without tethers. There were two vent ports on the back of the air bag, each approximately 5.5 centimeters (2.2 inches) in diameter, located at approximately the 9:30 and 2:30 o'clock positions. Inspection of the air bag fabric revealed some blood stains, most likely due to blood splatter from the driver, located on the upper left quadrant of the air bag. There was also some type of fluid spill/stain at the lower right corner.

Figure 14: Overview of front right passenger air bag

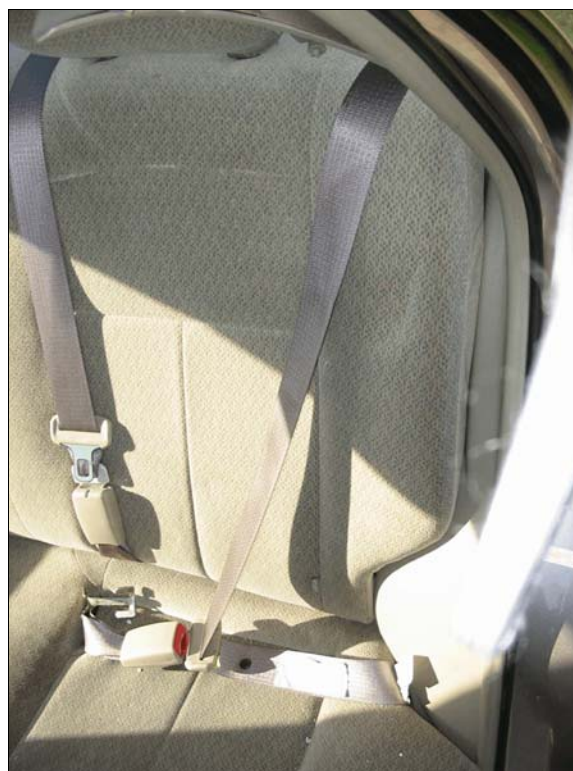
The case vehicle's back left passenger was restrained by her manual, three-point, lap-and-shoulder safety belt system. Inspection of the safety belt assembly (**Figure 15**) revealed a scuff on the safety belt webbing (**Figure 16**) and a load mark on latch plate belt guide (**Figure 17** below).

Figure 15: Overview of back left seat position with safety belt buckled

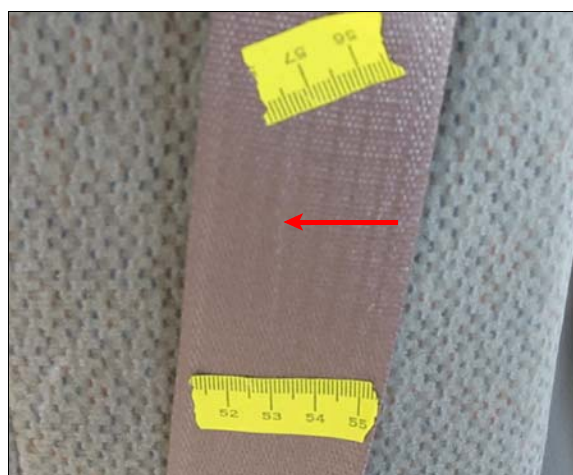
Figure 16: Arrow shows scuff on back left passenger's safety belt from latch plate belt guide

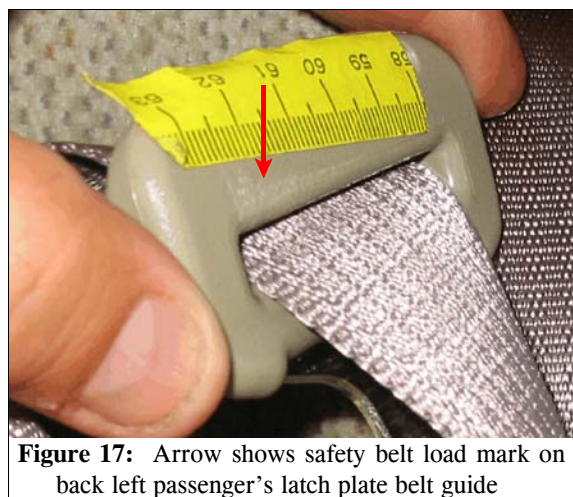
Figure 17: Arrow shows safety belt load mark on back left passenger's latch plate belt guide

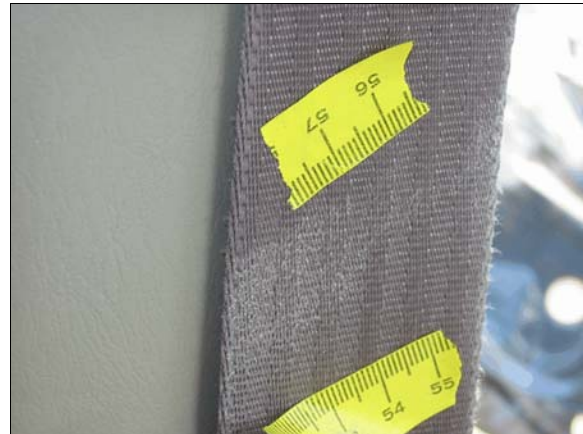
The case vehicle's driver was restrained by her manual, three-point, lap-and-shoulder safety belt. Inspection of the safety belt assembly revealed load marks on the shoulder belt webbing (**Figure 18** below) and on the "D"-ring (**Figure 19** below). In addition, the safety belt had been cut by rescue personnel in order to remove the driver from the vehicle.

Figure 18: Load mark on driver's shoulder belt

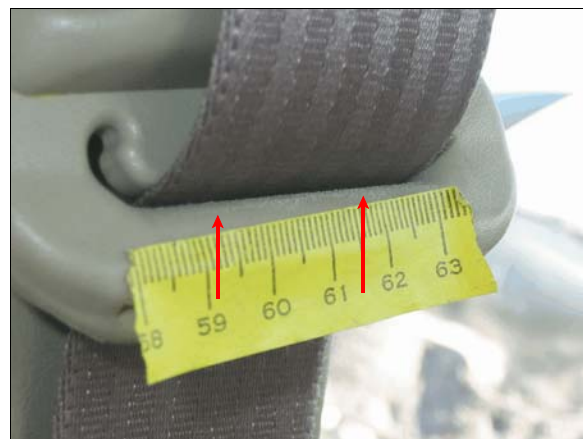
Figure 19: Arrows show load mark on belt guide of driver's "D"-ring

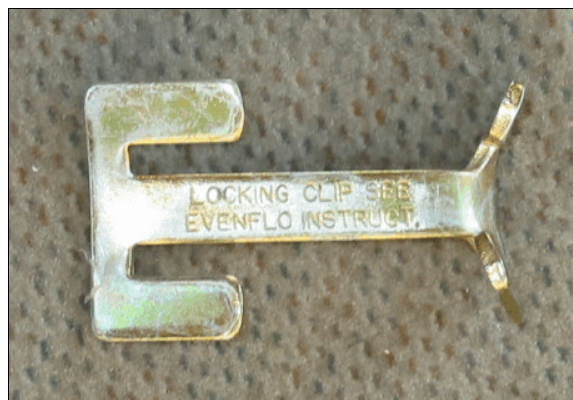
Figure 20: Deformed safety belt locking clip for back right child safety seat

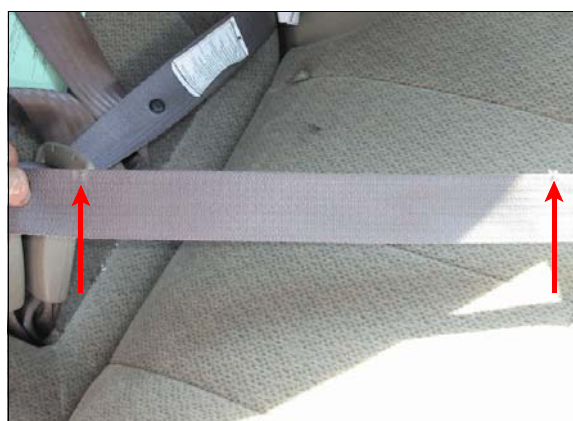
Figure 21: Arrows show load marks on back right passenger safety belt, photo view from top left
