**CALSPAN ON-SITE CERTIFIED ADVANCED-208 COMPLIANT VEHICLE
CRASH INVESTIGATION**

SCI CASE NO. – CA06-012

SUBJECT VEHICLE – 2006 TOYOTA COROLLA

CRASH DATE – MARCH 2006

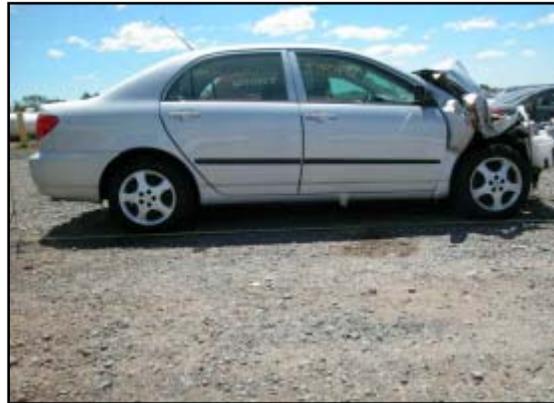
Figure 1. 2006 Toyota Corolla subject vehicle.

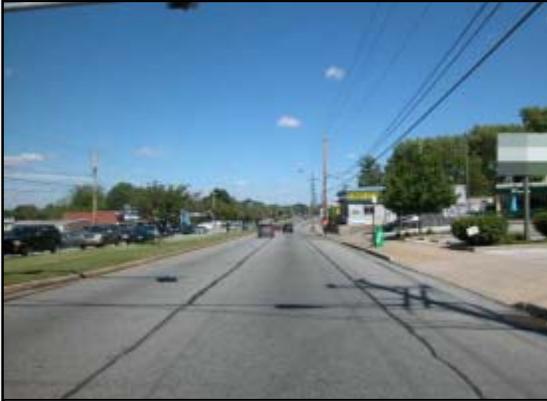
The restrained 28-year-old male driver of the 2006 Toyota Corolla was operating the vehicle westbound on the two-lane roadway (**Figure 2**). Witnesses to the crash reported to the police that the driver of the Toyota was weaving in and out of the travel lanes and the shoulder at a high rate of speed. The 2001 GMC was legally parked on the shoulder and was unoccupied. As the driver continued to operate the Toyota in this manner, he entered the shoulder and failed to detect the parked GMC.

Figure 2. Pre-crash travel direction for the Toyota.

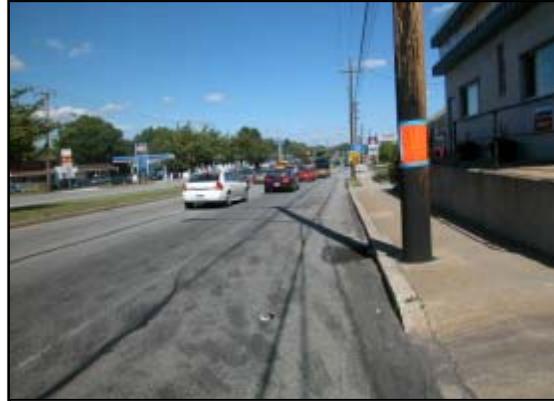
Figure 3. Area of impact with the parked GMC.

The front of the Toyota impacted the rear of the parked GMC on the shoulder (**Figure 3**). Due to the height of the GMC, the Toyota pitched downward as the vehicle crushed. This impact produced an underride damage pattern to the front of the Toyota. The resulting directions of force were 12 o'clock for the Toyota and 6 o'clock for the GMC. The GMC was beyond the scope of the WINSMASH program; therefore, the WINSMASH program's barrier equivalent algorithm was used to calculate a delta-V for the Toyota. The total delta-V for the Toyota was 30.0 km/h (18.6 mph). The longitudinal and lateral components were -30.0 (-18.6 mph) and 0 km/h, respectively. The Toyota's EDR maximum recorded delta-V was 42 km/h (26.1 mph) at 153.6 milliseconds, which was consistent with the damage to the vehicle. Due to the combination of the underride crash dynamics, averaged crush values, and the barrier equivalent algorithm, the WINSMASH calculated delta-V was underestimated. The Toyota's driver's frontal air bag deployed due to the severity of deceleration sustained during the impact.

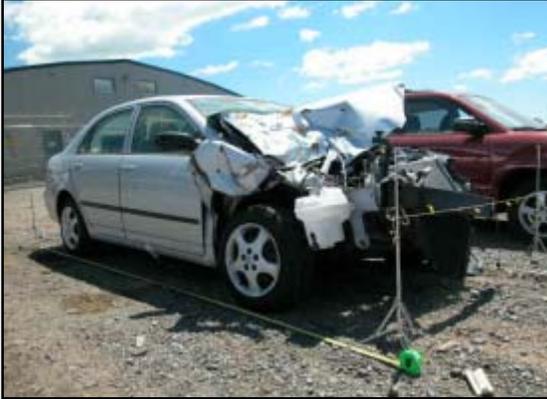
The 2006 Toyota Corolla sustained moderate severity frontal damage as a result of the impact with the GMC (**Figure 4**). The damage consisted of longitudinal deformation to the frontal structure that included the bumper fascia and support, upper radiator support, radiator, A/C condenser, hood, and the right front fender. Additionally, the hood contacted and fractured the windshield.

Figure 4. Overall view of the frontal damage.

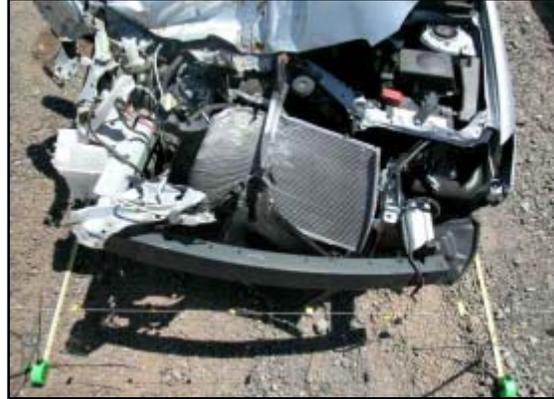
Figure 5. Overhead view of the residual crush to the frontal structure.

The direct contact damage began 5 cm (2.0”) left of the centerline and extended 66 cm (26.0”) to the right front fender. The total direct contact damage width measured 71 cm (28.0”). The impact resulted in an underride damage pattern; therefore, two crush profiles were documented at the bumper beam and the upper radiator support. The maximum crush at the bumper beam was 2 cm (0.8”) and was located 67 cm (26.4”) inboard of the left corner. The crush profile was documented across the full width of the bumper beam of 112 cm (44.0”) and were as follows: C1 = 0 cm, C2 = 0 cm, C3 = 2 cm (0.8”), C4 = 2 cm (0.8”), C5 = 2 cm (0.8”), C6 = 0 cm.

The maximum crush at the upper radiator support was 57 cm (22.4”) and was located 45 cm (17.6”) inboard of the right end. The residual crush at the upper radiator support was as follows: C1 = 0 cm, C2 = 17 cm (6.7”), C3 = 43 cm (16.9”), C4 = 57 cm (22.4”), C5 = 45 cm (17.7”), C6 = 53 cm (20.9”). An additional crush measurement was taken at the leading edge of the right fender, which yielded 45 cm (18.7”) of crush. **Figure 5** is overhead view of the crush to the frontal structure. The Collision Deformation Classification (CDC) for this impact was 12-FZEW-3.

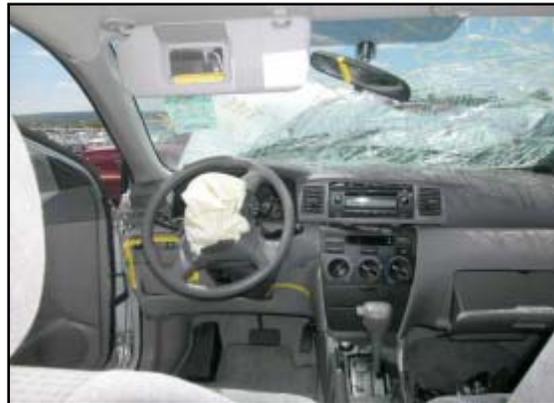
The interior of the Corolla sustained moderated severity damage that was attributed to occupant contact points. The occupant contact points consisted of two knee strikes to the knee bolster that resulted in approximately 3 cm (1.0”) of longitudinal deformation. These contacts to the knee bolster resulted in deformation to the center stack, which dislodged the trim panels for the HVAC, center vents, and the radio.

Although the driver contacted the deployed air bag, no contact evidence was present on the air bag. He loaded through the air bag resulting in 1 cm (0.4”) of deformation to the steering wheel rim and compression of the steering column. Due to the deformation of the knee bolster, the panel could not be removed to allow for an inspection of the shear capsules. To document the steering column compression, a measurement was taken from the top aspect of the steering wheel rim to the top of the left instrument panel. The steering column compression was 5 cm (2.1”).

The driver also contacted the sun visor with his head, which fractured the vanity mirror that was located on the inboard aspect of the sun visor. Additionally, the driver’s right hand contacted and displaced the rearview mirror downward and forward.

Damage was noted to the right front air bag cover flap that was mounted on the top of the instrument panel. This damage resulted from the hood crushing rearward which engaged the windshield. The hood and windshield continued rearward and contacted the cover flap deforming it downward into the air bag module. The total deformation was approximately 3 cm (1.0”) at the lower left corner of the air bag cover flap. There was no passenger compartment intrusion. **Figure 6** is an overall view of the driver’s contact points.

Figure 6. Overall view of the driver's contact points.

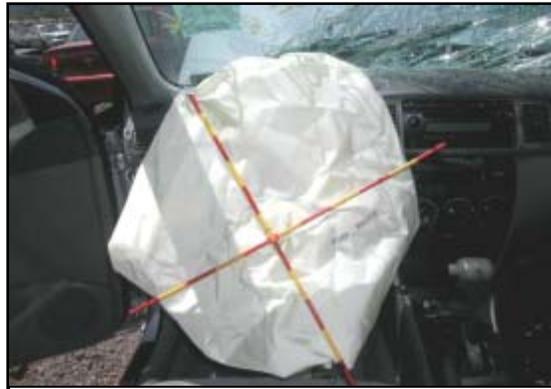
The driver’s air bag was conventionally located in the center of the steering wheel hub (**Figure 7**). Three T-shaped cover flaps were used to conceal the air bag. The top cover flap measured 15 cm (6.0”) in width and 9 cm (3.4”) in height. The lower cover flaps measured 7 cm (2.8) in width and 5 cm (1.8) in height. The air bag membrane measured 60 cm (23.5”) in diameter in its deflated state. The driver’s air bag was tethered by two wide band tethers that were located at the 9 and 3 o’clock positions on the face of the air

bag and measured 11 cm (4.3”). Two vent ports vented the airbag at the 11 and 1 o’clock positions on the rear panel. The maximum excursion of the air bag membrane at the tethers measured 36 cm (14.0”). Although the driver contacted the air bag, no occupant contacts were present on the air bag membrane. The following identifiers were printed on the face of the air bag:

Figure 7. Deployed driver's frontal air bag. Note the steering wheel was turned slightly left.
