15 Passenger Van Rollover Investigation / Vehicle Rollover
Dynamic Science, Inc. / Case Number: DS06012
2004 Ford E350 Van
Utah
May 2006

1. Report No. DS06012	2. Government Accession No.		3. Recipient Catalog No.	
4. Title and Subtitle 15 Passenger Van Rollover Investigation			5. Report Date August 25, 2006

This on-site investigation focused on a 2004 Ford E350 van involved in a rollover. This is a single vehicle crash that occurred in May 2006 in a rural area of Utah. The crash occurred on a US highway. The case vehicle is a 2004 Ford 15-passenger van. At the time of the crash, the van was being driven by a 32-year-old American driver who was transporting 13 international passengers. The passengers ranged in age from 20 to 33. The van was traveling northbound. As the vehicle attempted to pass another vehicle, the driver lost control of the vehicle due to a reported tire malfunction. The driver swerved left, then right, then departed the roadway and rolled several times. Seven passengers were ejected from the vehicle. One occupant, a 21-year-old male, sustained head injuries and died in the crash. The injured were taken to three separate hospitals.

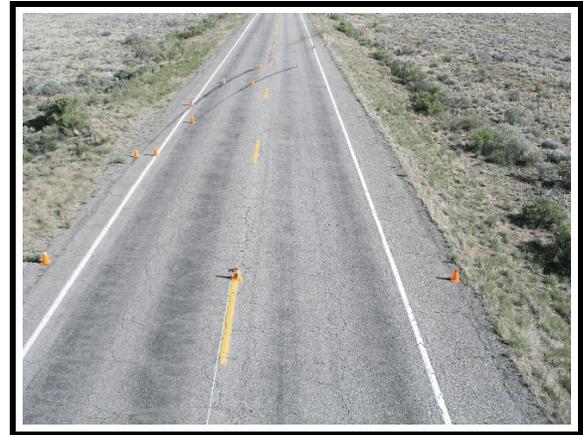
The driver lost control of the vehicle. The vehicle began a clockwise rotation, tripped and began a left side leading rollover. The vehicle rolled at least two times and came to rest on its wheels on the east roadside. Seven passengers were ejected from the vehicle. One occupant, a 21-year-old male, sustained head injuries and died in the crash. The injured were taken to three separate hospitals.

Figure 4. Overview of overturn and roadway departure area

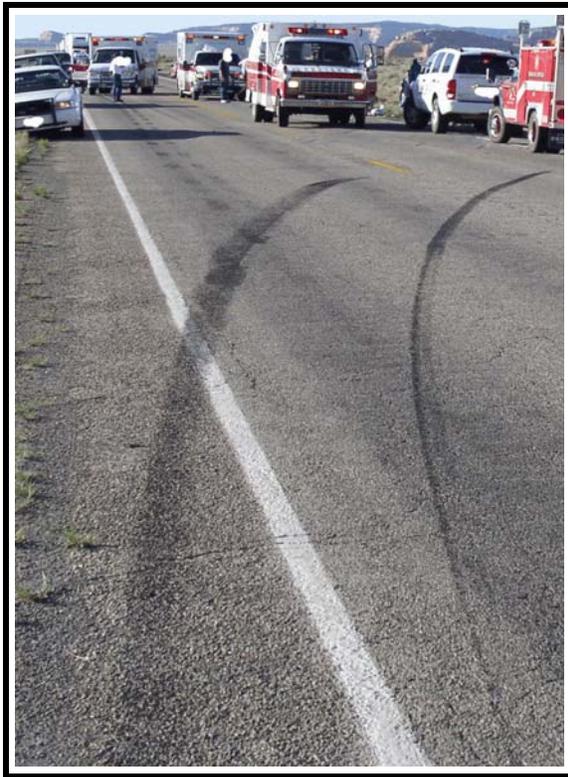
Figure 5. Left front and left rear tires approaching trip point

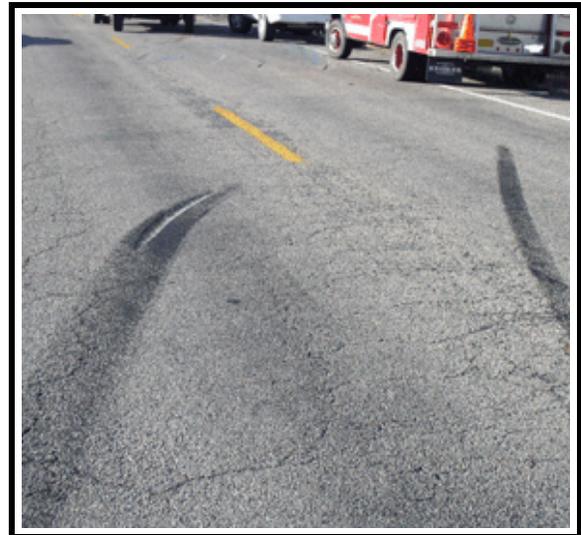
Figure 6. Left front and left rear tires at trip point—left rear gouging roadway

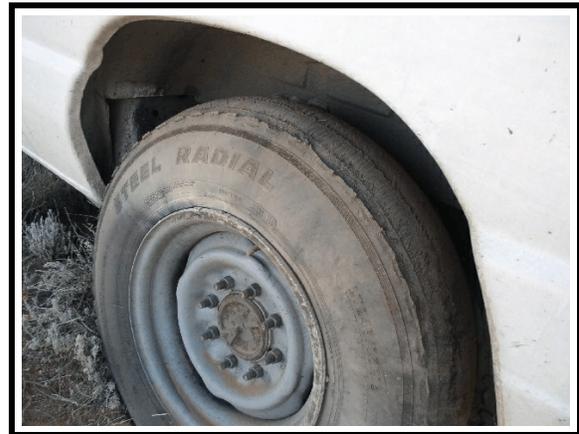
The 2004 Ford E350 van was equipped with Bridgestone LT245/75R16 V Steel tires on the front and Cooper Chaparral LT245/75R16 tires on the rear. The rear tires were manufactured for Del_Nat in Tennessee and the build date was the second week of February 2005. Both rear tires had been replaced prior to the vehicle inspection. The entire tread had come off the right rear tire. Approximately 91 cm (3 ft) of the tread was found under the right side fender well. The entire tread had come off the left rear tire. The tread had wrapped around the axle and wheel. The manufacturer's recommended cold tire pressure for the front and rear tires was 552 kPa (80 psi). The specific tire information is as follows:

Position	Measured Pressure	Measured Tread Depth	Restricted	Damage
LF	207 kPa (30 psi)	10 mm (12/32 in)	No	None
LR	Unknown	5-8 mm (6-10/32 in), inside to out	NA	Tread separation
RR	Unknown	2-6 mm (3-8/32 in), inside to out	NA	Tread separation
RF	545 kPa (79 psi)	10 mm (13/32 in)	No	None

Figure 7. Left rear tire (police photo)

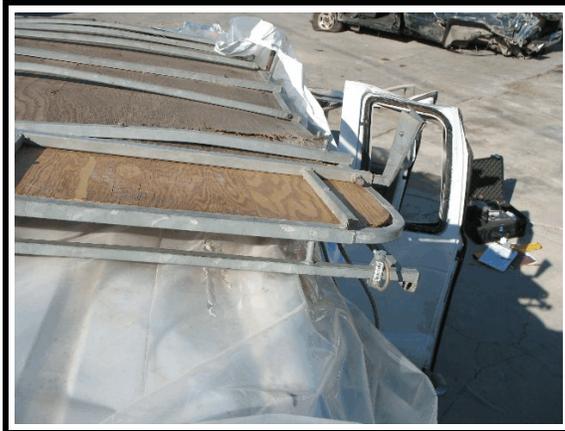
Figure 9. Roof attachment point

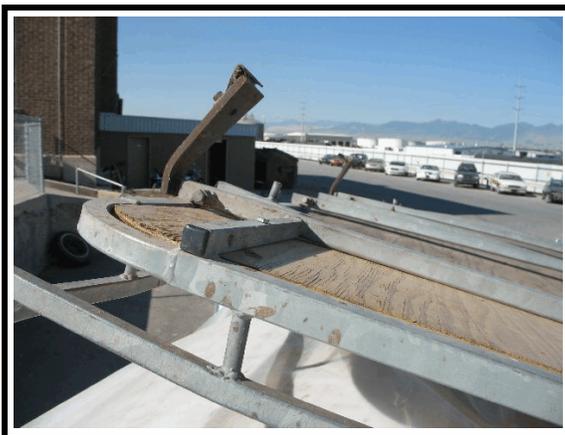
Figure 10. Roof attachment point

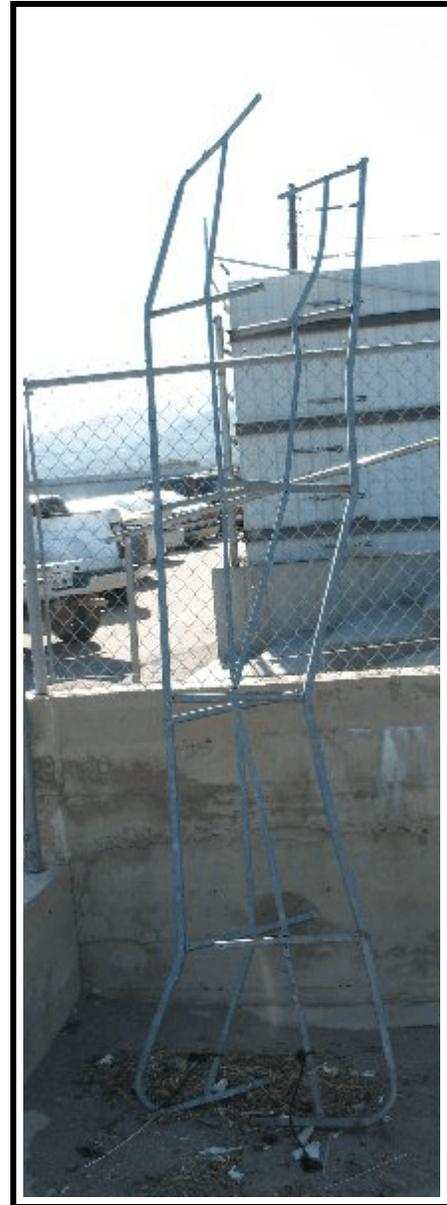
Figure 8. Roof rack side rail

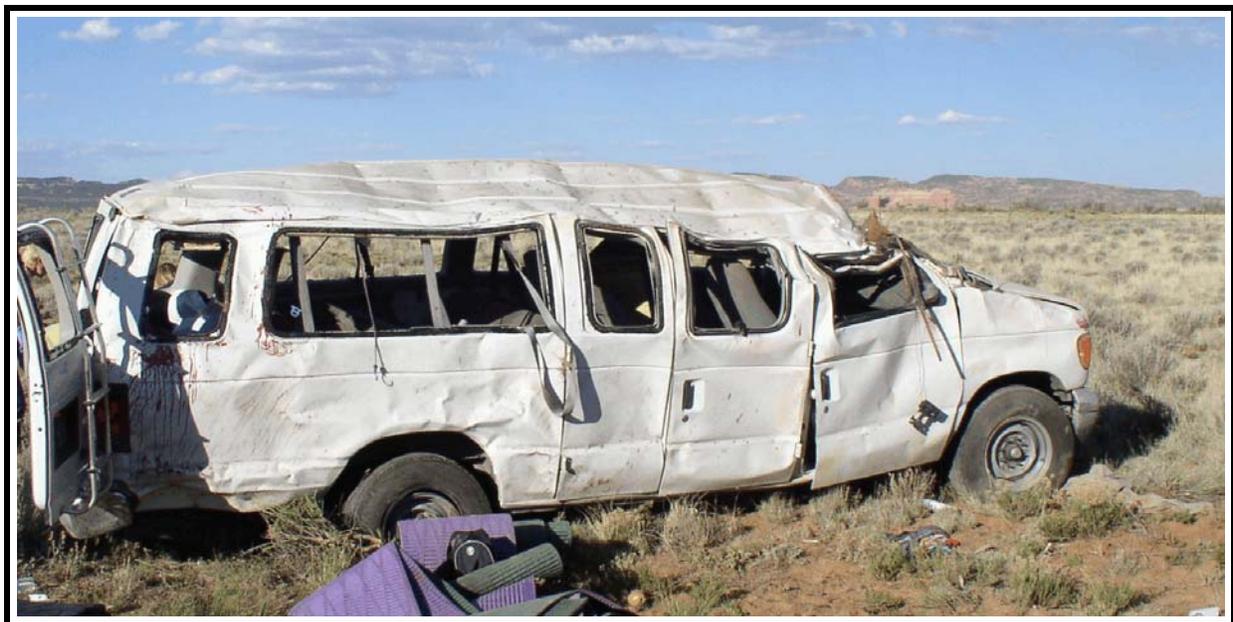
The 2004 Ford E350 van sustained moderate rollover damage to the roof and both sides of the vehicle. A Collision Deformation Classification (CDC) was assigned as 00TDDO3.

Pillar	Left	Right
A	12.0 cm (4.7 in) vertical	34.0 cm (13.3 in) vertical, 32.0 cm (12.6 in) lateral
B	6.0 cm (2.4 in) vertical	19.0 cm (7.5 in) vertical, 37.0 cm (14.6 in) lateral
C	3.0 cm (1.2 in) vertical	9.0 cm (3.5 in) vertical
D	2.0 cm (0.8 in) vertical	7.0 cm (2.8 in) vertical
E	None	2.0 cm (0.8 in) vertical

Figure 11. Right side, Ford E350

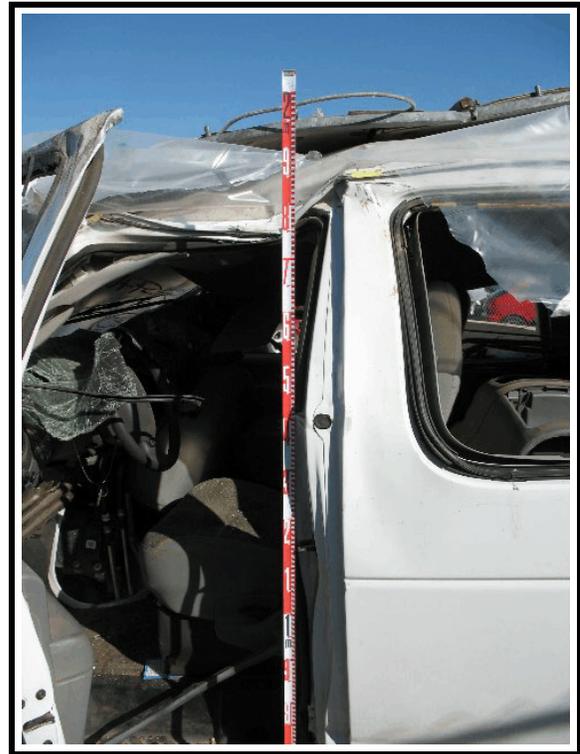
The 2004 Ford E350 sustained moderate interior damage from intrusion, occupant contacts and the failure of one of the bench seats. The glazing was disintegrated at every side glass location. The windshield was fractured. There was A pillar, B pillar, windshield header, roof rail and side rail intrusion to both front seat locations. There was roof and side rail intrusion located for each outboard seat location.

Figure 12. Left side roof rail intrusion

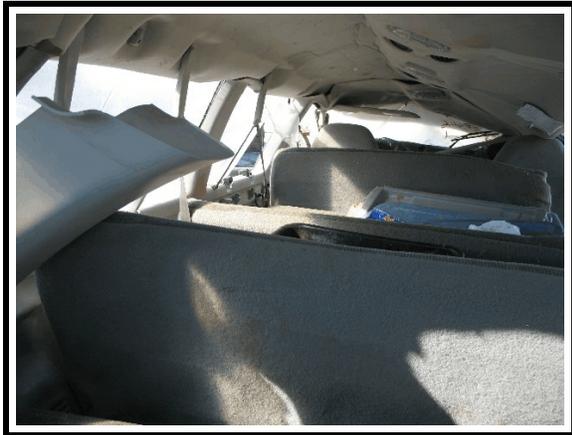
Position	Intruded Component	Magnitude of Intrusion	Direction
LF	A pillar	12.0 cm (4.7 in)	Vertical
LF	B pillar	10.0 cm (3.9 in)	Vertical
LF	Windshield header	14.0 cm (5.5 in)	Vertical
LF	Roof	10.0 cm (3.9in)	Vertical
LF	Left side rail	30.0 cm (11.8 in)	Vertical
RF	A pillar	40.0 cm (15.7 in)	Vertical
RF	Side rail	38.0 cm (14.9 in)	Vertical
RF	Roof	46.0 cm (18.1 in)	Vertical
RF	B pillar	42.0 cm (16.5 in)	Vertical
2nd row right	Side rail	34.0 cm (13.4 in)	Vertical
2nd row right	Roof	34.0 cm (13.4 in)	Vertical

Figure 13. Overview of intrusion, left side

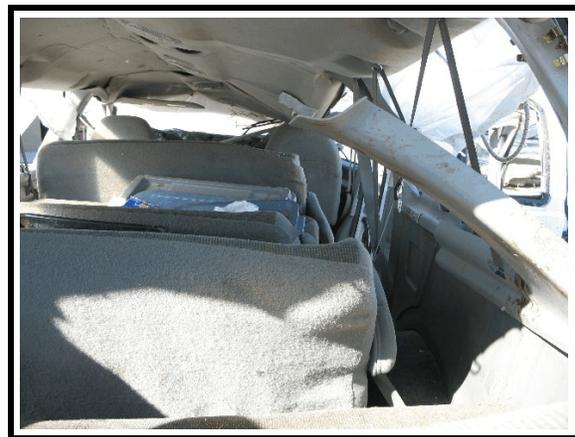
Position	Intruded Component	Magnitude of Intrusion	Direction
3rd row right	C pillar	13.0 cm (5.1 in)	Vertical
3rd row right	Roof	14.0 cm (5.5 in)	Vertical
3rd row right	C pillar	12.0 cm (4.7 in)	Lateral
4th/5th row right	Side rail	7.0 cm (2.8 in)	Vertical
4th/5th row right	Roof	9.0 cm (3.5 in)	Vertical
5 th row left	Fascia	38.0 cm (14.9 in)	Lateral
5 th row right	Fascia	32.0 cm (12.6 in)	Lateral

Figure 14. Overview of intrusion, right side

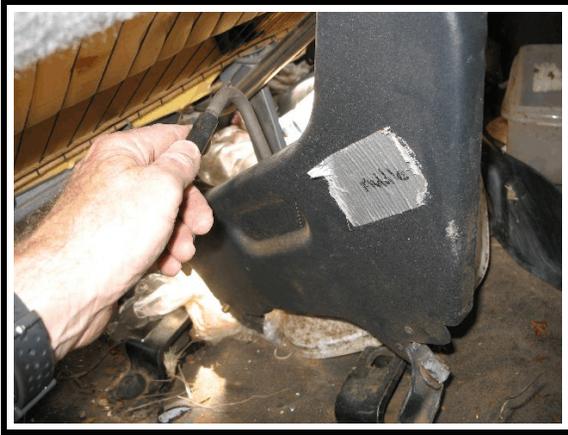
It appears that the double rear doors came open during the rollover. The right front door was jammed shut. There was blood found along the upper right side window frame adjacent to the third, fourth and fifth rows. The blood extended down the exterior right rear of the vehicle. The fifth row seat back was deformed. There was blood forward of the right D pillar. Brown scuff marks were located along the left interior roof, as well as above the third row seat. The third row seat was separated from its base. The seat is designed to be removable. A lever at the base is rotated rearward to unlock the seat from the floor attachment. At the time of the vehicle inspection, the seat was no longer locked in place and was rotated rearward at approximately a 45 degree angle.

Figure 15. Seat locking lever, third row right

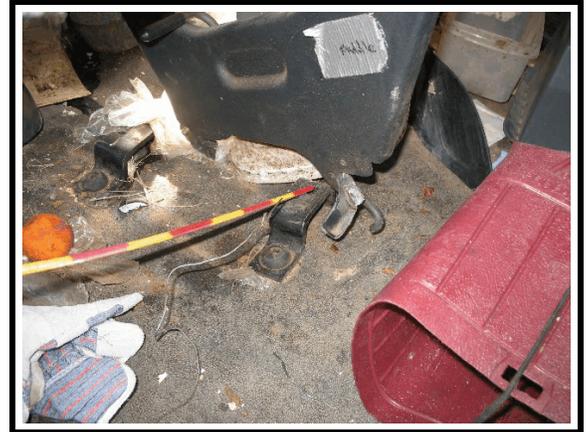
Figure 16. Seat locking attachment, third row right

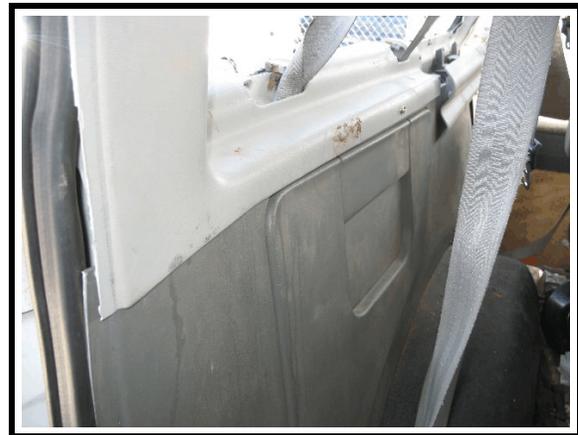
Figure 26. Blood splatter contact at side glass frame

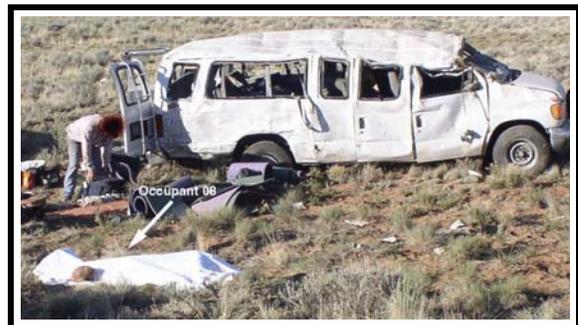
Figure 27. Final rest, Occupant 08

right. The seat base separated from the vehicle. It appears that this occupant was fully ejected from the vehicle through the right side window. This occupant was fatally injured. The time of death was indicated to have been immediate. The Certificate of Death indicated that he had died due to a blunt head trauma.

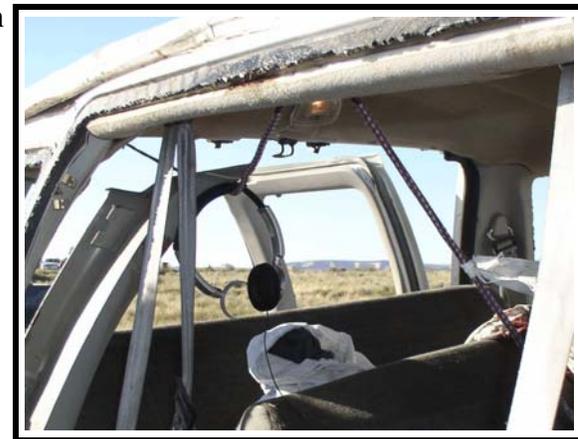
Figure 29. Close up of blood/hair at right rear window

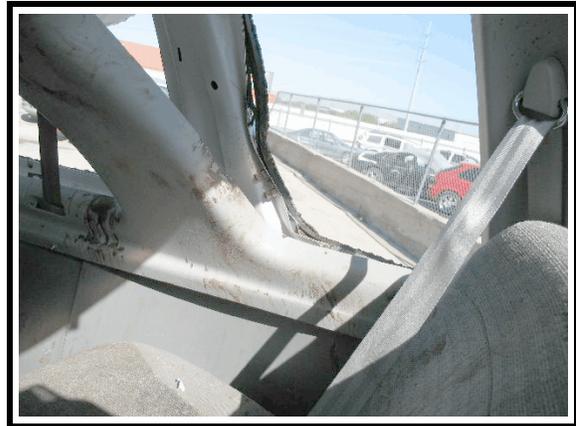
<u>Injury</u>	<u>OIC Code</u>	<u>Injury Mechanism</u>	<u>Confidence Level</u>
Fracture, closed, nose	251002.2,4	D pillar, right	Probable
Multiple blowout fractures, left orbit (medial orbital wall, ethmoid sinus and left orbital wall	251204.3,2	D pillar, right	Probable
Multiple abrasions, left lower leg	890202.1,2	Ground	Probable
Multiple abrasions, right and left hands	790202.1,3	Ground	Probable
Contusion, left orbit (soft tissue)	297402.1,2	D pillar, right	Probable
Laceration NFS, right upper lip	290600.1,8	Ground	Probable
Fractures, upper and lower incisors	251404.1,8	D pillar, right	Probable

Figure 31. Contact to D pillar from Occupant 12.
