**CALSPAN ON-SITE POTENTIAL SAFETY-RELATED
DEFECT CRASH INVESTIGATION**

SCI CASE: CA06-019

**VEHICLE: 1997 FORD EXPLORER
LOCATION: GEORGIA
CRASH DATE: MAY 2005**

<p>14. <i>Sponsoring Agency Code</i></p>	
<p>15. <i>Supplementary Note</i> An investigation of an alleged tread separation on a 1997 Ford Explorer involved in a subsequent rollover crash.</p>			
<p>16. <i>Abstract</i> This on-site investigation focused on an alleged safety-related defect that involved the tread separation of the left rear tire on a 1997 Ford Explorer sport utility vehicle. The Ford Explorer was eastbound on the inboard lane of a two-lane divided interstate highway at highway speed. The Ford was driven by a 19 year old unrestrained male and was occupied by a 19 year unrestrained female in the front right position, and two unrestrained males in the rear seat. As the driver was proceeding on the roadway, the left rear passenger reported that he heard a loud explosion from the left rear area of the vehicle. The driver steered the Ford Explorer toward the right shoulder and as he crossed the rumble strips, he over-steered the vehicle to the left to regain the travel lane. The Explorer subsequently tripped an

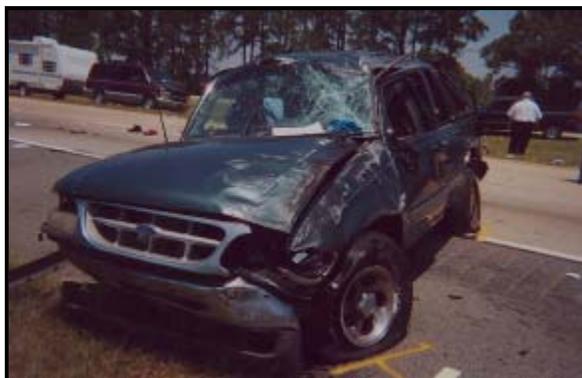
This on-site investigation focused on an alleged safety-related defect that involved the tread separation of the left rear tire on a 1997 Ford Explorer sport utility vehicle, **Figure 1**. The Ford Explorer was eastbound on the inboard lane of a two-lane divided interstate highway at highway speed. The Ford was driven by a 19 year old unrestrained male and was occupied by a 19 year unrestrained female in the front right position, and two unrestrained males in the rear seat. As the driver was proceeding on the roadway, the left rear passenger reported that he heard a loud explosion from the left rear area of the vehicle. The driver steered the Ford Explorer toward the right shoulder and as he crossed the rumble strips, he over-steered the vehicle to the left to regain the travel lane. The Explorer subsequently tripped and initiated a right side leading rollover event. The driver and the three unrestrained passengers were ejected during the 12 quarter turn rollover sequence. The driver expired two days following the crash and the female front right passenger was pronounced deceased at the scene. The two males occupants seated in the rear of the vehicle survived the crash. The crash occurred during the daylight hours of May, 2005 in the state of Georgia. The weather was clear and not a crash factor.

Figure 1: 1997 Ford Explorer

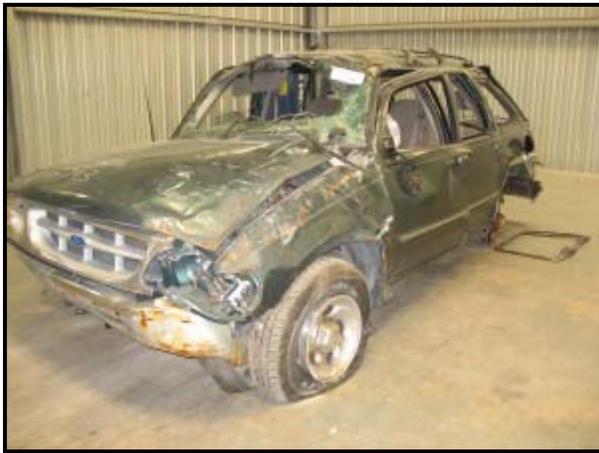
Figure 2: Left front oblique.

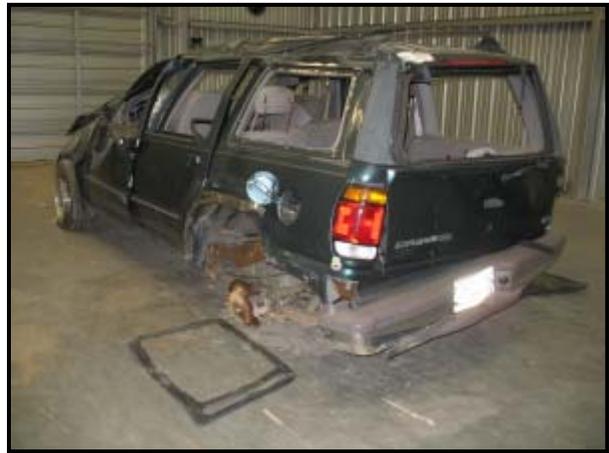
Figure 3: Left rear oblique.

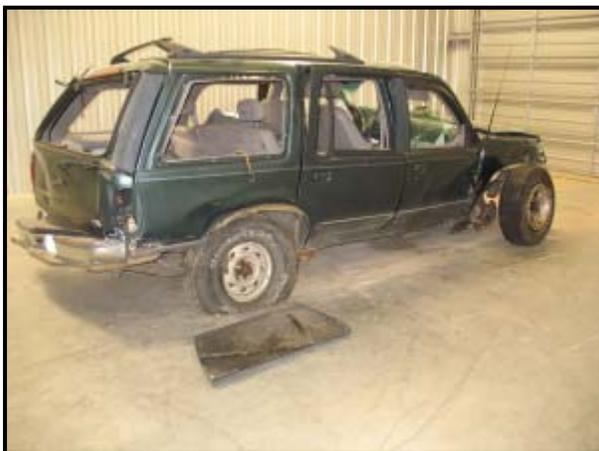
Figure 4: Right rear oblique

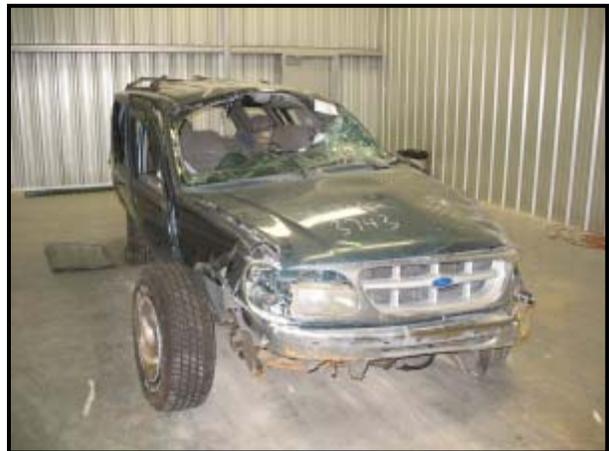
Figure 5: Right front oblique.

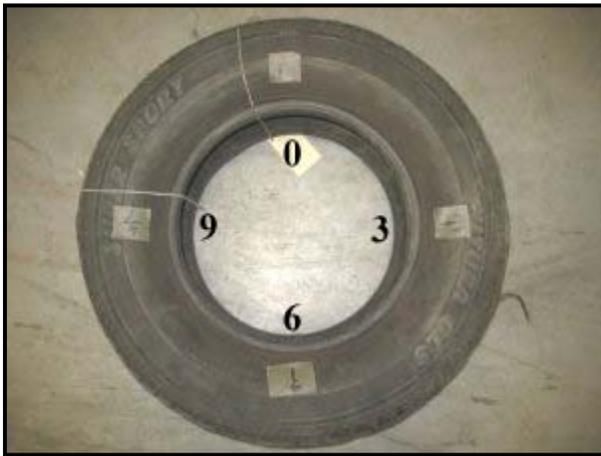
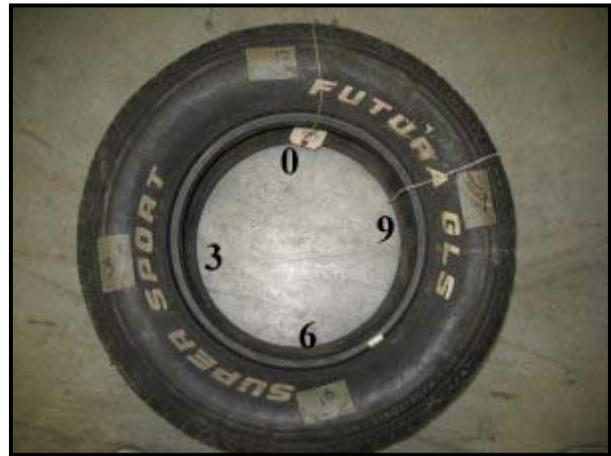
The general condition of the tire, **Figures 6 and 7**, was considered to be worn. The sidewalls of the tire were dry rotted at the shoulder around the entire circumference. The tread was thoroughly worn as noted above (center tread 1/32 in). The tread and casing had been punctured twice and repaired by fiber plugs. The two plugs (identified by P1 and P2) were located 46 cm

Figure 6: DOT side of tire (inboard).

Figure 7: Non-DOT side (outboard).

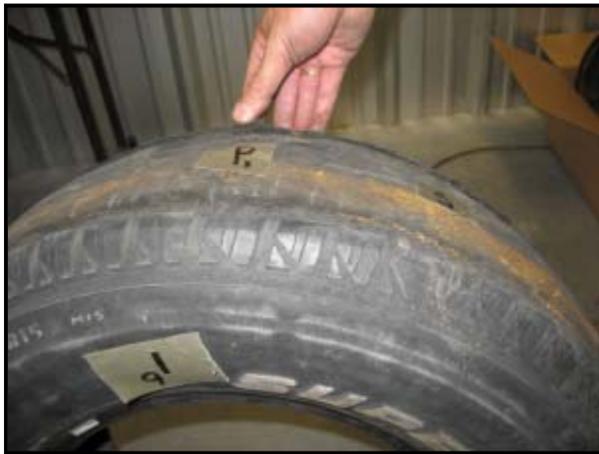
(18.25 in) apart. Plug P1 was located between the 5 and 6 o'clock sectors, **Figure 8**. Plug P2 was located at 8 o'clock. The remains of a screw [approximately 16 mm (5/8 in) in length] were present in the tread. The screw (located at 5 o'clock) became embedded at an angle and the head of the screw was worn away. Refer to **Figure 9**. Inspection of the tread in this area indicated the screw penetrated the first steel ply and abraded the second steel ply but did not puncture through. A failure line was noted emanating from the screw's location along the ply diagonally to the shoulder, **Figures 9 and 10**. The tire sustained a 100 percent circumferential separation of the tread from the tire casing, **Figures 11-13**. The separation occurred between the 2 steel plies and along both shoulders. The separated tread measured 226 cm (89 in) in total length. The age and multiple punctures and repairs to the tire were probable contributing factors in the tread separation.

Figure 8: Plug P1 and screw S at 5 to 6 o'clock Non DOT side shown.

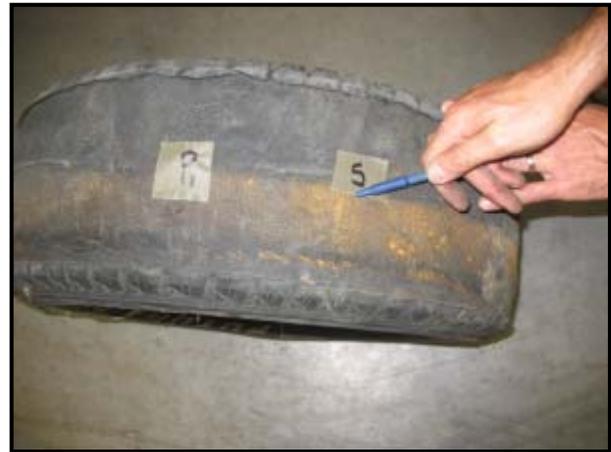
Figure 9: Plug P1 and screws. Note, the diagonal line emanating from S.

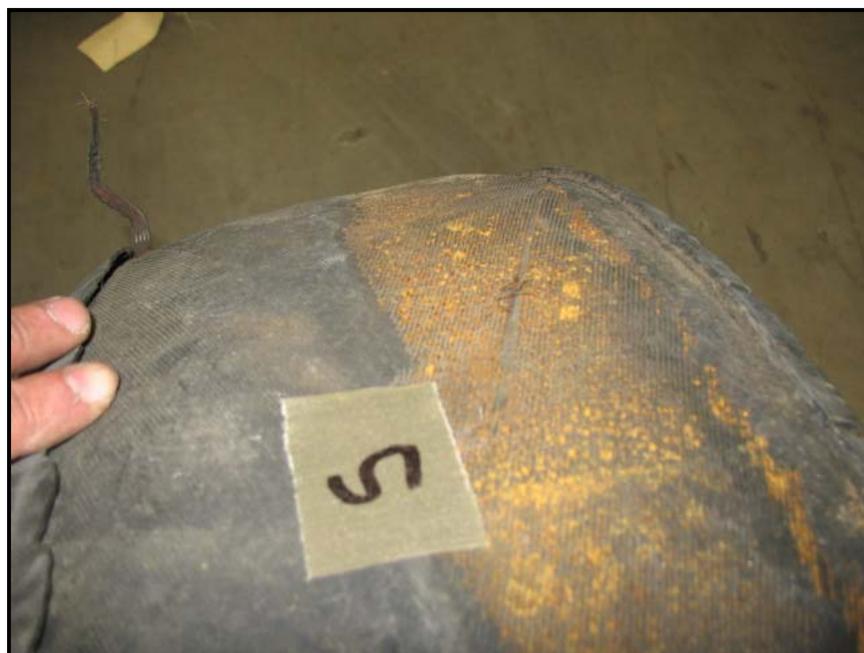
Figure 10: Close-up view of the detread at S.

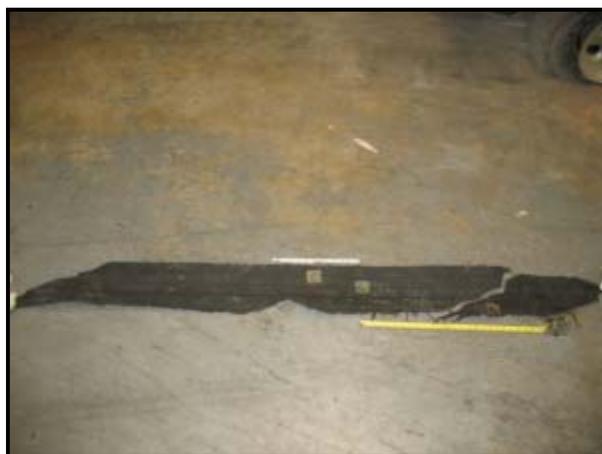
Figure 11: Tire tread exterior surface.

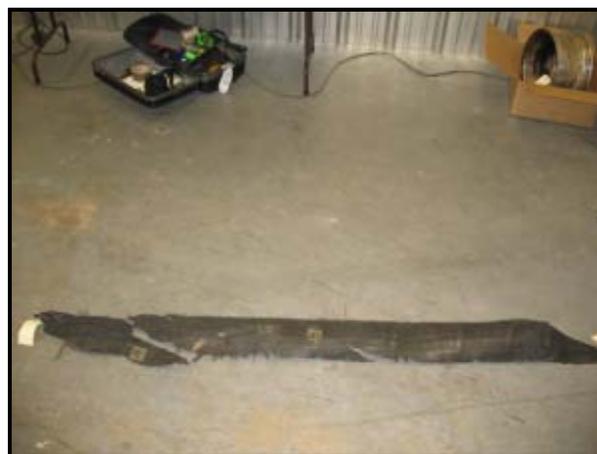
Figure 12: Tread interior surface.

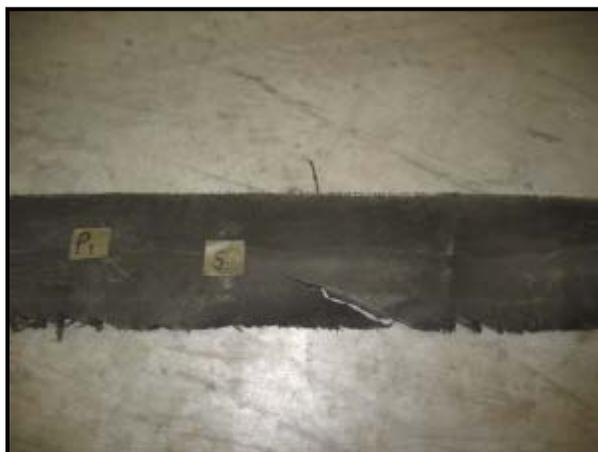
Figure 13: Close-up of interior surface at S.
